INSPECTION AND STRUCTURAL EVALUATION OF THE WILLIAM POWELL BRIDGE IN MIAMI-DADE COUNTY, FLORIDA

Bradley J. Bell, PE, Gannett Fleming, Inc., Orlando, FL

ABSTRACT

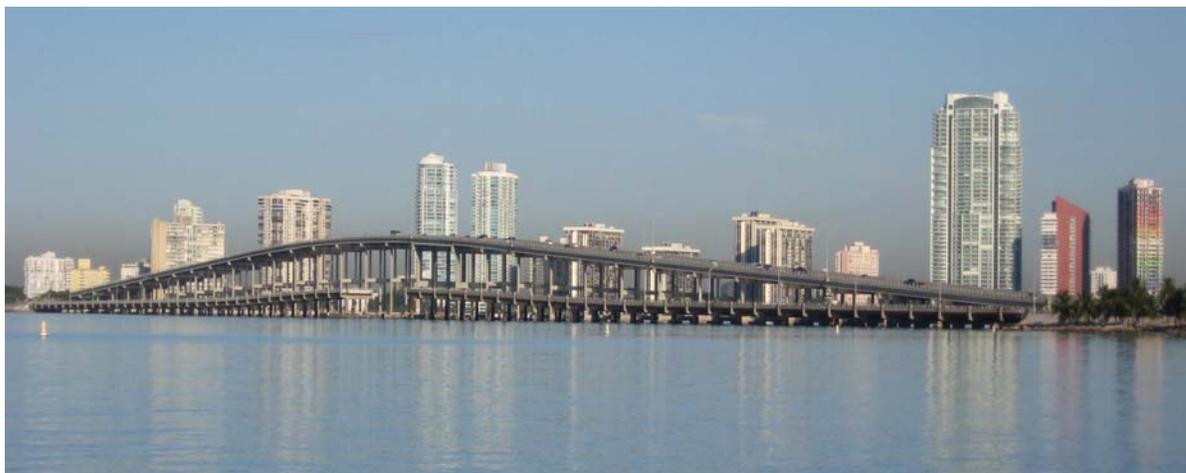
Photo 1. Elevation of William Powell Bridge

The William Powell Bridge (Photo 1) is a high-level crossing of the Intracoastal Waterway and a dominating feature of the Rickenbacker Causeway, which provides a link from the Miami mainland to Virginia Key and the resort island of Key Biscayne. Rising to a height of over 90', the thirty-five span structure carries three westbound traffic lanes, two eastbound traffic lanes, two 8' shoulders, two 4' shoulders, and an 8' sidewalk across the navigable portion of the Intracoastal Waterway. Constructed in 1985, the 3611' long bridge replaced the outdated structure immediately to the south, which has since been restricted to pedestrian traffic and converted to fishing piers.

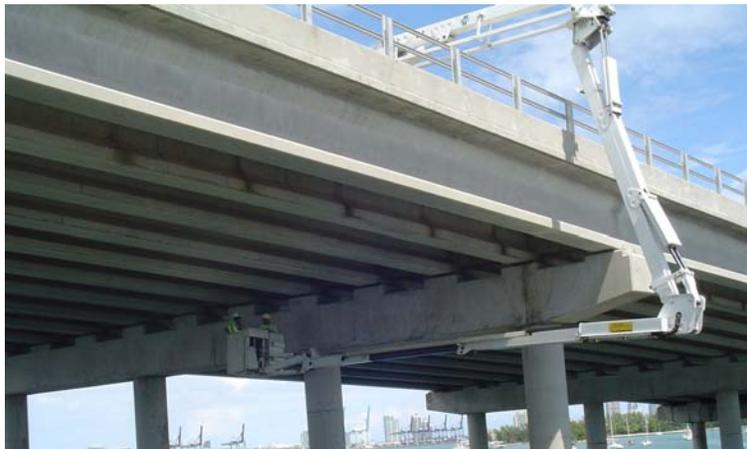
Photo 2. Access to Pier Caps with Aspen Aerial

A condition inspection of the William Powell Bridge was performed from September 24 - 28, 2007. This operation required the use of an Aspen Aerial UB-50 snooper under bridge inspection vehicle to access the caps (Photo 2) and the closure of one traffic lane, which was accommodated through an MOT plan based on the provisions presented in FDOT standards.

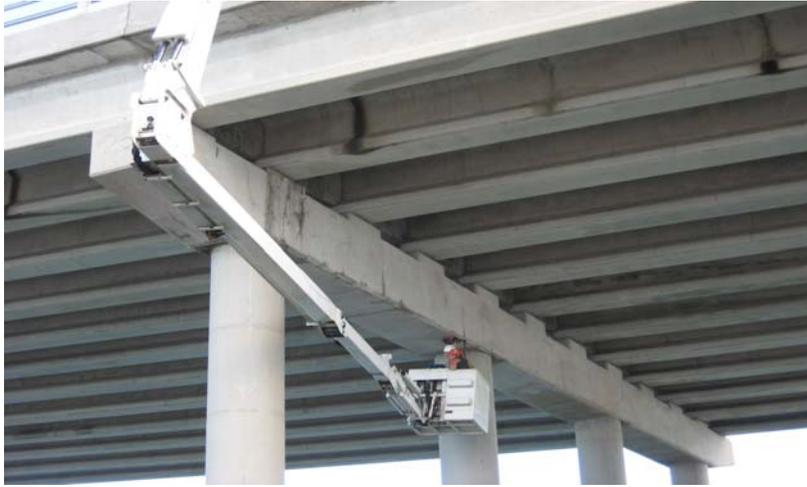
Photo 3. GPR Scan of Representative Pier Cap

GPR surveys were conducted on the south half of pier caps 25 and 32 (Photo 3). These caps exhibit extensive cracking and appeared to be good candidates for such investigations. Vertical and horizontal scans were made on the side and bottom faces of the caps to determine the number and approximate size of longitudinal and transverse reinforcement, as well as to assure the soundness of the concrete. The GPR study confirmed the steel provided in the pier caps is in conformance with the design documents.

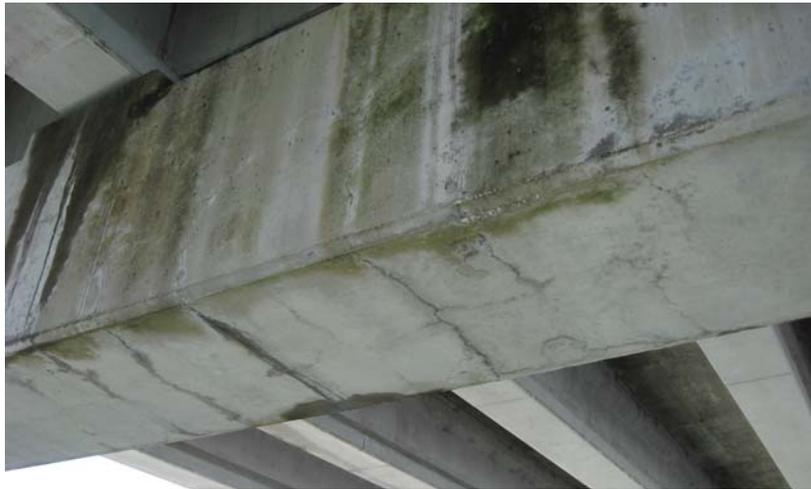
Photo 4. Typical Cracks in Positive Moment Region Between Columns

The flexural cracks present in the bottom of the caps between columns (Photo 4) are not a major concern in terms of the integrity of the structure. At these locations the stress trajectories are relatively flat given that shear stresses are low, and longitudinal reinforcement is provided in the same plane to resist tension the cracked concrete is no longer able to carry. In fact it is necessary for concrete to crack in order to transmit significant force to the reinforcing steel, and these cracks are evidence of that. The behavior at these locations is similar to that of shallow beams, which was well defined in the codes used to design the caps. Cracks in this region were less than 0.010", which is in the expected range of normal behavior and fine enough to limit the penetration of detrimental substances that can corrode the steel.

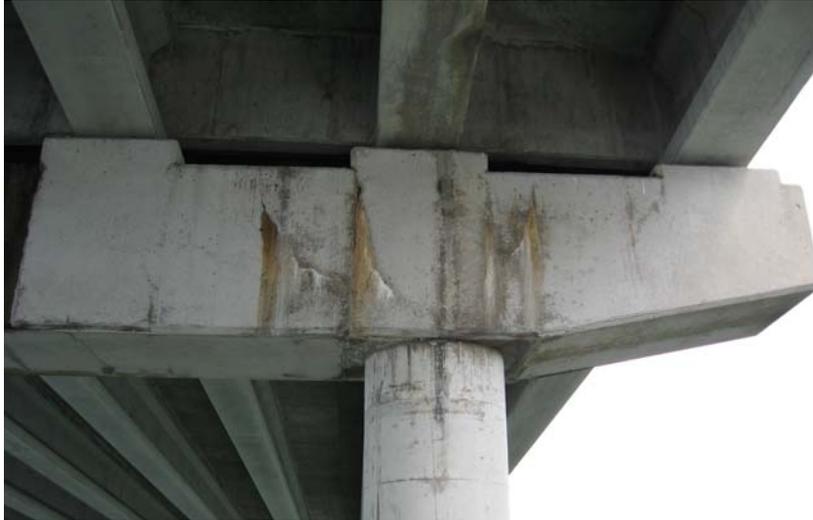
Photo 5. Typical Crack Pattern in Cantilever and Over Exterior Column

The cracks present in the cantilever and over the columns, specifically over the exterior columns on the south side, are a little more significant (Photo 5). The magnitude and pattern of these cracks are indicative of reinforcement overstress and/or inadequate development, for what was observed is not typical behavior. Most of the cracks are fine, with widths less than 0.010" common, though a limited number of widths up to 0.060" were measured. The current edition of the *AASHTO LRFD Bridge Design Specifications* limits crack width to 0.017", a value that is significantly exceeded in these localized areas. Many of the cracks contain leakage with white and brown efflorescence, especially those located at piers supporting an expansion joint. The concrete was sound around these cracks, inferring that excessive corrosion of the reinforcement has not yet developed. It does, however, signify breakdown of the epoxy coating and deterioration of the reinforcement is occurring.

Though documentation presenting the history of these cracks does not exist, some assumptions can be made as to their origin. Many of the cracks propagating from the top of the cap near the bearing seats could have occurred during construction, being associated with early shrinkage due to the abrupt change in section and/or early form removal. The cracks would have initially been small, and grew due to the application of additional loads and the creep effect of concrete. Map cracking may be the result of insufficient consolidation of the concrete, leaving an imperfect finish susceptible to such deficiencies. The fact that cracking is more prevalent on the south side can be attributed to meteorological conditions. The south side is exposed to direct sunlight, resulting in the potential for extreme volume changes due to thermal effects not experienced on the shaded north side. With time, this cyclic load could exacerbate cracks already in existence.

Calculations do not indicate there is danger of catastrophic collapse, though the caps currently exhibit flexural and flexural-shear deficiencies. The behavior of such elements in this condition is difficult to predict, and corrective procedures can vary from minimal operations to the most extreme of retrofits. As a minimum, the cracks need to be monitored on a regular basis. Phase II of the project, which is currently underway, involves the installation of crack gauges on several of the pier caps so consistent measurements can be taken and maintained, allowing it to be identified if the cracks are continuing to propagate or if their growth has arrested. If the cracks have arrested, no further action is required with the exception of sealing the cracks with an FDOT approved penetrating sealant. If the cracks are continuing to grow, however, additional steps may have to be taken. Such action could include externally post-tensioning or carbon fiber wrapping the caps to increase their load carrying capacity. Concrete core samples can also be taken to determine the actual compressive strength of the concrete and, in turn, get a better grasp of the ultimate load carrying capacity of the member.
