PRECAST REPAIR OF BRIDGE APPROACH SLAB SUPPORT

Bridge owners are frequently faced with the need to replace critical bridge components during strictly limited or overnight road closure periods. This paper presents the development, testing, installation and monitoring of precast concrete bridge elements specifically designed for the Iowa Department of Transportation to address this condition.

A rapid precast paving notch replacement has been developed, which could be installed quickly using a single overnight bridge closure. The system consists of a precast prestressed concrete support that is connected to the rear of the abutment backwall using high-strength stainless steel rods and epoxy adhesive. Researchers at Iowa State University have performed full-scale laboratory testing of the paving notch replacement system and the Iowa Department of Transportation did a demonstration project on a bridge repair in central Iowa in the summer of 2007.

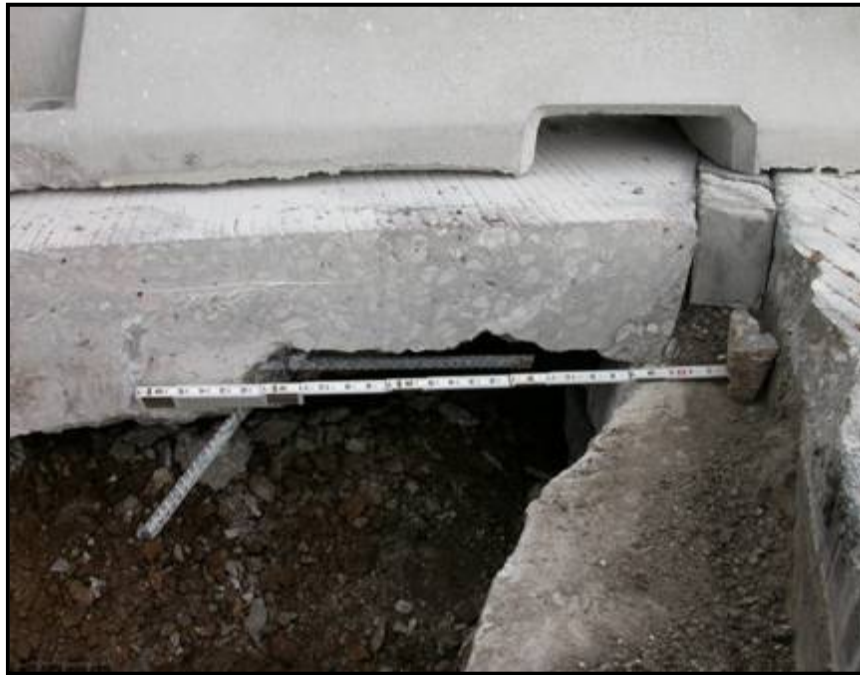
Approach pavement settlement at the end of bridges has been an ongoing problem for Iowa bridges. The failure of the bridge paving support, generally referred to as the “paving notch”, has been documented through previous investigation by the Iowa Department of Transportation (Iowa DOT) as a contributing factor in this settlement. Figure 1 presents an example of a deteriorated paving notch that has been uncovered.

Figure 1. Deteriorated paving notch on an integral abutment bridge.

Deterioration of the paving notch is due to a combination of circumstances including:

1. Improper construction of the approach pavement. During casting of the approach pavement, the top of the paving notch is not properly cleaned off resulting in overstresses condition due to uneven bearing of the approach slab on the notch.
2. Debris collecting in the open joint between abutment and approach pavement. This debris is compacted each time the bridge expands with annual thermal cycles, allowing additional material to accumulate. Over the course of time, the approach pavement is “pushed” off the paving notch.
3. Improper installation of reinforcing steel in both the paving notch and the end of the approach pavement. The result is un-reinforced areas that are prone to spalling. Insufficient attention by contractors and inspection personnel has been identified as one of the leading causes of this condition.

4. Settlement and erosion of the backfill material beneath the approach pavement permit the pavement to rotate and may create a localized loading at the tip of the paving notch.

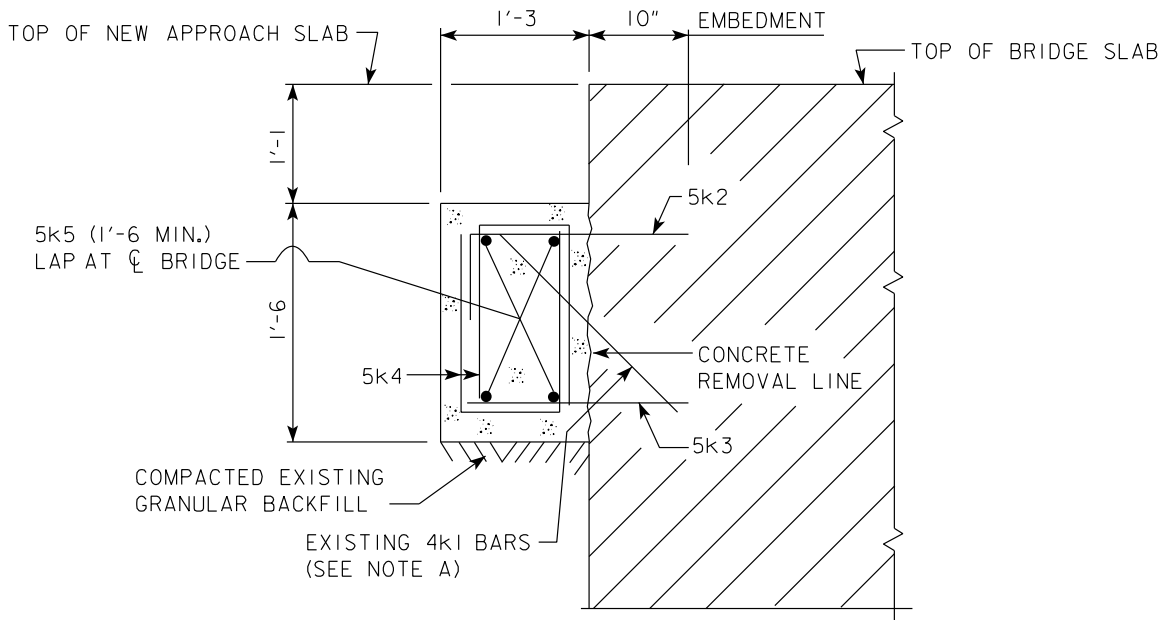
The current repair method by the Iowa Department of Transportation consists of removing the deteriorated paving notch concrete while preserving as much of the existing reinforcing as possible. Wood forms are constructed, and a cast-in-place concrete paving notch is placed (See Figure 2). Following sufficient curing of the new support, a replacement approach slab pavement is constructed.

Figure 2. Cast-in-place paving support

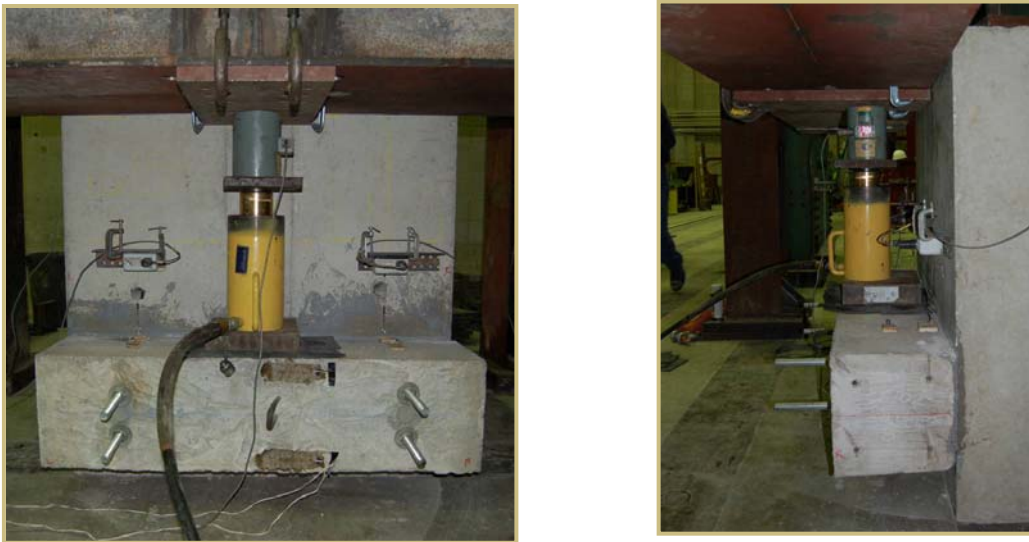
Before this system was used in the field, a series of tests were performed by the Bridge Engineering Center (BEC) at Iowa State University (ISU) to determine the fatigue capacity and ultimate capacity of the system. The laboratory test specimen consisted of 1'-0 x 1'-0 x 4'-0 precast sections. Test loads were applied to simulate an AASHTO HS-20 wheel load of 16 kips. One million cycles of a 16 kip load was applied followed by 100,000 cycles with a 32 kip load. The specimen was then loaded to an ultimate load of 122 kips before failure (see Figure 3 for details of the test setup). Results of these tests were presented at the 2006 PCI National Bridge Conference.

Figure 3. Laboratory testing of support

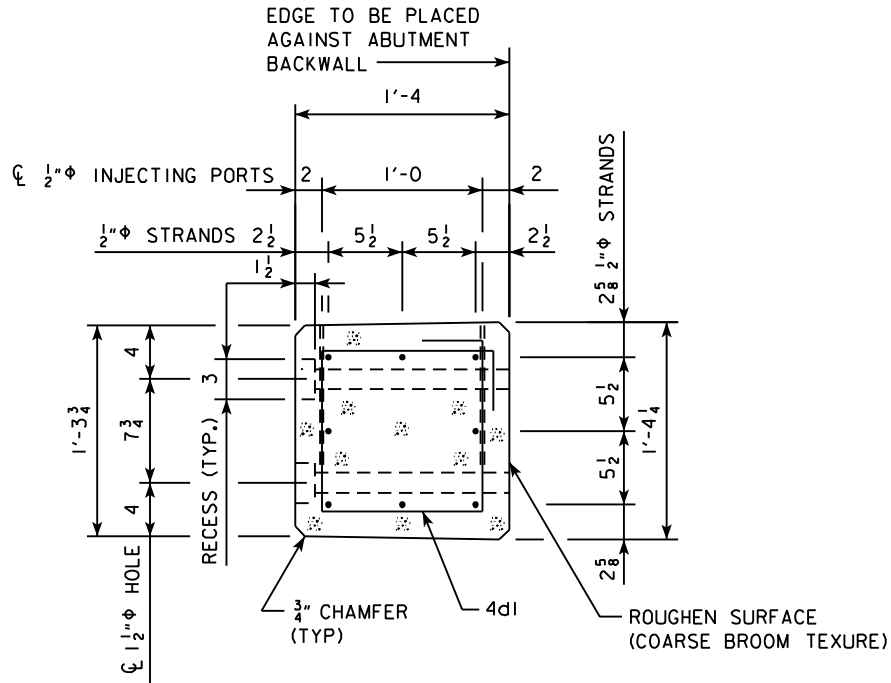
Based on the laboratory testing, a 1'-4" x 1'-4" cross section was chosen for the project, which allowed local fabricators to use standard precast pile forms for the section. The section used eight - ½ inch strands that were stressed to 75% of guaranteed ultimate for an initial prestress force of 248 kips. The design compressive strengths for release and final were 4,500 psi and 6,000 psi, respectively. The initial duct size for the threaded rod anchors was 1½ inches, which was revised during shop drawing review to 2 inches, to allow proper connection of the ½ inch diameter grout ports. In addition, the ends of each section were sealed with epoxy to prevent corrosion of the strands. See Figure 5 for cross section details.

Figure 5. Selected precast section

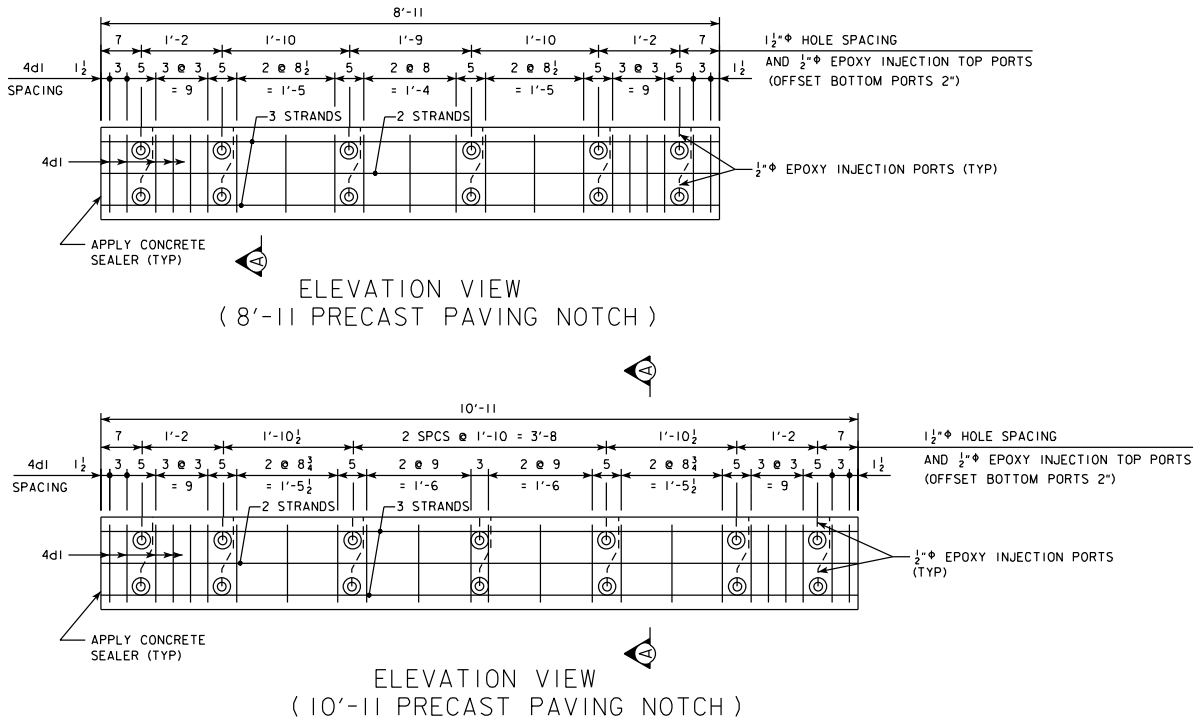
Four precast sections per abutment (two 8'-11" and two 10'-11" long sections) were provided. To connect to the backwall, pairs of 3/4 inch diameter stainless steel threaded rods were epoxy grouted into the backwall at 1'-2 to 1'-10 spacing. The units were installed to match the existing crown of the bridge at 1.5 percent cross-slope. To allow for construction tolerances, 1" and 1/2" gaps were provided between units at the centerline and at the gutterline, respectively. After attachment of the precast section to the backwall, the ducts in the precast unit were be injected with an epoxy grout through the 1/2" diameter grout ports (see Figure 6).

Figure 6. Elevation View of Two Precast Sections

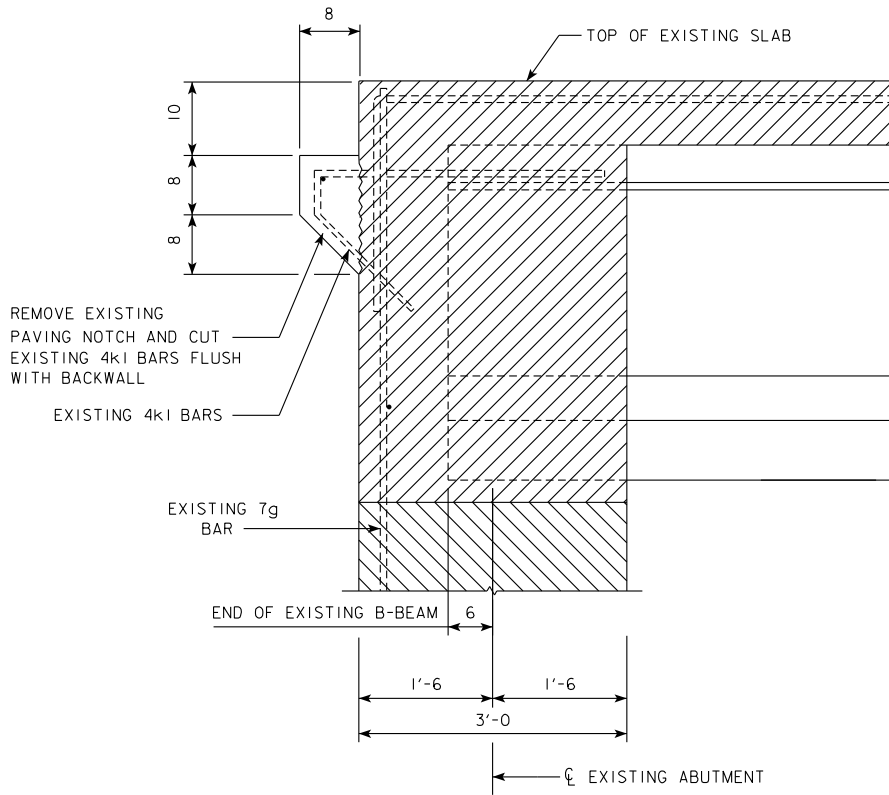
The existing paving block shown in Figure 7 was removed flush with the back-wall. The replacement precast unit was connected to the existing backwall with 3/4 inch diameter stainless steel dowels drilled in and epoxy grouted as shown in Figure 8 and 9. The dowels were anchored approximately 1'-0" into the existing backwall to avoid the existing prestressed beam. In the design details an attempt was made to miss the existing reinforcing steel in the backwall. The new notch was lowered 3 inches for the larger thickness of the replacement approach pavement of 1'-1". See Figure 9.

Figure 7. Side view of existing bridge abutment

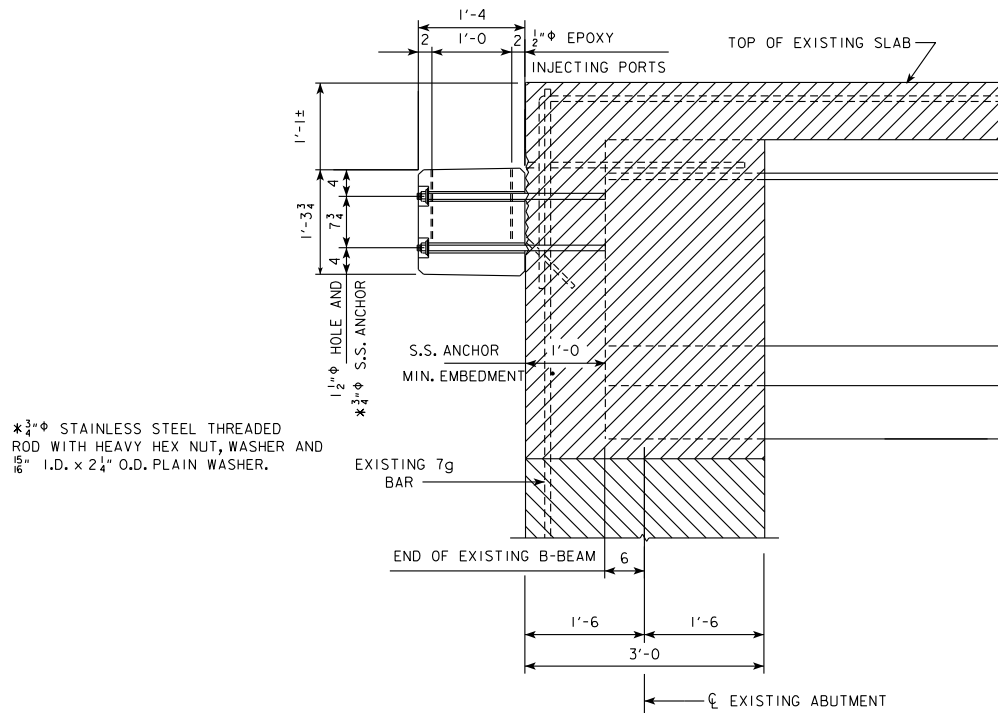
Figure 8. Side view of existing bridge abutment w/ precast section

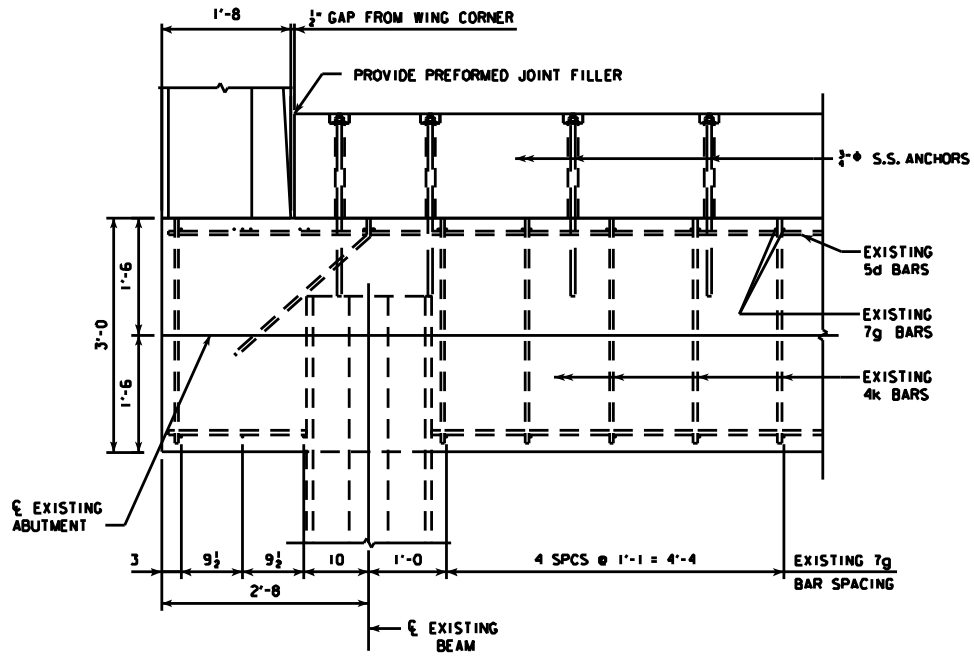
Figure 9 Part Plan View at Abutment Gutterline

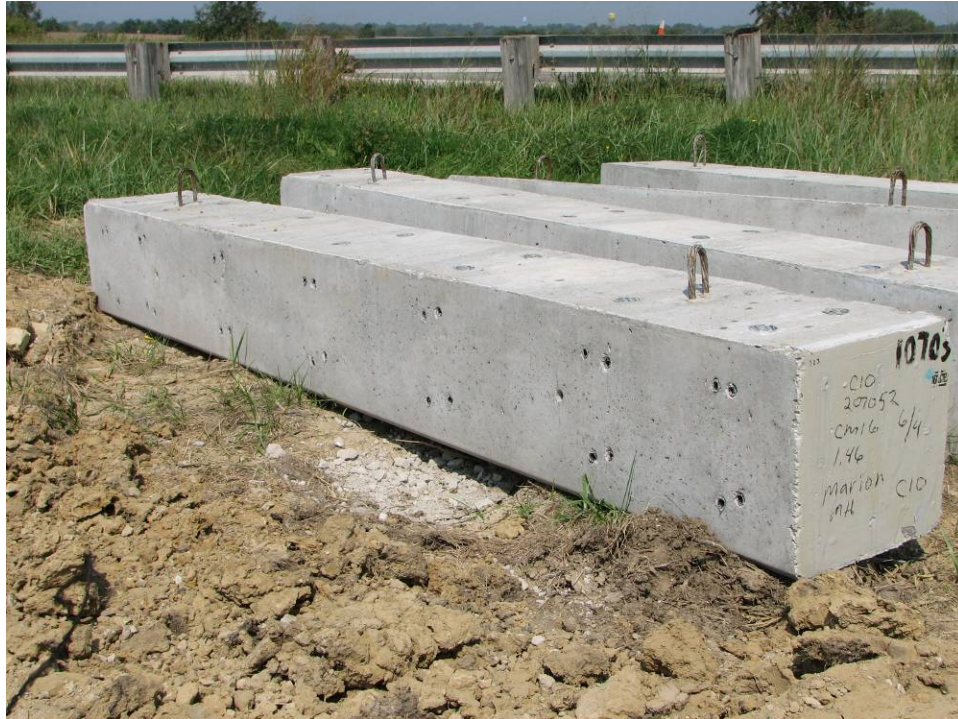
The following sequence of pictures shows the field installation of the precast sections. Installation went smoothly; however, the contractor was not under time constraint for this demonstration project. Figure 10 is a view of the precast sections on their side at the construction site before installation. Note the ends were sealed with an epoxy compound to prevent corrosion of the strands.

Figure 10. Precast units at the bridge site

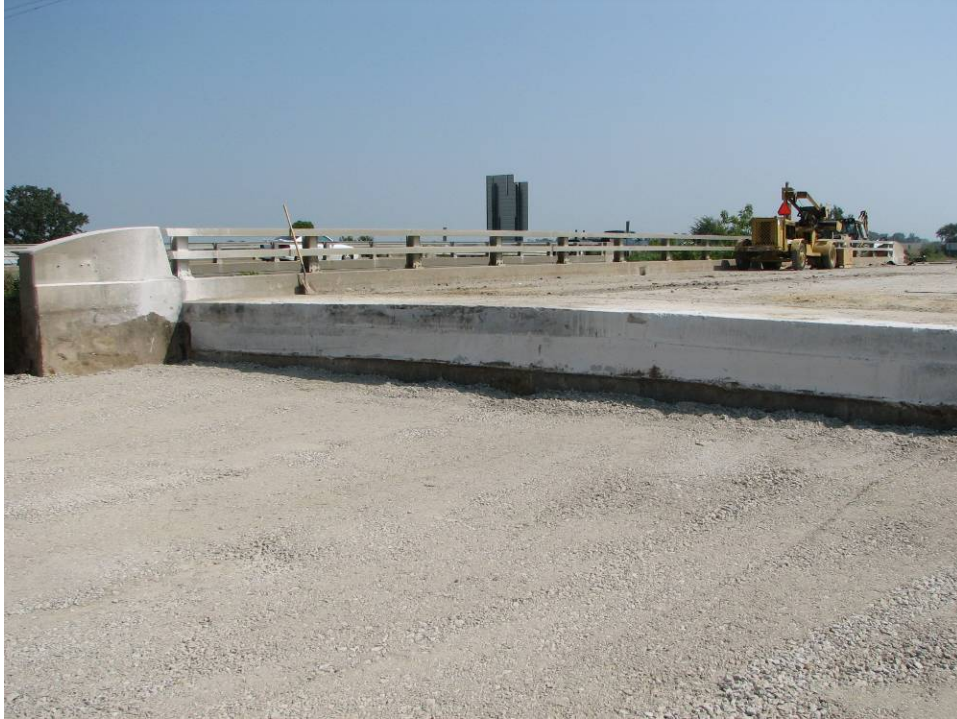
Figure 11 shows the backwall with the existing paving notch removed. A large concrete saw was used to cut off the majority of the notch along with a small jackhammer to complete the removal. The jack hammer was also used to roughen the contact area of the existing backwall to improve the epoxy bond between surfaces.

Figure 11. Existing abutment paving support removed

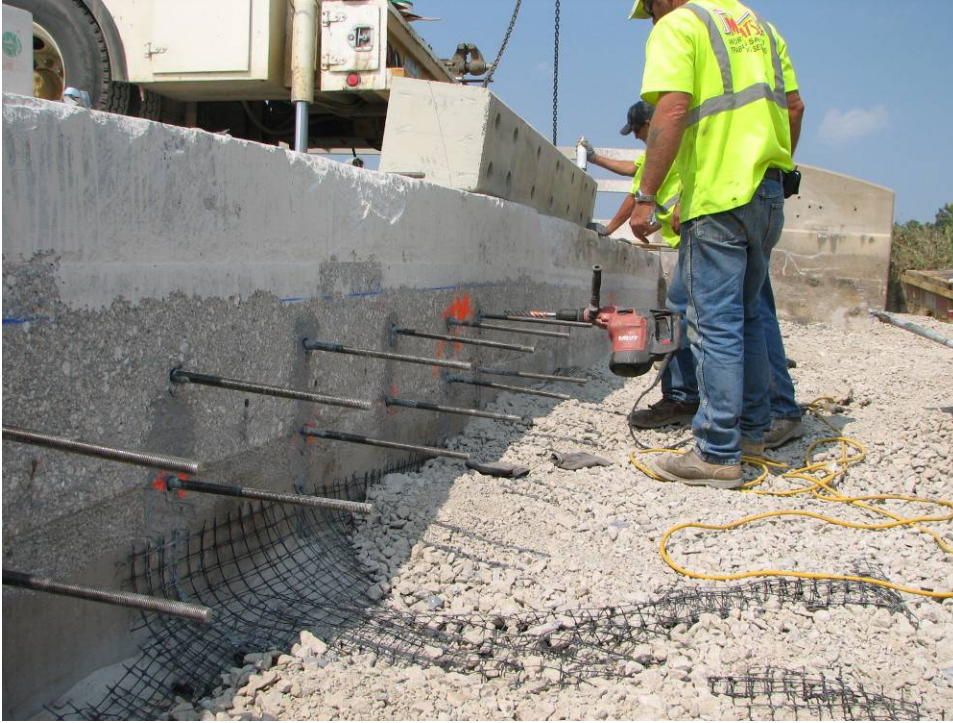
Figure 12 shows the drilling operation and the installation of the threaded stainless steel dowels. This portion of the installation was the most time consuming because of the difficulty of drilling through the existing concrete and reinforcing bars that were encountered in the backwall. The contractor was not allowed to shift the dowels because of the preset dowel locations in the precast section.

Figure 12. Drilling and installation of dowels

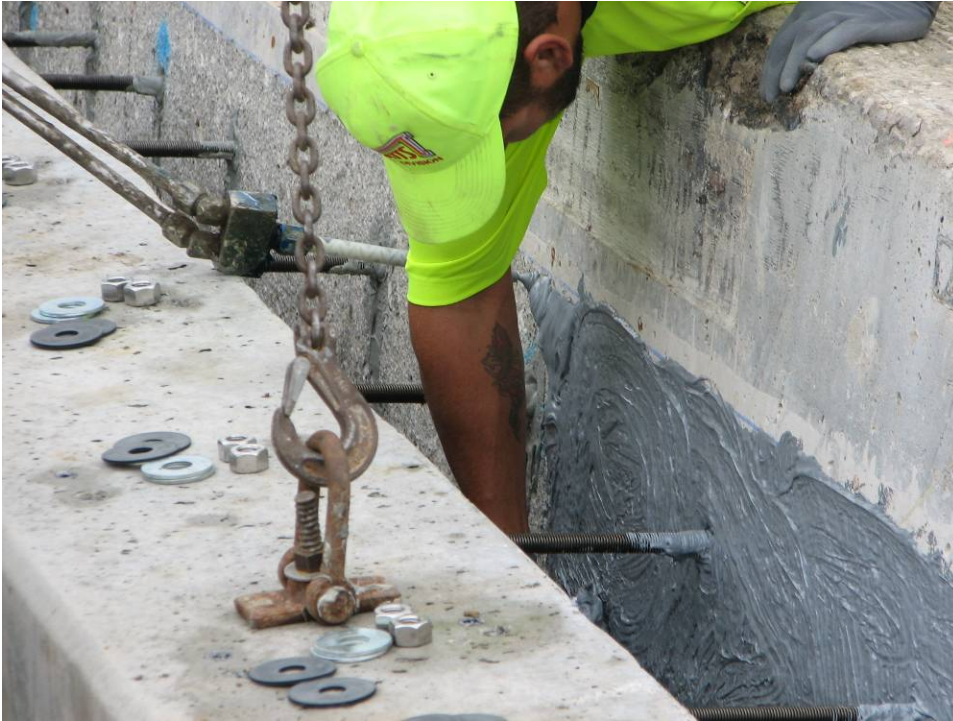
Figure 13 shows the application of the epoxy adhesive to the backwall and back of the precast section before the sections are bolted on. A two part epoxy paste (Rezi-weld) was used in the connection.

Figure 13. Applying epoxy paste to backwall

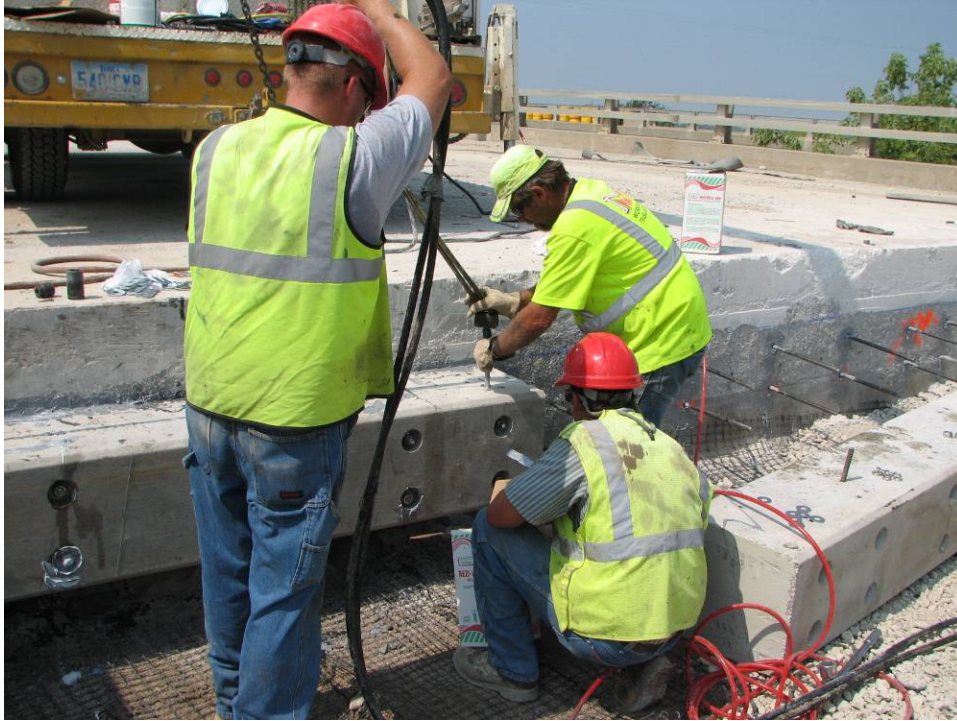
Figure 14 shows the first section being connected to the back wall at the gutterline, and Figure 15 shows final tightening of the connections. After tightening, the ducts were epoxy injected through the grout ports as shown in Figure 16. The additional sections were connected in a similar manner. Figure 17 shows the existing abutment with the four precast sections installed.

Figure 16. Grouting dowel ducts in precast units

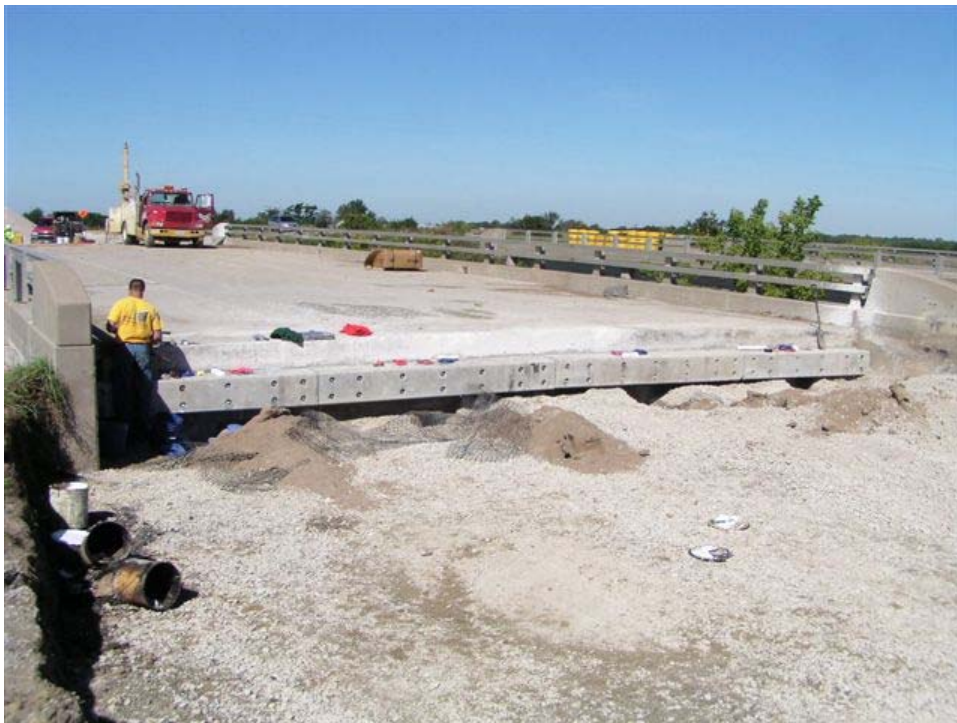
Figure 17. Final Grouting dowel ducts in precast units

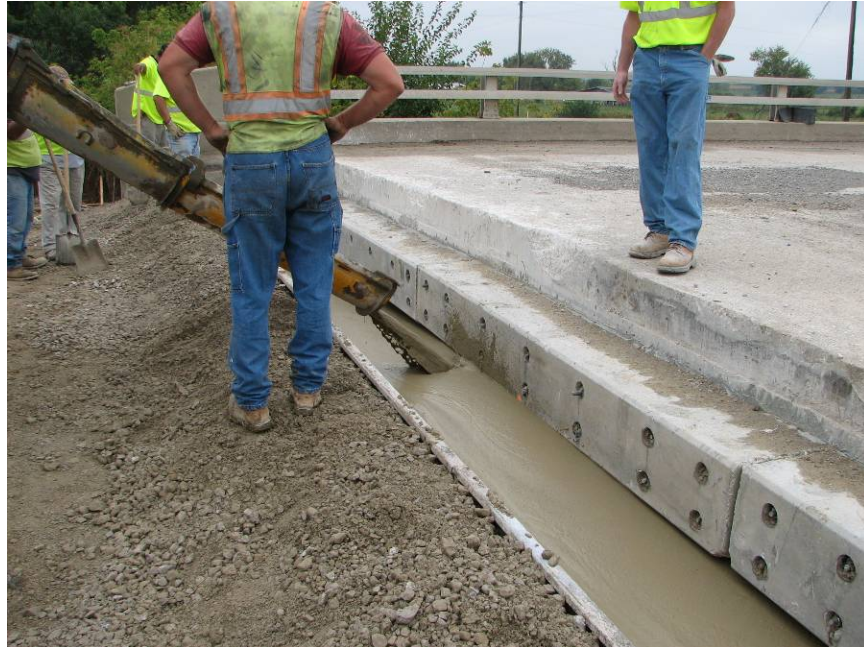
Flowable mortar was used for backfilling under the paving notch to prevent voids and achieve complete compaction. Figure 18 and 19 shows final placement of the mortar and the completed installation.

Figure 18. Backfilling the notch area with flowable mortar

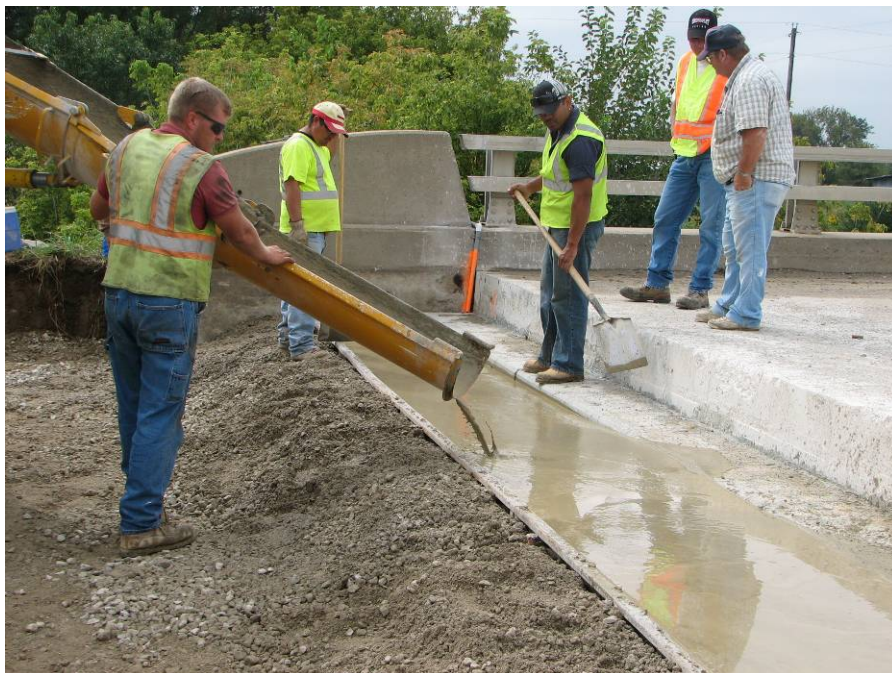
Figure 19. Backfilling the notch area with flowable mortar
