Field Monitoring Of Positive Moment Continuity Detail In A Skewed Prestressed Concrete Bulb-T Girder Bridge

This paper presents the results from a recently completed field study in Louisiana investigating the performance of a skewed prestressed concrete Bulb-T girder bridge made continuous. The bridge is part of the design-build John James Audubon Project that connects the cities of Saint Francisville and New Roads across the Mississippi River in Louisiana. A 96-channel monitoring system was designed and installed prior to bridge construction. The bridge utilized the positive moment continuity detail recommended in NCHRP Report 519. The Louisiana Department of Transportation and Development (LA-DOTD) chose to monitor the skewed segment with Bulb-T girders because both attributes were not within the scope of the experimental program covered in Project 12-53 that produced NCHRP Report 519. This paper presents details of the monitoring system developed for this project, which has been in service for over two years. Temperature, strain, rotation, and elongation readings are also presented and data preprocessing challenges are described. The bridge continuity is assessed based on the a

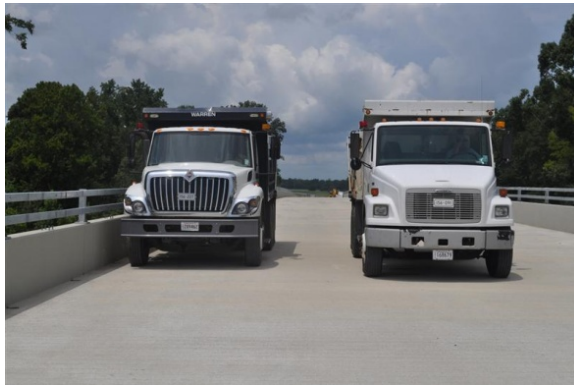
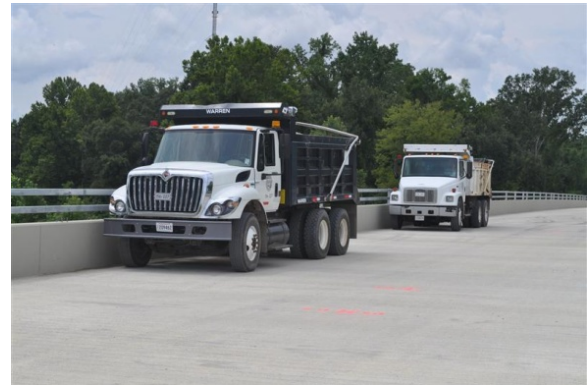
(b) Position P1

(c) Position N1

Fig. 11 Loading trucks in position for two of the nine static load positions

side midspan positive moment positions (P1 through P6) and 3 truck train negative moment positions at Bent 24 (N1 through N3) as can be seen in Fig. 10. Details of the truck positions, which were determined using finite element analyses of a full bridge model, can be found elsewhere¹¹. Due to the slow nature of the installed long-term monitoring system, the rate of data recording was 24 readings per hour, which were then averaged and stored for retrieval. This rate translated into one reading every 2.5 minutes. To ensure that more than one data point was collected for each static load position, the trucks were asked to stay at each position for a period equal to or longer than 11 minutes. During this period, at least three and probably four readings were recorded for each loading case. In between loading positions (P1 and P2, P3 and P4, P6 and N1, N1 and N2, and N2 and N3), the trucks were driven off the tested bridge segment to help determine a reference datum for the recorded readings. Fig. 11 shows the actual trucks in two of the static loading positions, namely P1 and N1.

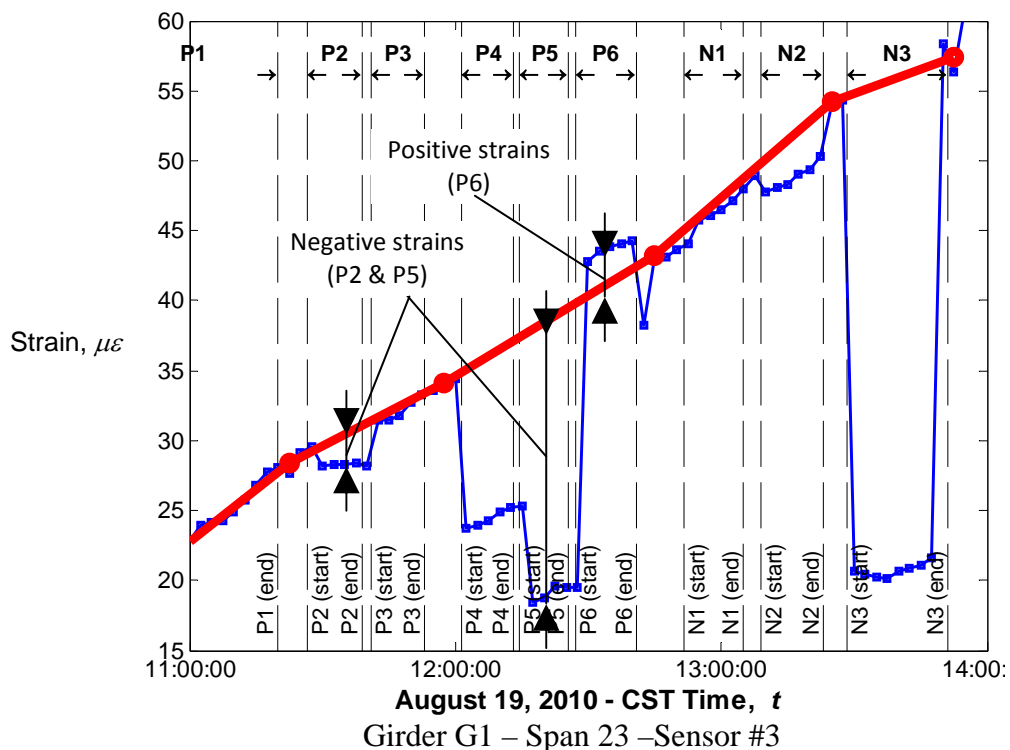
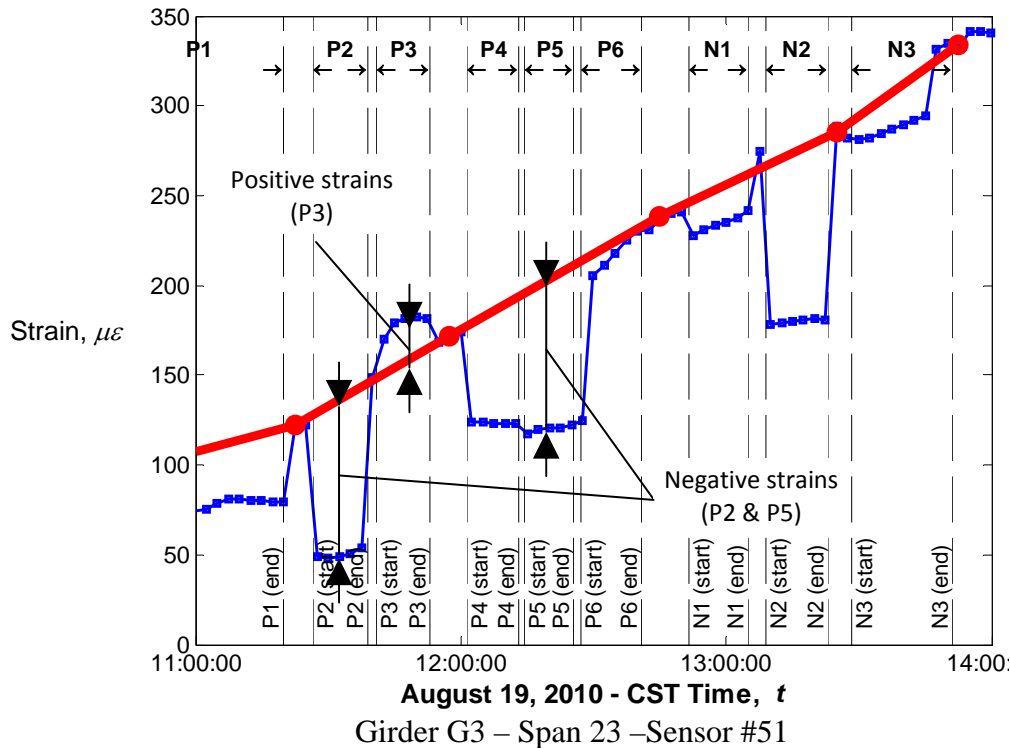
Fig. 13 Strains in hairpin bars showing positive values for faraway load cases

One interesting observation was that the hairpin strain records confirmed that forces were transferred from Span 25 (loaded span) to Span 23 (monitored span) for load positions P3 and P6. These two cases caused positive moments on the monitored continuity detail. Fig. 13 shows the magnitude of the strains, which are larger for Girder G3 than G1. A similar observation was related to the recorded negative strains for load positions P2 and P5. Both were load cases that target positive moment in the middle of Span 24. Therefore, trucks were positioned over Span 24. The trucks would, however, apply negative moments on the continuity diaphragm if it performed as intended. In both load positions (P2 and P5), the hairpin bars experienced negative strains that were, as expected, higher than the positive strains discussed earlier. Like the P3 and P6 load cases, the sensors were in one span and the loads acted on another for these two cases. Hence, the ability of the new detail to transfer forces between spans was confirmed. It should be noted that results from Girders G1 and G3 were only presented since Girder G5 was not instrumented on the hairpin bars in Span 23 and, therefore, a plot was not provided.
