Precast Pavement Installation on I-15 in Ontario, California

Jonathan den Hartog, PE, California Department of Transportation, District 8,
San Bernardino, CA

The California Department of Transportation (Caltrans) recently completed a large precast pavement project in Ontario, California. This was Caltrans' first experience with construction of a non-prestressed, non-post-tensioned precast pavement. A sole-source, proprietary precast pavement system was specified for the project. The 1.8 lane-miles of precast pavement was part of a larger pavement rehabilitation project on a heavily-traveled portion of Interstate 15 through the city of Ontario, CA. Over 700 precast panels were installed in 8 to 9-hour work windows.

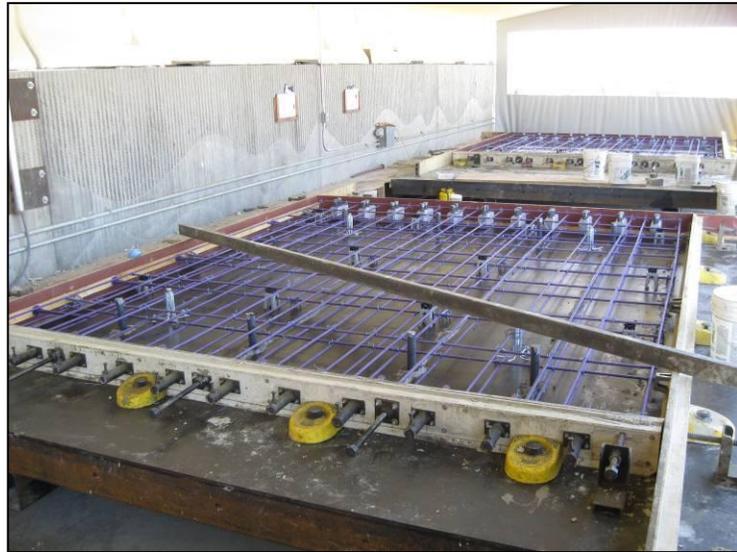
Picture 1 – Adjustable forms used to cast PCP panels for this project. The yellow objects at the edge of the form are large magnets, allowing easy adjustment of the dimensions of the panel.

Panels are cast on beds using four-sided, adjustable forms developed by the vendor (See Picture 1). The casting beds may be made adjustable vertically on one corner by means of a hydraulic jack, in order to cast warped panels (See Picture 2 below). Warped panels may be required in areas of horizontal curvature where a grade and/or super-elevation transition exists.

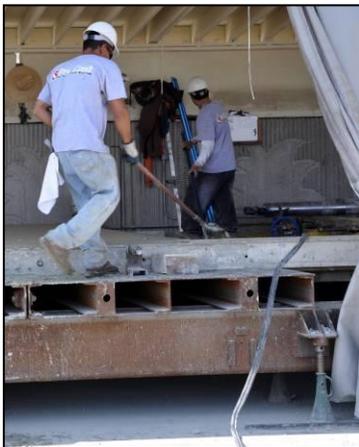
Picture 2 – Note the jack in the lower right of the picture used to ‘warp’ the PCP panel form.

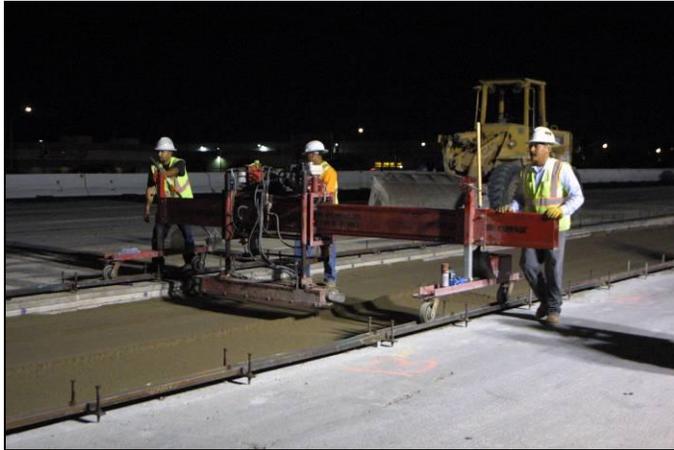
Picture 3 – Hand-operated grader (HOG) used to perform precise grading. Rails for the HOG are set by a surveyor.

ensure uniform support. Several alternatives for grading equipment are available for use from the vendor. For this project, a hand-operated grader (HOG) was used (See Picture 3). The HOG moves on rails set to a design profile grade by a surveyor. The rail elevations are fine-tuned using adjustment screws and shims.

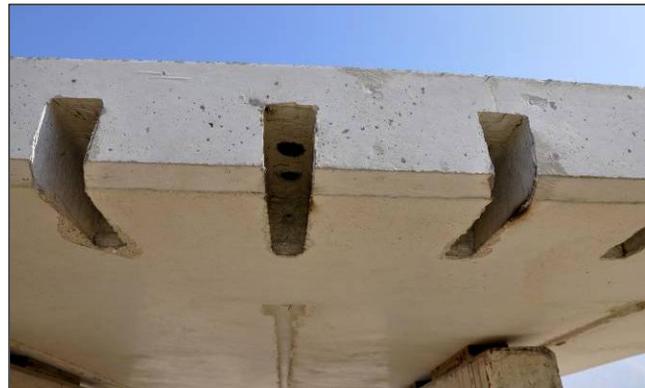
Picture 4 – Dowel slots and grout channels cast into the bottom of the panels.

Dowel grout is injected through ports cast into the panels above the dowel slots. Bedding grout is injected through other ports cast in the panel, and travels through channels on the underside of the panel to a port on the opposite end of the channel (See Picture 4), thus ensuring that the channel and any nearby voids are completely filled with grout. Four of these channels are cast into the base of each panel, ensuring a fairly uniform distribution of the bedding grout

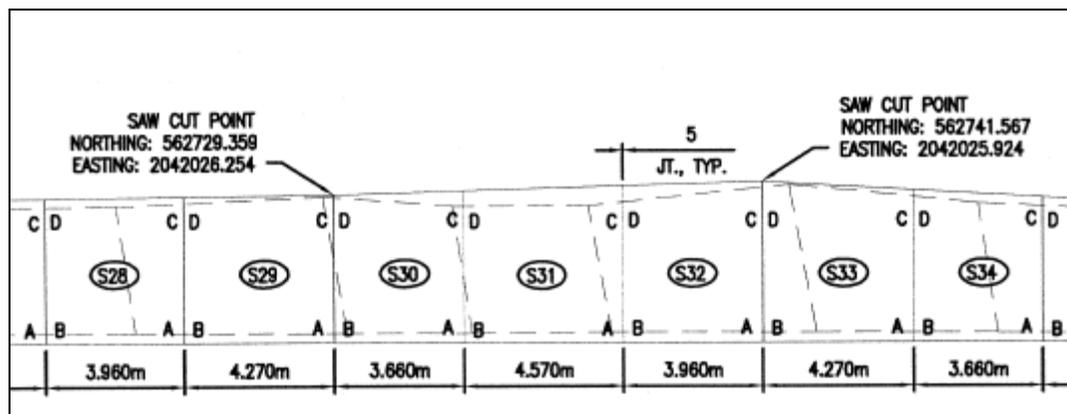
Picture 5 – Detail from shop drawings for this project, showing the variation between existing longitudinal joint (dashed line) and the edge of the PCP panels (solid line).

The longitudinal joints also require careful consideration during design, especially if the transverse joints of the PCP panels will not match the transverse joint spacing of the existing adjacent lanes. It is likely that during construction of the original pavement, multiple lanes were constructed simultaneously, with the longitudinal joint(s) created by saw cutting. Irregularities in the saw cut line can be significant. Also, since the transverse joint spacing does not match between the existing and proposed lanes, an overcut of the existing pavement is necessary (See Picture 5 below) to avoid the need for a five-sided panel (and additional casting forms).

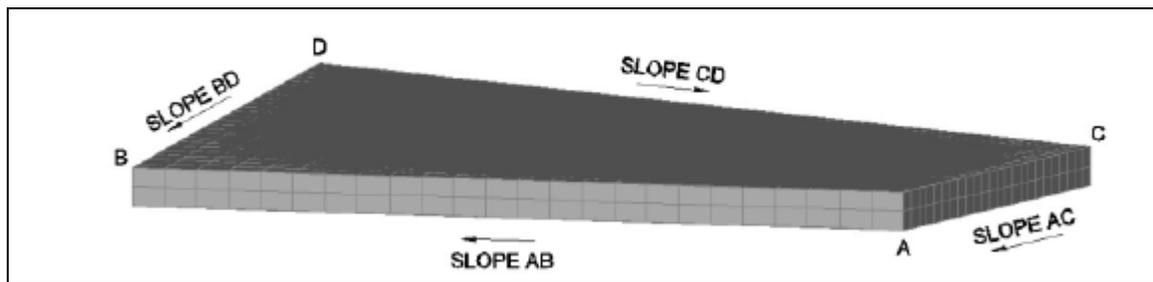
Picture 6 – Warped panel (exaggerated).

Warped panels can be defined as panels where the slopes of opposite sides differ. The magnitude of the warp is the vertical difference of one corner from the plane established by the other three corners (See Picture 6). Warped panels are necessary wherever panels are placed on a horizontal curve with a

If the panels at these locations had not been warped in this project, there would have been a 2 inch (47 mm) step at one corner between adjacent panels. A smaller radius curve would have a greater warp. This is not an issue that can be handled by grinding. In addition, the underlying subgrade must be graded to match this warp, in order to ensure uniform support under the panels and prevent cracking.

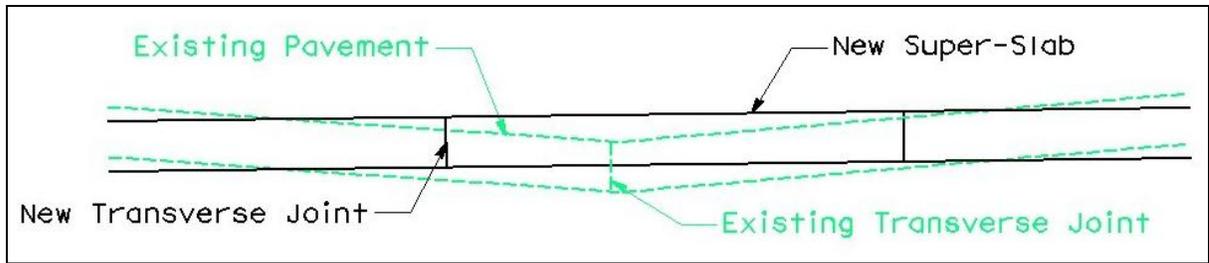
Picture 7 – Simplified diagram showing the relation of the adjacent lane profiles to the new precast panel profiles.

However this 'stringline' approach will likely result in low and high points in the bedding layer that can contribute to cracking of the panels after placement, and should not be used. This is especially true in the case where the new transverse joints do not match the adjacent existing transverse joints.

As can be seen in the above figure (Picture 7), a ‘stringline’ approach will result in high points in the bedding layer on the left and right side of the picture, and a dip in the bedding layer in the middle of the figure. This concept can be extrapolated to a three-dimensional approach, and to warped panels. It is apparent from this figure that the bedding layer must be graded to the *design profile* to avoid creating voids or high points under the precast panels.

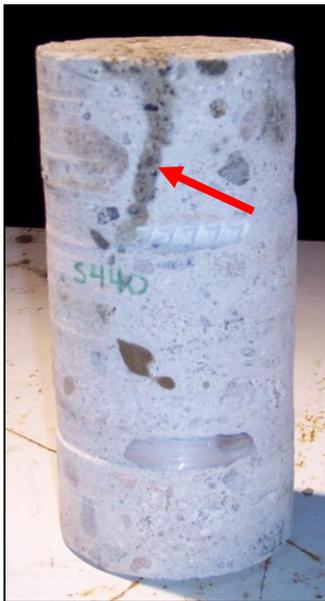
Picture 8 – Core of cracked PCP. Note how the cracking (red arrow) stops at the top mat of steel.

A petrographic analysis was performed on three cores taken from different locations along the installation, from panels that had been cast on different dates. It was observed in all of the cores that the cracks extended from the top of the panel down to either the first or second mat of steel in the panel.

- The cracking appeared to be structural, and not shrinkage cracking. This was evidenced by the fact that the cracks proceeded through the coarse aggregate, instead of around it.
- Concrete was well consolidated and aggregate was well distributed.
- The quality of the concrete did not appear to be a contributor to the cracking.

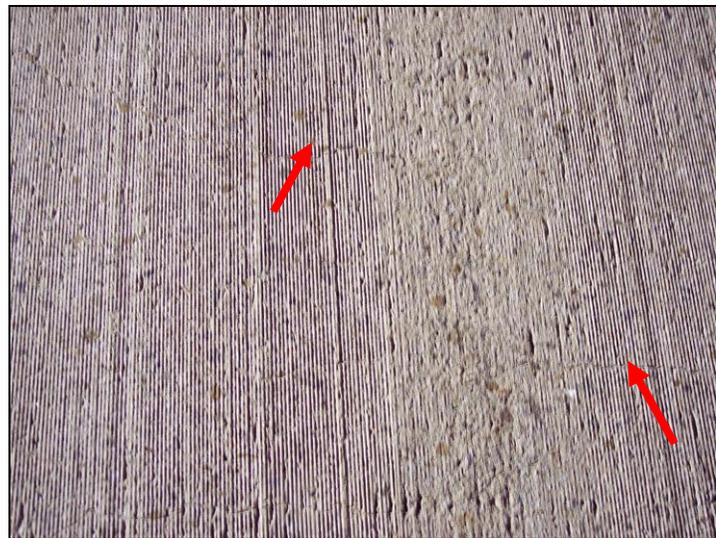
Picture 9 – Cracked PCP (noted with red arrows). Note that it was very difficult to get good photographs of the cracking, due to the tightness of the cracks.

Several months after the precast panels had been placed, cracking was discovered on a number of the panels. The cracking was generally very tight and difficult to see with the naked eye (See pictures below). The cracking was observed after a rain event, when the cracks dried at a different rate than the surrounding pavement. Cracked panels occurred even in areas that had not yet been opened to traffic, but had only experienced construction traffic.
