## WIDENING THE HISTORIC RIVER ROAD ARCH BRIDGE OVER HARRODS CREEK

**Daryl W. Carter, PE**, ENTRAN, PLC, Lexington, KY  
**Jeremy Raney, PE**, Louisville Metro Public Works & Assets, Louisville, KY

*The original River Road Bridge, constructed circa 1912, is a three-span, reinforced concrete, filled spandrel arch structure, carrying River Road over Harrods Creek in Jefferson County, KY. This bridge is eligible for listing in the National Register of Historic Places.*

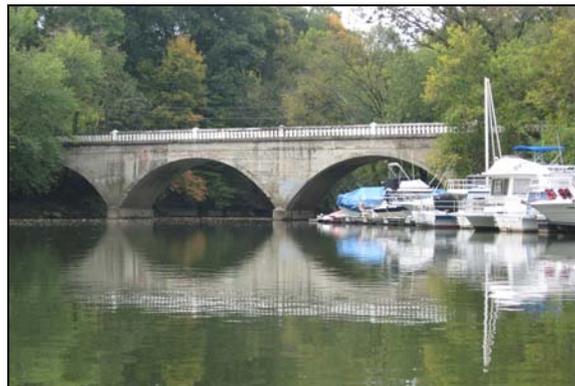
Fig. 1 – Elevation View of Existing Bridge

The original River Road Bridge, constructed circa 1912, is a three-span (64'-4"~ 66'-4"~ 64'-4"), reinforced concrete, filled spandrel arch structure, carrying River Road over Harrods Creek in Jefferson County, Kentucky (Fig. 1). Initially, the bridge was constructed to serve a few suburban properties in the vicinity. However, over the years, the traffic volume generated by local residents and others using the bridge for daily commutes to nearby Louisville has increased significantly, rendering the one-lane structure inadequate to handle the growth. Over the past several decades, motorists had grown accustomed to stopping at the ends of the bridge and taking turns crossing the bridge one at a time, in opposite directions.

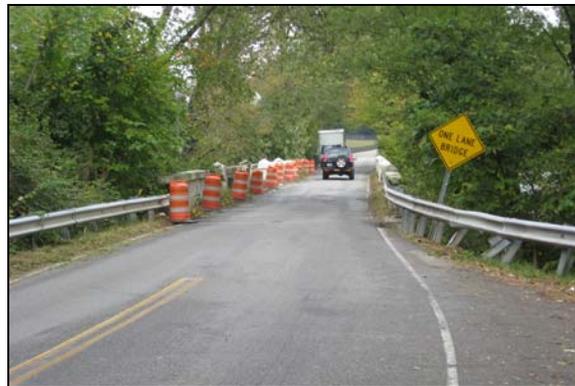
Fig. 2 – “Barrel Shot” of Existing Bridge  
Just Prior to Closure

Anticipating that a construction project was imminent, the watchdog group filed a lawsuit against the project in May 2008. During the time the project was in the planning and design phases, the architectural concrete balustrade bridge railing had continued to deteriorate – so much that it had become dangerously unsafe (Fig. 2). The bridge was closed to traffic in November 2008.

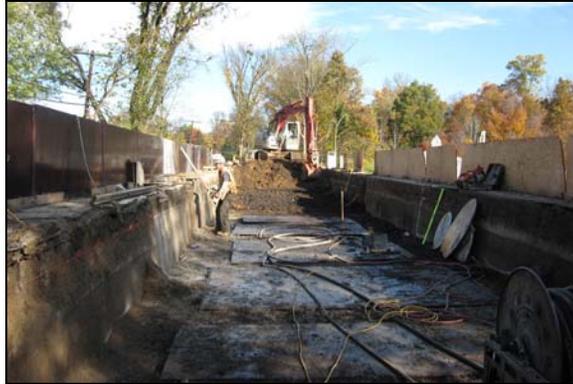
Fig. 4 – Removing Portions of Arch Infill

Unfortunately, during the removal of the cobble infill, it was discovered that the inside face of the spandrel walls were not vertical, but battered approximately 1 1/4" per foot – bringing to light the painful realization that the box beams would not fit between the spandrel walls as planned (Fig. 4). Raising the roadway profile grade was not an option because nearby property entrance profiles would be raised also, extending construction outside of the right-of-way limits. After some discussion, the decision was made to allow the contractor to chip a vertical notch into the inside face of each of the existing spandrel walls to provide the desired side clearance to the box beams. This required a considerable amount of meticulous manual work using hand-held pneumatic chisels.

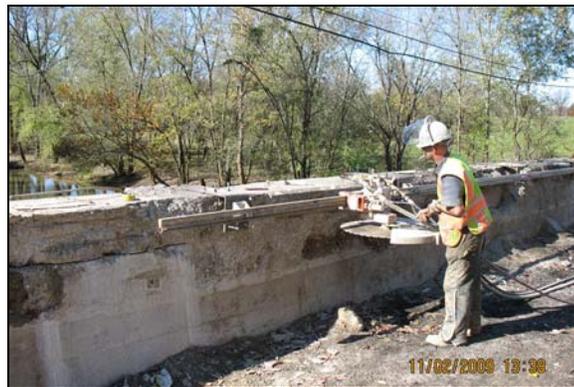
Fig. 5 – Sawing Spandrel Wall Below Plinth Block

Occurring simultaneously during the removal of the arch infill, the bottom portion of the existing concrete balustrade was removed. This was accomplished by making horizontal cuts with a water-powered, carbide-tipped, rotary saw through the plinth block at the base of the existing concrete balustrade railing. The elevation of this cut was pre-calculated to provide the 2 ½” of vertical clearance between the top of the spandrel walls and the bottom of the prestressed deck panels to be erected later (Fig. 5).

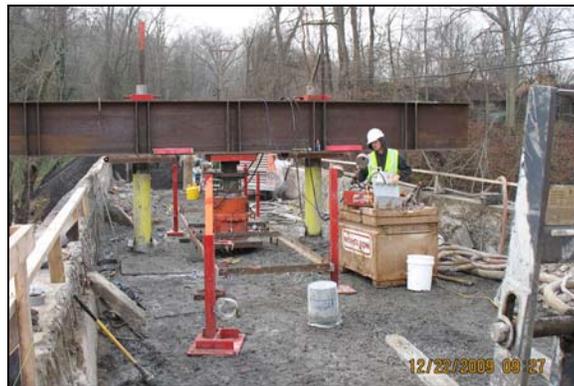
Fig. 7 – Proof-Load Testing Micropiles

One micropile at each pier was successfully proof-load tested in compression to 265 tons (160% of the design load) (Fig. 7).

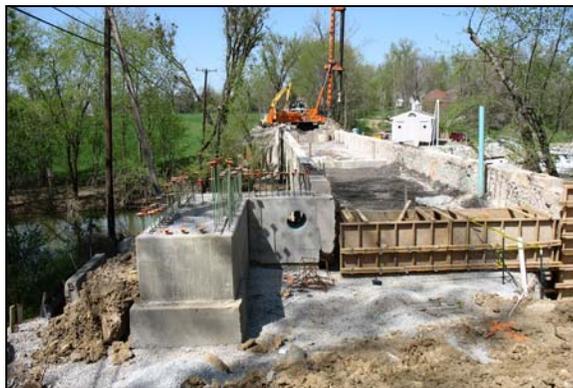
Fig. 8 – Installing Drilled Shafts at Abut. 2 (back)  
Curtain & Retaining Walls at Abut. 1 (fore)

Since the new roadway is much wider than the existing, an “L-shaped” reinforced concrete curtain wall and retaining wall arrangement is connected to the sides of each existing spandrel wall to contain the roadway embankment at the bridge ends. The curtain wall extends perpendicular to the spandrel wall, turns a 90° angle and then changes to a retaining wall that runs parallel with the roadway approaches. This arrangement occurs at all four corners of the bridge. The curtain walls and retaining walls are founded on a combination of drilled shafts (48” and 42” dia.), grade beams and spread footings (Fig. 8).

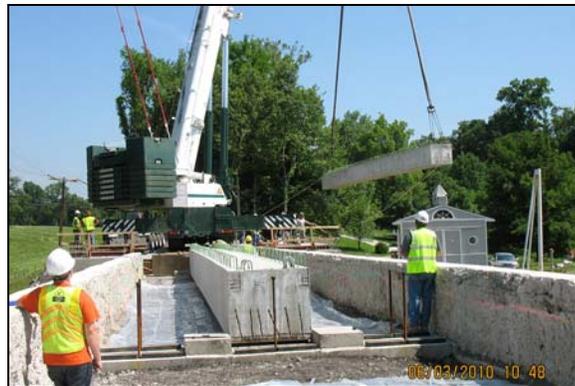
Fig. 9 – Erecting Prestressed Beams -  
(Note Preparatory Chipping of Spandrel Walls)

Because Harrods Creek is affected by backwater from the nearby Ohio River, both ends of each box beam are tied down to the abutment/pier caps to prevent float-off due to buoyancy during periods of high water. Tie-down is accomplished by passing a 1- $\frac{3}{8}$ " diameter threaded rod through a slotted hole in the ends of each box beam, secured with a nut on top and embedded into the abutment/pier caps at the bottom (Fig. 9).

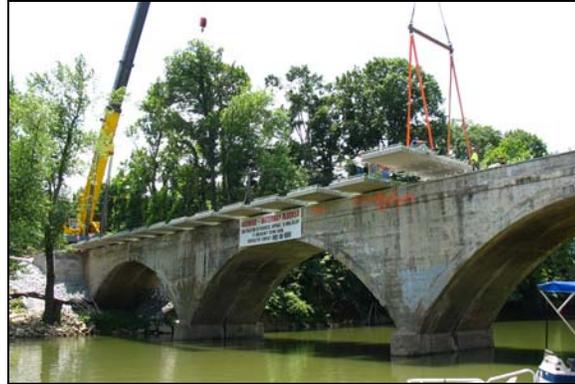
Fig. 10 – Erecting Prestressed Concrete Deck Panels

The bridge deck is comprised of twenty precast, prestressed concrete deck panels, with alternating CIP concrete closure pours. Each deck panel is 32'-0" wide, with lengths varying from 5'-10  $\frac{1}{2}$ " to 7'-11  $\frac{5}{8}$ ", and with a panel thickness varying from 10" at the gutterlines to 1'-1  $\frac{9}{16}$ " at the crown. The deck panels, also fabricated with 7500 psi (28-day) concrete, are prestressed transversely to handle the large deck overhangs, which, incidentally, support an 8" dia. waterline suspended from one side of the bridge (Fig. 10).

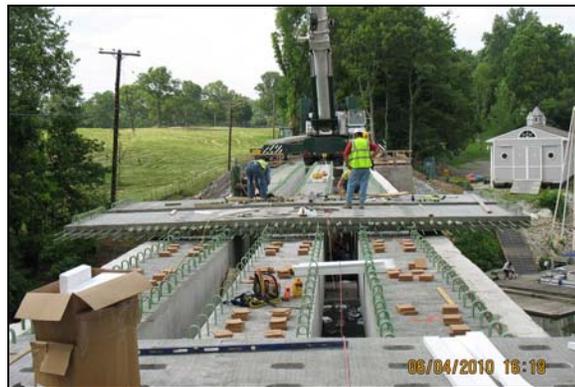
Fig. 11 – Typical Deck Panel in Erected Position

The prestressed deck panels have vertical open slots cast in them that align with and accept shear stirrups (epoxy-coated) that protrude from the tops of the box beams. After the panels were erected, both the slots and the fillet gap between the top of the box beams and the bottom of the deck panels were pressure grouted to provide composite action between the beams and the deck panels. The deck panels are isolated from the tops of the existing spandrel walls by a 2 ½” minimum vertical gap between them (Fig. 11).

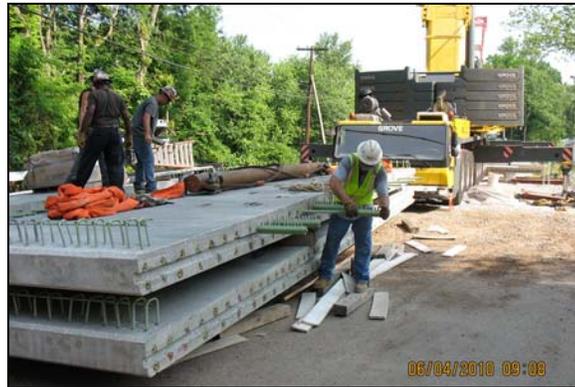
Fig. 12 – Pre-attaching #9 Screw-Lock Type Mechanical Connectors

To provide continuity of the longitudinal deck reinforcement, 3'-0" long CIP concrete closure pours placed with 5 ksi (28-day) concrete are located between each deck panel. All of the lines of longitudinal reinforcement in the top and bottom of the deck are spliced together within the closure pours by screwing the reinforcing bars into couplers cast into the faces of each deck panel. The bars are either straight (for #5 bars) or terminate in a 180° hook (for #6 bars). To provide the required flexural strength over the piers and negative moment regions, and to address the limited opening available for a conventional lap splice in a closure pour, #9 bars are spliced together with screw-lock type mechanical connectors. All of the reinforcing bars, couplers and mechanical connectors are epoxy-coated (Figs. 12, 13).

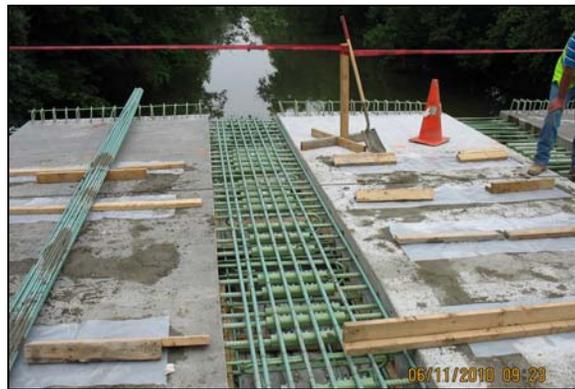
Fig. 13 – Reinforcement for CIP Concrete Closure Pour at Pier  
(Note Grouting of Stirrup Slots)

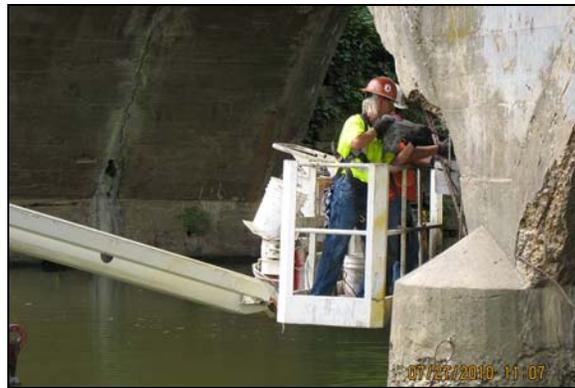
Fig. 14 – Worker Chipping Out Bad Concrete

Over the years, the ravages of time caused some of the concrete in the arch rings to delaminate and spall off, leaving the existing reinforcing bars exposed. During the design process, site visits were made to identify and quantify as accurately as possible these distressed areas. Typical details were included in the contract plans for making these repairs, which included chipping out bad concrete, cutting out corroded reinforcement and splicing in new reinforcement, and then applying the new epoxy concrete. A subcontractor that specializes in concrete restoration and repair was brought in to perform this work, all of which was performed from a manlift mounted on a small work barge (Figs. 14, 15).

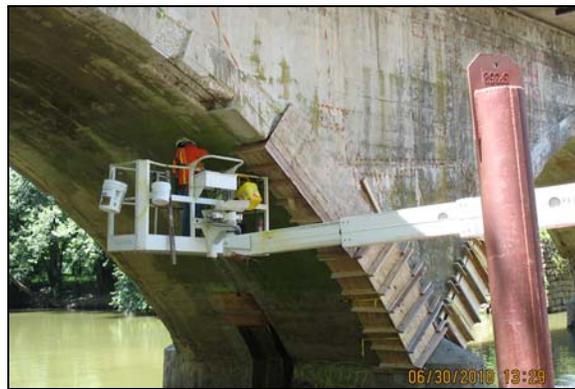
Fig. 15 – Installing Formwork for Epoxy Concrete
