Continuous composite hollow-core slabs

Jakob Fisker, PhD student, University of Aarhus, Dept. of Engineering, Denmark
Lars German Hagsten, Prof., Engineering College of Aarhus, Denmark

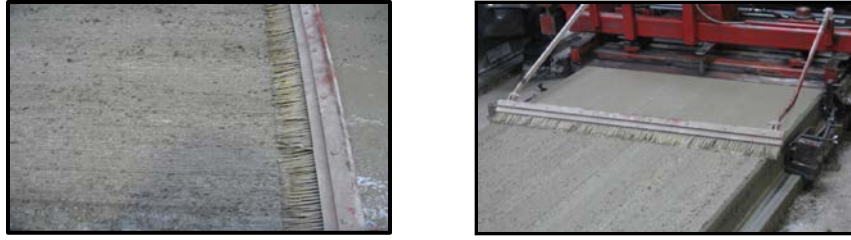
For the specimens A44-A47 and three of the B-specimens, the surface of the hollow-core slabs was roughened during extrusion using a stiff rake attached to the extruder see Fig. 7. This procedure left the slab-surfaces with a clearly visible macro-roughness of 1-3mm.

Figure 7: Roughening of hollow-core slab surface

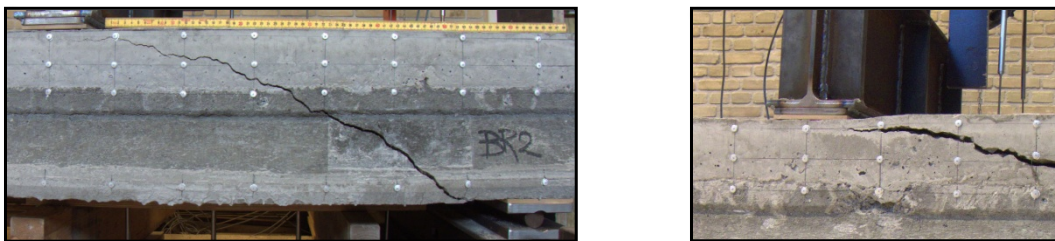
In Fig. 9 below the line of failure related to specimen BR2 is shown. The remaining specimens failed in an identical manner.

Figure 9: Typical mode of failure. Left; BR2, Right; BS2

At failure, a crack/failure-line propagated from the bottom-side near the support towards the point of load-application. In most cases, the line of failure propagated horizontally just underneath the loading-plate. This can be seen on Fig. 9, right, which displays specimen BS2 after a small increase in the applied displacement beyond failure. Hence, the parts on either side of the line of failure was not completely separated during failure.

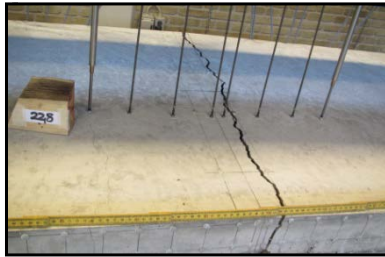
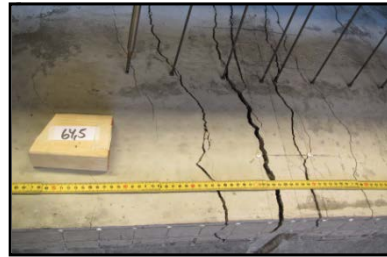
As mentioned, all specimens cracked during the first pre-loading cycle - the corresponding cracking-load can be seen in Table 4. The first visible crack appeared along one of the vertical interfaces at the joint in the middle. In specimens A1 only one crack developed prior to initiation of reinforcement yielding. Between initiation of yielding and load-peak two more cracks developed at a distance of approx. 300 mm from the joint. However, these cracks were only just visible, while the joint-crack reached approx. 15 mm just before failure. In Fig. 12, left, specimen A12 is shown just before failure.

Figure 12: Left; Specimen A12 ($u=22,8\text{mm}$), Right; Specimen A23 ($u=64,5\text{mm}$)

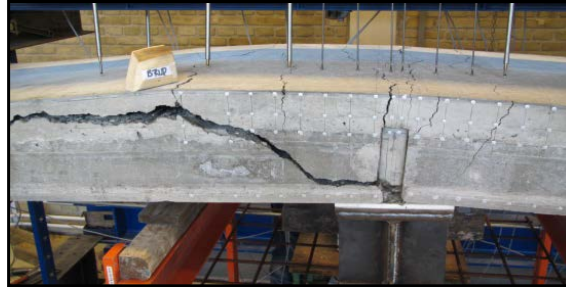
After a further increase of the applied displacement, the horizontal cracks at the level of the topping reinforcement and near the bottom became clearly visible. Finally, both specimens failed completely in a second failure involving crushing of the concrete in the joint. However, when this occurred the width of the inclined crack/line of failure had exceeded 2-3 mm. Fig. 14 below displays specimen A31 after the test.

Figure 14: Specimen A31 after test

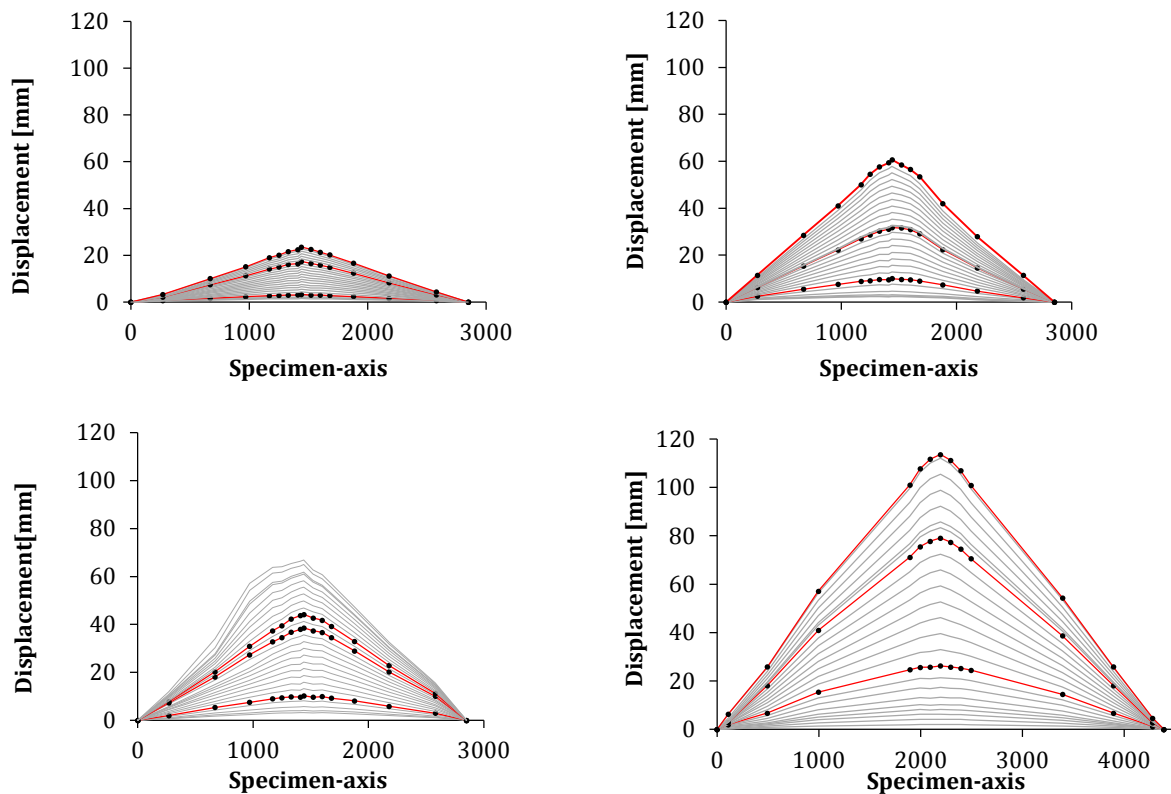
Transverse displacements were recorded at various positions along the length of the specimens. The diagrams in Fig.15 display the displacements at different load-steps. Only one diagram per specimen-group is shown. The dots indicate the position of the corresponding LVDT, and the thick, red lines represent initiation of yielding, load-peak and failure, respectively. For specimen A31 failure is given as the initiation of the descending branch.

Figure 15: Transverse displacement of A-specimens, Top; A12 & A21, Bottom; A31 & A43

In Fig. 15 the deflected shape of the A1, A2 and A4-specimens is displayed at different load-steps. The diagrams all reveal that, as the displacements are gradually increased, the change of rotation is gradually becoming localized within the central region around the point of load application. Combined with the fact, that a plastic plateau was actually developed this suggests that plastic hinges are developed.

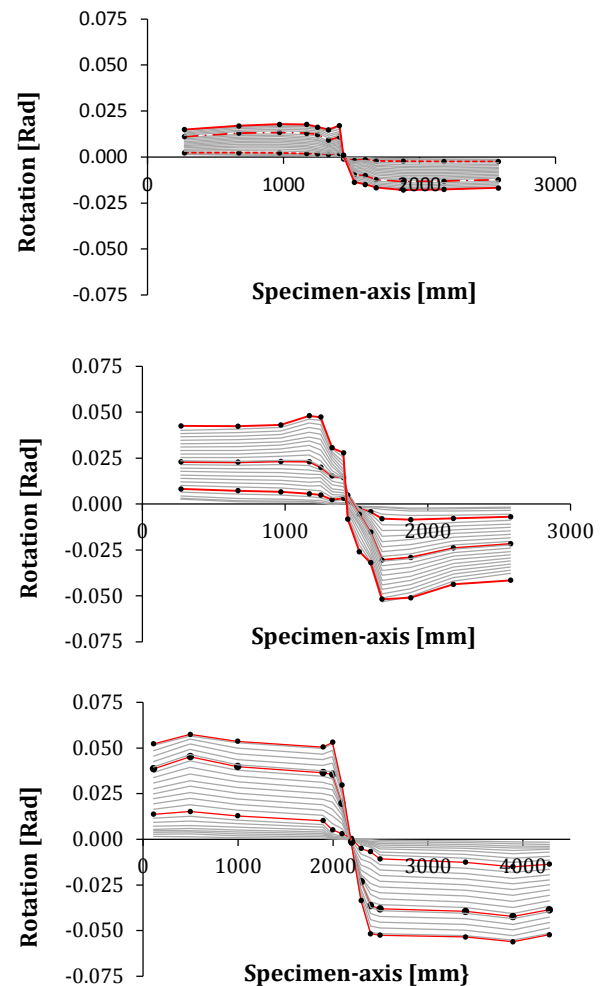
The corresponding rotation-diagrams are shown in Fig. 16, and have been derived using numerical differentiation. The diagrams evidently supports the supposition, that plastic hinges are developed, and that rigid-body movement is dominating within the post-elastic range.

When considering the A1-specimens, the term "hinge" might be slightly misleading since only a single crack was developed. This is also reflected by the rotation-diagram of A12, where the change of rotation appears to be restricted to a single point.

Figure 16: Rotation-diagrams; A12, A21 & A43

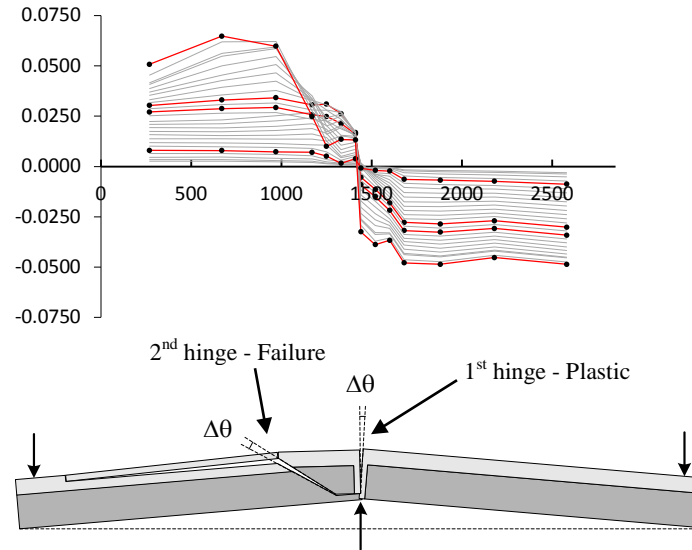
As stated, the behavior of specimens A31 and A32 was similar to the A2- and A4-specimens when considering the elastic range and the initial part of the plastic plateau. This similarity is also evident from the displacement- and rotation curves, which are shown in Fig. 15 and Fig. 18 for specimen A31, respectively. After yielding, a plastic hinge is developed at midpoint of the specimen, and this behavior continues until the applied displacement reaches the beginning of the descending branch. Subsequently, the gradual development of an additional point of rotation becomes apparent, approximately coinciding with the point of intersection between the topping reinforcement and the crack, that ultimately developed into the line of failure.

Fig. 18: Rotations, A31
