DAMAGE EVALUATION OF PRESTRESSED DOUBLE-TEES EXPOSED TO ACCIDENTAL BUILDING FIRE

ABSTRACT

CASE STUDY

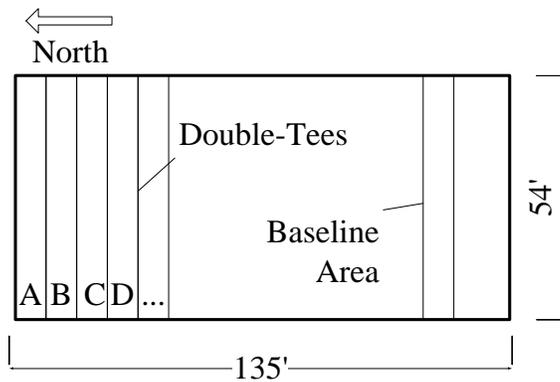
Figure 1 Building layout

The roof plan of the building was rectangular with length of 135' and width of 54' as shown in Figure 1. There were a total of 33 double-tee joists which spanned between the outer CMU bearing walls. The joists referenced in this paper are labeled from A through J, with A being the unit closest to the north wall of the facility. Cross-section details of the joists are shown in Figure 2. Although there was no design documentation available, the investigators assumed values in Table 1 as typical for double-tee units contemporary with the building. Initial visual inspection of the joists led the team to suspect damage in the northernmost 10 joists which were closest to the known location of the blaze. Heat-sensitive materials such as plastic containers, carpet, and paper were found in-tact towards the southernmost portion of the building, leading the investigators to assume that the joists in this area were also undamaged.

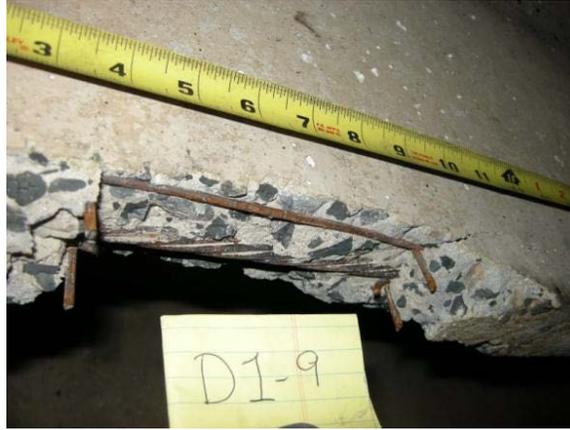
Figure 3 Spall and exposed prestressing strand

The findings of the two quantitative nondestructive test methods were corroborated by observations made during visual inspection of all joists located in the test area. Typical damage that was cataloged consisted of crazing, cracks, spalls, and delamination, as shown in Figures 3 and 4. The team located cracks ranging in width from 0.005” to 0.06”. Spalling was found on several of the joists and often exposed steel mesh as well as prestressing strands. Figure 5 provides a spatial mapping of the damage discovered during the visual inspection. The fire location is within the circle plotted on Figure 5. Cracking and spalling is evident on joist locations within approximately 30’ of

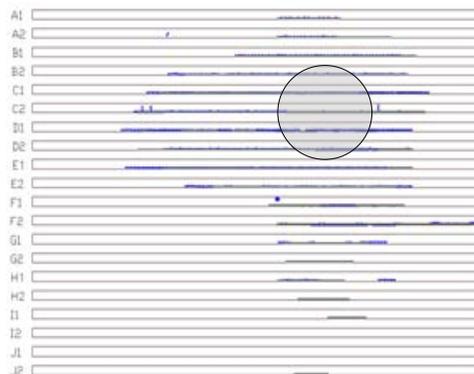
Figure 5 Location of damage discovered by visual inspection

the fire. The most severe damage was located on joists B, C and D, directly over the fire location.

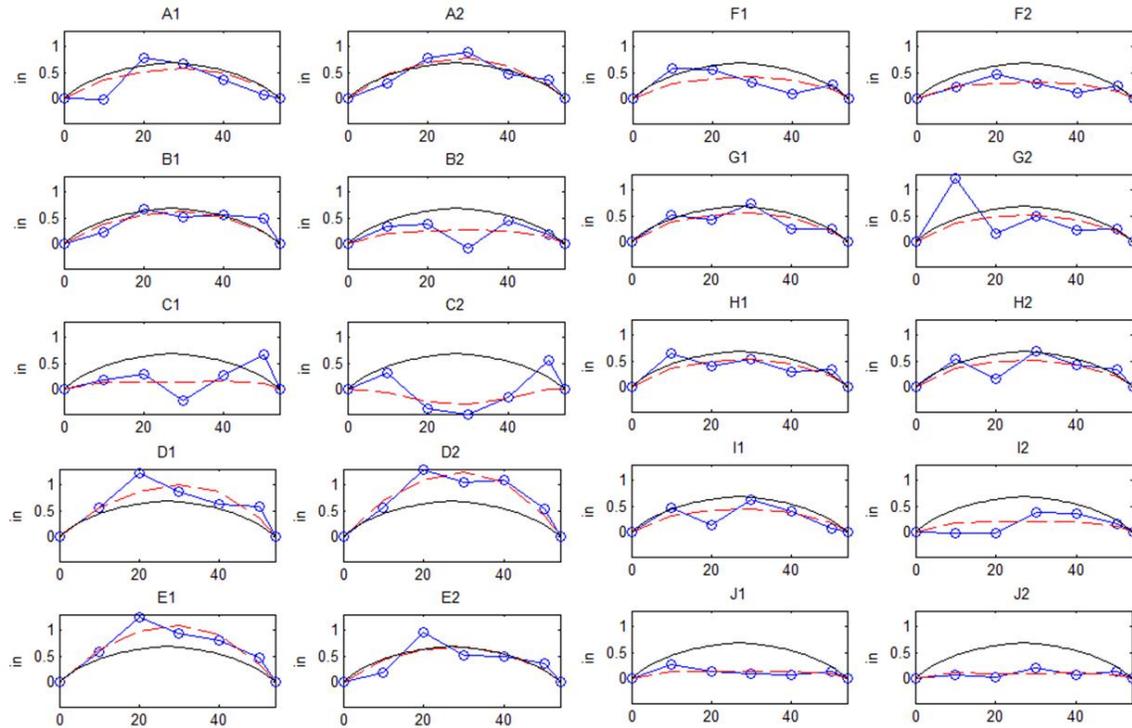
Figure 6 Camber measurements of units A through J

The visual inspection included measurement of change in camber by surveying the elevation of the stem bottoms along the length of several units. Measurements were made at 0, 10, 20, 30, 40, 50, and 53 feet from the west wall. The results are presented in the Figure 6, in which the circles represent the surveyed value measured relative to the beam end and the solid line represents the predicted camber profile for an undamaged beam. It can be seen that stem B2, C1 and C2 show marked loss of camber while stems D1, D2 and E1 show camber gains.

Table 3 also gives a comparison of the P-wave frequency measured by impact echo in the flanges versus the stems. The flange frequencies are not notably changed relative to the baseline. This may indicate that either the stems became hotter than the flanges during the fire or that they were more damaged by quenching during fire fighting. When this information is taken in together with change in camber measurements, some speculation about the nature of damage to the prestressing steel is possible. Because there was no significant variation in flange concrete modulus of elasticity, it appears that the joists that gained in camber possibly did so due to decreased concrete modulus of elasticity. Conversely, the joists that lost camber (B and C) possibly did so following loss of prestress due to loss of strand bond or heat damage to the steel.

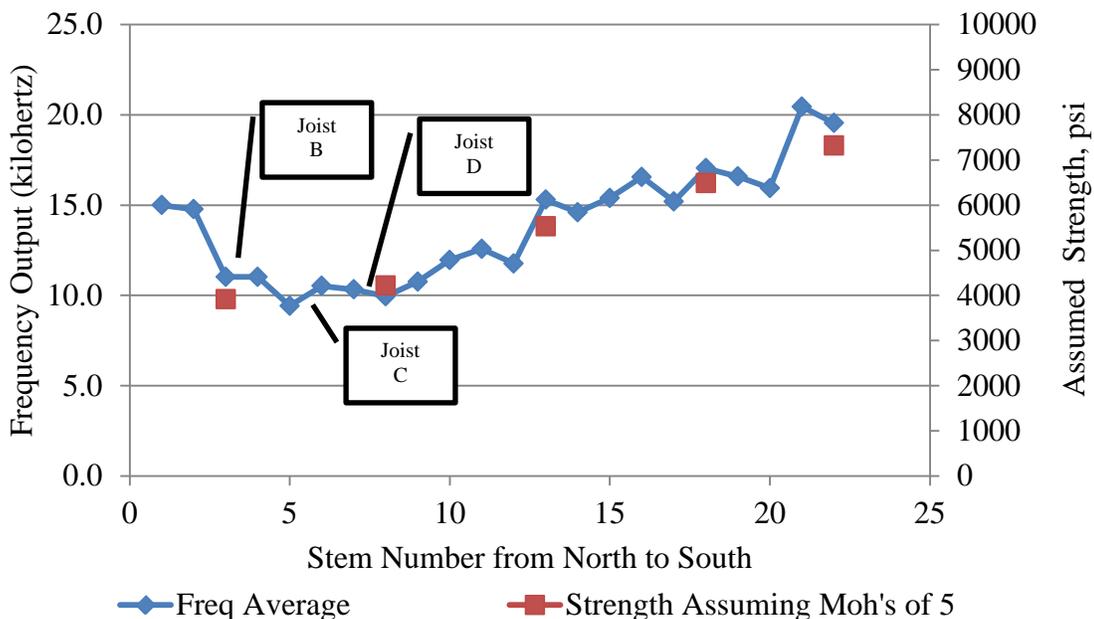
Figure 7 Correlation of Windsor probe and impact-echo findings

It is apparent that the joists displaying the most visually obvious damage (as depicted in Figure 7) are associated with the largest quantified changes in material behavior. Joists B, C and D were identified as the most impacted by Windsor probe data and impact-echo data. These were also the joists with the most extensive visual damage and change in camber. In the case of joists F and G, there was not alarming visually apparent damage. However, the impact echo and Windsor probe data predict reductions in elastic modulus and compressive strength of nearly 30%. In these cases, nondestructive tests were necessary to locate the damage not appreciable by eye.

In the absence of companion data from destructive tests, the results are not calibrated. However the impact-echo results and the Windsor probe results have illustrated a similar trend towards lower modulus of elasticity and lower compressive strength respectively. The magnitude of these changes is similar and the data are plotted simultaneously in Figure 7. The impact-echo data shown in Figure 6 consists of readings taken at the same location as the Windsor probes were set, so they are representative of the same material and damage conditions.
