## **Field Testing of Precast UHPC Piles and Long-term Performance Monitoring**

**Jessica A. Garder**, Dept. of Civil Engineering, Iowa State University, Ames, IA  
**Sri Sritharan, PhD**, Dept. of Civil Engineering, Iowa State University, Ames, IA  
**Kam Weng Ng, PhD**, Dept. of Civil Engineering, Iowa State University, Ames, IA

**Keywords:** UHPC Pile, Lateral Load Test, Vertical Load Test; field; implementation

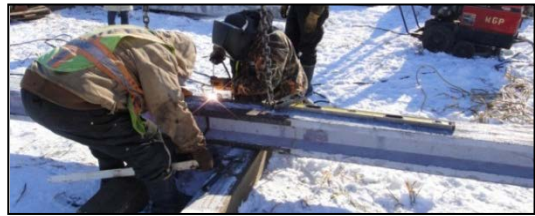
Before driving began, two 15 foot long piles were welded together end-to-end while placed horizontally on the ground as shown in Fig. 5. Once the splice was complete, the steel pipe for the SAA was welded to the web of P4 so that it could be driven with the test pile.

Fig. 5 Splicing UHPC Test Pile Horizontally on the Ground

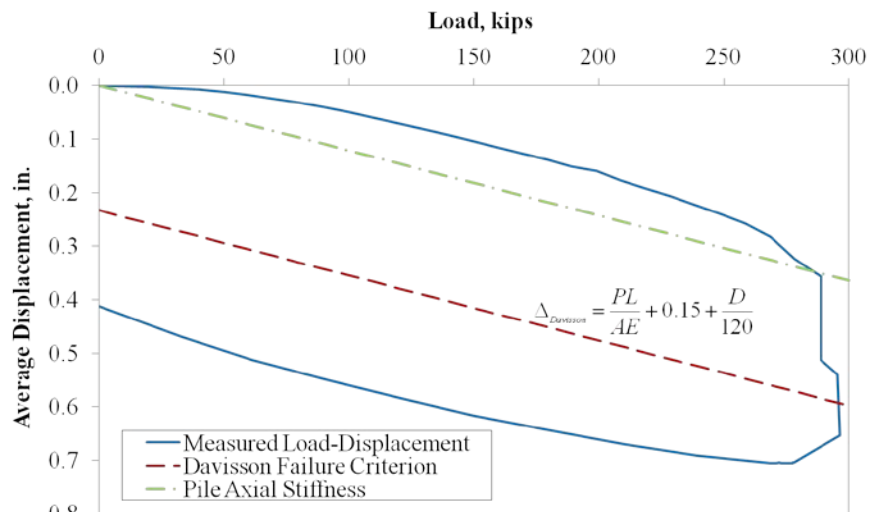
The load-displacement behavior of P3 is presented in Fig. 8. P3 was loaded to a maximum value of 297 kips and a maximum downward displacement of 0.71 inches. The Davisson Failure Criterion Line<sup>9</sup> was calculated using Equation (1), which corresponds to the load at the point where the Davisson Failure Criterion crosses the measured load-displacement curve. The ultimate measured capacity of P3 was determined to be 297 kips, which was 49 percent higher than the predicted ultimate capacity of 200 kips.

Fig. 8 Force-Displacement Curve of P3 during the Vertical Load Test

$$\Delta_{\text{Davisson}} = \frac{PL}{AE} + 0.15 + \frac{D}{120} \quad (1)$$

where:  $P$  = axial load, kips  
 $L$  = length of pile, in.  
 $A$  = cross-sectional area, in<sup>2</sup>  
 $E$  = modulus of elasticity, ksi  
 $D$  = diameter of pile, in.

For the vertical load test, the UHPC test pile reached an ultimate capacity of 297 kips which is 49 percent greater than the estimated nominal capacity of 200 kips. Both lateral test piles were subjected to a maximum lateral load of 20.6 kips with the largest lateral displacement of 10 inches for the pile that experienced weak-axis bending. The splice on P4, 15 feet from the pile head, performed well during installation and testing, with no distress to the splice or the pile connected to the splice attachment. Based on laboratory and field testing, the

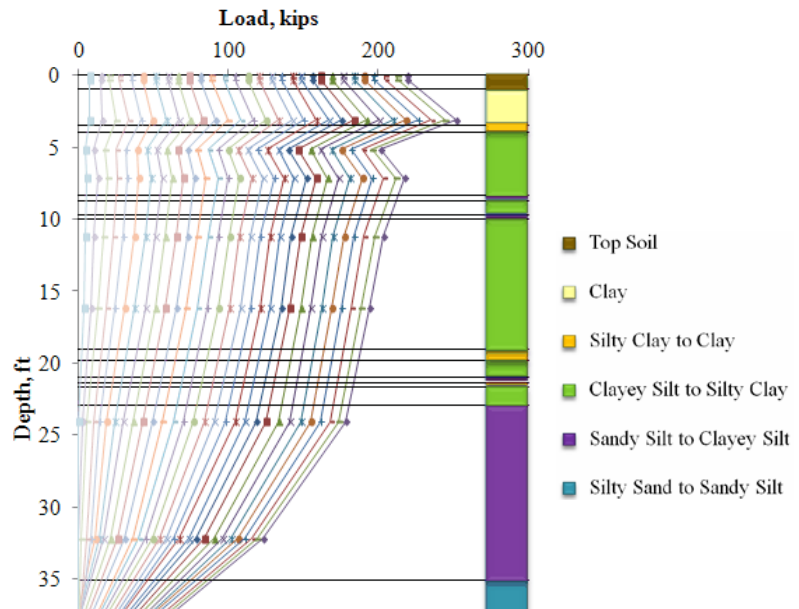
The strain gages embedded along P3 provided information about the skin friction along the pile. Fig. 10 shows the average calculated load transfer along the length of the pile from the measured strains. Even though the maximum vertical load applied to the test pile was 297.25 kips, the measured axial load from the strain gages 4 feet from the top of the pile head was only 220 kips as shown in Fig. 10.

Fig. 9 Load Transfer Response of P3 during the Vertical Load Test

One of the reasons that the load transfer curve does not match the measured applied load could be due to the way in which the gages were installed during the prefabrication process. The embedded strain gages were suspended between two prestressing strands. When UHPC was poured, the gages could have tilted in the y-direction or shifted in the x-direction changing the angle of the gage as well as the distance from the neutral axis.

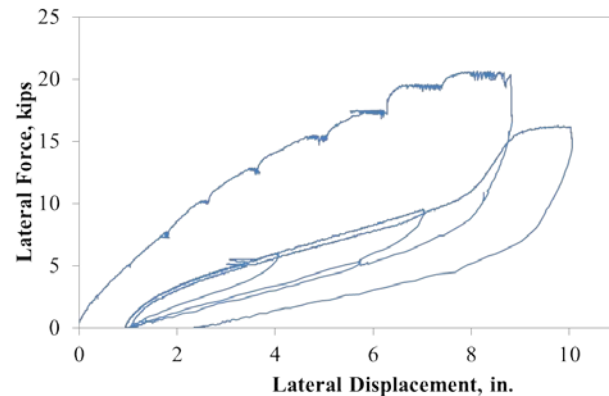
As previously mentioned, P4 was tested in weak-axis bending. Fig. 14 shows the lateral force-displacement curve for P4. The maximum measured load was 20.6 kips and the maximum lateral displacement was 10 inches. There was noticeable heaving of the soil on the east side of P4 during the lateral load test. P4 had a 2.35-in. residual displacement after completing all load cycles.

Fig. 14 Force-Displacement Curve of P4 during the Lateral Load Test

The splice on P4, located 15 feet from the pile head, performed very well during installation and testing. No visible damage from driving or the lateral load test was found on or near the splice after excavation. The splice was subjected to compressive stresses of 5.7 ksi and a tensile stress of 0.1 ksi during driving. The final elevation of the splice was 12 feet below the ground surface. Based on the field measurements, the splice was subjected to 2.6 kips of shear, 52.4 kip-in of bending moment, and 0.1-in of lateral displacement.

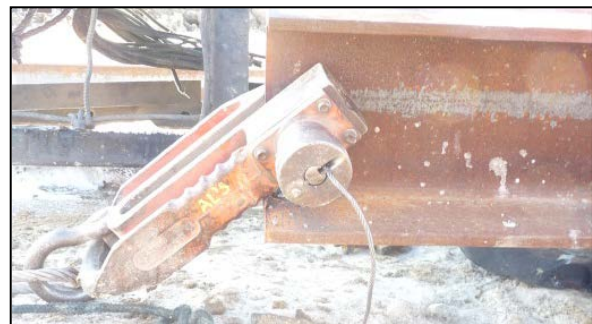
The steel piles were lifted into position by using the pickup point shown in Fig. 15. The pile was lifted to a vertical position and set into the 10-ft deep prebore hole. The crane was unhooked from the steel pile to pick up the hammer leads and position them on the top of the steel pile. When the leads, hammer and pile were in place, the ram of the hammer was lifted manually by the crane and dropped.

Fig. 15 Pickup Point for Steel Piles

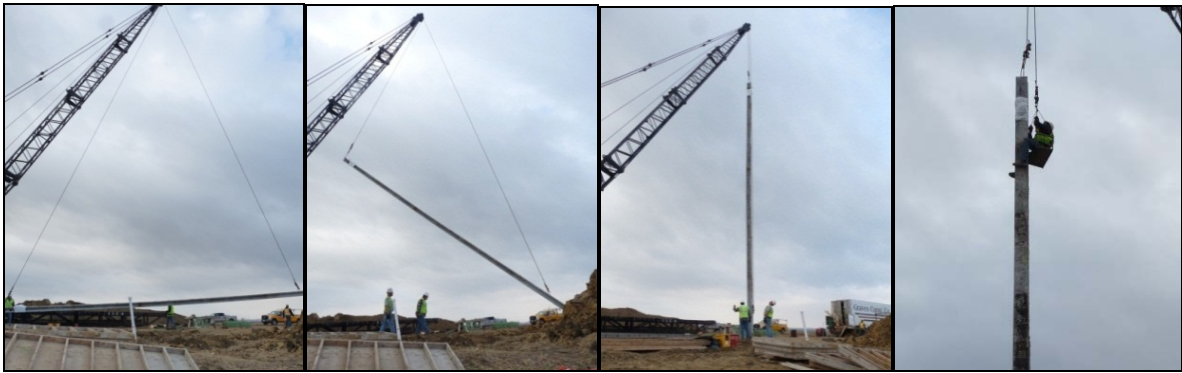
the pickup point at the pile head and the inserted prestressing strand hook at the toe of the pile. Once the pile was lifted off the ground, the crane operator rotated the pile to the vertical position in the air as shown in Fig. 17, which was very similar to that of a steel H-pile.

Fig. 17 Stages of the Pickup of UW1-2

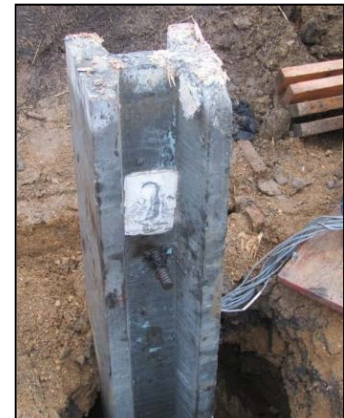
A 4-in. plywood pile cushion was used to protect the UHPC pile head, but UW1-2 punched through the pile cushion shortly after driving had begun. Instead of replacing the cushion with a new one, the pile was driven with essentially no cushion. There was slight cracking to the pile head corners of UW1-2 as shown in Fig. 18. This insignificant damage could also be due to the pile head being not perfectly centered under the helmet. It is also important to note that the UW1-2 was slightly tilted after driving and on the west side of the prebore hole as shown in Fig. 18.

Fig. 18 Slight Damage to UW1-2 at EOD
