LOCAL REPAIR OF PRECAST CONCRETE BEAMS USING BONDED COMPOSITE PATCH

Ozgur Yapar, Vanderbilt University, Nashville, TN
P.K. Basu, D.Sc., PE, Vanderbilt University, Nashville, TN
Wayne Seger, PE, Tennessee Department of Transportation, Nashville, TN
Jacob N. McNutt, Vanderbilt University, Nashville, TN
Nikolas A. Nordendale, Vanderbilt University, Nashville, TN

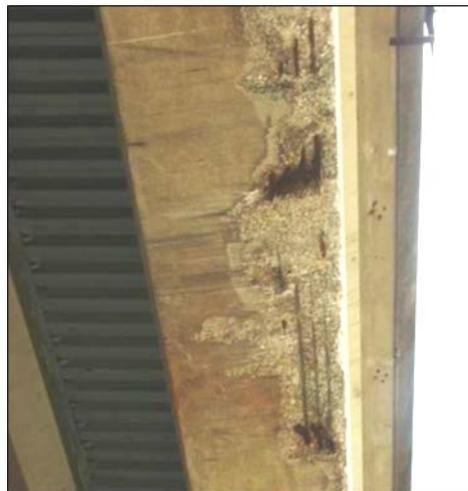
Fig. 1 Exposed strands due to damage caused by truck impact (Harries et al.²)

Nearly one-third of about 0.6 million bridges in our nation's transportation infrastructure are either structurally deficient, functionally obsolete, or both. The estimated price tag for replacing all the deficient and/or obsolete bridges within a few years is about \$140 billion, Schust¹. A sizeable percentage (about 30%) of all the bridges has precast concrete girders. Majority of these bridges were built in the 20th century and were designed to last 50 years or more. The age of a large proportion of these bridges is 40 years or more, and is undergoing deterioration as a result of chloride-ion penetration, carbonation, alkali-silicate reaction, sulfate attack, leaching and freeze-thaw and thermal cycles hastened by the corrosion of the embedded steel reinforcements and strands. Construction and design errors may also have contributed to the process. The aging process of a bridge may be accelerated by abnormally heavier, larger, and faster traffic loads. A very common form of damage caused to the soffit of bridge girders is by the impact of over-height vehicles in violation of warning signs on actual vertical clearance. In Fig. 1 is shown the bottom of girder damaged by vehicle impact exposing some of the strands.

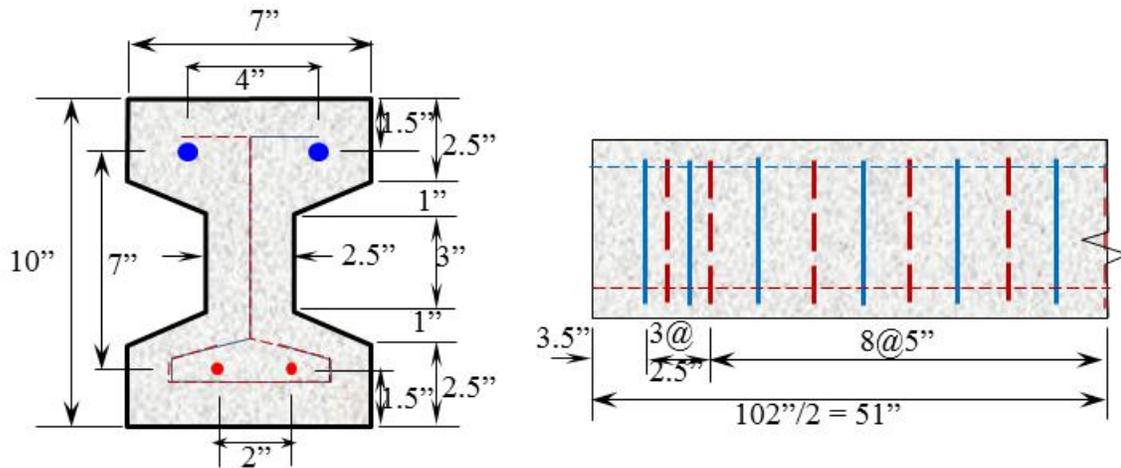
Fig. 2 Prestressed concrete test beam

(a) Details of cross-section (b) Stirrups

The three precast prestressed test beams were proportioned for a total limit load of 22.25 kips, keeping in view the available test facilities in the laboratory, appropriate weight of the test beams for ease of handling, feasibility of fabrication in laboratory conditions, and nature of tests to be undertaken. The details of the test beams are shown in Fig. 2. Two ½" dia. prestressing strands with ultimate tensile strength of 270 ksi are used. The top hanger bars

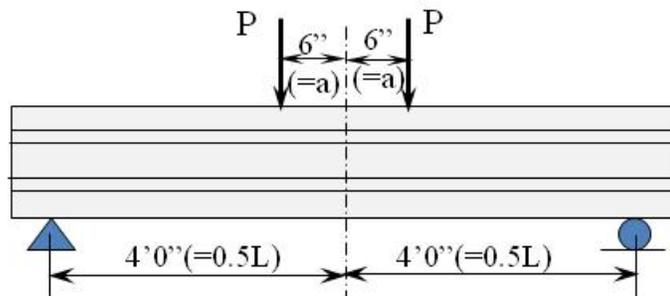
Fig. 3 Loading configuration

are of #3 size and stirrups are of #2 size. The average concrete strength at 28-days is 6.5 ksi. The beams were subjected to four-point loading, as shown in Fig. 3.

Two of the beams, designated as PSCB1 and PSCB2, were loaded as shown in Fig. 3, past the service load, to cause damage in the form of structural cracks. Beam PSCB1 developed shear cracks on one side and was loaded to 16.3 kips and PSCB2 developed flexural cracks near the center of span and was loaded to 24.3 kips. PSCB1 was subjected to shear patch repair using 8" wide Hexwrap U-jacket. The flexural patch repair of PSCB2 was done by bonding a 4"x18" Carbodur strip in the bottom flange, see Fig. 8. Further details of patch design are given in Table 3. Patch repair was followed by installation of sensors to measure the strains in the patches during load testing.

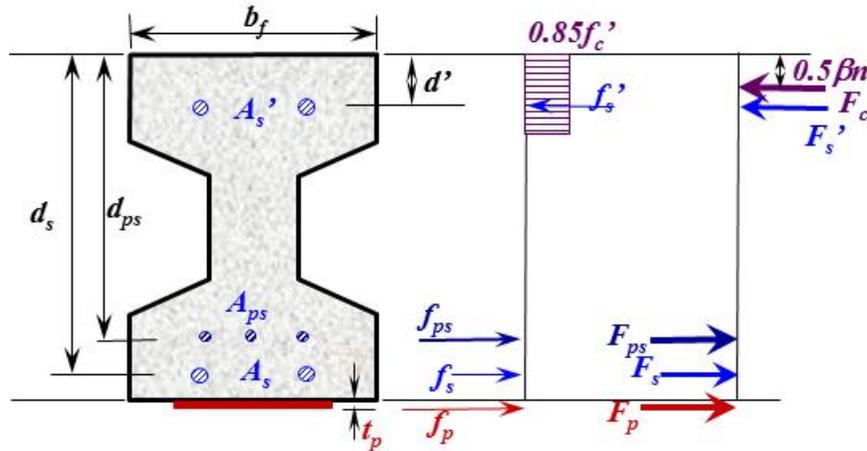
Fig. 4 Prestressed concrete beam (PSC) at flexural limit state

In the prestressed concrete (PSC) section shown Fig. 4, apart from bottom steel strands of area A_{ps} and top reinforcing rods of area A_s' , additional bottom reinforcing rods of area A_s is shown. Here, four flexural strength limit states can be identified, namely, (i) all steel elastic,

(ii) all steel plastic, (iii) top steel and strands elastic and bottom steel yielded, and (iv) top steel elastic and all bottom yielded. The flexural stresses and forces in the patch-repaired beam section are also shown in Fig. 4, with all steel yielded and concrete reaching the crushing strain. Summing the moment of the internal forces about the center of the composite patch yields the nominal moment capacity. Substitution of the expressions for F_c, F_s', F_{ps} and F_s into the moment capacity expression leads to the Eq. 3 for the neutral axis depth,

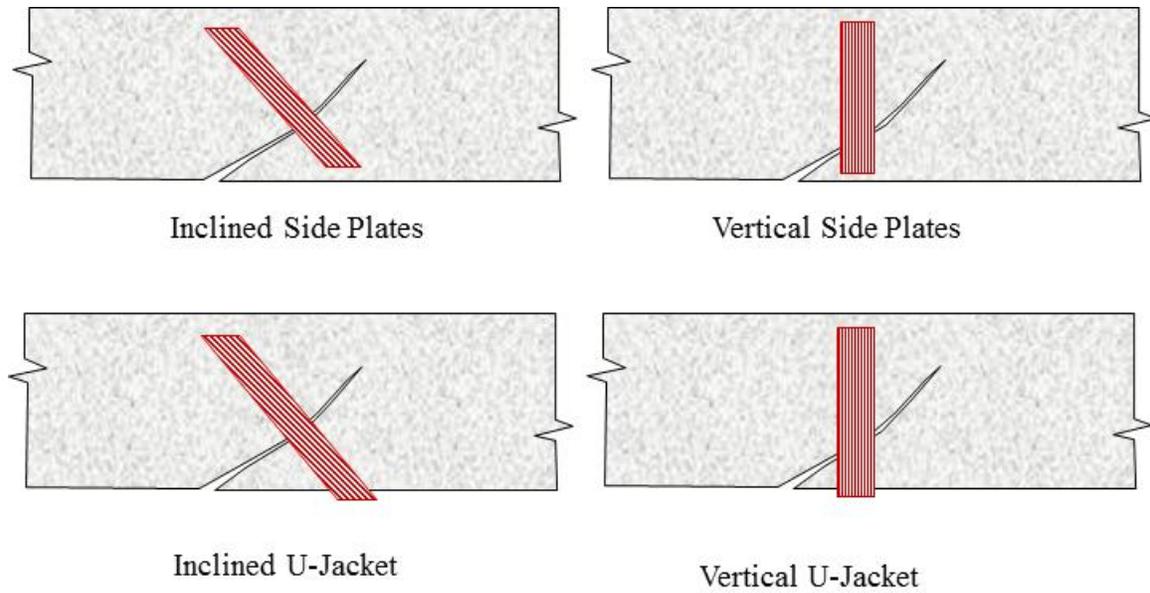
Fig. 5 Shear patch configurations

Possible shear patch configurations are shown in Fig. 5, comprising of a pair of inclined side plates, a pair of vertical side plates, an inclined U-jacket and a vertical U-jacket. U-jackets are considered advantageous over side plates in the sense that, in the former case, the patch is prone to debonding above the crack only; whereas, in the latter case, the patch is prone to bond failure on both sides of the crack. Full wrapping of the beam is not possible because of the presence of the deck slab and also not desirable because of the possibility of explosive failure under overload.

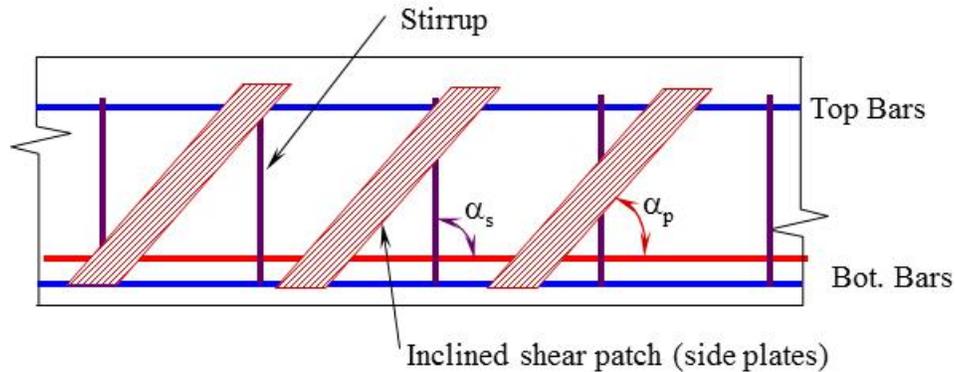
Fig. 6 Series of inclined patch strips in pairs

The shear capacity of the shear-patch shown Fig. 6 is given by Eq. 4 shown below.

For some situations, the concrete resistance, V_c , may need to be ignored. The design force for each pair of patches is given by $F_p = V_p d / s (\sin \alpha_p + \cos \alpha_p)$. If only one pair of inclined patch strips is used, the design force for each patch will be $V_p / \sin \alpha_p$.

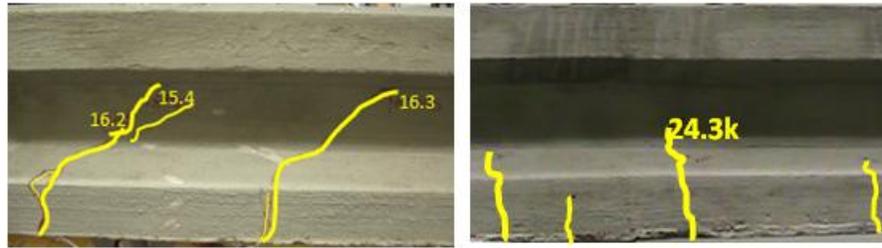
Fig. 7 Cracks in damaged beams before repair

(a) Shear crack in PSCB1 near right support (b) Flexure cracks in PSCB2 near midspan

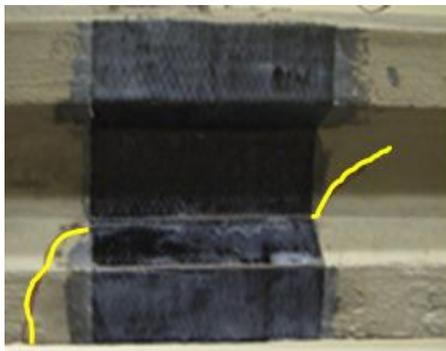
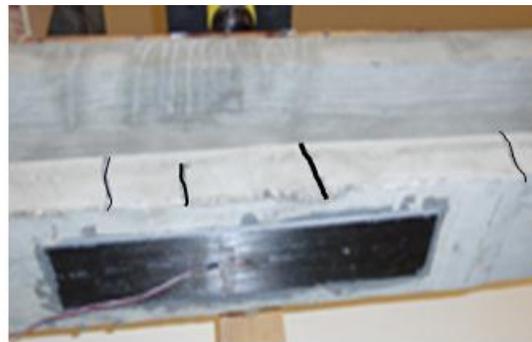
Fig. 8 Patch repaired beams PSCB1 and PSCB2

(a) Hexwrap U-Jacket patch

(b) Carbodur patch in bottom

The patch repair of beams PSCB1 and PSCB2 are shown in Fig. 8. Fig. 8(a) shows the bonded Hexwrap U-jacket covering the shear cracks in PSCB1. Fig. 8(b) shows the bonded

Carbodur plate spanning the flexure cracks in the bottom flange.

The patch repairs were first instrumented with strain gages, as can be seen in Fig. 8(b), and then the beams were subjected to the same four-point loading setup, shown in Fig. 9, similar to what was done to cause damage to the beams before undertaking any repair. The load was applied at ASTM specified loading rates for concrete beams. Loading was continued until failure. Data on load vs. deflection as well as load vs. strain were recorded. In the case of PSCB1, the failure was again in shear, initiated by the elongation of existing cracks and creation of new shear cracks, Fig. 10(a). This was followed by progressive cracking of the patch normal to the axis of the carbon fibers in the U-jacket accompanied by debonding, especially near the bottom flange, Fig. 10(b). In this case, the failure load hardly exceeded the failure load without patch. However, the beam continued to support the maximum load

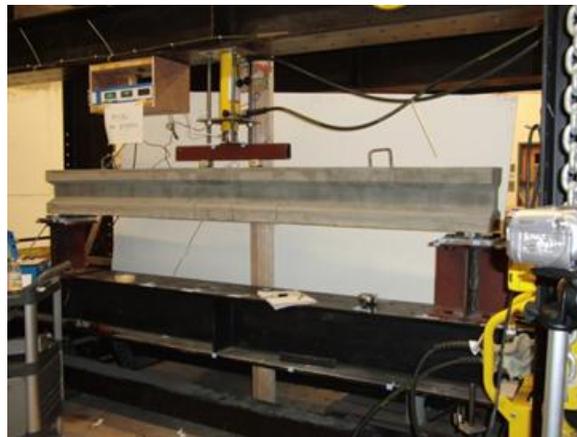
Fig. 9 Load testing of PSCB2 in progress

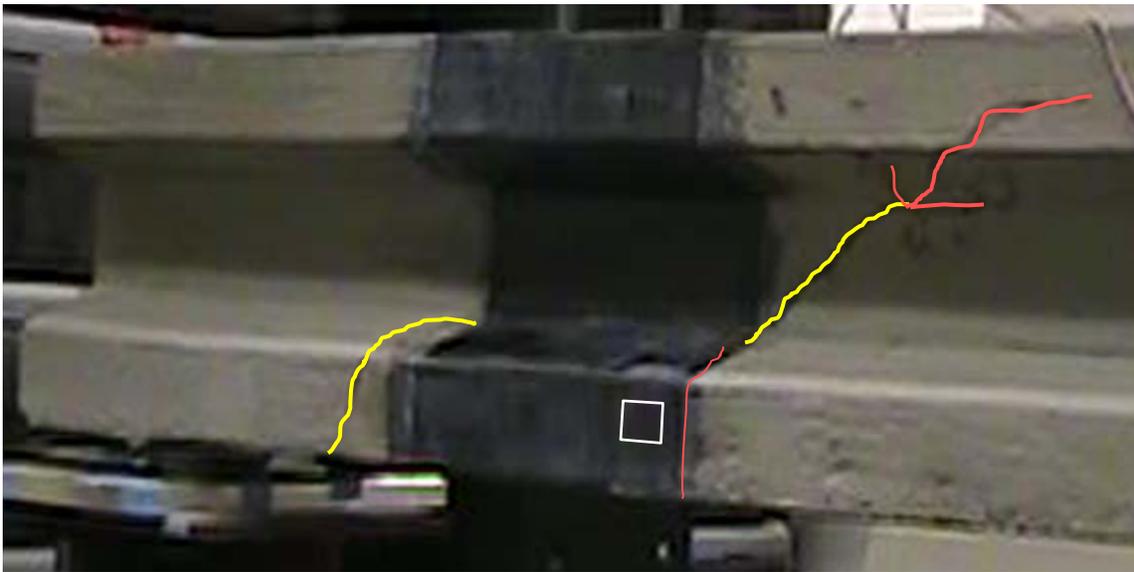
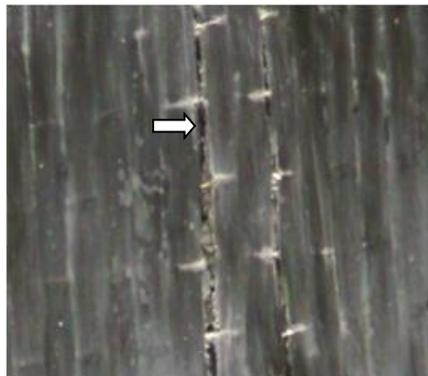
(a) Cracking of PSCB1 at a load of 16 kips

(b) Cracking of U-jacket in the boxed area shown above
Fig. 10

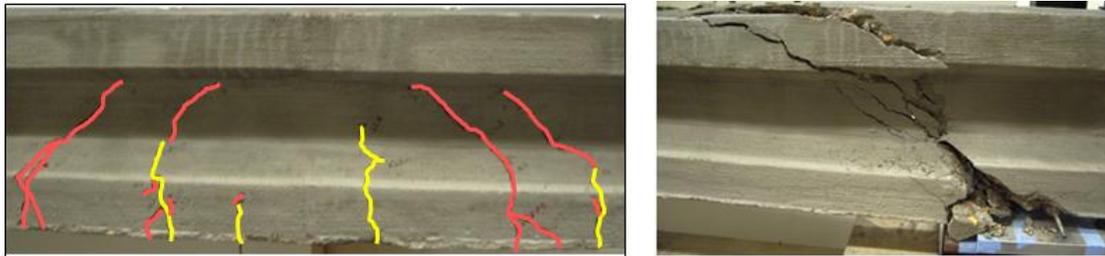
Fig. 11 Failure patterns of PSCB2 after repair

(a) Flexural cracks at failure load

(b) Failure caused by shear cracks near one support

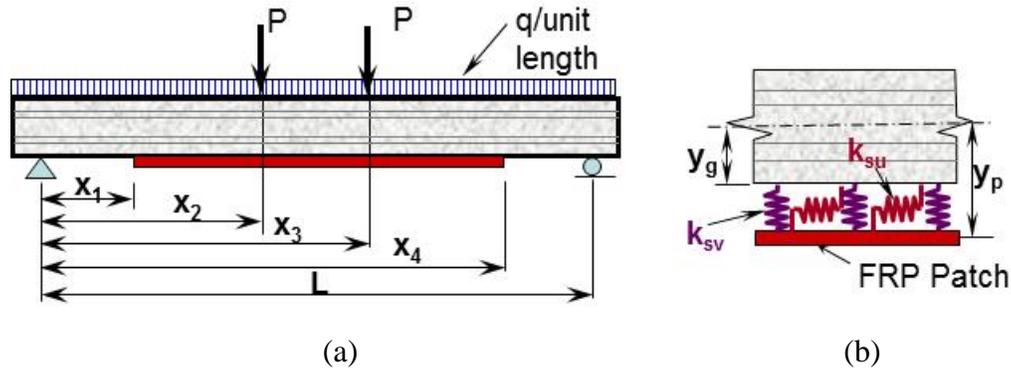
Fig. 12 Simply supported beam with flexural patch repair in bottom

As a simpler alternative to finite element analysis, a scheme for reasonably accurate analysis of bonded patch repair of bottom flange of the beam was developed based on time tested principles of mechanics. The analysis is valid up to the limit state. A schematic view of the beam is shown in Fig. 12(a). Fig. 12(b) shows normal and shear spring model to represent the normal and tangential resistance of the adhesive layer. Tests were conducted to determine the equivalent spring constants for the adhesive, as shown in Table 2. One common assumption made in the analysis is that the plane sections in the beam as well as patch remain so, allowing relative deformation between the two. The effect of material nonlinearity in concrete is allowed for indirectly by modifying the stiffness with the progression of damage. No delamination of patch is allowed. The total potential energy of the beam can then be expressed as Eq. 7.

In this expression, v_g and v_p are vertical displacements of the beam and patch at any point, $(EI)_g$ and $(EI)_p$ are flexural rigidities of the beam and the patch at any point, $(EA)_p$ is the axial rigidity of the patch, and y_p is defined in Fig. 12. Also, $\delta_{sv} = v_g - v_p$, and $\delta_{su} = y_g \frac{dv_g}{dx} - \frac{t_p}{2} \frac{dv_p}{dx}$ are the extensions of the equivalent vertical and horizontal springs representing the stiffness of the adhesive at the interface of patch and beam bottom. In solving the problem, the unknown deflections, v_b and v_p , will be represented by the following Fourier series with unknown coefficients.

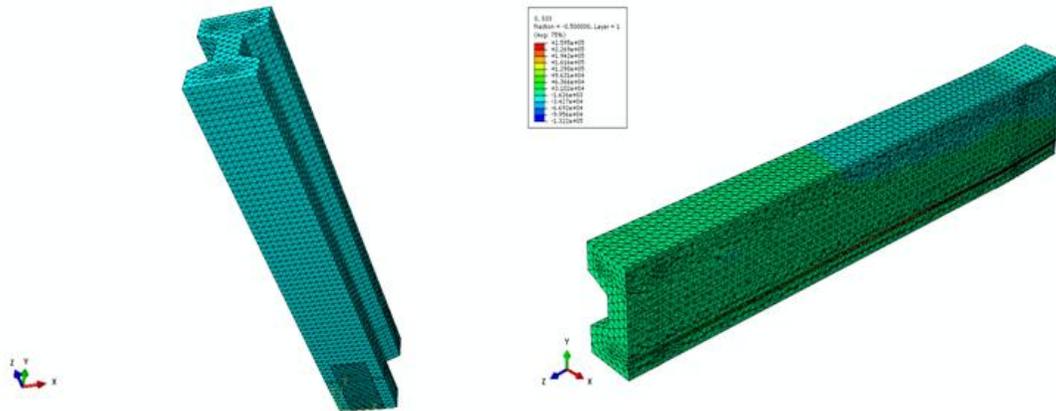
(a) Finite element model for half beam (b) Longitudinal stress (S33) contours
 Fig. 13 Finite element modeling of flexural PSC beam with bottom patch repair

In the model developed for the present study, the properties of concrete, namely, tensile, compressive and bond behaviors were properly characterized. The model also included tension stiffening action allowing for progressive micro-cracking in concrete with a stiffness which is higher than the one based on no tension resistance in concrete. The concrete behavior is represented by using the concrete damage plasticity (CDP) model. This model assumes two main failure modes of concrete which are tensile cracking and compressive crushing (Hibbitt et al.¹⁴). In the CDP model, the compression data of the concrete was input as a function of compressive stress versus inelastic strain. Behaviors of reinforcing steel and prestressing strand were defined as elastic-perfectly plastic. The yield strength of unstressed steel was taken as 60 ksi. The bond between the reinforcement and the concrete was assumed as cohesive with stiffness of 5.72 k/in. The yield strength of strand was taken as 243 ksi. The ultimate compressive strength of concrete was taken as the usual compressive strength of concrete (f_c') which was defined as 6.5 ksi. The crushing strain corresponding to the ultimate compressive strength of concrete was defined as 0.003. The ultimate strain at which the compressive stress reaches zero was taken as 0.005. For the sake of computational efficiency, the symmetry of the beam about its center line was taken advantage of by considering only one-half of the beam and applying appropriate boundary conditions at the line of symmetry. The finite element model shown in Fig. 13(a) comprises of 62,636 C3D4 elements, and in the Carbodur patch there are 420 C3D8R elements. The stirrups did not form a closed loop, so were ignored in the model. Fig. 13(b) shows the normal stress contours in the longitudinal sectional view of the beam.

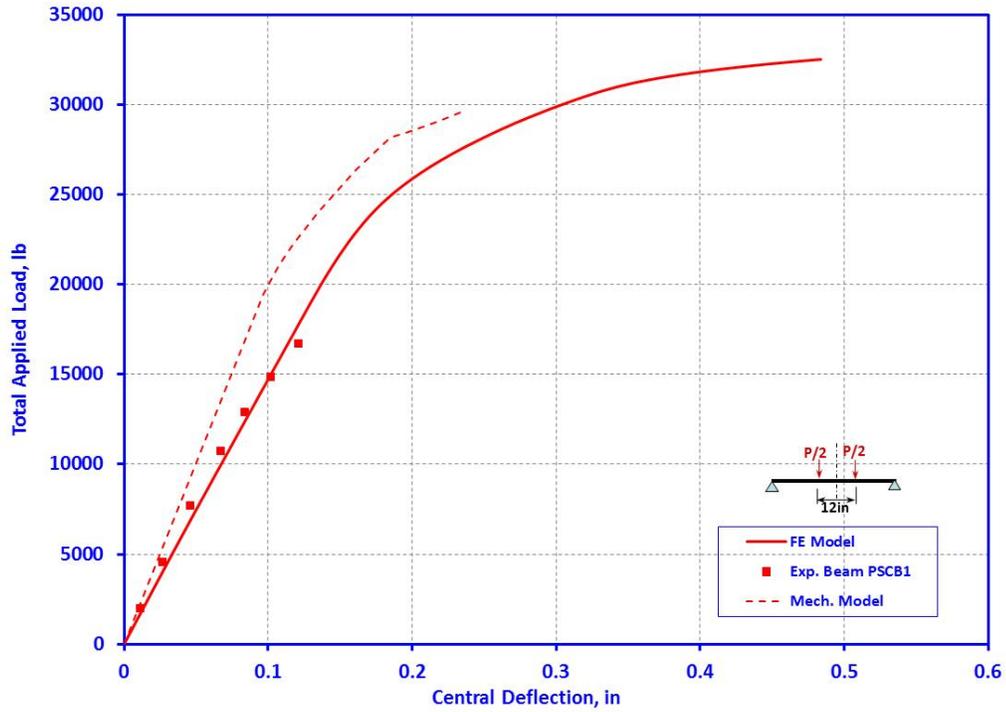
Fig. 14 Variation of deflection with applied load for virgin PSCB1

reached under increasing deformation, showing significant ductility. No flexural cracking in the maximum moment region was noticed. The load vs. deflection experimental curve for virgin PSCB1 is shown in Fig. 14. In Fig. 15 is shown the variation of experimental normal strain in the top of beam with the applied load. In the case of PSCB2, the final failure was also in shear taking place suddenly at a load of 30.5kips. The flexure patch repair seemed to do its job well. The shear failure of PSCB2, occurring just at one support, is shown in Fig. 11(b). The plots of Figs. 16 to 18 give the variation of experimental central deflection, top normal strain and maximum patch strain for flexural patch repaired PSCB2.

The result of mechanistic model for virgin PSCB1 is shown in Fig. 14, showing somewhat stiffer response than experimental result. This may be attributed to the assumption of perfect interfacial bond between concrete and strands/rebars. In the case of patch-repaired beam PSCB2, the Fig. 16 plot of load vs. central deflection based on mechanistic model shows good agreement with experimental data in the early phases of loading, but appears to be stiffer at higher loads, further confirming the effect of perfect bond assumption in the mechanistic model. In Fig. 17, however, the top strain values at midspan show reasonable agreement with experiments.

The finite element results are for virgin PSCB1 (applicable to PSCB2 as well) and patch-repaired PSCB2 are shown in Figs. 14, 16 thru 18. In general, the results show excellent agreement with experimental data. However, the mechanistic model results in Fig. 14 appear to represent somewhat stiffer behavior, but those in Fig. 17 show better agreement with respect to finite element results.

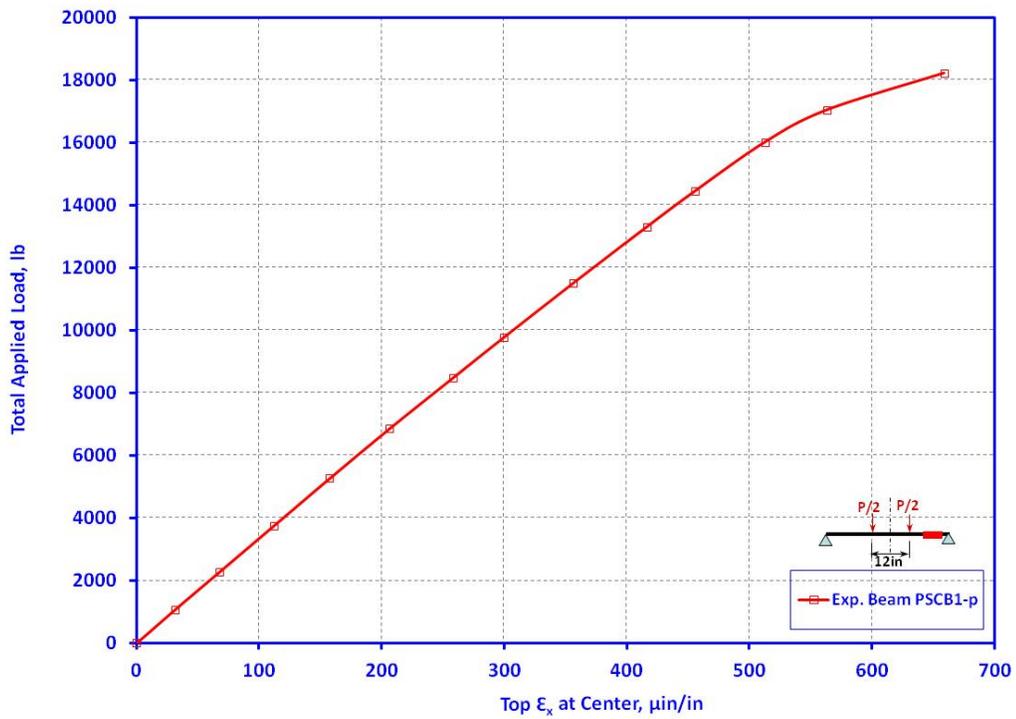
Fig. 15 Variation of maximum concrete strain with applied load for PSCB1

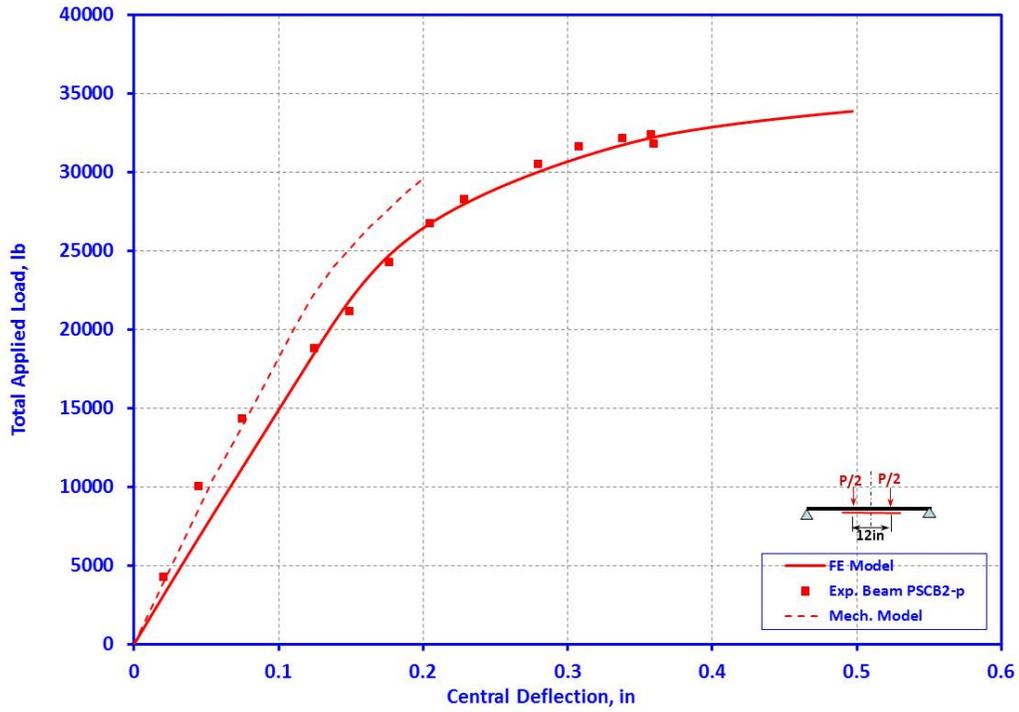
Fig. 16 Variation of central deflection with applied load for PSCB2

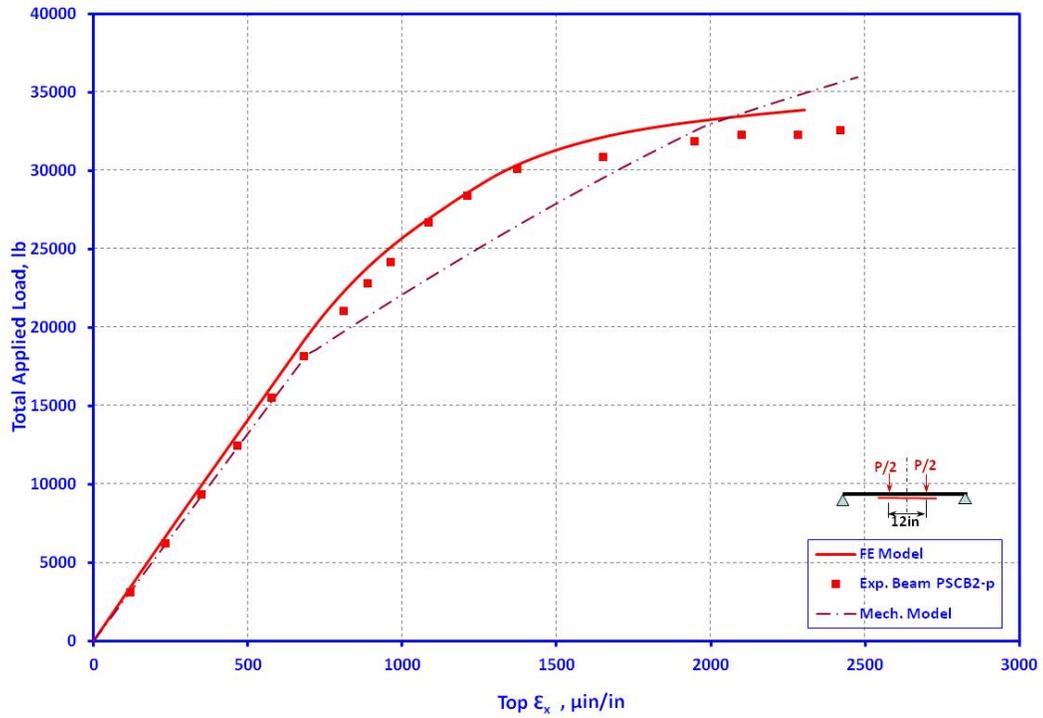
Fig. 17 Variation of maximum top strain with applied load for PSCB2

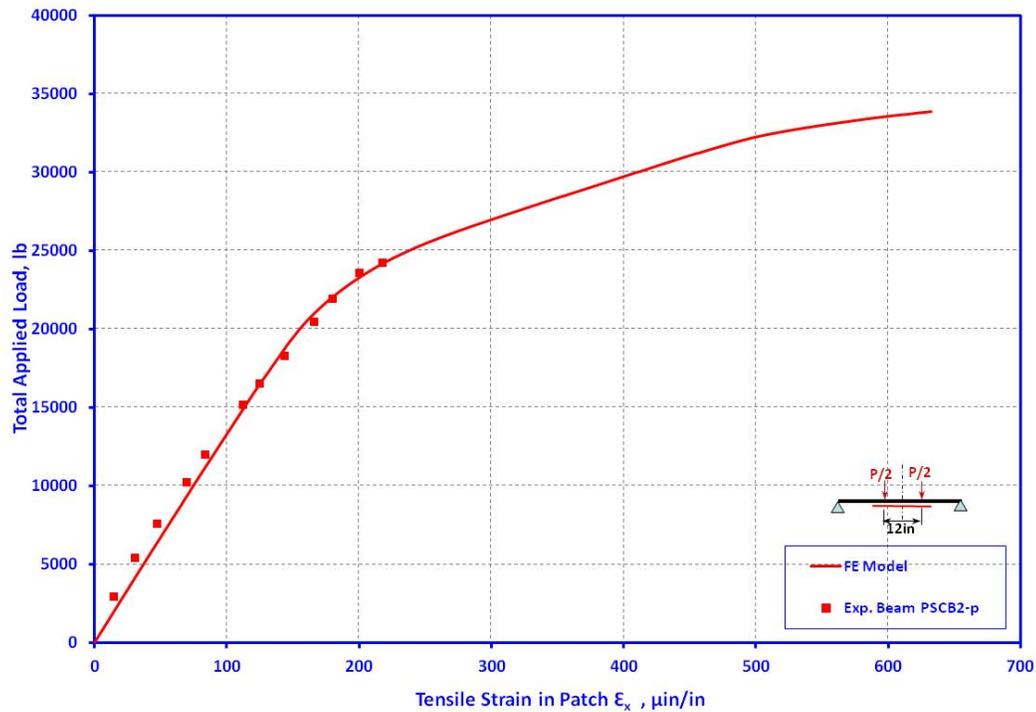
Fig. 18 Variation of maximum patch strain with applied load for PSCB2
