## **DURABLE, JOINTLESS, TWO SPAN, BULB-T OVERPASS**

**Robert S. Bulger, PE**, Maine Department of Transportation, Augusta, ME

Deficiencies of the previously existing bridge identified two critical design requirements of the replacement structure: to make the overall bridge corrosion resistant to counter effects of intense de-icing salts use; and to increase both vertical and horizontal clearances under the overpass. Failed bridge seals in conjunction with chloride contaminated run-off had severely deteriorated the previous structure's rolled steel beams, the bearings, the bridge seats, and the exposed sides of the substructure. Prestressed concrete beams are not only a more corrosion resistant material, their range of concrete thermal movements is less than steel, facilitating design and details for a jointless bridge.

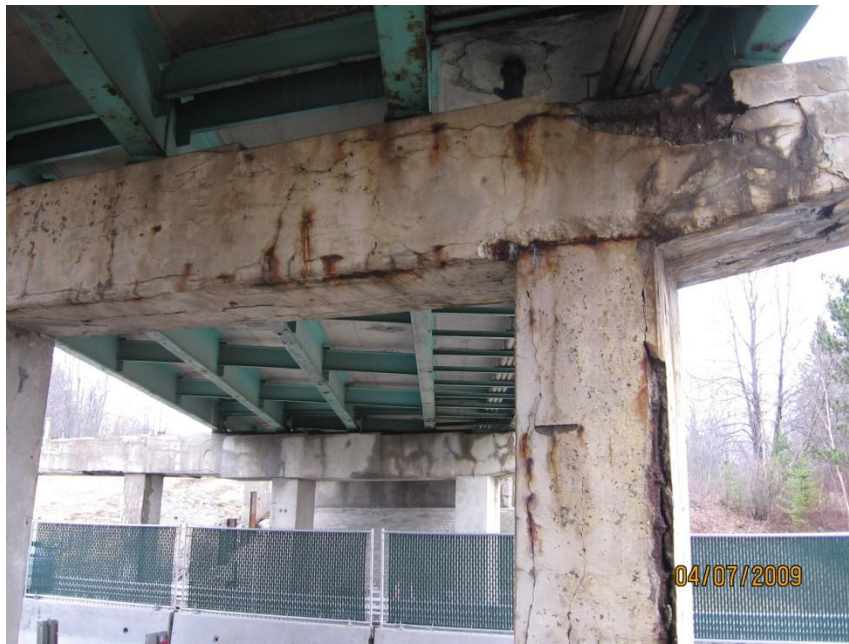
Plant fabricated, high quality prestressed concrete beams were selected as the most viable and corrosion resistant superstructure elements for carrying Hammond Street over Interstate 95 in Bangor, Maine. The previously existing structure exhibited deteriorated steel beams and bearings, as well as deteriorated concrete bridge seats, pier caps, and other surfaces. The use of a jointless superstructure system could eliminate seal failures such as the one that resulted in the accelerated deterioration shown below.

Underneath Previous Bridge w/ Central Pier in Foreground

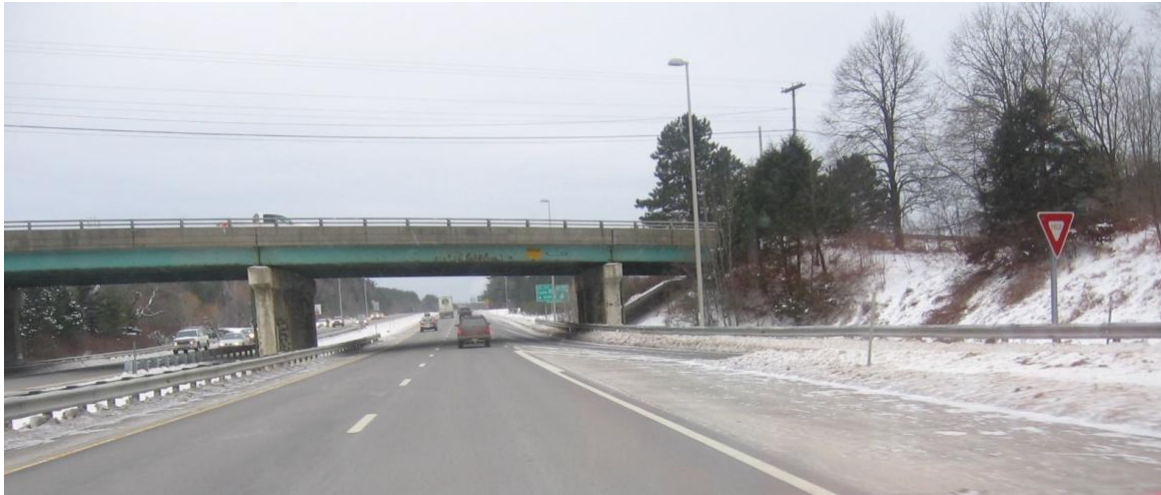
The need to increase vertical underclearance, particularly over the west edge of the southbound side, made the design more challenging. The target minimum underclearance was 16.5 feet; while underclearance for the previous structure was approximately 14.5 feet. This presented a severe restriction on the superstructure depth, particularly the beam depth. Shaving every inch possible from the superstructure depth, the new beam depth is 39.5 inches (1.00m). By this stringent limitation of the beam depth and a limited 1.6 foot grade increase of the bridge profile over the West abutment, this two-span superstructure actually provides nearly two feet additional underclearance compared to the four-span steel superstructure it replaces.

Looking Southerly at West Half of the Previously Existing Bridge

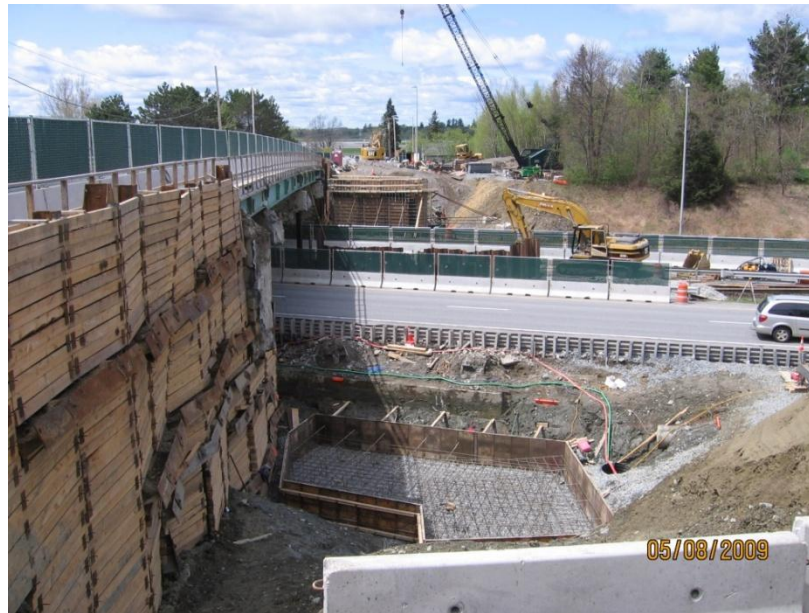
To avoid exorbitant roadway costs, the new structure was built at a 23 degree skew, matching the existing horizontal alignments. The heavy skew presented considerable difficulty in the forming of the cast-in-place beam splices and end diaphragms, that also required block-outs for utilities.. Forming the superstructure and substructure was also complicated with longitudinal construction joints since the bridge had to be constructed in stages to maintain traffic.

Looking Westerly with North Half of Previous Bridge Removed

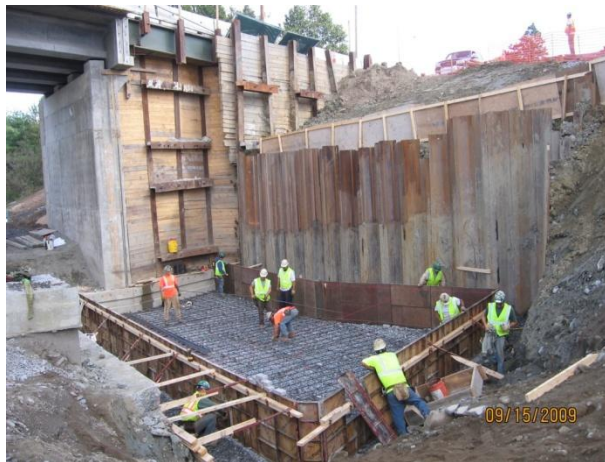
Stage Construction of 2<sup>nd</sup> Half of Abutment #2 Footing – SE Corner

Note the lighter shoring extending from the centerline shoring. The Contractor effectively used the same centerline shoring for both halves of the abutment backfill excavation.

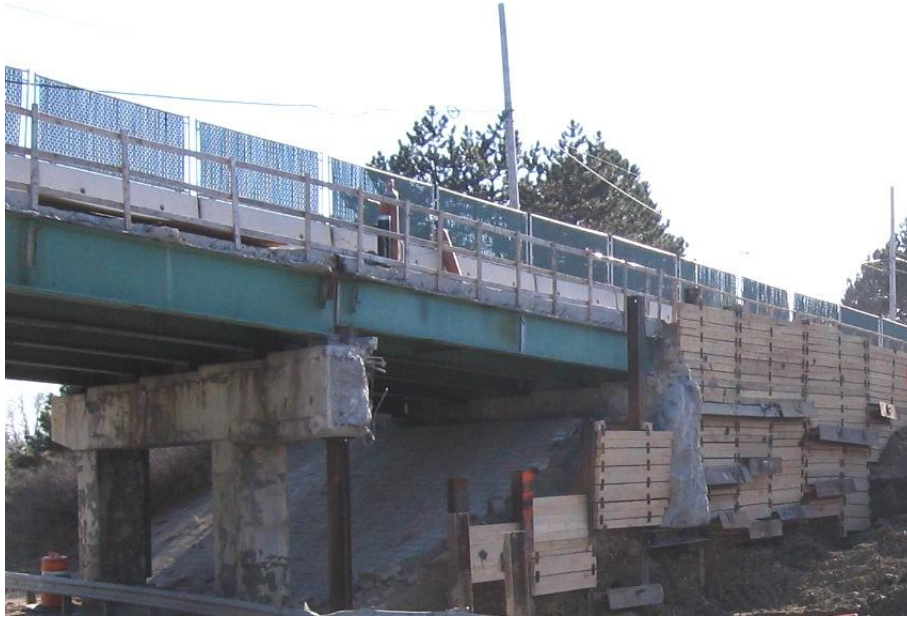
For the designer, one nightmarish staged construction concern was the maintenance of traffic over half of the existing bridge, which meant supporting trucks on half of each deteriorated, four column pier. The previously existing piers suffered visible deterioration, some apparently from Silica Alkaline Reactivity. Making matters worse, the original piers were for lighter loads. They did not have the reserve strength the replacement piers would. Without careful demolition of the first half removed, the Contractor could easily weaken the half bents kept to support the existing bridge and all vehicular traffic through the first stage of construction. Surprisingly, analysis showed that the pier bents would only need bracing if truck loads were transversely located such that an outside truck wheel-line was offset from the projected plan area of one of the remaining columns.

Half Existing Bridge Supported on Half of Westerly Pier

The Contractor's engineer for the stage construction plan, Calderwood Engineering Etc, solved the issue neatly. Instead of providing for the maximum temporary traffic width possible, and crowding the protected work area, the consulting engineer limited the Stage 1 traffic placement to a twenty foot width. The temporary traffic plan for Stage 1 centered the traffic between the two remaining columns such that it minimized stresses due to the possible truck wheel line locations. Admittedly, twenty feet is a small width for bi-directional traffic, but the reduced width area and its approaches are tangent, and construction traffic speeds were reduced. The safety measure gained from sharply reducing live load stresses was considered more than sufficient reason for limiting the temporary traffic width.

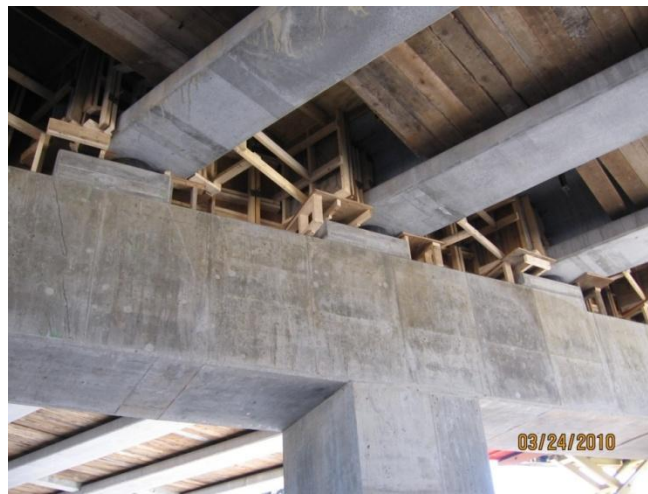
The 23 degree skew complicated the project's construction formwork and structure dimensioning significantly. This was particularly troublesome at each support diaphragm and bridge seat area. The alignments of utility block-outs, and therefore the layout of somewhat crowded reinforcement around them had to be carefully considered. Consider the back of the approach slab, the line for joints and devices to accommodate thermal expansion/contraction. It must be square to the beams while the front of the slabs rests on a skewed backwall. Both approach slab areas are about sixty feet wide. Each slab system is divided into three segments. The alignment of the three approach slab expansion joints varies by 22 feet.

Framing for Formwork of the Pier Continuity Collars and Diaphragm

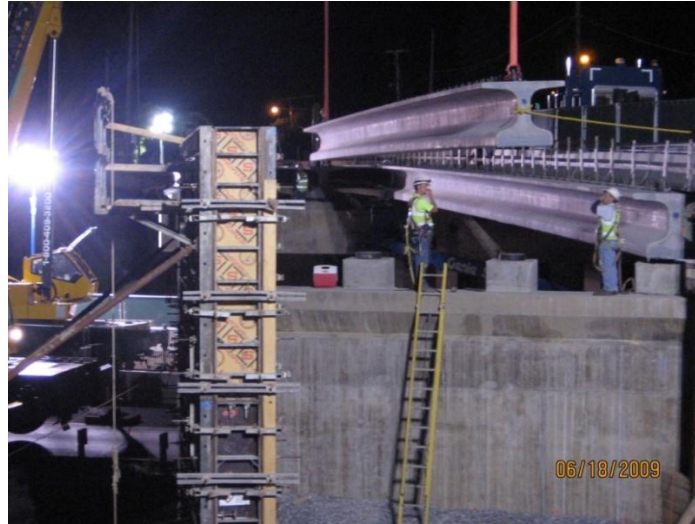
As noted previously, vehicular traffic on the bridge was maintained at all times except for nighttime girder erection. Safe crane positioning also required brief closures of the interstate in one direction, as shown below for the southbound lanes.

Erection of Northerly Span #1 Girders, Showing Back of Abutment #1

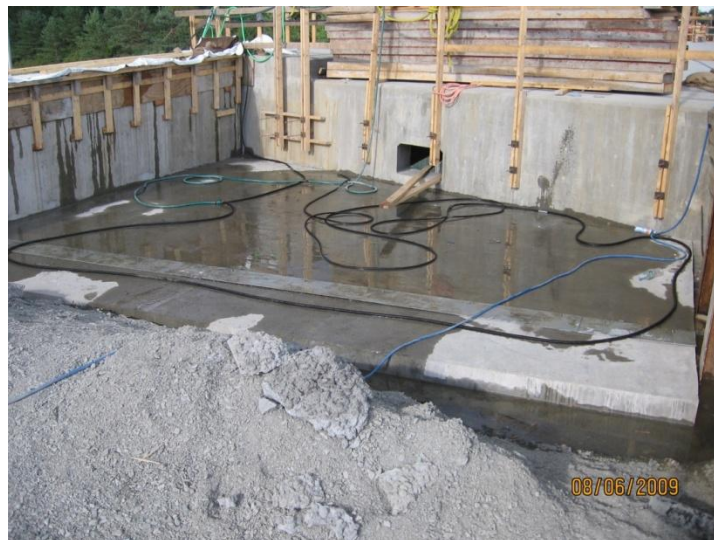
Several aspects of the combination tied-approach-slab and sleeper slab have been discussed already. The Maine Department of Transportation has been exploring at grade approach slabs for integral and semi-integral abutment bridges, whereas buried approach slabs may be considered “old school”. However, the MDOT Bridge Maintenance office has tested and negatively reviewed a few pavement compression joint systems. A good argument is made in studies of approach slab systems, that the soil pressure bulb at an approach slab end has a less effect on the pavement if it is buried. See the following page for a picture of: the tied approach slab; the sleeper slab; the back of the skewed Abutment #1 backwall with a utility block-out; and the top of the return wingwall.

Approach Slabs: No Bond to Wingwall at the Slab Level

There are a few obvious disadvantages to the approach slab system. With the expansion/contraction system placed twenty feet behind the backwall, this work causes a longer traffic disruption to the approach roadway. The entire roadway (and utilities) over the tied approach slab will move longitudinally with annual thermal cycles, so the pavement cast against the stationary return wingwalls will tend to shear at the gutter line. Hopefully frictional forces from the sides of tied approach slabs do not move the adjacent sleeper slabs during expansion movements. With the predictive total range of expansion/contraction only  $\frac{1}{2}$  inch, there is hope that these effects will be insignificant. Since superstructure flexure ends at the floating backwall and the expansion/contraction movement is carried to the end of the tied approach slab, the gas utility company found it necessary to install joints to allow for

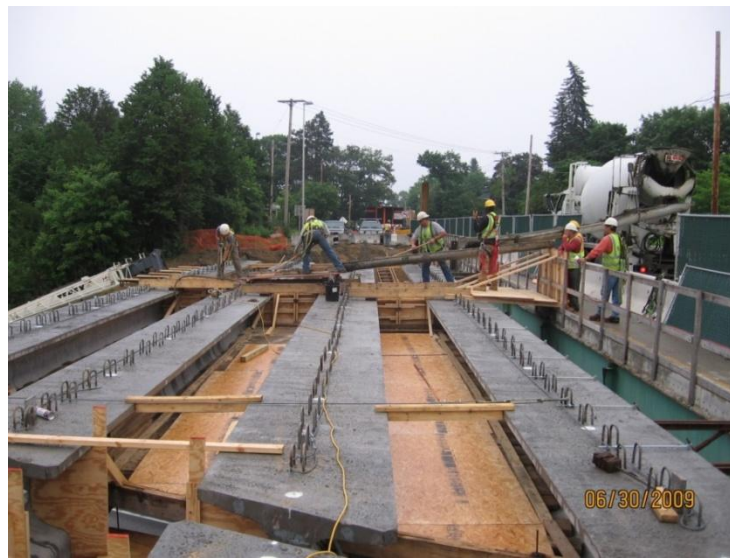
The author has had no prior experience with the massive “continuity collars” that were based on a Massachusetts D.O.T. detail. A colleague, the Preliminary Design Engineer for this Hammond Street Bridge project, used this type of continuity device for the Calais International Bridge between the Province of New Brunswick and the State of Maine. So far, I am not aware of any problems with the function of this type of continuity splice. However, with sincere thanks to Dr. Frank Russo and William Nickas P.E., I learned that in some instances enveloping, cast-in-place, support diaphragms have cracked around the bottom of prestressed concrete beams. The cracking is the result of rotation of the beam ends due to continuing camber growth after erection.

Intermediate Diaphragm Placement w/ Beams Awaiting Pier Splice

In my opinion, despite scheduling challenges and the potential to increase bid costs, it would be worthwhile for my agency to use more exacting procedures to assure that every beam has aged at least three months outside of the prestressing beds, and to track camber of beams to provide for valid bearing seat adjustments just prior to beam erection and valid slab blocking adjustments immediately after erection. Significant camber growth after erection is a serious problem, particularly for prestressed beams that are made continuous.
