HORIZONTAL SHEAR STRENGTH OF FULL-SCALE COMPOSITE BOX AND SLAB BRIDGE BEAMS HAVING HORIZONTAL SHEAR REINFORCEMENT WITH LIMITED DEVELOPMENT LENGTH

ABSTRACT

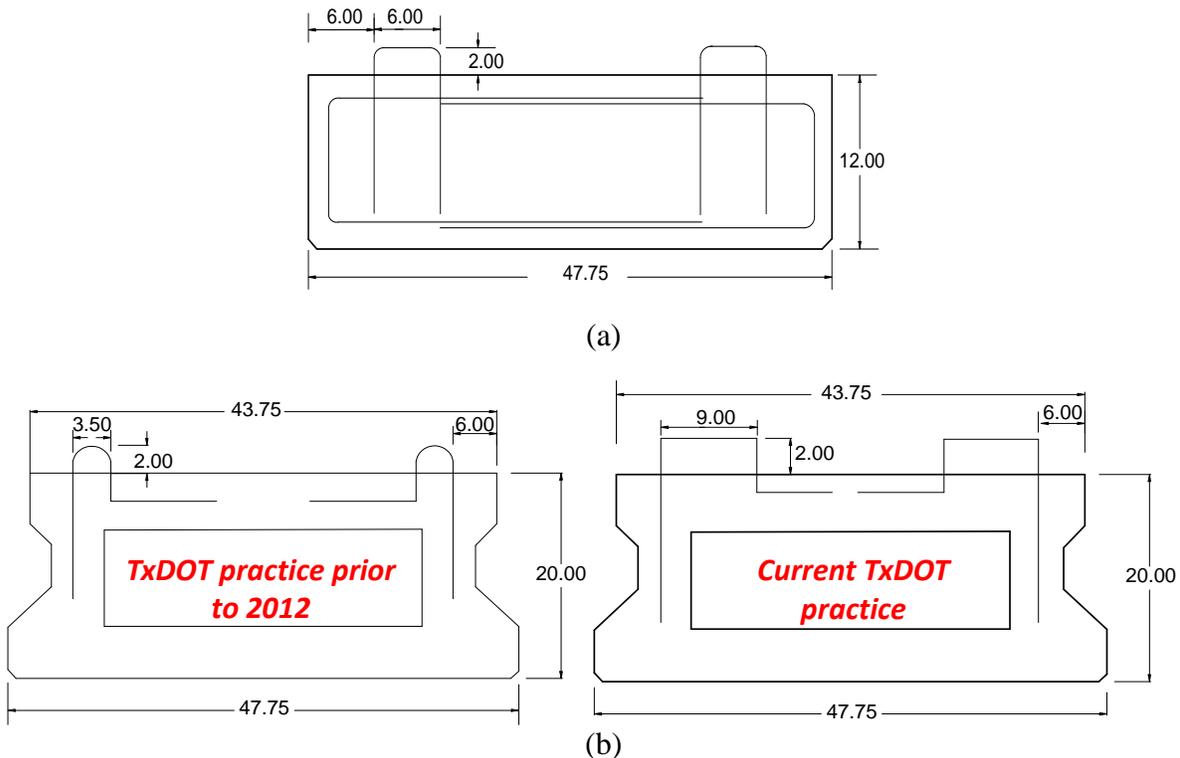
Fig. 1 Standard TxDOT (a) slab and (b) box beam details

by embedment, hooks, or other method to develop the design yield stress. AASHTO Section 5.11.2.4 provides guidelines for determining the development length needed for standard hooks in tension. The equation provided results in an embedded length of 6.7-in. not possible in a 5-in. CIP slab. However, horizontal shear reinforcement do not qualify to be considered as “standard hooks” according to AASHTO and there is no equation suitable for typically horizontal shear reinforcement. Since the shear friction action of the interface shear reinforcement relies on yielding of the bars (Item 3 of Eq. 1), a short embedded length inside the composite slab can lead to localized concrete fracture prior to yielding, thus providing insufficient clamping force. Given that a 5-in. thick composite concrete deck is used on the current TxDOT prestressed slab beams and box beams, the embedded length of interface shear reinforcement is only about 2-in. (Figure 1).

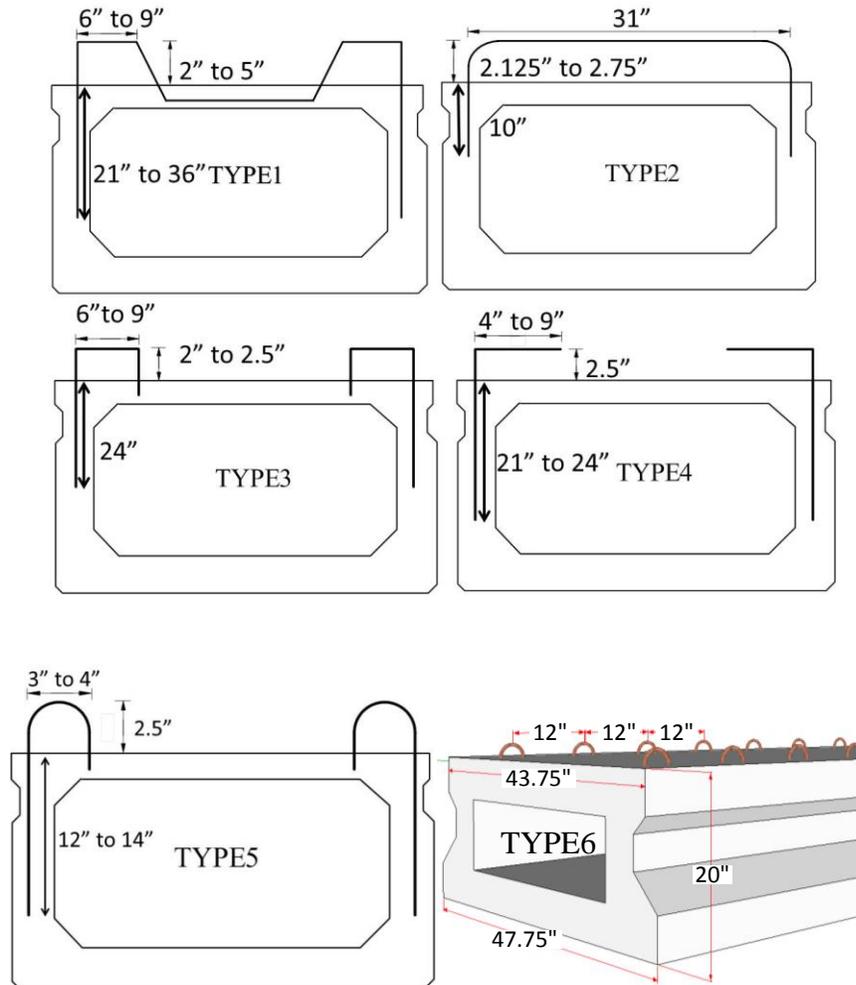
Fig. 2 Types of Standard box beams for DOTs in the US

This study also gathers information on the current practice used for box and slab beams of the 50 states in the U.S. The study set out to determine other DOTs’ practices especially as is concerned with the width and embedded depth of horizontal shear reinforcements. It was found that there are essentially six types of horizontal shear reinforcement (Figure 2 and Table 1) being used in different states. The embedded length of the horizontal shear reinforcement varied between 2-in. and 6-in. depending on the thickness of the CIP slab used in the respective state. It should be noted that some states do not use either box or slab beam or neither, while some states provide a thin asphaltic concrete as the wearing surface and hence do not provide horizontal shear reinforcement. An embedment length of about 2 in. was observed in nearly 70% of the states having box and slab beams.

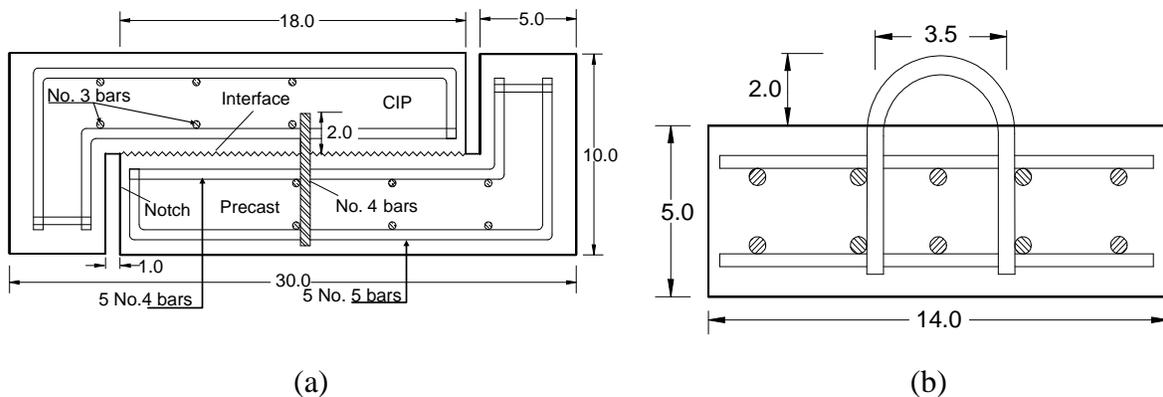
Fig. 3 Reinforcement layout for push-off specimen (a) elevation view and (b) section view

Each test specimen measured $30 \times 14 \times 10$ in. ($762 \times 355.6 \times 254$ mm), this gives a shear interface area of 252 in^2 (18×14 in.). This interface area size is close to the largest interface areas used by prior push-off specimens. The specimen consisted of a 5-inch (127 mm) thick cast-in-place part (which is consistent with the cast-in-place slab on box and slab beams) on top of a 5-inch (127 mm) precast part. Minimum longitudinal and transverse reinforcement was provided to prevent premature flexural failure from occurring. Similar push-off specimen geometry and reinforcement layouts have been used by other researchers (Mattock and Hawkins (1972)⁵ Khan and Mitchell (2002)⁶; and Hofbeck et al., (1969)⁷). It should be noted that this reinforcement layout provides a higher reinforcement ratio as compared to that used in actual girder/deck (Figure 3).

Strain gauges were installed on the horizontal shear reinforcement on both sides so as to obtain strain information. The strain gauges were located 0.5-in. away from the interface to ensure they were not damaged once a crack occurred. The horizontal shear reinforcement was then tied to the reinforcement caging at approximately the center of the interface area (Figure 3a).

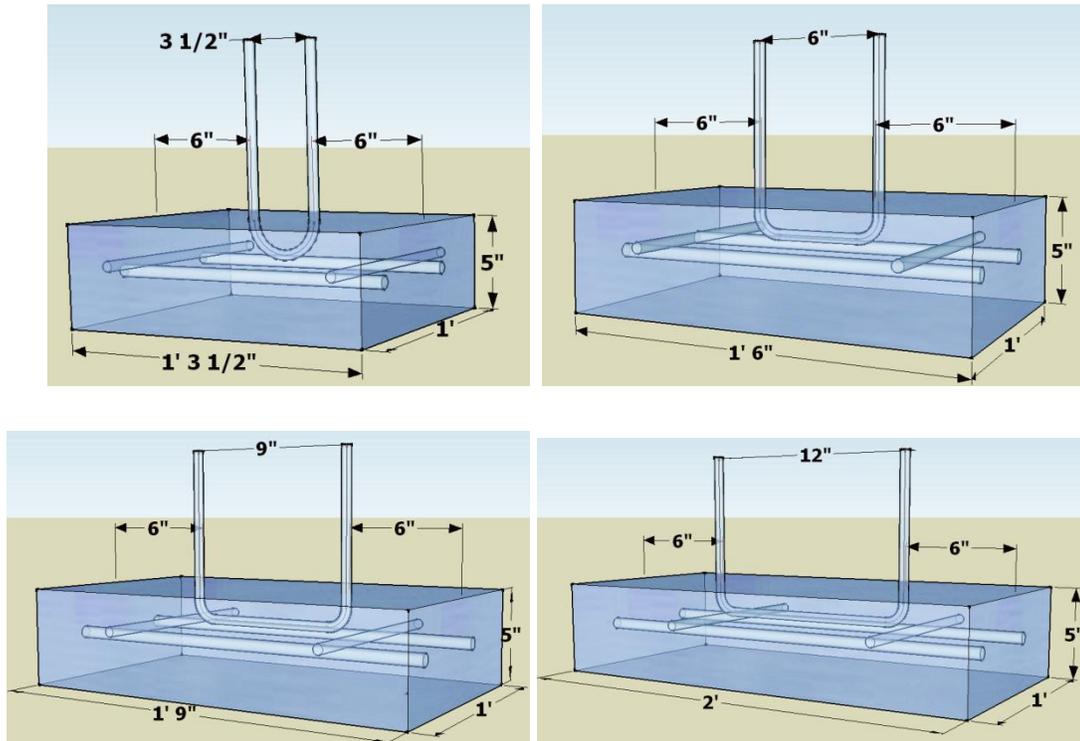
Fig. 4 Pullout specimen configuration

Different pullout specimen geometries were proposed depending on the width of the horizontal shear reinforcement. The four different widths of horizontal shear reinforcement tested were 3.5-in. (88.9 mm), 6-in. (152.4 mm), 9-in. (228.6 mm), and 12-in. (304.8 mm). The 3.5 in. width reinforcements tested were of both a 180° and a 90° bend. The 6 in., 9 in., and 12 in. width specimens had two configurations; one having a continuous bar with a 90° bend and the other having two bars spliced at the center with a 90° bend angle. According to the TxDOT CIP slab standard drawings, the transverse reinforcement is spaced at 6-in. (152.4 mm) maximum whereas the longitudinal reinforcement is spaced at 12-in. (304.8 mm) maximum. Hence transverse reinforcement in all the specimens were provided at 6-in. (139.7 mm) and longitudinal reinforcement at 12-in. (304.8 mm) spacing with a 2.5-in. (63.5 mm) clear cover as specified in the standards. The TxDOT standard drawings also show that the horizontal shear reinforcement is located at 6 inches from the end of the beam. This dimension was maintained constant for all of the different bar widths, therefore the total length of each specimen was the bar width plus 6 inches on both sides, to represent the shortest dimension in the standard drawings that will result in more realistic confinement of the bar by the surrounding concrete as used in the actual decks. This resulted in four different specimen geometries; 15.5×12×5 in. (393.7×304.8×127 mm) for the 3.5-in. reinforcement, 18×12×5 in. (457.2×304.8×127 mm) for the 6-in. reinforcement, 21×12×5 in. (533.4×304.8×127 mm) for the 9-in. reinforcement, and 24×12×5 in. (609.6×304.8×127 mm) for the 12-in. reinforcement, as shown in Figure 4.

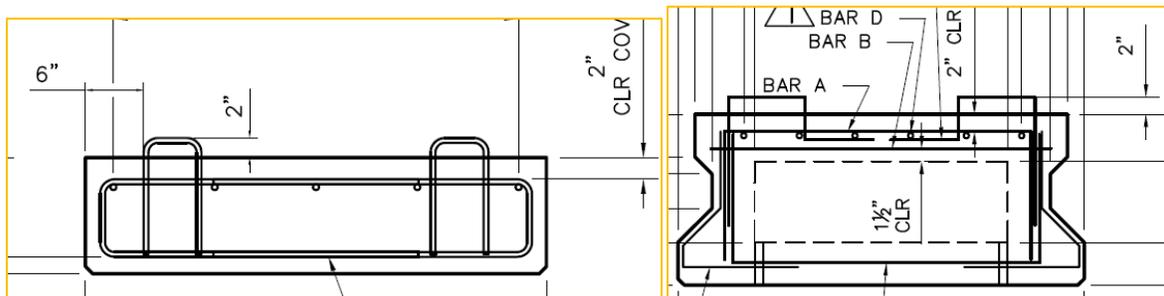
Fig. 5 Typical (a) slab and (b) box beam

Two types of full-scale composite beams: TxDOT box beam (4B20) and TxDOT slab beam (4SB12) (see Table 3) were tested to determine if adequate horizontal shear capacity is provided by the 5-in. concrete deck in current TxDOT slab and box beams, despite lack of reinforcement development. “Adequate horizontal shear capacity” means that horizontal shear failure will not occur before reaching the beam’s ultimate flexural strength. The precast beams with a 5-in. composite deck were constructed and instrumented at a fabricator in Houston and then delivered to UT Arlington Civil Engineering Laboratory Building (CELB) for testing. The slab beam measured 360×47.75×12in. whereas the box beam measured 360×47.75×20 in. One of the box (4B20#1) and slab beam (4SB12#1) was designed using the current reinforcement detail according to TxDOT² specifications so as to represent a typical beam used in practice (Figure 5). Strain gauges were mounted on the horizontal shear reinforcement to provide useful information to check the calculations.

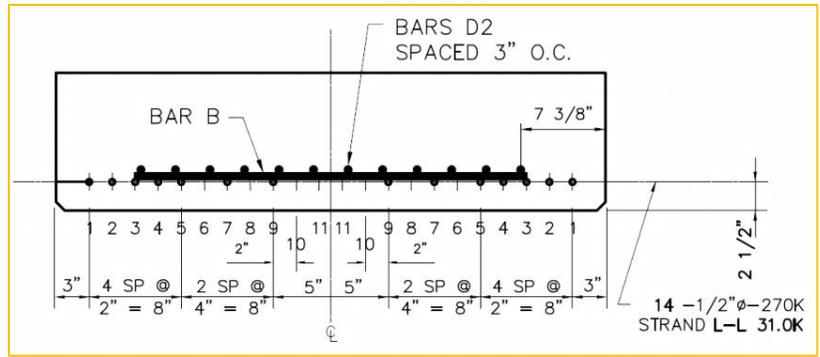
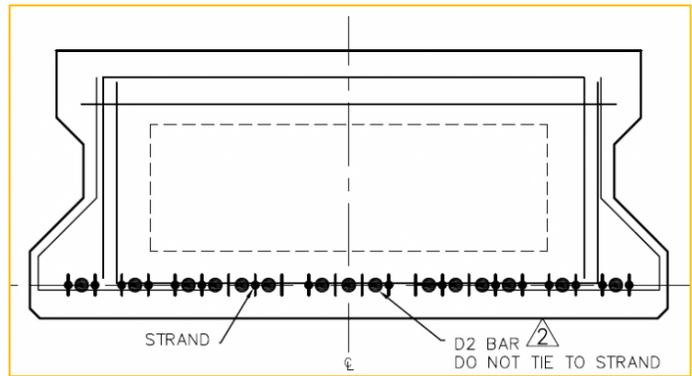
Fig. 6 Second set of specimens with additional longitudinal mild steel reinforcement (a) slab and (b) box beam

The same detailing was maintained for the second box (4B20#2) and slab beam (4SB12#2) with the addition of flexural reinforcement so as to force a horizontal shear failure and evaluate the horizontal shear strength of the beam as a whole. A total of fifteen #8 rebars were added as flexural reinforcement in the box beam while twelve #8 rebars were added in the slab beams. These beams were designed to result in a shear demand higher than that in the strongest TxDOT box beams and slab beams typically used in practice. The flexural reinforcements were placed in the most convenient spacing to avoid obstruction of voids and strands (Figure 6). The beams were designed to ensure tension-controlled behavior and no premature shear failure even with the additional longitudinal reinforcement. Results from push-off and pullout tests had showed that horizontal shear reinforcement provided very minor contribution to the interface shear strength, hence they were completely eliminated in these beams. Strain gauges were mounted on the flexural reinforcements to measure strain on the bars during the test.

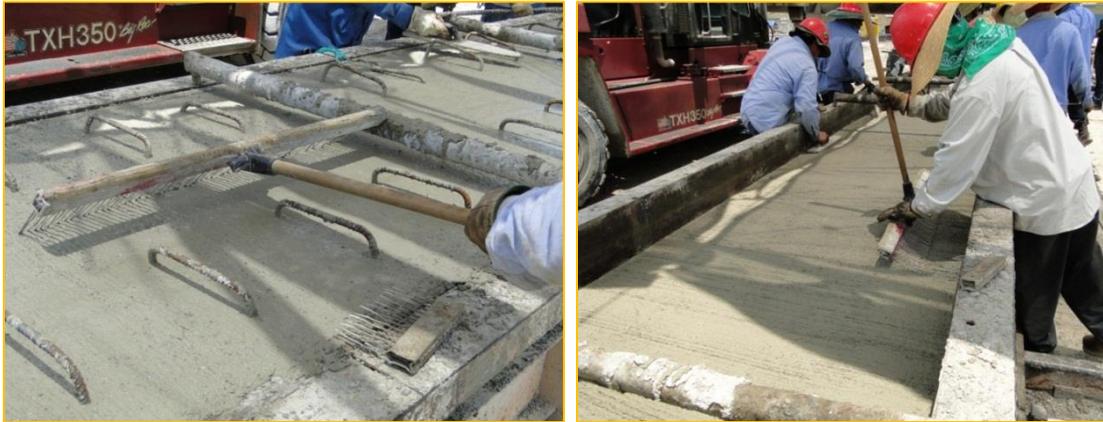
Fig.7 Rake finish on beam specimens

The beams were prepared by a fabricator in Houston. The prestressing bed was first cleaned and sprayed with water because of the high temperatures on the day of casting. The prestressing strands were then drawn and stressed at a jacking force of 31 kips per strand. The longitudinal reinforcement was then placed followed by the stirrups. Strain gauges were installed on the longitudinal bars and on stirrups so as to monitor the strains on the bars. Cylinders were also made to test the compressive strength of the mix after 28 days. Since the fabricator typically provides a rake finish on all slab and box beams, a rake finish was provided on all the specimens as shown in Figure 7. The CIP part of the specimens was cast a few weeks later with concrete Class “S” as shown in Figure 8.

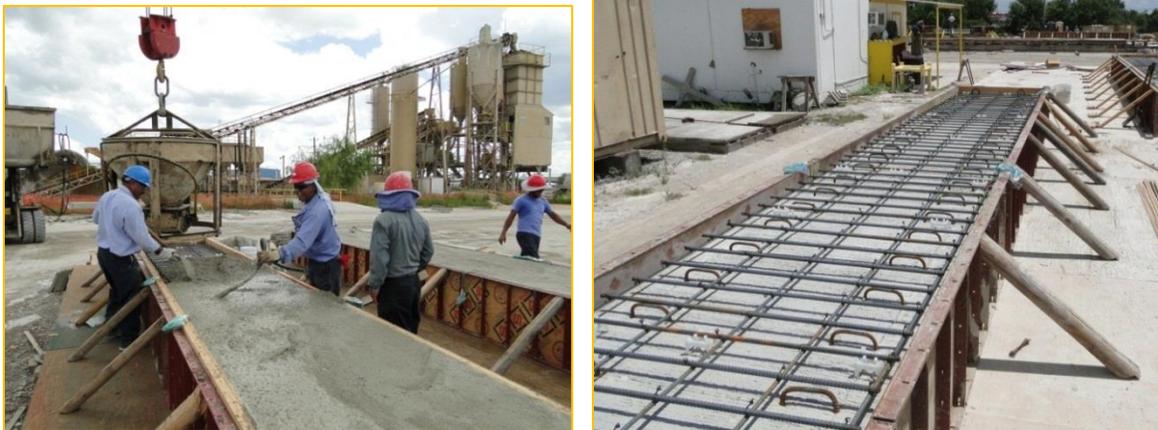
Fig. 8 CIP casting

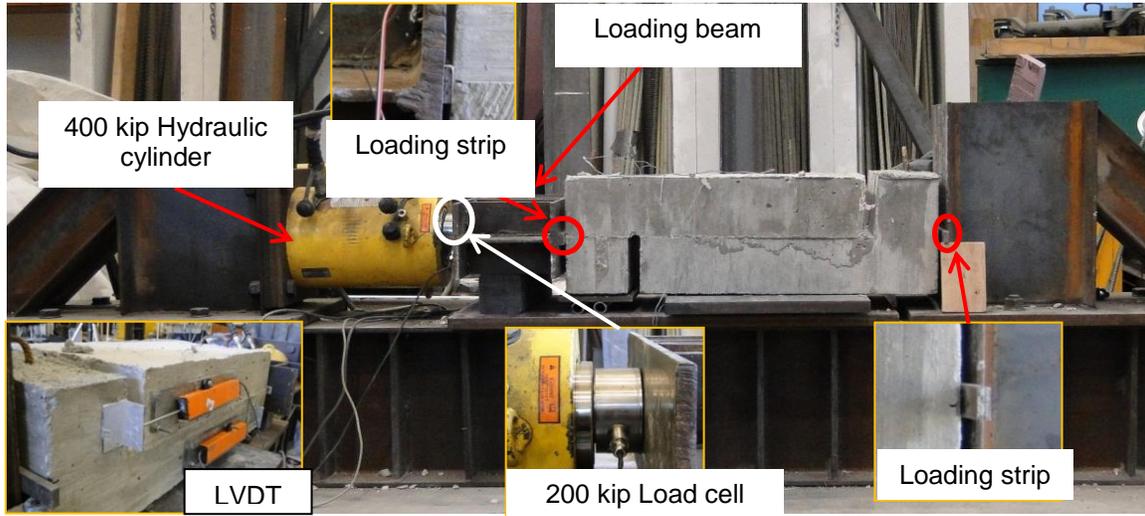
Fig. 9 Push-off test setup

The test setup for the horizontal push-off test with horizontal shear reinforcement is shown in Figure 9. It consisted of a hydraulic cylinder that applies the horizontal force on the interface, a load cell to record the load being applied, and a W8×24 loading beam. A 14×1×0.5 inch

loading strip was used to ensure minimal eccentricity of the applied loads. The specimen was instrumented with two Linear Variable Differential Transformers (LVDT's) placed on both the CIP and precast parts to measure the slip during testing. For specimens that had a 4-in. shear reinforcement embedded length, a vertical LVDT was placed to measure the crack opening at the interface.

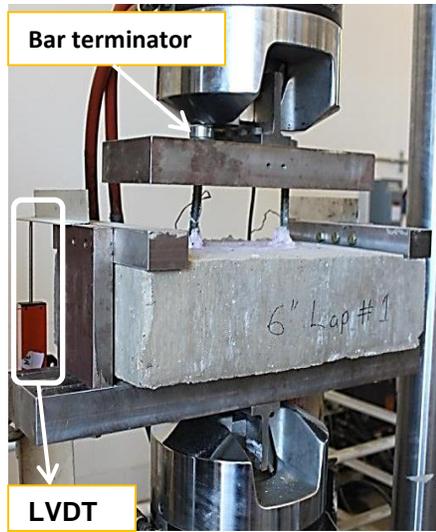
Fig. 10 Pullout test setup

The test setup for the bar pullout test is as shown on Figure 10. It consists of a 100-kip servo-controlled closed-loop MTS machine, a top plate, and a bottom plate. The specimen is placed on top of the bottom plate and the two threaded bars are passed through the holes in the top plate which have been pre-drilled for each respective bar width. The specimen is restrained by two restraining blocks on the bottom block which have slotted holes to aid in adjusting the side plates to fit the specimens. The bars are fastened with a terminator onto the top block so as to be held in place as the MTS machine applies a tensile load. Linear variable differential transformers (LVDTs) were also provided to measure bar slip and strain gauges mounted on the bar to record bar strains.

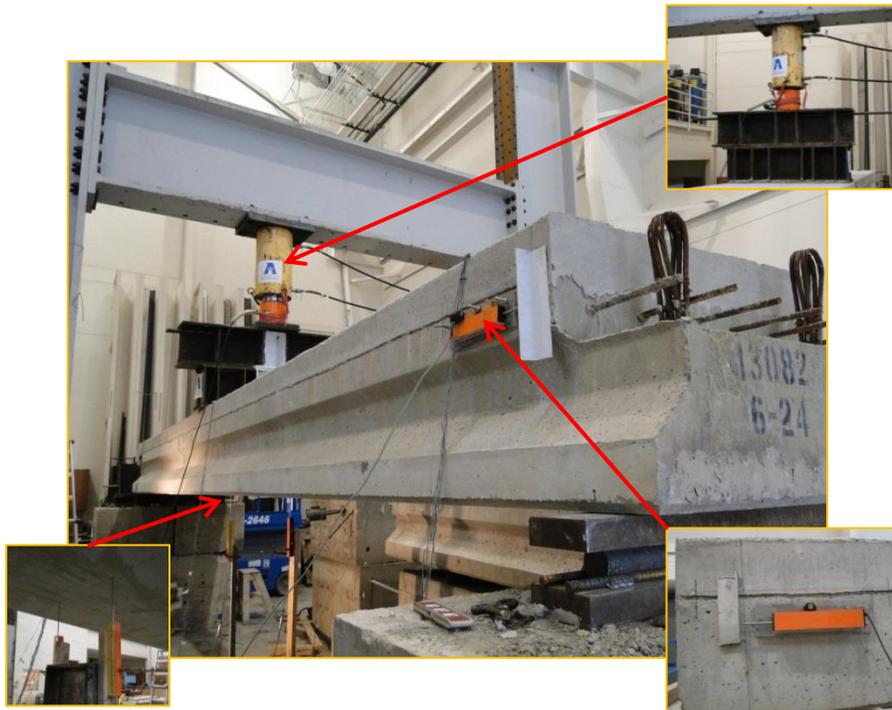
Fig. 11 Full-scale beam test setup

The test setup for the full-scale beams (Figure 11) is composed of a reaction frame with a hydraulic cylinder attached to apply the load. Two W12×72 wide flange sections were used as the loading beam (stacked one on top of the other) so as to apply the load uniformly along the width of the beam. A load cell was placed between the hydraulic cylinder and the loading beam to accurately record the load being applied. The specimen was instrumented with three LVDT's placed at the interface to measure the relative slip between the precast and CIP parts during testing. Two LVDT's were placed under the midpoint of the beam to measure the displacement during loading. To reduce any load eccentricities, the actual position of the loading beam and load cell were marked on the specimen before testing.

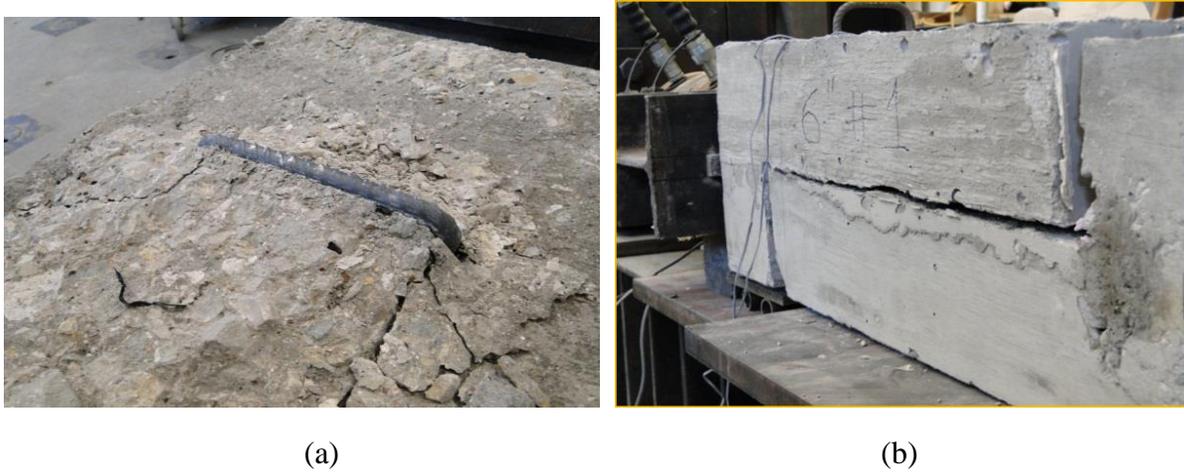
Fig. 12 Typical failure mode of push-off specimen failure with (a) 2-in. embedment; bar pulled out from the CIP slab (the concrete shown in the figure is the precast part); (b) 4-in. embedment; no pullout of the bar was observed

Results from specimens having horizontal shear reinforcement with a width of 3.5 inches placed in both the longitudinal and transverse location (used by Maine DOT, Rhode Island DOT and Massachusetts DOT), showed no significant change in the failure load. The bars did not yield and the main mechanism of failure was by bar pullout (Figure 12a). These results are consistent with the results from bar pullout tests, which indicated that the short embedded length (2-in.) could not provide sufficient bond to allow bars to yield before pullout. A bar stress of not more than 24 ksi was recorded for these specimens. Specimens having a 6-in. width horizontal shear reinforcement with a 90° curvature, failed at the interface with the bar pulling out from the CIP part. An average peak load of 63.5 kips (282.46 kN) with larger fractured volume of the concrete on the CIP part was observed compared to the 3.5-in. horizontal shear reinforcement. The highest bar stress recorded was 18 ksi. On the other hand, specimens that had the 6-in. horizontal shear reinforcement embedded 4-in. into the CIP showed higher peak loads. Bars in all the specimens in this case were very close to nominal yield strength at failure with yielding occurring at a slip of approximately 0.1-in. No pullout of the bar was observed (Figure 12b) hence it was not possible to examine the failure plane after the test. The specimens having a 9-in. width bar with a 90° curvature showed an increase in the average peak load to specimens 79.3 kips (352.74 kN). The failure was by bar pullout with no yielding experienced in all the specimens and a maximum bar stress of 19 ksi recorded. Severe fracture of the concrete in the CIP part of the specimen was observed in most of the specimens. This is consistent with the large fracture volume noticed in the bar pullout test with the same configuration. For the specimens having a 4-in. embedded length, yielding of the bar occurred at a slip of less than 0.1-in. An average peak load of 76.4 kips (339.84 kN) was recorded for these specimens. Strain gauge information shows very small strain on the bars before the maximum horizontal shear strength was reached in the specimens having a 2-in. embedded length. This indicates that the dowel action of the bar does not contribute to the maximum shear strength. Although the 4-in. embedded length specimens registered higher strains on the horizontal shear reinforcement, a majority of the specimens did not reach yielding at maximum peak load. The strain on the reinforcement markedly increases once a crack had occurred at the interface. This indicates that using the AASHTO equation could over-estimate the dowel action which assumes that the horizontal reinforcement can significantly contribute to the interface shear strength by yielding the reinforcement. Previous tests had been conducted on push-off specimens without horizontal shear reinforcement and having a woodfloat finish. Comparing those results to these, it was observed that there is a 50% increase in horizontal shear strength regardless of the geometry and embedment length. It was observed that although dowel action did not contribute to horizontal shear strength, the presence of horizontal shear reinforcement provided an overall increase in horizontal shear strength. The maximum horizontal shear strength recorded from these specimens was lower than the horizontal shear strength predicted by AASHTO equation (Figure 13). The results of the push-off test are tabulated on Table 3.

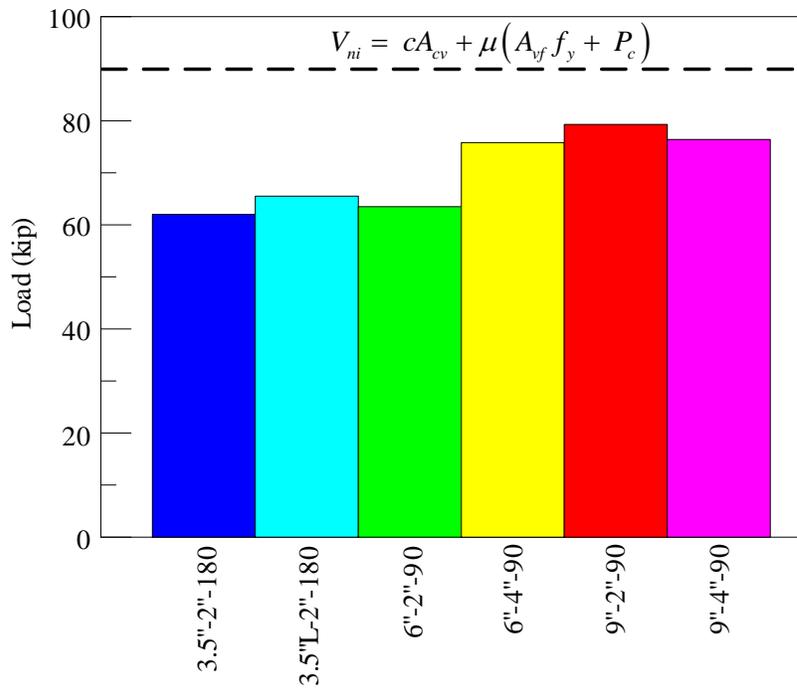
Fig. 13 Horizontal shear strength comparison.

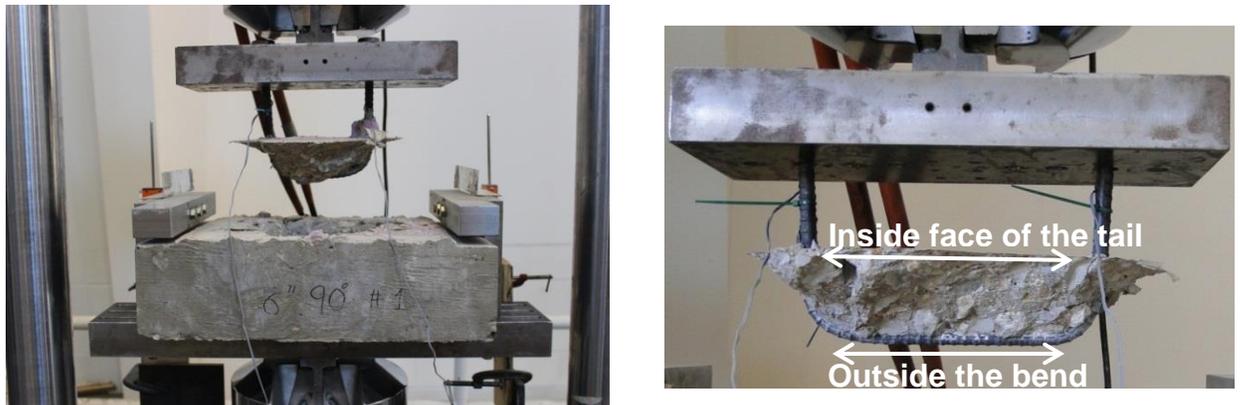
Fig. 14 Pullout test; modes of failure

All the test specimens exhibited similar modes of failure as seen in Figure 14. First cracking of the concrete occurred on the front face and back face of the specimen radiating from the bar leading to a strength drop. As the load increased, cracks started forming around the bar. Once the cracks propagated around, the bar was gradually pulled out. The 12-in. specimens showed a more explosive failure after the concrete on the inside of the tail portion cracked. Observation of the specimens after failure also implies that the bar tends to pull away from the concrete on the outside of the bend.

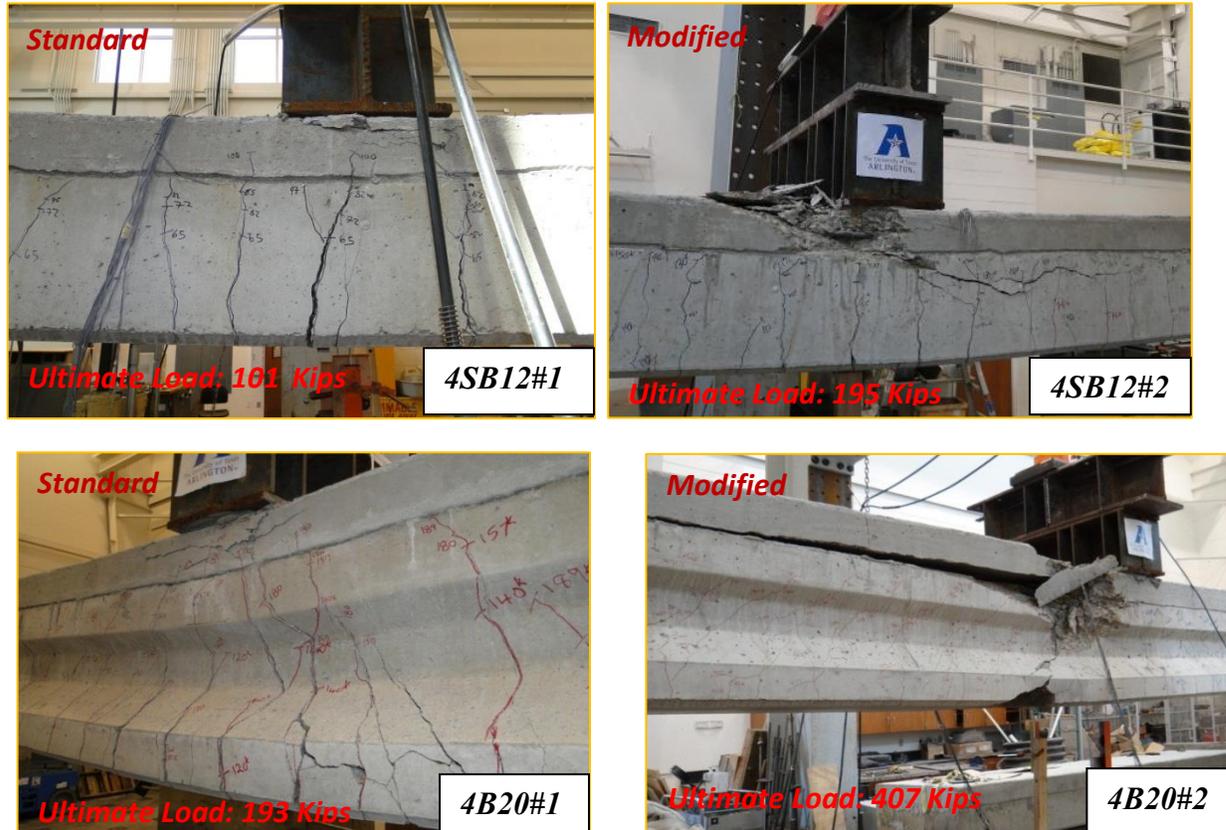
Fig. 15 Full-scale beam specimens at failure

The load was first applied at 5-10 kip interval until the first flexural crack was observed at 55 kips, near the mid-span of the beam. With an applied load to 82 kips, the cracks continued to propagate eventually reaching the interface between the CIP slab and the precast beam. At 90 kips, the cracks propagated into the 5-in. CIP slab but not along the interface. The beam eventually failed in flexure at a peak load of 102 kips corresponding to a displacement of 7 in. Crushing of concrete occurred under the loading point and the cracks significantly widened to more than 6 mm. No cracks at the interface were observed and no slips were recorded. No significant strain was measured from the strain gauge data of the horizontal shear reinforcement, thus indicating that there was very minor contribution from the horizontal shear reinforcement.

In the second slab beam which had no horizontal shear reinforcement, the first flexural crack was also observed at a load of 55 kips. The cracks had propagated into the CIP slab at a load of 180 kips. However, no cracks propagating along the interface were observed. The beam also failed by flexure at a load of 197 kips with crushing of the concrete at the loading point. The load then dropped to 177 kips after failure. With continued load application, an explosive failure occurred with a decrease in load of more than 100 kips and the formation of a horizontal crack 2-in. below the interface. The cracks widened to 5 mm and the concrete at the loading point was further crushed. The interface remained intact without any cracks forming across it. Although some hairline cracks propagated along the interface at failure on the south-face side, it did not extend further and was not observed on the north-face side of the beam.

The first flexural crack in the box beam specimen was observed at 110 kips. At a load of 170 kips, flexural cracks had progressed reaching the interface of the CIP slab and the precast beam. Cracks of 1.0 mm in width were recorded with some spalling being observed. At 189 kips, the cracks progressed into the CIP slab with crack widths as wide as 1.5 mm been recorded. It should be noted that the flexural cracks did not propagate along the interface but instead passed through the interface into the CIP slab. The beam failed in flexure due to concrete crushing in the compression zone within the CIP slab. No cracking was observed within the interface of the prestressed beam and the CIP slab.

Similar results were observed for the box beam without horizontal shear reinforcement. At 180 kips, cracks had progressed further up the beam with shear cracks being observed. At a load of 350 kips, the cracks had progressed up to the interface of the CIP and precast sections. Initial crushing of the concrete under the loading point was observed at 400 kips. With increase in load, the concrete crushed and the cracking propagated into the interface

leading to a sudden horizontal shear failure. However, the horizontal shear crack did not propagate the entire length of the beam. Therefore no slip was recorded by the LVDTs at the ends.
