FULL-SCALE LATERAL IMPACT TESTING OF PRESTRESSED CONCRETE BEAM

ABSTRACT

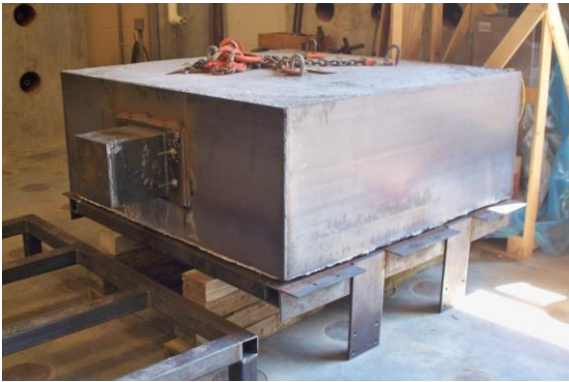
A track with the change of height in 10 ft was constructed. In order to reach the required initial energy, the weight of the impact cart was determined to be 8000 lbs. The impact cart is a 50 cubic foot concrete block with a 10 inch x 10 inch x 10 inch impactor supported by a steel frame, as shown in Figure 1. Eight casters are also attached to the steel frame, four of which are used to support the weight of impact cart, and the other four act as side wheels to provide straight tracking. The dimension of the concrete block turned out to be 5 ft x 5 ft x 2 ft, and the actual weight of impact cart is 9000 lb. A pull hitch was also fabricated on the steel frame in order to pull the impact cart up the track.

Fig. 1 Impact cart

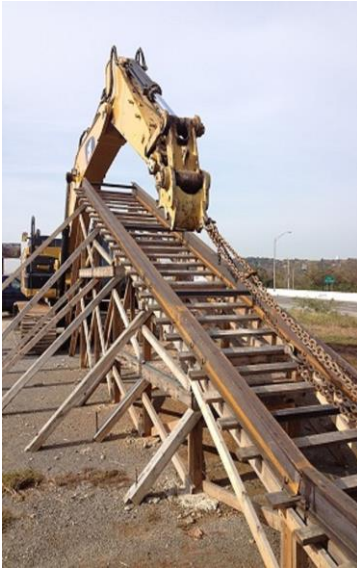
Framework that is capable of withstanding both gravity and lateral loads is required for the track system for this testing setup. The track system consists of posts, bracing, work platforms and a rail system. The bottom of the track is set at a height of one foot, and the height at the top of the track is 11 ft. The impact cart needs to roll down a smooth surface to create an impact with the specimen and the surface was provided by rails that were placed on top of the post line. Figure 2 illustrates the track system used in the impact testing.

Fig. 2 Track system

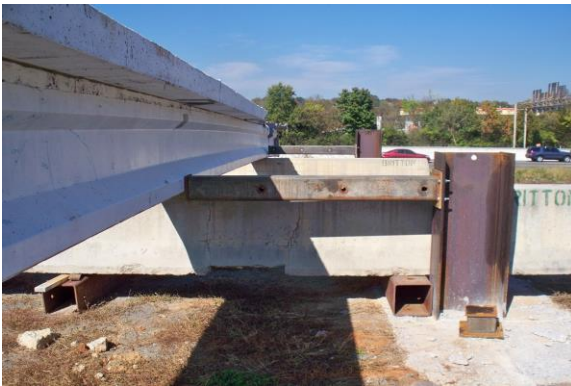
The backstop was designed to provide lateral support that prevents the specimen from sliding horizontally during the impact. The backstop consists of two wide flange steel beams that are set in concrete footings. HSS tubes were used to transfer the loads from the specimen to the wide flange steel beams. The HSS tubes are removable so that multiple specimens can be tested using the facility. Figure 3 displays the backstop system.

Fig. 3 Backstop system

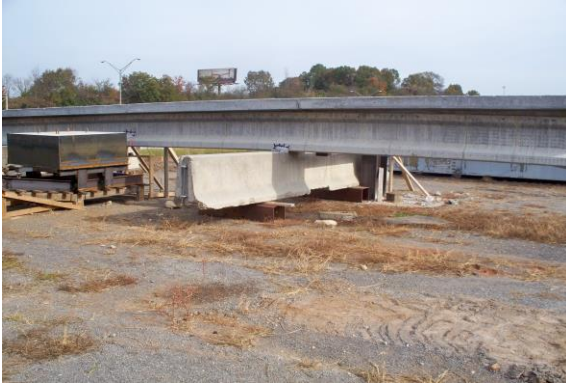
of the bottom flange is lined up with the center of the impactor. The support system consists of New Jersey Barriers and HSS tubes beneath the barriers, which are readily available at the testing site for other purposes. The support system is illustrated in Figure 4.

Fig. 4 Support system

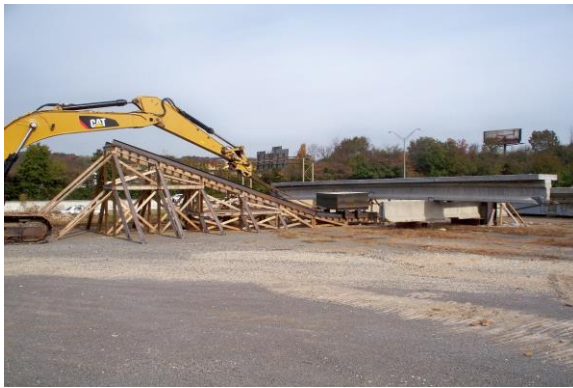
Fig. 6 Prestressed concrete beam setup

The specimen used in the impact test was an AASHTO Type I prestressed concrete beam with 0.7-inch strands. The compressive strength of concrete girder is 14100 psi, and the compressive strength of concrete deck is 10631 psi. The deck concrete strength was higher than that of a typical deck in order to use a much narrower width of the deck for testing, yet still maintain the deck equivalency. The length of the beam is 56 ft and this beam was statically tested at both ends according to Cabage ⁹. After the static test was completed, the beam was shipped to the impact testing site. This prestressed concrete beam was set up so that the middle portion of the beam can be tested by impact while leaving the failed beam ends from the static testing cantilevered out from the supports. The cross section view is shown in Figure 5. The track system, impact cart and concrete beam setup is indicated in Figure 6.

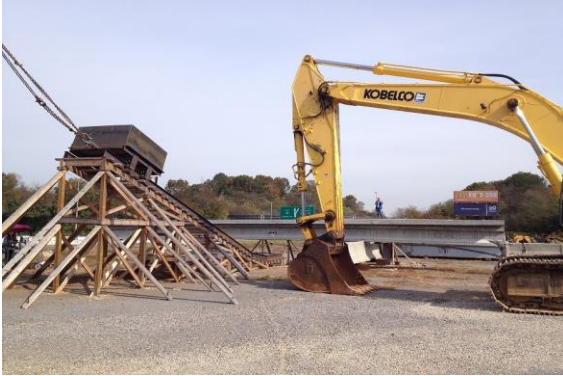
Fig. 8 Impact cart at designed height

The impact testing was conducted in November 2014. The purpose of the testing was to evaluate the testing facility and data acquisition system, as well as observe the response of the concrete beam during collision. Before the impact, the cart was connected to an excavator by a chain and a shackle that was connected to the pull hitch on the cart. Once the cart was pulled up the track, a second excavator was placed on the front side of the impact cart to prevent it from rolling down. Once the second excavator has secured the cart, the chain was slacked and shackle was unfastened. The bucket of the second excavator was raised to release the cart. Figure 8 shows the impact cart pulled up the track before impact. From the moment the impact cart was released, the whole collision took about 3 seconds and then the cart was completely stopped without a second hit.

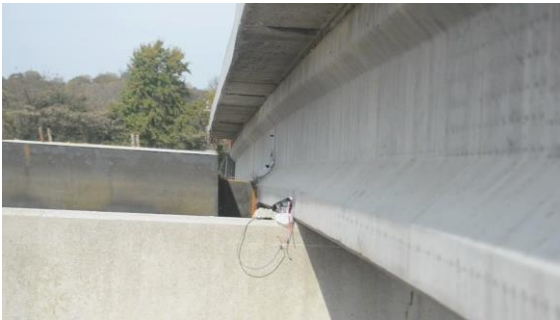
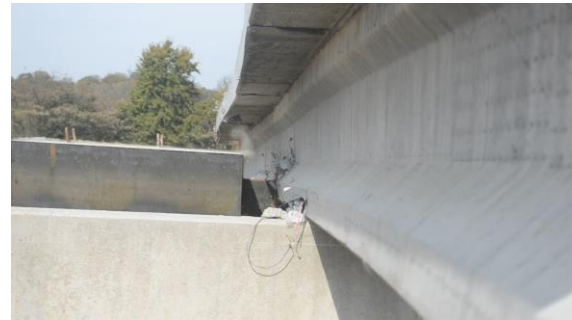
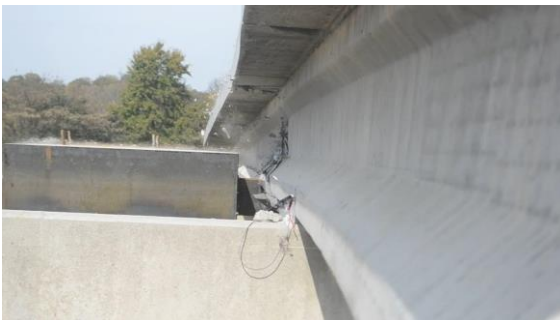
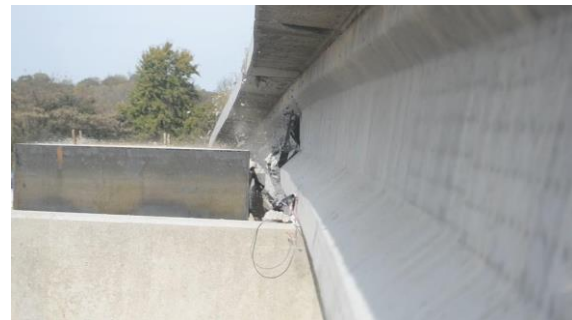
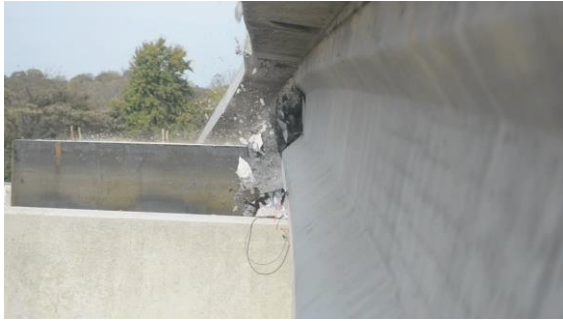
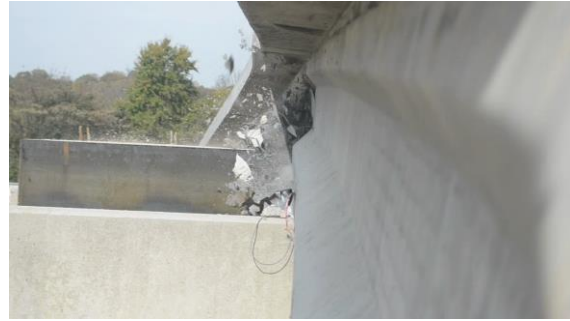
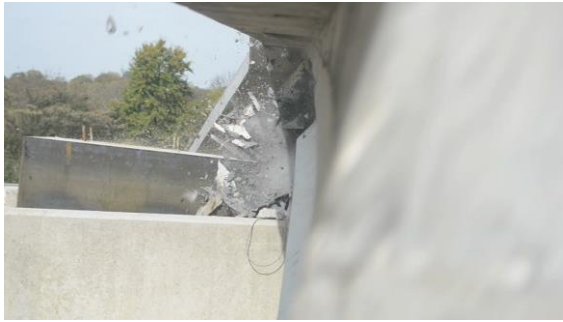
Figure 9 presents the process of the collision from side view of the beam and the first picture shows the beam just before impact. It can be seen from the side view that the impact forced the bottom flange of the prestressed girder to rotate and move upward, with concrete spalling near the point of impact. The beam crumbled and the cracking was observed all the way through the beam. The prestressing strands were all uncovered and the pre-tensioning forces were released from all of the strands. The prestressed concrete girder was totally destroyed after the impact. Figure 10 shows the beam after impact, in order to miss the prior damaged zones, the length of each overhang is relatively long. Due to the gravity of the overhangs, beam bow upwards after collision.

Fig. 9 Collision process from side view

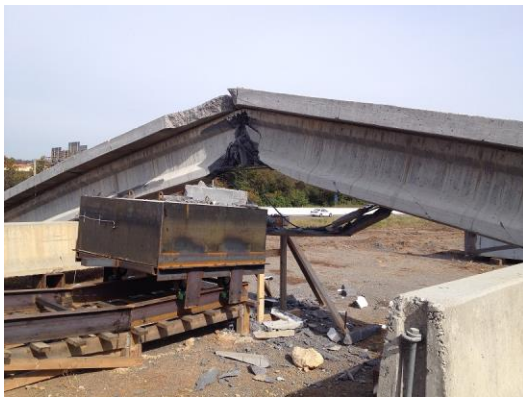
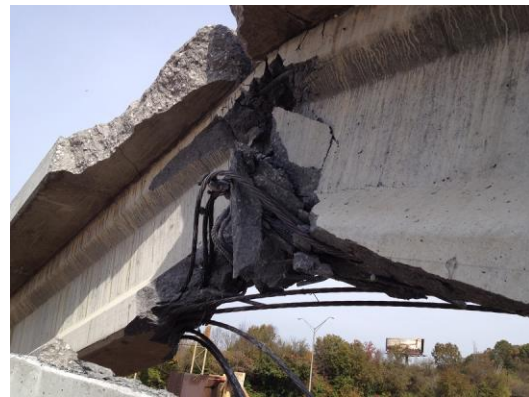
Fig. 10 Beam after impact

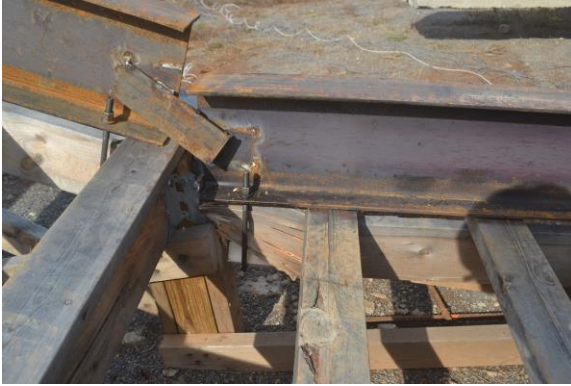
The supporting structure performed well, however when the impact cart hit the first angle change near the bottom of the ramp, a section of the track failed. The joists nearly sheared completely in two and the welds on the rails broke, as illustrated in Figure 11. The section that was damaged has been redesigned and repaired. Despite this damage to the track, the facility as a whole worked for the intended purpose.

Fig. 11 Damaged joists and welds

During the impact test, the whole system was proved to be working as expected except for the structure failure of one section of the track, which has been redesigned and fixed. All the data obtained from the data acquisition system are reasonable, which are currently being analyzed. The duration time of the lateral collision was found out to be 0.08 seconds.
