**PRESTRESSED CONCRETE RAILROAD TIE BURSTING STRAIN  
DEVELOPMENT**

*Concrete railroad ties are often made as one continuous concrete structure in long-line prestressing beds and saw-cut into individual railroad ties. Indented strands or wires are used to prestress the concrete ties. As the forces spread out from the steel-concrete interface to the full concrete cross section, strains in the transverse direction are created called bursting strains. Short transfer lengths lead to larger bursting strains. These bursting strains have been linked to splitting cracks seen in concrete railroad ties after saw-cutting the large prestressed concrete element into individual ties. A recent study was undertaken to measure the bursting strains created in prestressed concrete railroad ties with time to quantify their magnitude and growth.*

**2016 PCI Convention and National Bridge Conference, March 3 – 6, Nashville, TN  
Instructions for Preparation of Full Paper**

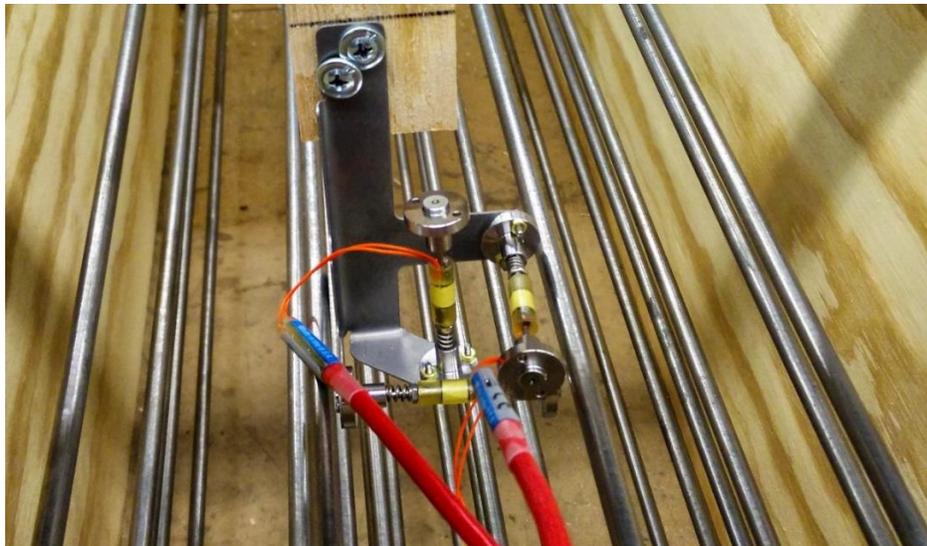
Figure 1: Vibration wire gauges setup inside the ties

Vibration wire gauges were installed in six concrete railroad ties in a triaxial configuration as shown in Figure 1. These gauges (Geokon 4202x) were placed at 6.5 in. (165.1 mm) from both ends of the ties, leading to six gauges placed in each tie. The gauges were not attached to any prestressing wires but were suspended in the concrete between the wires as shown in Figure 2. The installation process was performed at a prestressed concrete manufacturing facility. Ties were made upside down in a long-line bed as shown in Figure 3. Separators with holes allowing the wires in a bed to pass were used on each tie end. Once the prestressing wires were, the concrete was placed into the forms. After the concrete hardened, the prestressing wires were saw-cut at each tie ends'. Two of the concrete railroad ties made were unreinforced. Figure 4 shows the unreinforced tie cover in plastic for curing. Another two were made with twenty-four 0.209 in. (5.32 mm) diameter wires but not prestressed. The remaining two ties were made with the same twenty-four 0.209 in. (5.32 mm) diameter wires and were prestressed to 7000 lbs per wire. The prestressed and non-prestressed ties were made with two stirrups at each end for each tie. These wire stirrups fully encircled the prestressing wires, as shown in Figure 2. The manufactured ties were 8.5 ft (2.6 m) long, with a trapezoidal cross section 10 in. (254 mm) wide on top, 10.5 in. (267 mm) on the bottom and 10.5 in. (267 mm) in height.

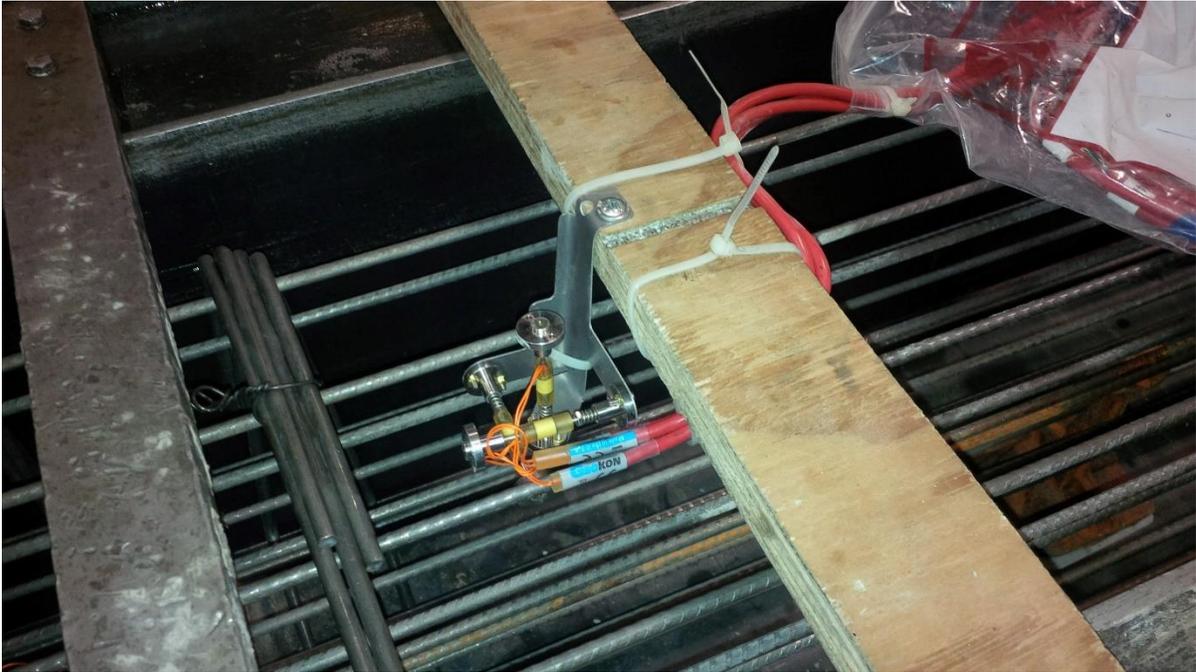
Figure 2: Vibrating wire gages in the tie next to the two stirrups

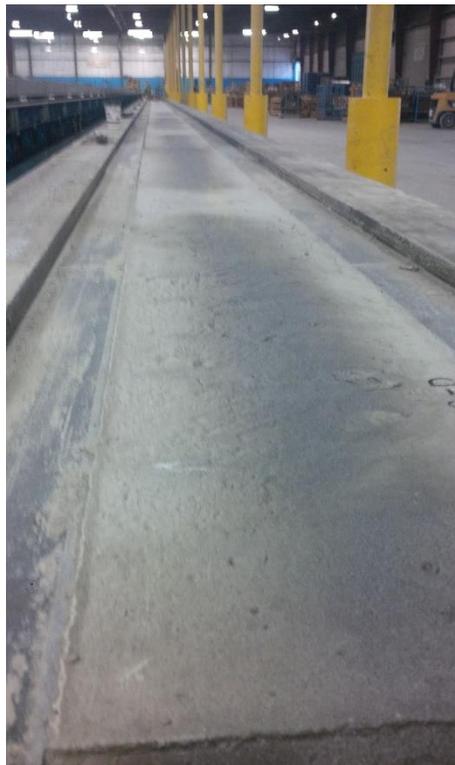
Figure 3: Ties in a long-line bed form

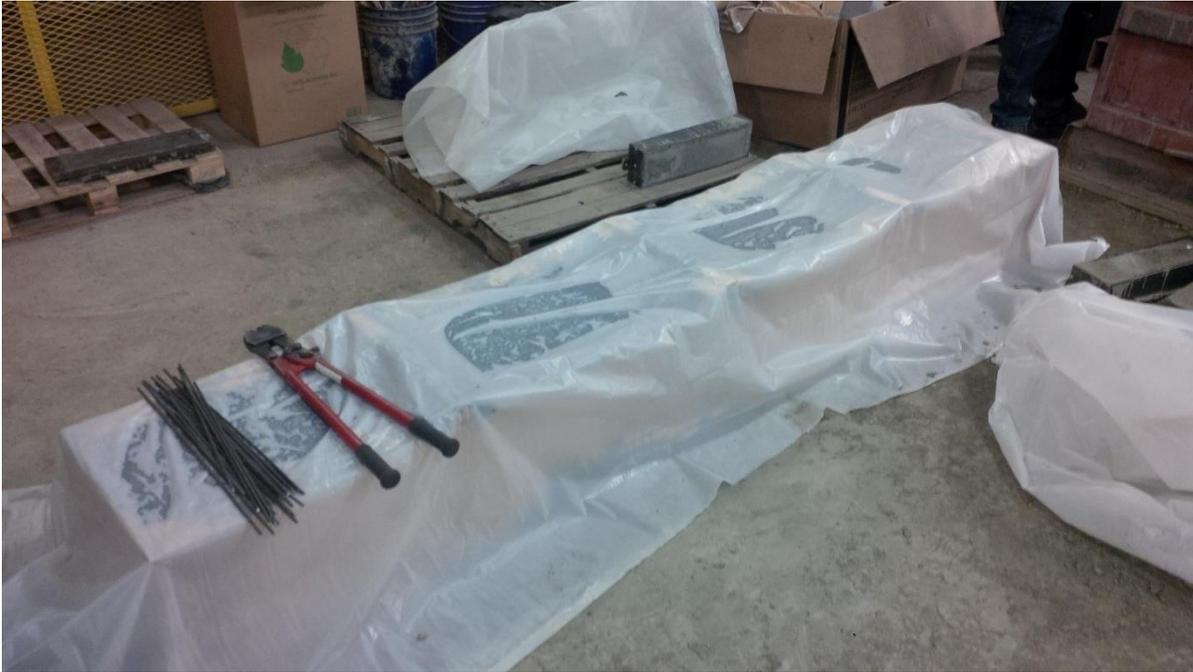
Figure 4: Unreinforced tie covered in plastic

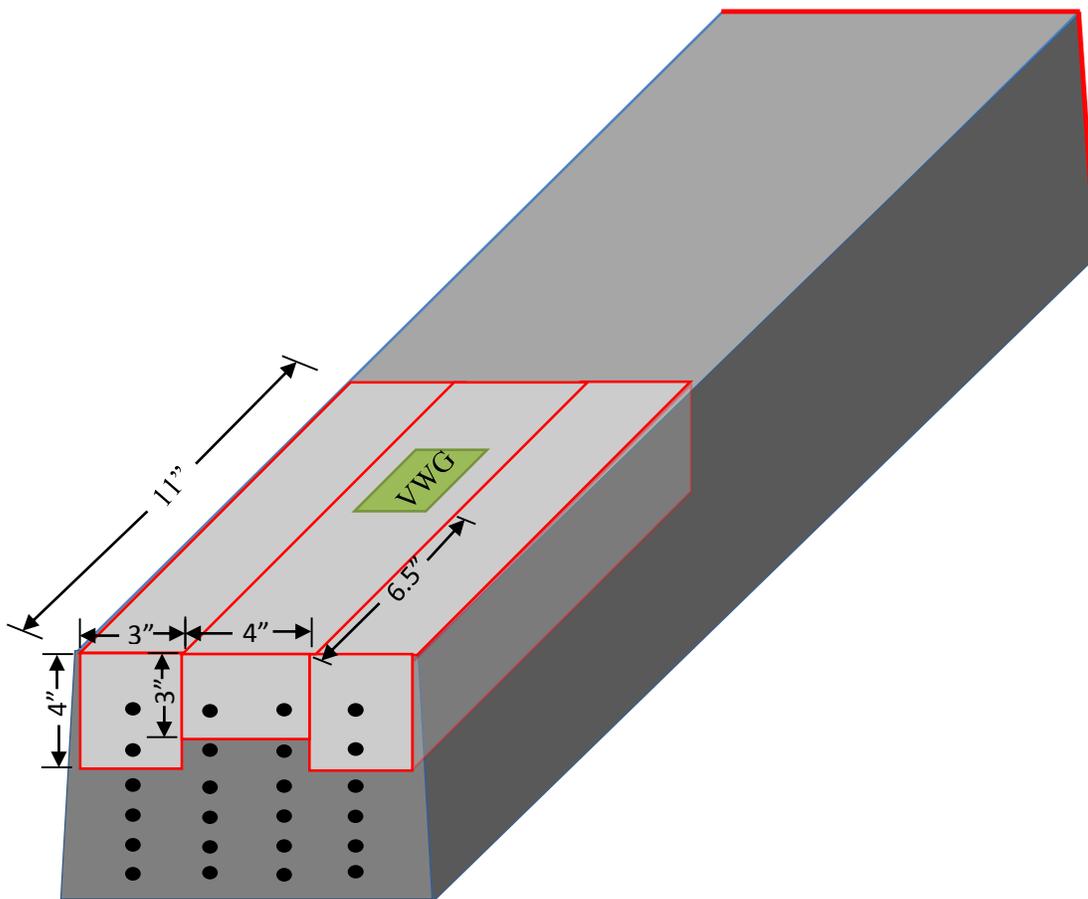
Figure 5: Saw-cutting locations made on the ties are colored red and the gauge (VWG) is colored green

A handheld vibrating wire gage reader (GK-404) was used to take strain and temperature readings; after hardening, after detensioning, after demolding and wires saw-cutting, after delivery to the K-State labs, after saw-cutting the ties in half and after excising the ASTM C666 samples. Unfortunately some of the delicate vertical and transverse gauges stopped working either after the concrete hardened or after detensioning. The locations of the cuts made and the gauge are shown in Figure 5.

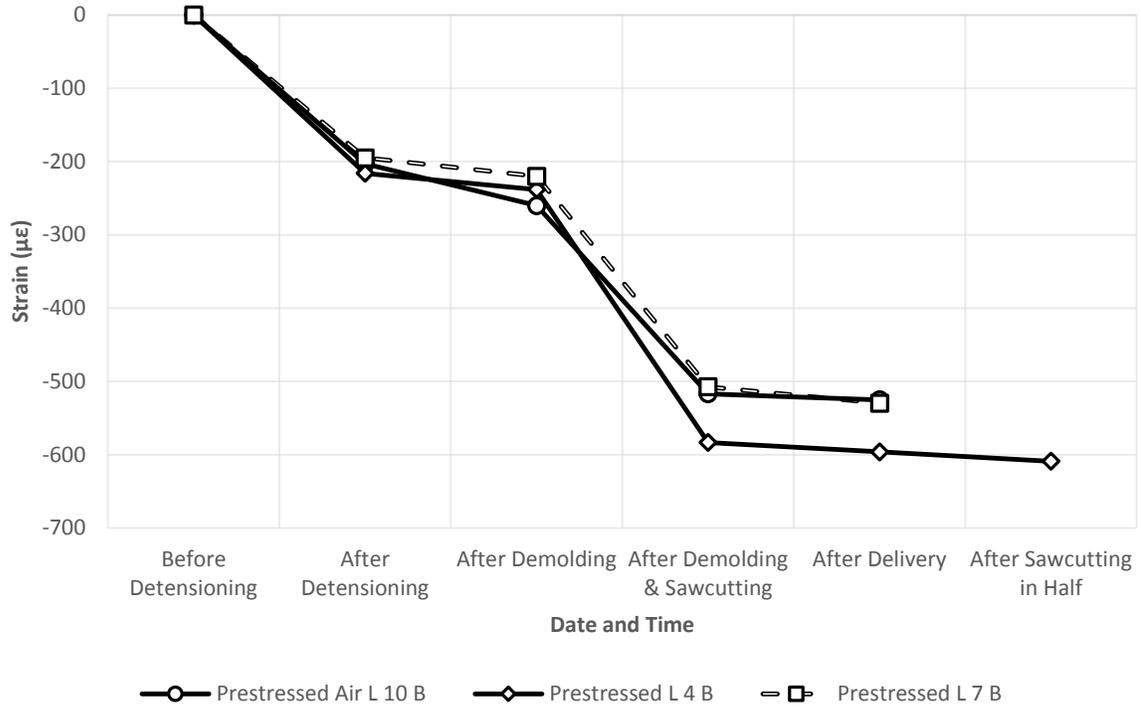
Figure 6: Longitudinal strains development in non-air entrained concrete samples vs air entrained concrete

Table 3 includes a list of all the gauges that remained functional after concrete hardening. The large number of non-functional gauges can be the result of either the strains going beyond limits of the gauge (4000  $\mu\epsilon$ ) or the gauges were damaged during the placement or the hardening process. The results obtained shows that the ties in the longitudinal direction underwent compression as a result of the prestressing as shown in Figure 6. Furthermore, no apparent effects on the strains in the longitudinal direction were seen as a result of air entrainment, as expected. While one of the gauges in the non-air entrained samples failed after saw-cutting the tie in half, it is most likely that the strains jumped to values beyond the limits of the gages. Transfer length was measured using surface strain measurements and was found to be on average 11.7 in. for the ties studied.

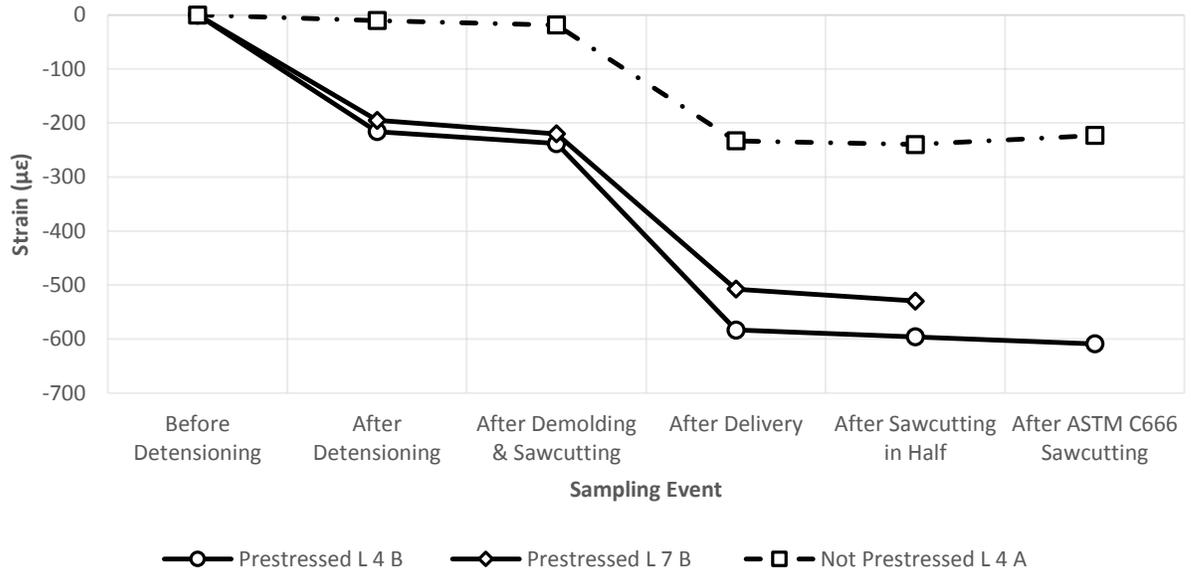
Figure 7: Longitudinal strains development in non-air entrained concrete samples

When comparing the prestressed strains to the non-prestressed strains of non-air entrained concrete in the longitudinal direction in Figure 7, it can be seen that there are compression strains even in the non-prestressed tie. While the longitudinal strains in the prestressed tie are three times that of the non-prestressed tie. The presence of these longitudinal strains in the non-prestressed tie can be the result of shrinkage and thermal stresses. The transverse strains recorded for the air entrained samples are presented in Figure 8. The transvers strains shows that the samples were under tension in the transverse direction resulting either from the prestressing force in the case of the prestressed sample or the shrinkage in the non prestressed samples.

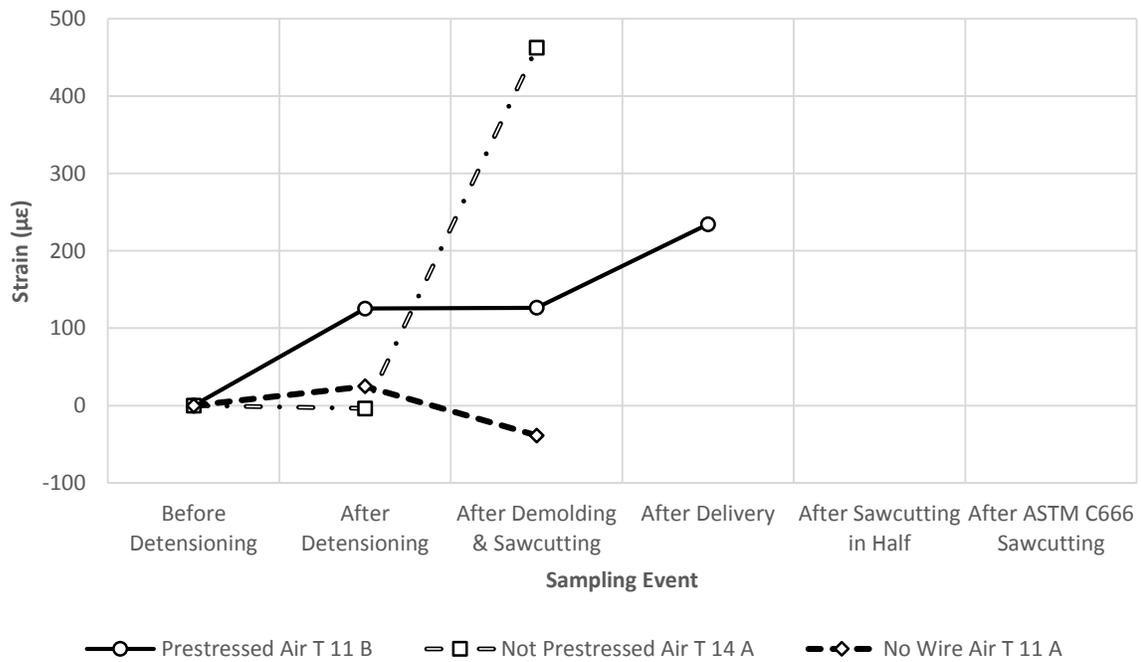
Figure 8: Transverse strains development in air entrained concrete samples

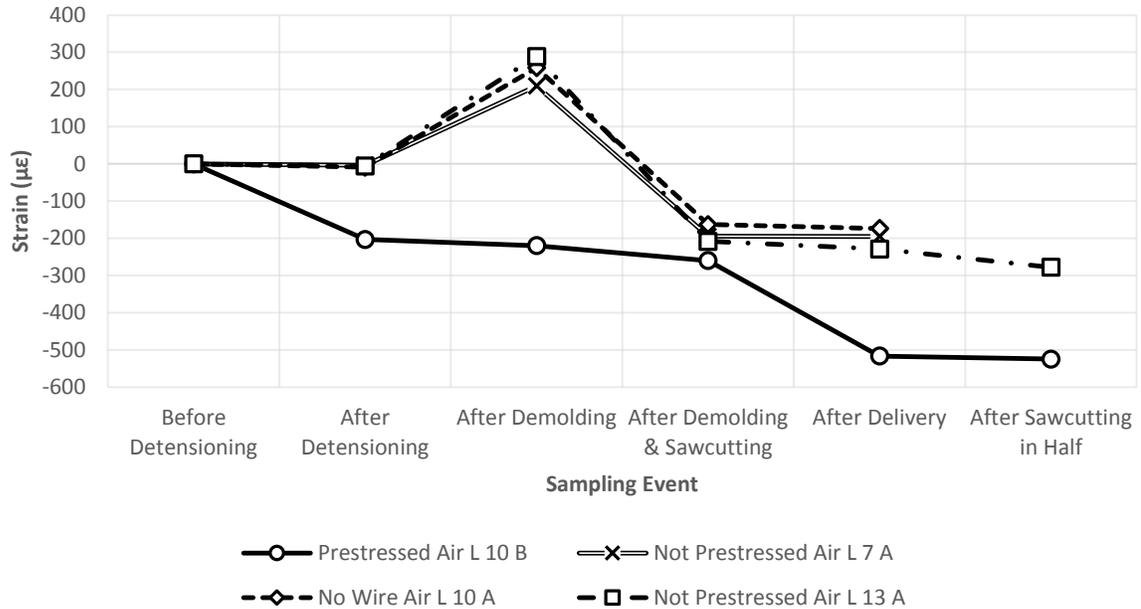
Figure 9: Longitudinal strains development in air entrained concrete samples

As for the air entrained concrete ties, the longitudinal strains in the non-prestressed and plain ties varied between +290 µε and -50 µε. These variation in compression and tension can be the result of variation in the thermal and shrinkage stresses inside the ties. These longitudinal strains, in the non-prestressed and plain ties, remain smaller than that of the prestressed tie

since the prestressed tie had the prestressing force on top of the thermal and shrinkage stresses. Figure 9 represent the variation in the longitudinal strains of the air entrained non-prestressed and plain concrete ties in comparison to the prestressed air-entrained tie. Similar to the non-air entrained concrete, the longitudinal strain in the prestressed tie tends to increase from one stage to the next. This increase was more prominent in the case of vibrating wire gage L 10 B which can be the result of gauge failure.

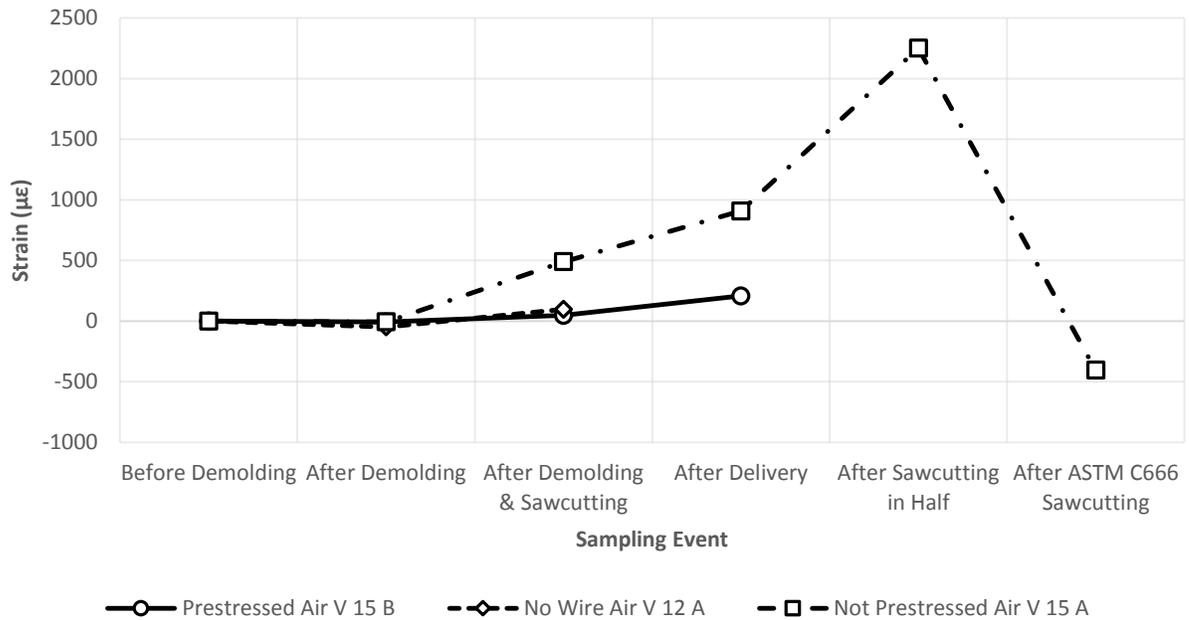
Figure 10: Vertical strains development in air entrained concrete samples

While no transverse gauges remained working in the case of the air entrained concrete ties, the vertical gauges remained operational to a certain stage as shown in Figure 10. The recorded vertical strains in the case of the air entrained non-prestressed tie were higher than that of the air entrained prestressed and the plain tie. This can be the result of: shrinkage, creep, temperature variation between the concrete and the gauges. Concrete tends to shrink as its water content diminishes and swells when it absorb water. These shrinkage and swelling lead to increases in the recorded strains which are not related to load or stress changes.

(psi). This gave 83 and 128  $\mu\epsilon$  for the non-air-entrained and air-entrained concrete mixtures, respectively. These strain values were easily exceeded in the vertical direction between sawcutting and delivery. The ties instrumented included stirrups to prevent the ties from cracking during fabrication, which may explain why cracking was not seen in the ties until after saw-cutting small ASTM C666 samples.

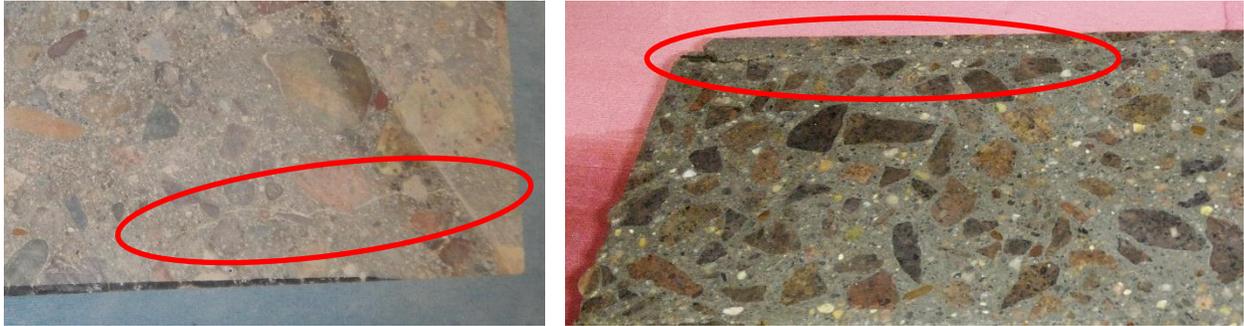
Figure 11: Cracking due to the stress release from saw-cutting

All these increases in the strains in the various directions, but especially in the longitudinal direction, can be described as bursting strains. The effects of these bursting strains, increase in strains, can be very apparent when the saw-cut samples crack on their own without any freeze-thaw testing, as can be seen in Figure 11. It was noticed that many of the samples saw-cut to the small ASTM C666 compliant sample sizes tended to crack in a direction parallel to the prestressing wires. Even when increasing the concrete cover, which could only be increased to 0.75 in (19 mm) in the case of the tested ties, the concrete still cracked in some of the saw-cut samples. In addition, some of the wires in some of the samples slipped inside the concrete for 0.04 in (1 mm) indicating a new sample transfer length was created when the sample was saw-cut, creating stresses and cracking. This cracking and reinforcing wire shrinkage could be exaggerated when the samples containing any of these outcomes of bursting strains are subjected to freeze-thaw cycles.
