# LARGE SCALE STRENGTH TESTING OF HEXCRETE SEGMENT DESIGN FOR TALL WIND TOWERS

**Robert Pegg**, PhD Candidate, Iowa State University, Ames IA  
**Sri Sritharan**, PhD, Wilkinson Chair in the College of Engineering, Iowa State University, Ames, IA

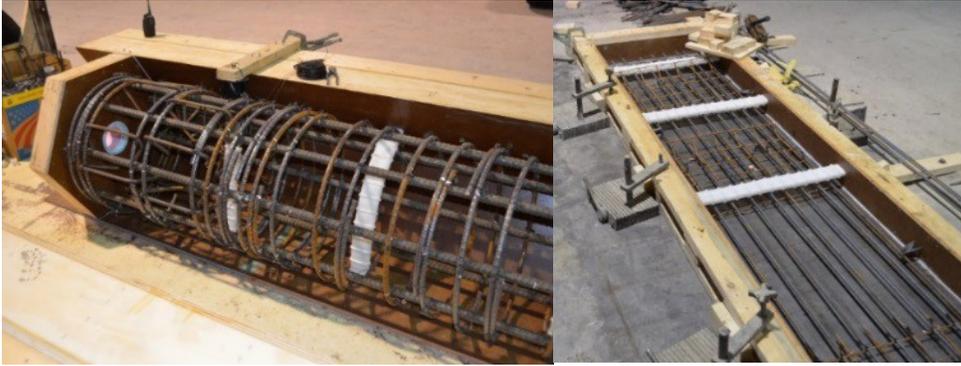
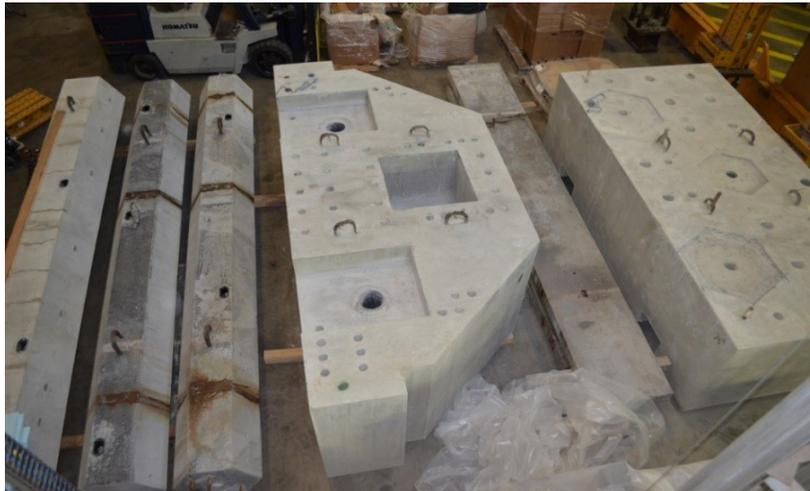
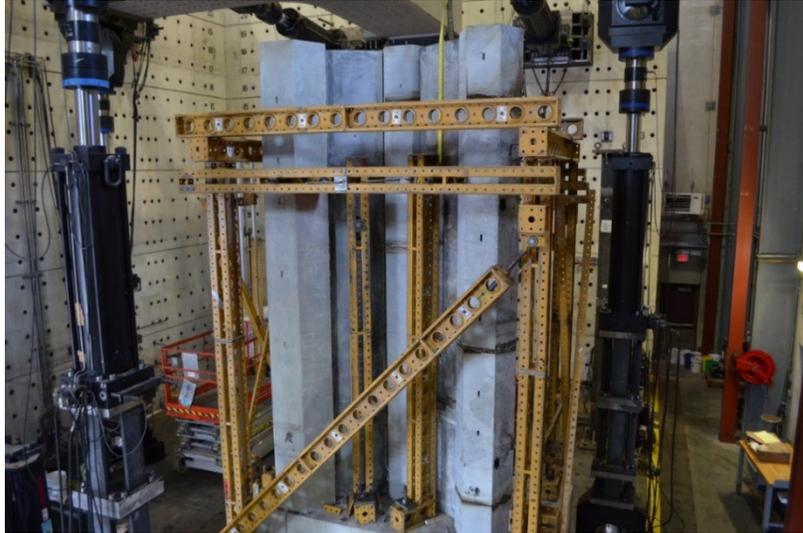
The precast concrete pieces for the test unit were fabricated at Coreslab Structures in Omaha, Nebraska, as shown in Error: Reference source not found and then shipped to MAST (Error: Reference source not found). The test unit was constructed in two halves due to space and lifting limitations within the lab. Each half consisted of a single foundation block, three columns, two panels, and a single top block. This construction approach did not benefit the two panels that would connect the test unit halves, since the panels would not be subject to precompression from the vertical post-tensioning, but was necessary due to laboratory limitations. A temporary support frame was constructed to hold the columns and panels in place during the construction process as shown in Error: Reference source not found.

Prior to positioning the columns on the foundation, grout forms and steel shims were placed at the column locations for grouting the column-to-foundation interface. The columns were set in place on the steel shims and attached to the support frame. The grout pads were not poured at this time in order to allow adjustment of the columns during placement of the connecting wall panels. The wall panels were then positioned between the columns and attached to the support frame for stability. The tower segment was designed with a 0.75 in. gap between each column and panel to allow for construction tolerances. High strength epoxy was applied in this gap in order to provide a uniform bearing surface for radial post-tensioning. The epoxy was mixed and then manually packed into the joints between the columns and panels using trowels. No compression force was applied to the joint during the curing process. After curing of the epoxy, six 0.5 in. diameter tendons were utilized to temporarily connect the columns and panels. Two tendons were placed through the top, middle, and bottom of the half test unit and subsequently tensioned to an effective stress of 126 ksi per tendon. The half test unit was not yet permanently attached to the foundation block, but the self-weight of the pieces and the support frame kept the members in place during the temporary radial tensioning. Grout pads were then poured at the top of the columns, the top block was set in place, and the vertical post-tensioning tendons were installed. At this time, the grout pads at the base of the columns were also poured. After all the grout pads were sufficiently cured, the vertical post-tensioning was tensioned to an effective stress of 163 ksi per tendon and the support frame was removed. The half test unit was then lifted into its final position for testing and attached to the MAST strong floor. The second half of the test unit was constructed using the same method, moved into the correct position and attached to the strong floor as well.

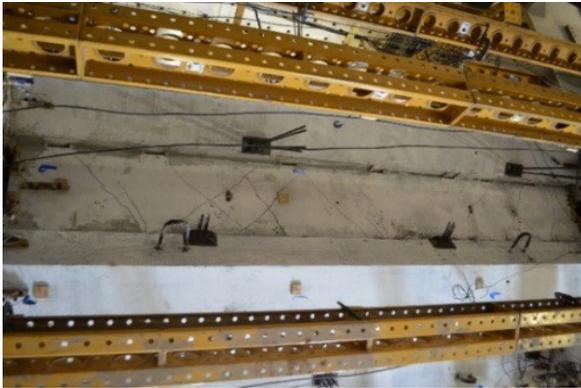
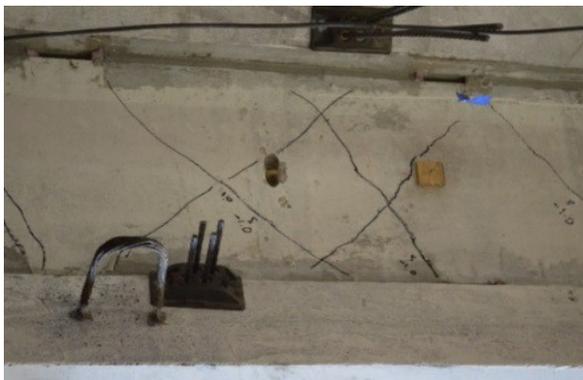
Figure 6: DLC 1.1 – Operational overturning moment response

Figure 7: DLC 4.2 – Operational shear response

Figure 8: DLC 2.2 – Operational torsional response

Operational loads were the first set of loads applied to the test unit. For each load case the loads were applied in 25% increments until the full load was reached. The operational loads corresponding to DLC 1.1 and 4.2 were applied with no observable damage and small amounts of deflection as shown in Figure 6 and Figure 7. For the torsional loading of DLC 2.2, the test unit responded in a linear manner ( Figure 8); however, hairline cracks were observed on all the HSC panels at 100% load. The two HSC panels which connected the two test unit halves during construction experienced moderate amounts of cracking as shown in (Error: Reference source not found) while only a single crack appeared in the third HSC panel. These cracks, which were marked with a black marker for visibility, did not exceed a width of

As previously stated, the HSC panels were not designed to crack under operational torsional loads. After further investigation of the data collected from the panel instrumentation, it was determined that the construction sequence and use of smaller radial tendons were both responsible for the observed cracking. The vertical post-tensioning introduced a larger amount of precompression in the panels than was predicted before the test and this precompression was not present in the connecting panels. The reduction in radial post-tensioning also contributed to the panel cracking in contrast to the calculations performed at the time of construction.

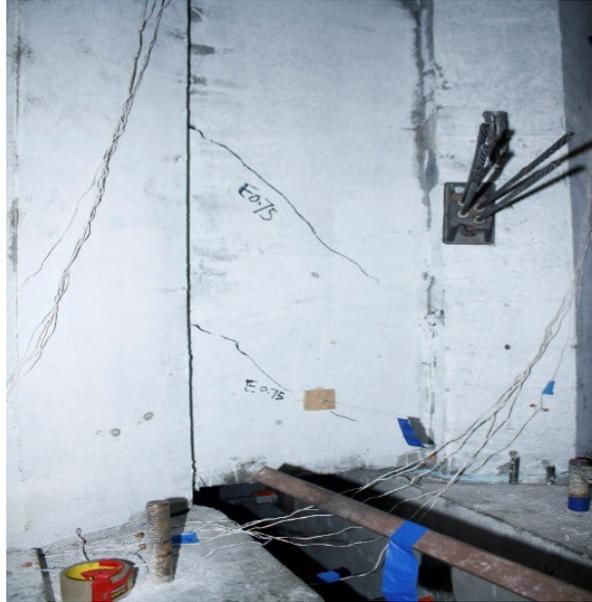
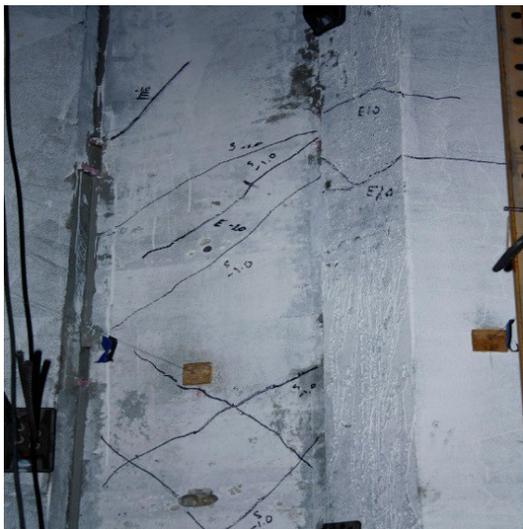
Figure 9: DLC 4.2 - Extreme overturning moment response

Figure 10: DLC 1.1 - Extreme shear response

Figure 11: DLC 2.2: Extreme torsional response

After completion of the operational loads, extreme load values were applied to the test unit. No damage occurred in the test unit when loads for DLC 4.2 and DLC 1.1 were applied and the test unit continued to behave in an elastic fashion as shown in and Figure 10. At 75% application of the extreme torsional load (DLC 2.2), new 0.004 in. cracks were observed on the base of one of the two HSC connecting panels as shown in Error: Reference source not found. The original cracks that occurred during operational loading, increased in width to 0.008 inches. Additional 0.004 in. cracks also appeared on the connecting HSC panels at 100% extreme torsional load, a single new crack appeared at the base of the third HSC panel, and 0.004 in. cracks formed on one of the UHPC columns. The cracks on the UHPC column were localized around a radial PT anchorage location as shown in Error: Reference source not found, which appears to lack steel fibers in the UHPC at this location. These type of cracks did not appear in any other columns which reinforces the idea that the problem is a local issue. UHPC fiber distribution can be improved by reducing the amount of reinforcement in the columns and based on the observed performance of the test unit, it is expected that the column reinforcement can be reduced. It is also important to note that the panel cracking was limited to HSC panels and that UHPC panels did not experience cracking under torsional loads. The absence of cracks in the UHPC panels is due to the higher tensile capacity of UHPC. After applying 100% of the extreme torsional load DLC 2.2, the force-displacement response of the test unit continued to be linear with no decrease in strength as shown in Figure 11. As was the case for operational loads, all cracks closed completely when the loads were removed from the test unit and no further damage to the test unit was observed.

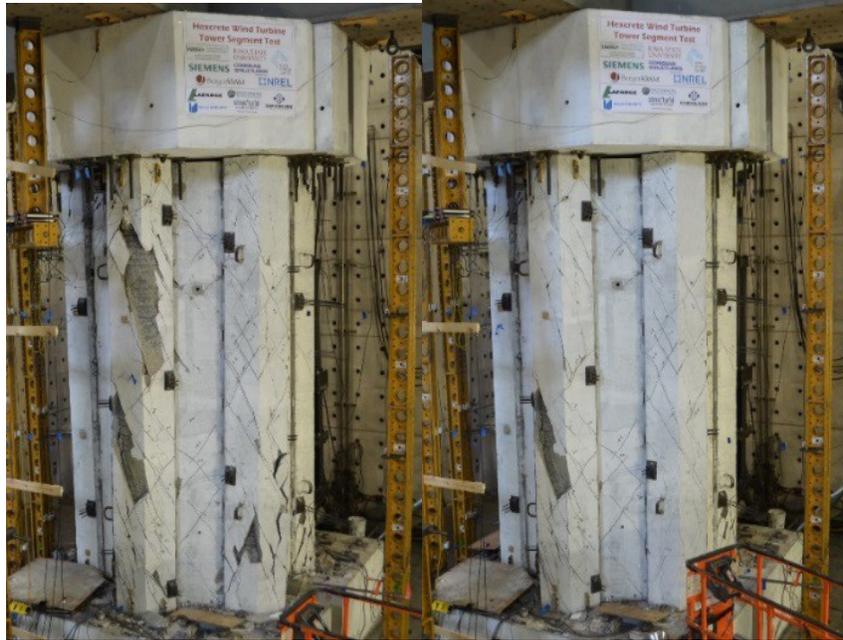
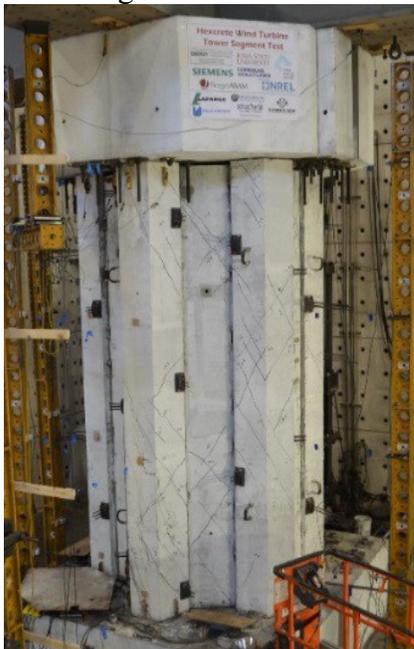
Figure 15: Large rotational displacement response

The test unit retained a large amount of load capacity after the decrease in stiffness, and therefore, torsional displacements were continuously applied in increasing magnitude beyond the extreme load envelope. Damage to the test unit progressed steadily as the torsional displacement increased beyond 1 degree of rotation (1 degree of rotation was five times the rotational displacement for extreme torsional loading). Both HSC and UHPC columns experienced torsional cracking, new cracks continued to appear on the HSC panels, and the epoxy between all of the column and panel connections began to crack or split vertically. The UHPC panels did not experience visible cracking, but gaps up to 0.25 in. opened between the UHPC panels and columns at the epoxy joint. At 4 degrees of rotation spalling had occurred on both HSC and UHPC columns and the test was terminated due to damage to the foundation blocks which made continuation of testing potentially unsafe. The progression of damage to the test unit during the large displacement cycles is shown in Error: Reference source not found while Figure 15 shows the tower rotational displacement response. Much of the damage to the test unit was spalling of cover concrete which protects the steel reinforcement from corrosion. The cover concrete does not significantly affect the structural capacity of the test unit and the unit was still able to support the axial load simulating the weight of the nacelle and rotor after the completion of testing. The response of the test unit

displacements demonstrated that the tower had sufficient ductility beyond extreme loads.
