## **SHEAR BEHAVIOR OF 45-YEAR-OLD AASHTO TYPE II BRIDGE GIRDERS**

**Cameron D. Murray**, University of Oklahoma, Norman, OK  
**Brittany N. Cranor**, Guernsey Engineers, Architects, and Consultants, Oklahoma City, OK  
**Royce W. Floyd, Ph.D., P.E.**, University of Oklahoma, Norman, OK  
**Jin-Song Pei, Ph.D.**, University of Oklahoma, Norman, OK

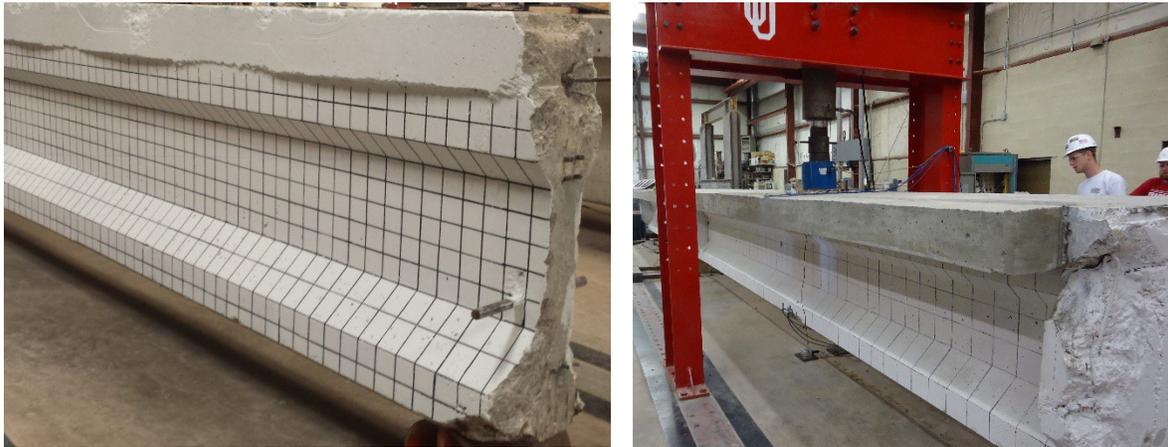
Figure 1: Girders A (left) and C (right)

Two girders taken from the I-244 bridge over the Arkansas river in Tulsa, Oklahoma, were tested as part of this program. The first, girder "A," was a 32-ft-long AASHTO Type II

girder prestressed with six straight  $\frac{1}{2}$  in. strands and four harped strands. This girder had been cut from the full bridge in a way that left a section of the 8.5 in. deck of a roughly equal width to the top flange intact. More detail about girder A can be found in the master's thesis of one of the authors.<sup>24</sup> The second girder is labeled as girder "C" in this study, and it was taken from a different span of the same bridge. Girder C was a 46-ft-long AASHTO Type II girder prestressed with ten straight strands and six harped strands. It was delivered with a roughly 36 in. wide portion of deck. The deck was cut off-center however, so an additional 10 in. of deck was cast on the short side to regain section symmetry using a concrete mixture designed to match the strength of cores taken from the deck. Continuity was maintained by embedding number 4 bars in the existing girder using structural epoxy to the depths specified by the epoxy manufacturer. The spacing was selected based on the spacing of steel in the bridge deck and on interface shear forces using AASHTO 5.8.4. The concrete face was roughened with a jackhammer to improve the bond between the old and new deck concrete and meet the roughened surface requirements described in AASHTO 5.8.4.3. Girder C also had partial diaphragms remaining at the center and the ends. Both girders were reinforced for shear with double No. 4 Z bars spaced at 4 in. for the first 12 in. of the beam from each end, 8 in. until 30% of the length from each end, and 12 in. for the interior 40% of the beam. Figure 1 shows the girders prior to testing. Figure 2 and Figure 3 show the cross sections of the girders and the sections including the deck, respectively. The deck of both girders included a 2 in. concrete wearing overlay. This overlay tended to control the ability of the deck to carry compression forces.

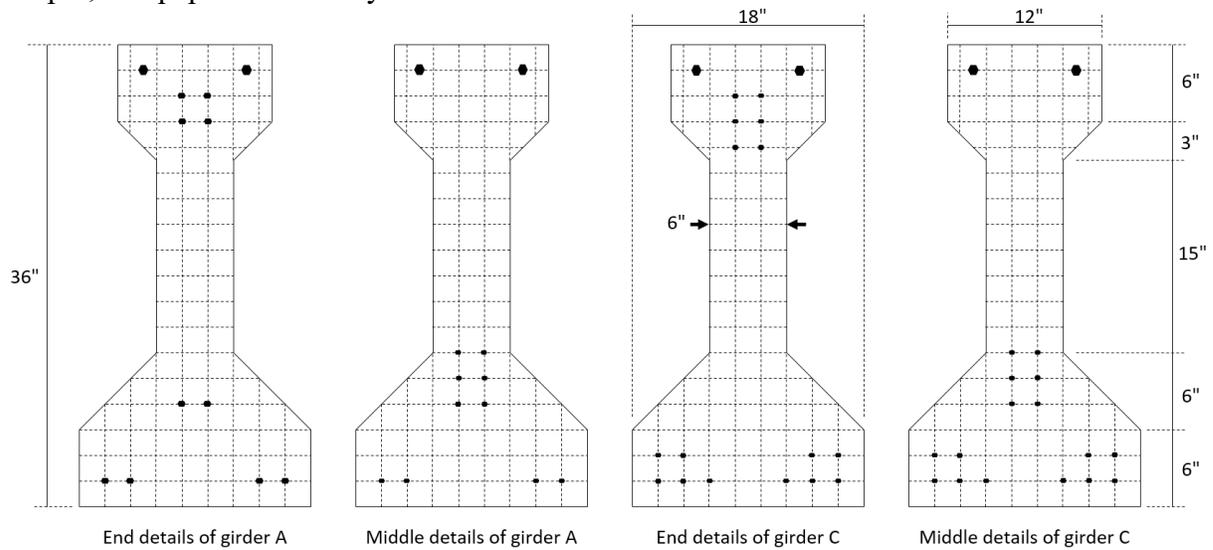
Figure 2: End and middle details of girders (2'' grid shown by dashed lines)

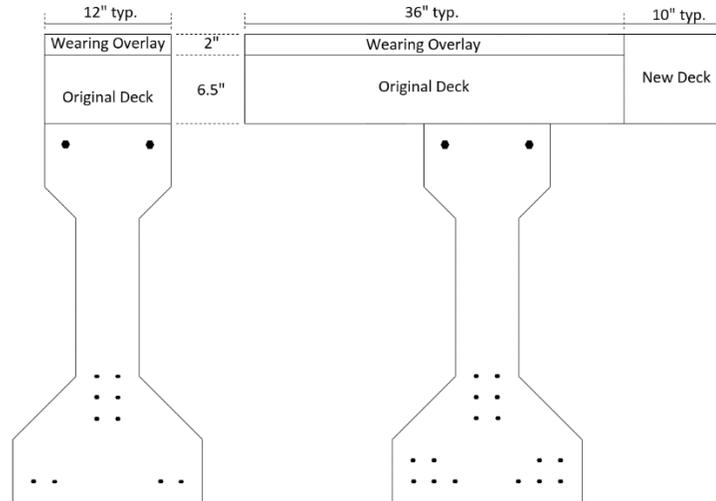
Figure 3: Details of remaining deck on girders A (left) and C (right)

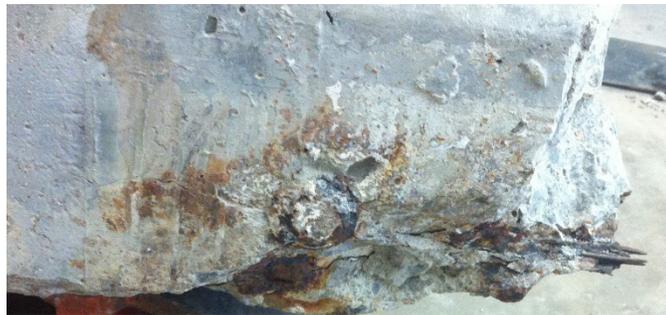
Figure 4: Corrosion at tested end for A1

A summary of all shear tests is shown in Table 1. The first shear test of girder A (A1) was performed at an  $a/d$  of 2.5 and a span length of 18.75 ft. Initial cracking occurred at a load of 170 kips directly under the load point. The first shear crack was a web shear crack 4.5 ft away from the load towards the near support and occurred at a load of 225 kips. As the load was increased, several shear cracks began to enter the bottom flange. At a load of 255 kips, the bottom four strands slipped, leading to a loss of load carrying capacity. Slip was measured for six of the strands before failure, possibly influenced by corrosion (Figure 4) present at the girder end. According to discussions with ODOT engineers, similar corrosion

is frequently observed in Oklahoma bridges. Load was increased to 260 kips, at which point the deck overlay delaminated. The cracking pattern for this test is shown in Figure 5. This failure mode could be characterized as “bond-shear” because strand slip reduced the capacity of the section and ultimately led to failure. A picture of the failure is given in Figure 6.

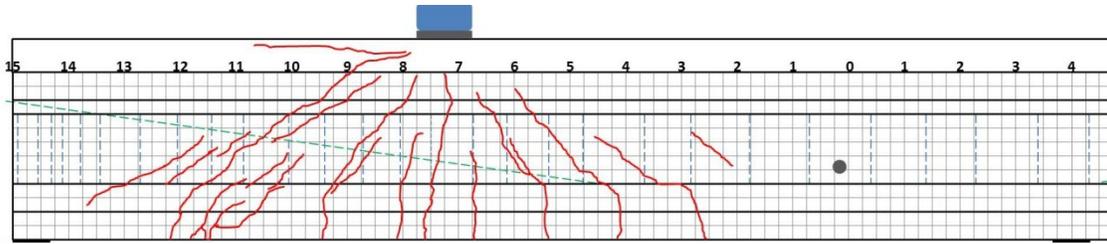
Figure 5: Shear test A1 cracking (3 in. grid shown)

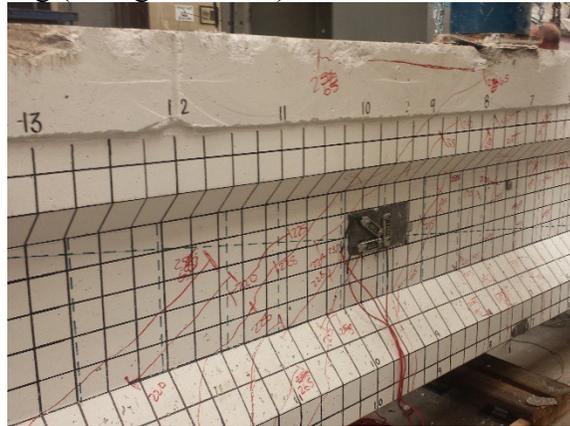
Figure 6: Shear test A1 failure, note deck overlay failure and shear cracking in the foreground

and possibly due to corrosion. This test can be characterized as a bond-shear failure. Based on strain compatibility, the flexural capacity of the section should have been reached at an applied load of 239 kips; less than the 260 kip applied load at failure. In this case, the capacity of the section can be estimated conservatively by strain compatibility, even when bond is lost due to shear cracking. One could argue that the estimated force to fail the section was conservative based on moment capacity determined by strain compatibility, however the shear equations failed to predict a loss of bond due to shear cracking, which is potentially un-conservative. Future work will involve analysis using a free body diagram at the shear crack face to determine the expected capacity after the shear crack forms, similar to the method reported by Ross and Naji.<sup>25</sup>

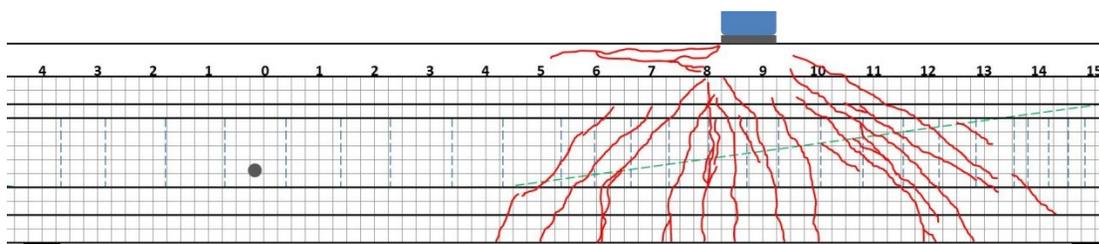
Figure 7: Shear test A2 cracking; strand rupture occurred at the 8-ft mark (3 in. grid shown)

The second shear test of girder A (A2) was performed at an  $a/d$  of 2.0 and a span length of 19 ft. Initial cracking occurred at a load of 190 kips directly under the load point. The first shear crack was observed at a load of 225 kips in the web and the bottom flange roughly 1 ft away from the support. Load was increased to an ultimate capacity of 289.5 kips at which point there was a sudden failure corresponding to delamination of the deck overlay and rupture of multiple prestressing tendons. The strands ruptured roughly 1 ft away from the load point in the direction of the longer side of the span. The cracking pattern is shown in Figure 7 and a failure photo is given in Figure 8.

During test A2, prestressing strands near the load point ruptured, indicating a flexural failure. The flexural capacity of the section based on strain compatibility was exceeded during the test. The extent of shear cracking indicates that the girder maintained adequate ductility and load carrying ability during the test. At the failure load, all shear capacity calculations were conservative.

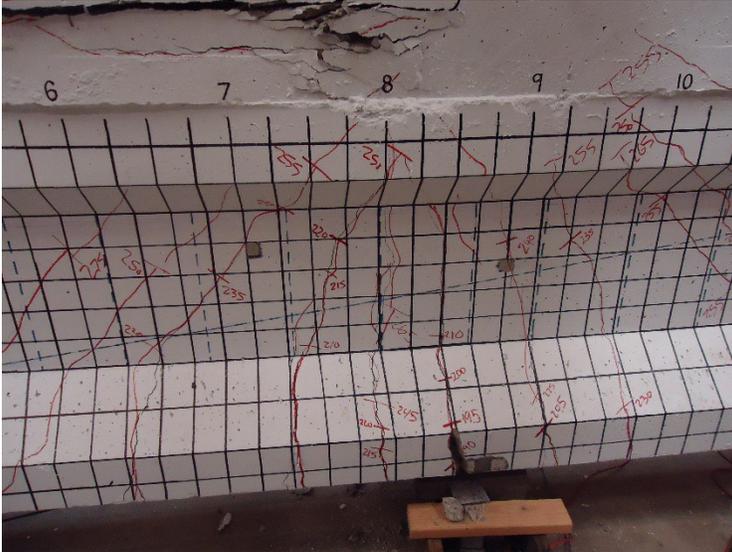
Figure 8: Test A2 failure, note deck crushing at the top of the image and the large flexural crack at the bottom where strand failure occurred

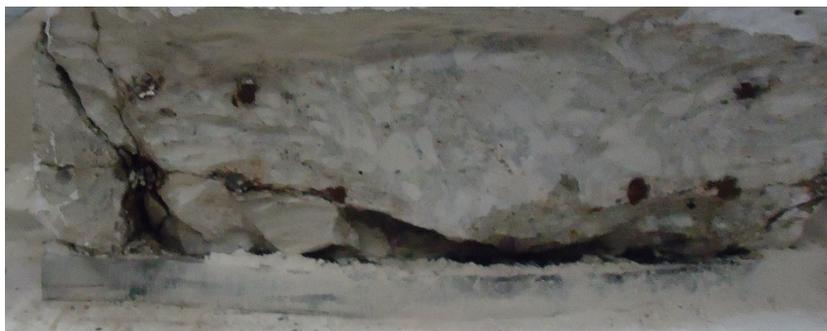
Figure 9: Spalling under load initiated by cracking caused by corrosion

The first shear test of girder C (C1) was performed at an  $a/d$  of 3.0 with a span length of 25 ft. At an applied load of 90 kips, spalling was observed at the end nearest the load point. There was corrosion of the strands at that end similar to that described for girder A and the bearing force caused the pre-existing cracks caused by corrosion at this end to open and for pieces to spall off of the bottom flange (Figure 9). At this point the test had to be stopped so the LVDT's on the strands at that end could be repositioned. When the test was resumed, spalling more or less ceased and web-shear cracks were observed at a load of 160 kips at the web-top flange interface. Flexural cracking under the load was observed at 185 kips and at a load of 195 kips some shear cracks began to enter the bottom flange of the girder. A data acquisition error caused this test to be halted at 195 kips before continuing the load to failure. As load increased beyond 195 kips, several shear cracks began to align themselves with the strands in the bottom flange, indicative of a possible bond-shear issue. Once a load of 318 kips was reached, the shear cracks at the bottom flange became wider and the strands slipped leading to additional deflections and delamination and crushing of the deck overlay. The cracking pattern for test C1 is shown in Figure 10 and a photo of the failure is given in Figure 11.

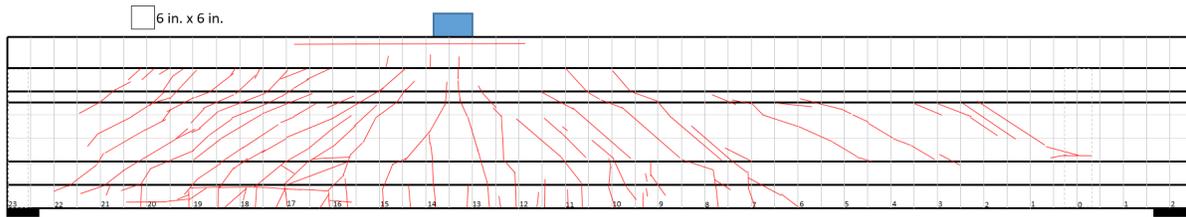
Figure 10: Test C1 cracking (6 in. grid shown)

Test C1 resulted in a bond-shear failure with shear cracks entering the zone of prestress transfer and reducing the capacity of the section. The codes were conservative with the exception of the 2012-SIMP (by a factor of 1.11). Test C2 on the other hand was performed at the quarter-point, the critical location for shear per the 1973 code. The span length was increased to 28 ft for this test to increase the shear demand at the testing location. The girder failed when the deck and top flange crushed, indicating either a flexural failure or shear-compression failure.<sup>21</sup> In this case, the applied load exceeded the flexural capacity as calculated by strain compatibility. The code equations were conservative with the exception of the 1973-STD and 2012-SIMP by factors of 1.24 and 1.30 respectively.

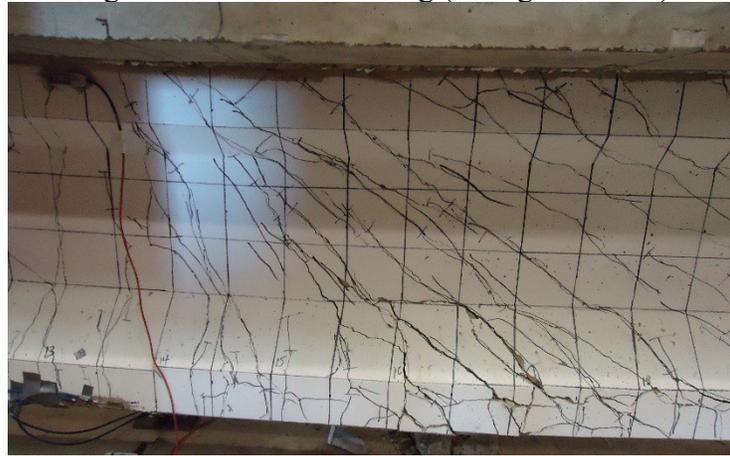
Figure 11: Test C1 failure, note large shear cracks and failure of the bottom flange concrete

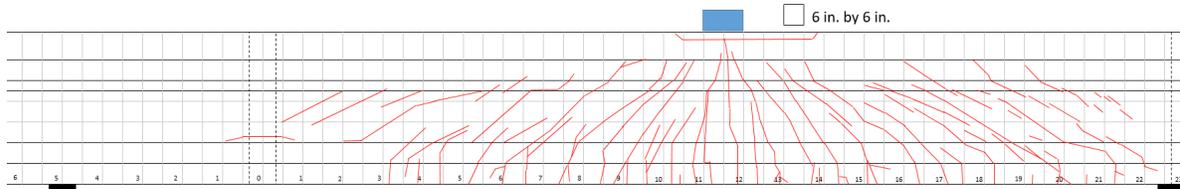
Figure 12: Test C2 cracking (6 in. grid shown)

The second test of girder C (C2) was performed at an  $a/d$  of 3.83, corresponding to a quarter of the original span length. In the 1973 AASHTO-STD this point would have been taken as the critical section for shear. However, this far into the span moment is expected to control the failure. The test span was increased to 28 ft to increase the shear demand on the short side of the span. The first observed cracks were web-shear cracks at a load of 150 kips followed by flexural cracking at 160 kips. At 195 kips of load, web-shear cracks entered the bottom flange of the girder. As in C1, some of these cracks oriented themselves in the direction of the strands as they entered the bottom flange. As in previous tests, the girder failed when the forces in the deck overlay were too large, causing the overlay to delaminate and crush. The max load was 301 kips. The compressive forces during this test were so large that the top flange crushed and compression steel in the top flange and the deck buckled. This failure type could be described as compression-shear or a flexural failure. Compression-shear is caused by shear cracks entering the compression flange<sup>21</sup>. The cracking pattern for test C2 is shown in Figure 12 and a photo of the failure is shown in Figure 13.

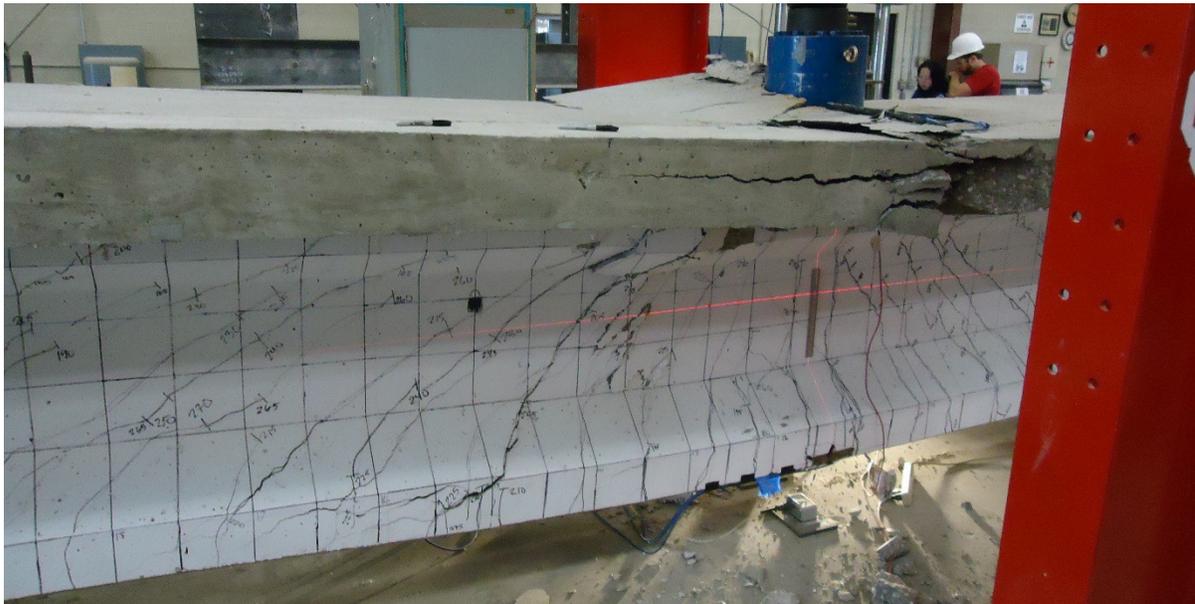
Figure 13: Test C2 failure, showing a large shear crack in the center of the image that entered the top flange causing catastrophic compression failure

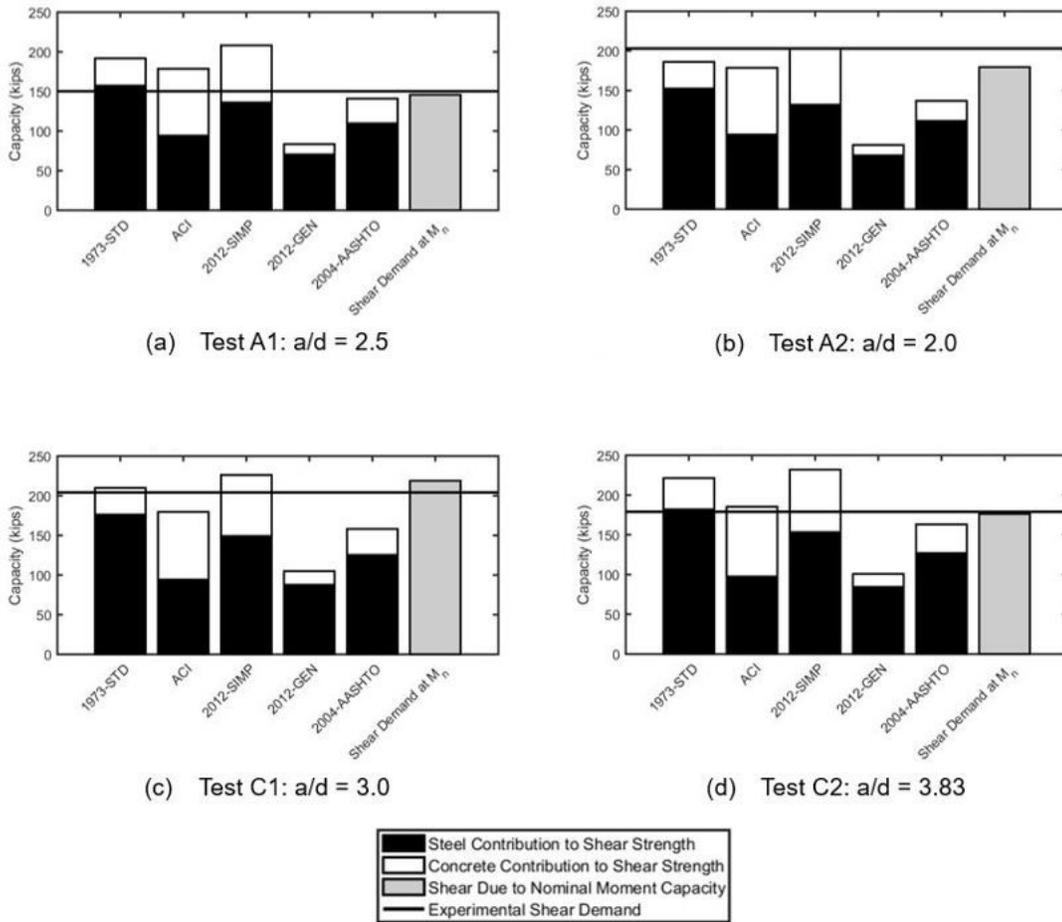
In Figure 14 there is a general trend that the 2012-GEN and 2004-AASHTO methods (both based on MCFT) give conservative estimates of strength for each location tested. In the case of the 2012-GEN method, the estimate was conservative by a factor (predicted ultimate shear/experimental ultimate shear) of 0.40 to 0.56. The 2004-AASHTO methodology is slightly less conservative, with factors between 0.68 and 0.91. The 2012-GEN was developed

Figure 14: Tested capacities compared to codes

as a simplification of the 2004-AASHTO method and it was reported by its developers to be more conservative.<sup>12</sup> Both of these methods also predict a low concrete contribution to shear strength. The concrete contribution to shear strength is influenced by the factor  $\beta$  which differs between the 2004-AASHTO and 2012-GEN methods. In all cases, the 2012-GEN method provided a low capacity and predicted a large shear crack angle ( $\sim 50$  degrees), limiting the capacity from the stirrups. The equation for the shear crack angle is based on the strain at the level of the tension reinforcement; in these cases, the applied moment increased

the strain, resulting in a reduced capacity. The moment was relatively high because the girder had to be supported near the center to facilitate testing both ends, increasing the applied moment for a given shear demand. The 2004-AASHTO method produced an accurate prediction of shear crack angles, only differing with the actual shear crack angle by an average of 3 degrees.

The other shear equations were occasionally un-conservative. For test A1, the 1973-STD, ACI, and 2012-SIMP were all un-conservative, over predicting capacity by factors of 1.20, 1.12, and 1.31 respectively. During test A1 there was a loss of bond due to shear cracking
