EFFECT OF CORROSION ON END REGION BEHAVIOR OF PRETENSIONED, PRESTRESSED BRIDGE GIRDERS

Darion T. Mayhorn, Bureau of Reclamation, Denver, CO
Cameron D. Murray, University of Oklahoma, Norman, OK
Royce W. Floyd, Ph.D., P.E., University of Oklahoma, Norman, OK
Gary S. Prinz, Ph.D., P.E., University of Arkansas, Fayetteville, AR

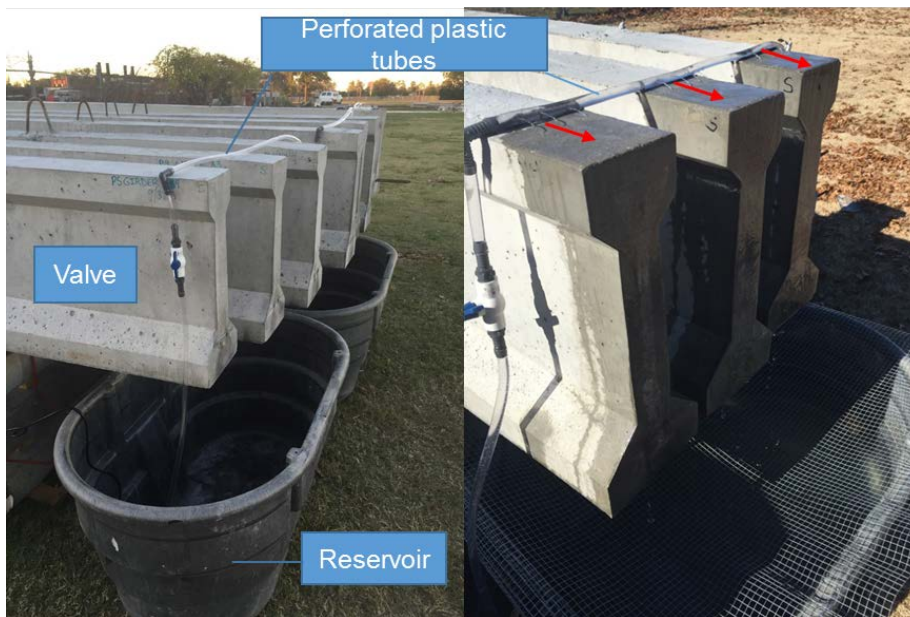
Figure 1. Completed girders placed in corrosion accelerant setup (red arrows indicate the direction of flow from the perforated tubes)

After the girders reached an age of 28 days, they were placed in a corrosive environment consisting of a chloride solution spray to induce end-region corrosion. The use of a chloride spray was intended to simulate the effect of a leaking expansion joint on the ends of the girders similar to that described by previous research^{3,4} and observed by the authors in the field. No end diaphragms or other concrete cover was included on the ends of the beams, as would be present in the field, in order to speed up the corrosion process. Initially, a literature review was performed to understand chloride solutions successfully used for similar applications in previous research, as well as the optimum duration for wet/dry cycles of chloride saturated water.^{6,14} Ultimately, a 5 percent by weight sodium chloride solution was used as the corrosive agent. A large plastic tub was used as a reservoir, with a submersible pump to circulate the chloride solution over one end of the beams. Perforated plastic tubes were bonded to the beams approximately 6 in. from the beam ends to correlate with the typical distance exposed to leaking joints observed by the authors for beams in the field. The perforations consisted of four 3/32 in.-diameter holes spaced to evenly spray the chloride solution over the beam ends. A valve was used to control the flow rate of the chloride solution through the perforated tubing. The final arrangement is shown in Figure 1. A cycle time of two hours on and two hours off was chosen based on the literature review, limitations of available timers, and to ensure drying between cycles.

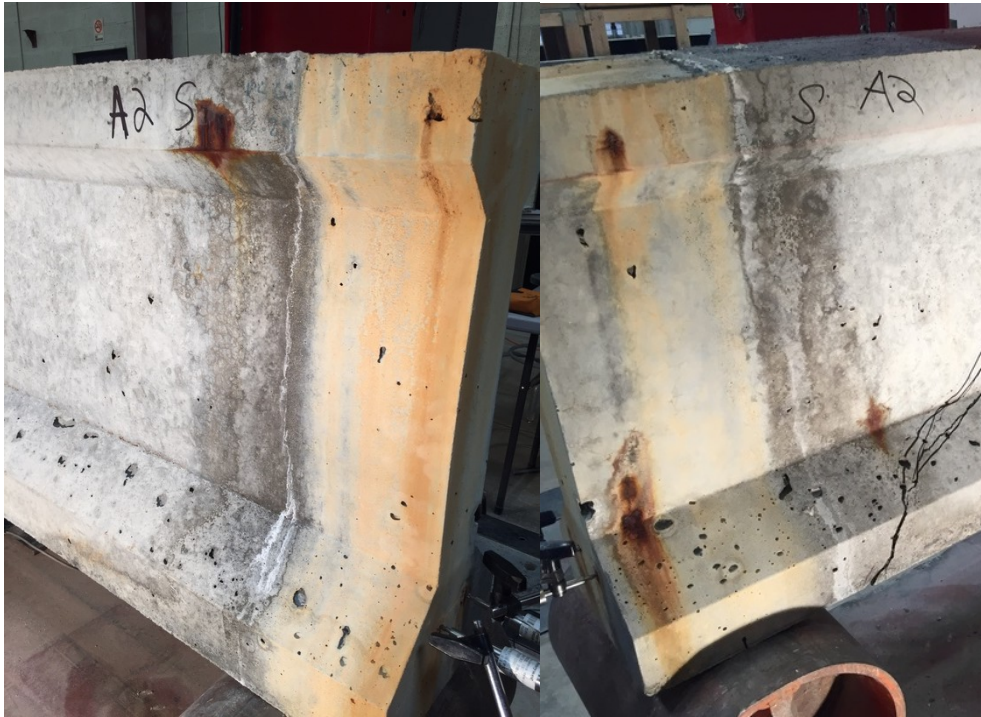
regimen, the girders were removed and prepared for shear testing. Figure 2 is an example of a corroded beam end after six months of the accelerated corrosion process. Rust staining is clearly visible on the surface of the beams at the location of the mild steel shear reinforcement and below the exposed strand ends. An autopsy of the corroded specimens to determine how far the corrosion extended into the beams was not conducted during this analysis.

Figure 2. Example of a corroded beam end after the accelerated corrosion process.

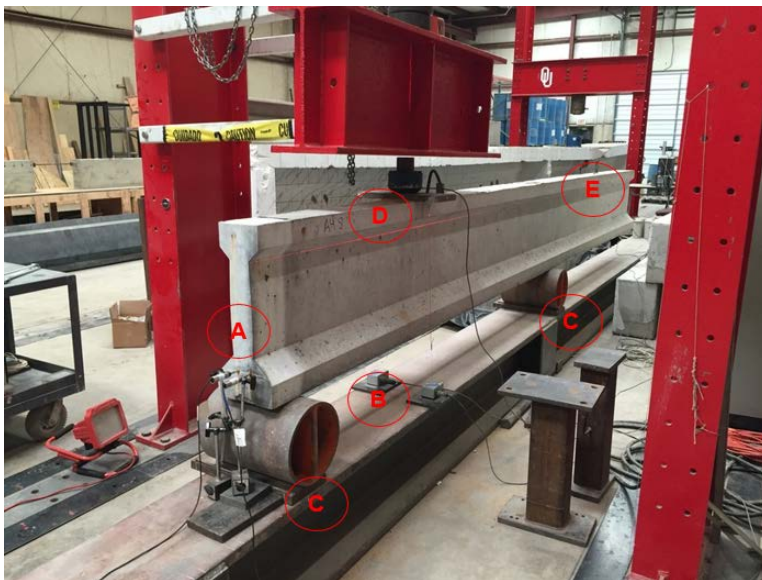
Figure 3. Typical shear test setup looking towards the north – (A) LVDT 1 & 2, (B) wire pots 1 (west) & 2 (east), (C) supports at 9 ft center-to-center, (D) single load point with load cell at 41 in. from end of beam, and (E) 8 ft - 8 in. overhang of the beam

Following the accelerated corrosion period for the 2 month, 4 month and 6 month specimens, each end of each exposed specimen was tested in shear. A three point bending arrangement using a hydraulic actuator to apply load to the girder specimens was used and the untested end of the beam was cantilevered over the support to prevent damage during the first test of each specimen. The loading arrangement for shear was based on a shear span to depth (a/d) ratio of 2.0, intended to induce a bond-shear type failure. However, the chosen a/d ratio is at the border line of creating a discontinuity region for the entire section between the applied load and the nearest support, which could affect the applicability of typical capacity prediction equations. The support nearest the load point was located 4 in. from the end of the beam and the center-to-center distance between the supports was 9 ft, leaving 8 ft - 8 in. of overhang on the untested side. A single point load was applied through a 6 in. wide plate, centered 41 in. from the end of the beam. Sand was placed between the load plate and the beam to ensure uniform load distribution. The girders were loaded in 5000 lb increments before initial cracking and 2000 lb increments after initial cracking until failure.

Deflection at the load point was measured using wire potentiometers (wire pots) on each side of the beam. Strand end slip was measured using linear voltage differential transformers (LVDTs) attached to the prestressing strands on the non-corroded end and placed touching the strand ends on the corroded end. Manual deflection measurements were also taken after each load increment using a steel ruler. Visual mapping of cracking was conducted during the testing by marking cracks with a permanent marker and noting the load increments. Data were collected from all instruments during testing using a single data acquisition system. The data were used to compare the findings to the nominal strengths calculated using the ACI¹³ and AASHTO LRFD¹ methods and to identify the failure mechanism. A strut and tie model was also considered for the beam end region to account for the loading configuration creating a discontinuity region at the end of the beam. The results of tests of the undamaged ends of the girders were compared to tests of the corroded girder ends to identify differences in performance. Figure 3 illustrates the shear test setup.
