SERVICE LOAD AND FAILURE TESTS OF SHORT SPAN PRECAST REINFORCED CONCRETE ARCH BEAMS

Brianna Crabtree, Clemson University, Clemson, SC

ABSTRACT

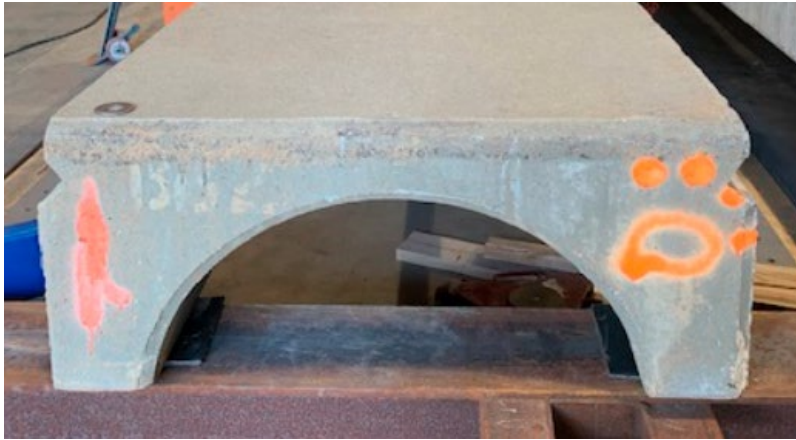
Figure 1 - Cross Section of Arch Beam

The South Carolina Department of Transportation (SCDOT) currently has hundreds of operative bridges that are constructed with precast reinforced concrete arch beams, the cross-section shape is shown in Figure 1. These beams are placed side by side with three evenly spaced bolts connecting the beams together transversely (Figure 2). The arch beams span in the direction of travel and are 25 ft. long, 17 in. deep, 41 in. wide and have two 6 in. webs. In the field these beams could have a non-structural asphalt topping and a grout pocket helping with transverse load distribution.

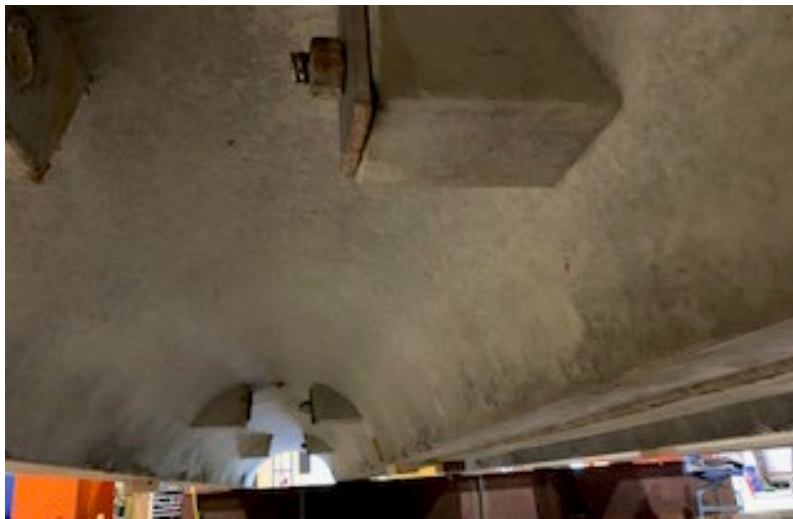
Figure 2 – Bolt Connections between Arch Beams

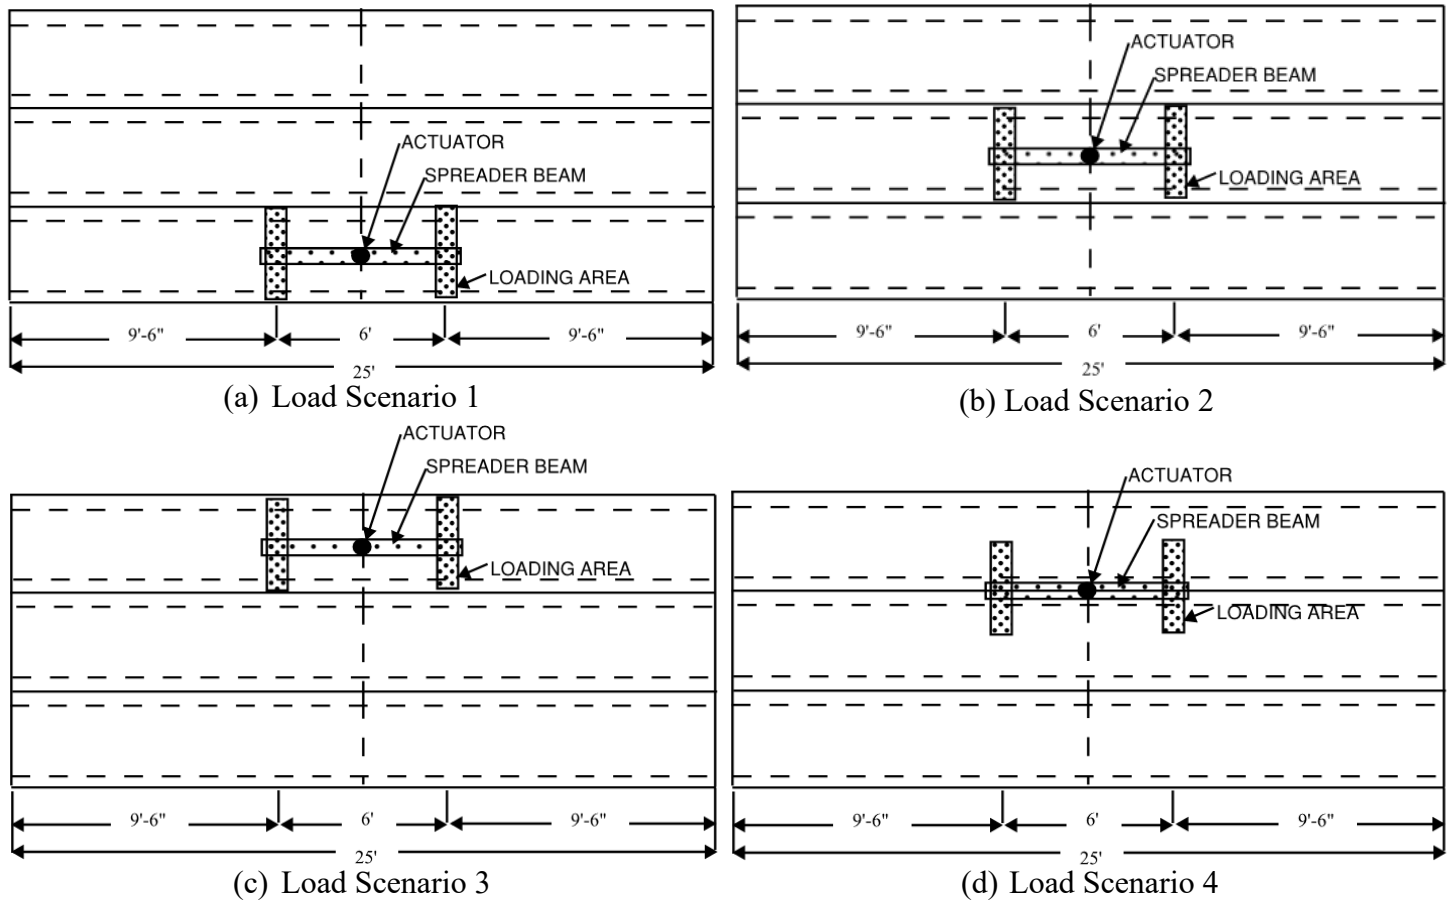
Figure 6 – Service Loading Scenarios

Four different loading locations were used during the service load tests (Figure 6). The first three locations had the hydraulic ram placed at the center of each of the three arch beams. While the fourth location had the hydraulic ram placed above the center of two adjoining beams. These four locations were used to measure the transverse load distribution between adjacent beams as well as evaluate how the bolt connections distributed the load. To measure bolt efficacy, tests were conducted with the bolts wrench-tight, the bolts hand-tight (loose), as well as no bolts at all.

The bolts connecting adjacent arch beams for the first round of service load tests were wrench-tight. This was thought to be the best-case scenario for bolt tightness for bridges of this age. Figure 10 shows example data collected from a service load test, in this case scenario 1 (Figure 6a).

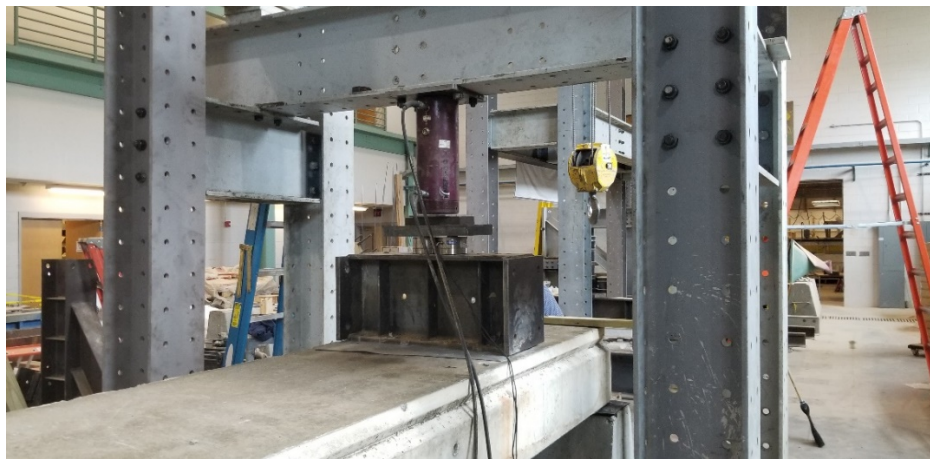
Figure 7 - Load configuration

Shear capacity is always a critical consideration for bridges, but particularly for bridges without plans³. Accordingly, a shear test to failure was conducted on a single 25 ft. arch beam. Force was applied using a single hydraulic ram rated for 300 kips. The test frame supporting the load was composed of a single I-beam oriented transversely relative to the test specimen, with support beams above and below to transfer the load to the vertical support structure which was bolted to the laboratory strong floor (Figure 7).

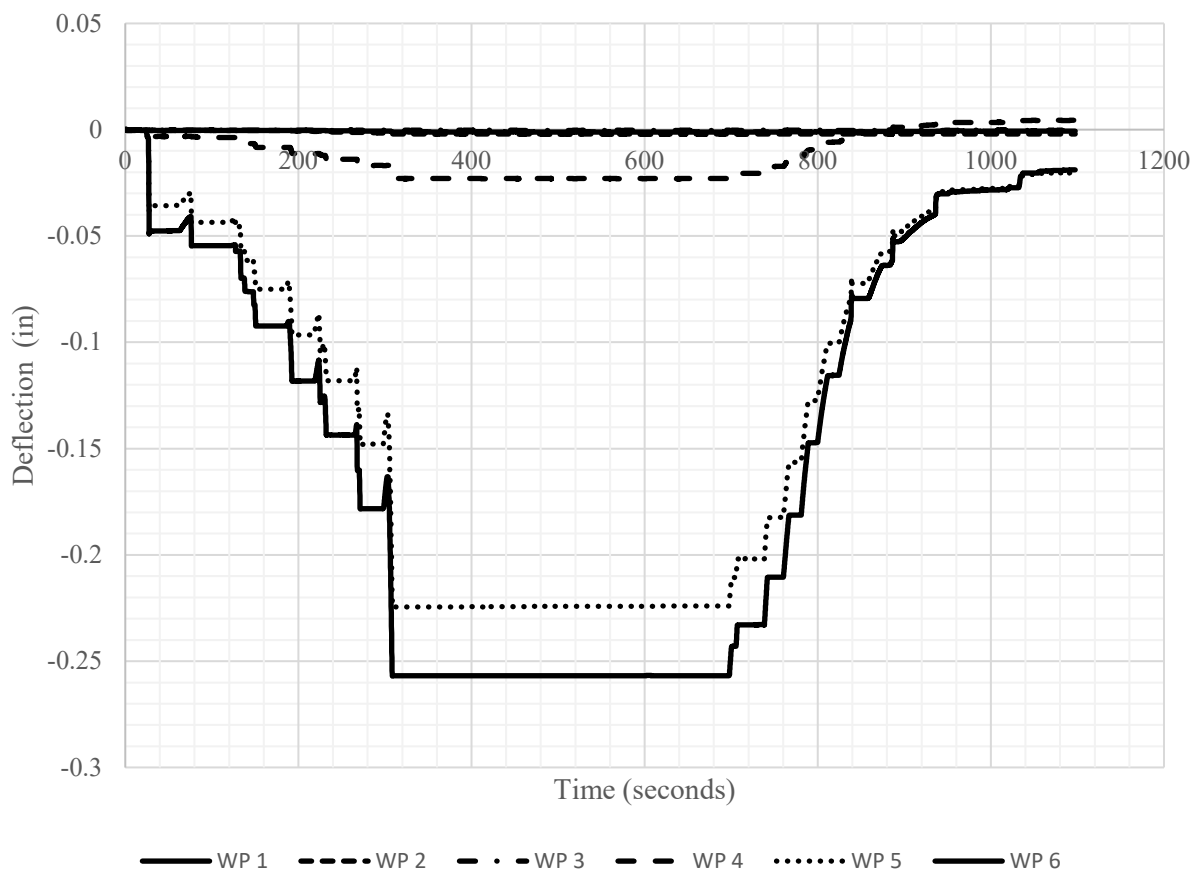
Figure 10 – Data Collection from Wire Potentiometers during Load Scenario 1

From the plot it is noticeable that the changes in displacement correspond to the two kip increments of the applied load. It is also evident that the two wire potentiometers on loaded beam 3 (WP 5 and WP 6) experience the largest vertical displacement. However, WP 5 is slightly less than WP 6 because of the bolts connecting beams 2 and 3 together. The maximum deflections in WP 4, WP 5, and WP 6 are approximately 0.02 inches, 0.22 inches, and 0.26 inches, respectively. The deflection of WP 4 is about 10% of that in WP 5 indicating that some load is shared between beams 2 and 3.

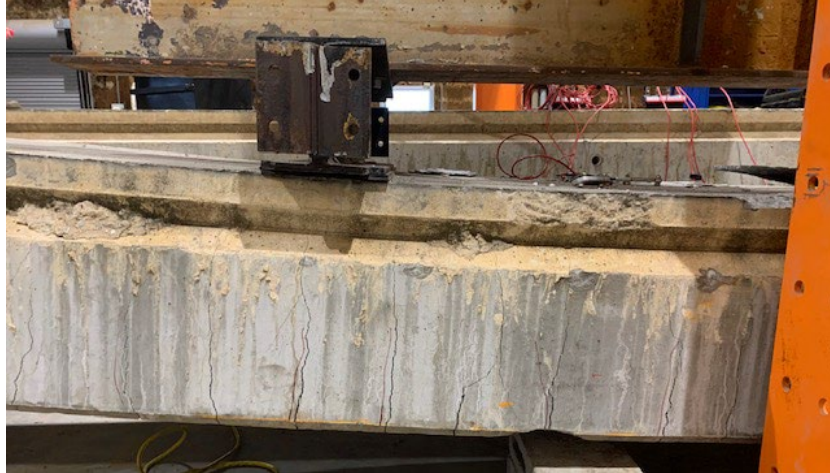
Figure 14 – Deformation at Failure

Flexural failure occurred at around 597 kip-ft. At failure the arch beam had undergone significant deformation (Figure 14) and had many flexural cracks (Figure 15). At the peak moment the concrete at the top of the member crushed in compression (Figure 16) and the reinforcement near the top of the beam buckled Figure 17.

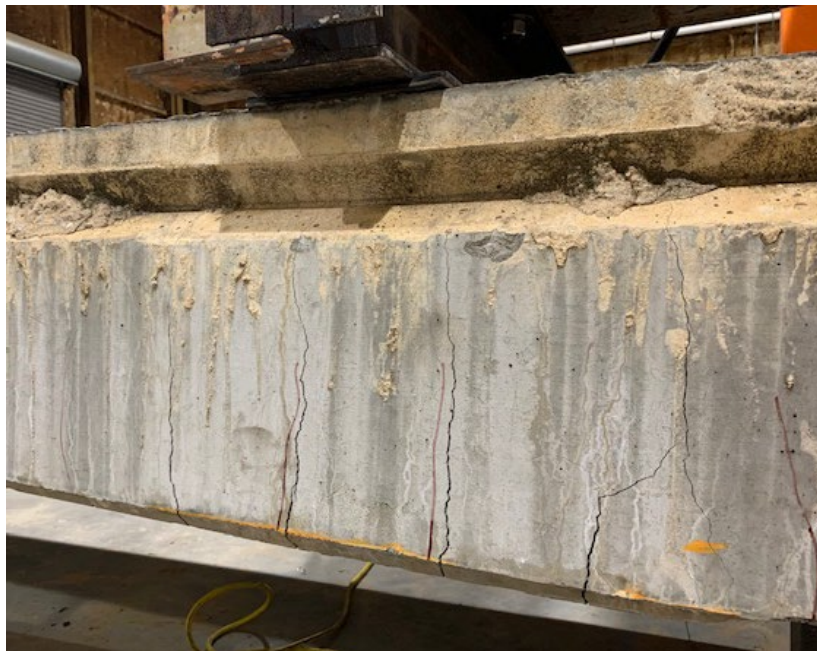
Figure 15 – Cracking near Load Point

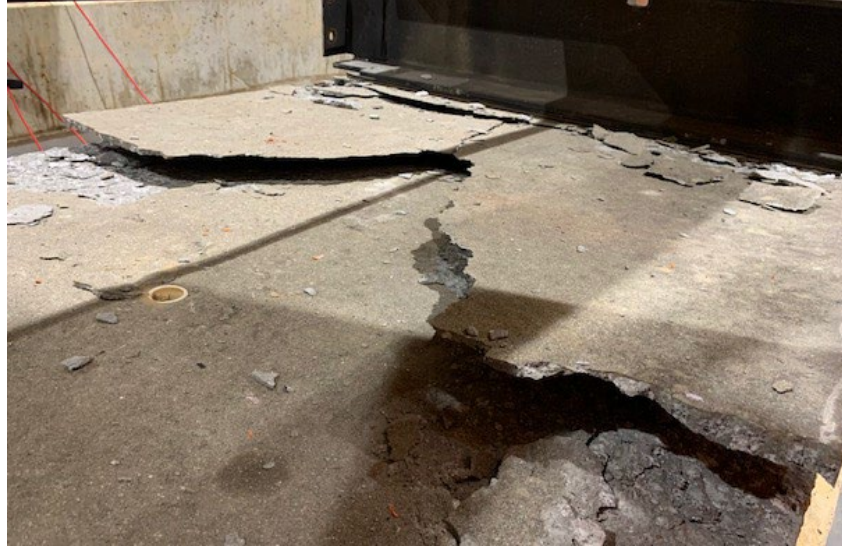
Figure 16 – Top Flange Concrete Compression Failure

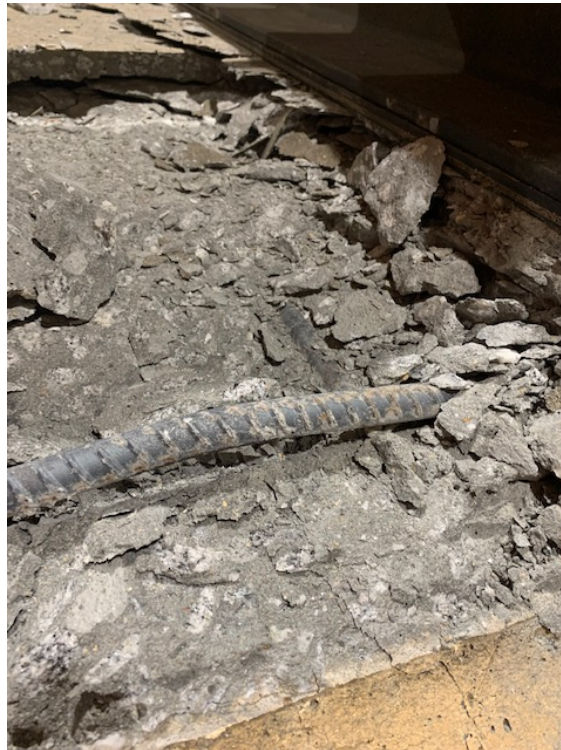
Figure 17 – Buckled Compression Steel

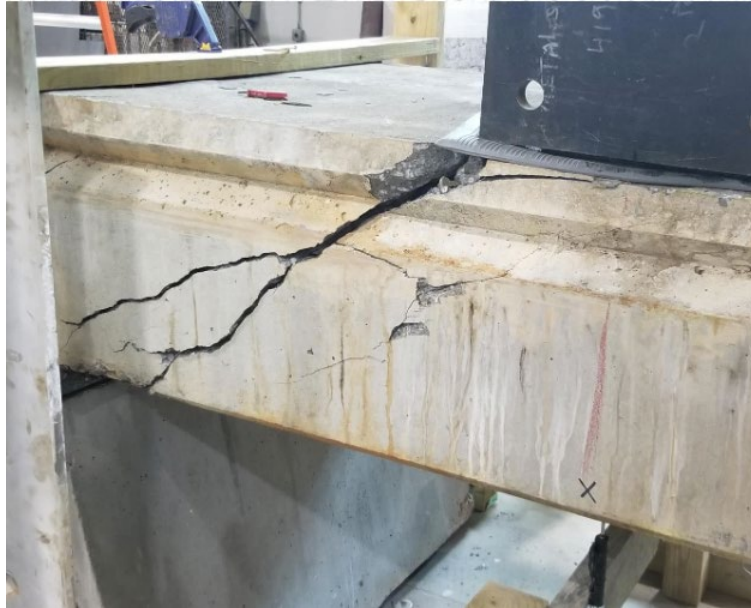
Figure 19 - Photograph of failure mode

The failure load for the arch beam was 117 kip, which corresponded to a peak shear force of 108 kip at the support nearest to the load point. The failure mode is shown in Figure 19. Shear and displacement data for the shear test is shown in Figure 20. The displacement data presented in Figure 21 is from LVDT 3 and 4 (Figure 9). Shear behavior was relatively linear with minimal cracking to shear force until approximately 50 kips. At this level of load noticeable cracking occurred and continued until ultimate shear capacity was reached. Shear failure occurred in only one web.

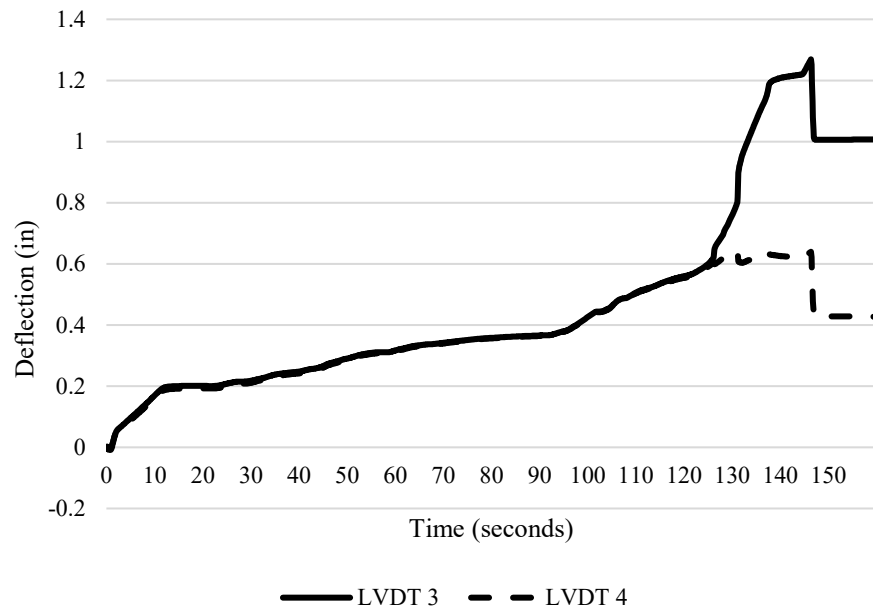
Figure 21 - Deflection vs. Time

After shear failure the load and displacement were asymmetric, resulting in noticeable differences on the different sides of the specimen (Figure 21) as the load approached peak shear capacity. Displacement on both sides of the beam was approximately 0.6 in immediately prior to shear failure and peak load.

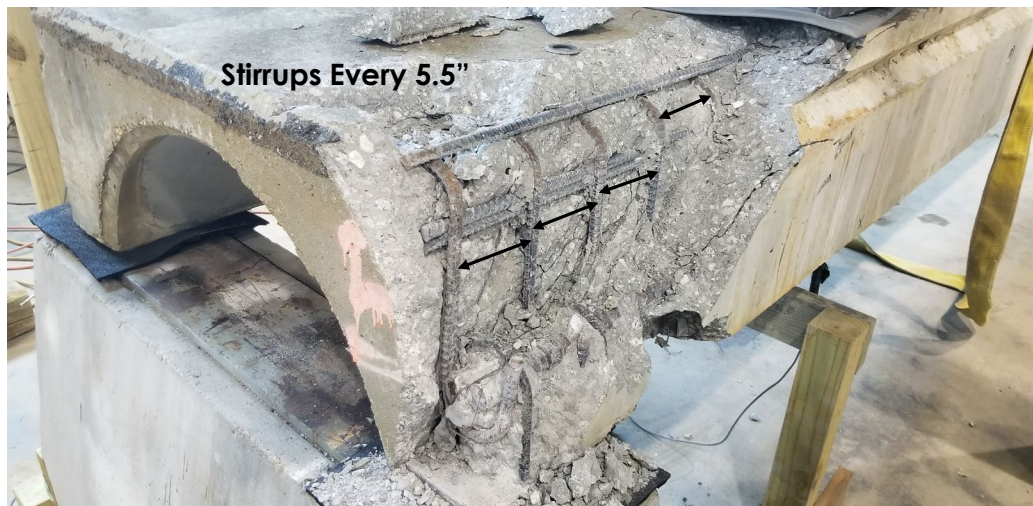
Figure 23 – Autopsy Showing Reinforcement Pattern and Bearing Plate

Once the arch beams were tested to failure, a jackhammer was used to further expose the reinforcement by breaking away the concrete. Once the reinforcement was sufficiently uncovered, a tape measure was used to measure the spacing between reinforcements and a caliper was used to measure the diameter of the reinforcement. The findings are shown in Figure 22 and Figure 23.
