Precast prestressed voided slabs were used effectively to replace the superstructure of an old deteriorated vehicular bridge.

## Highland Avenue Bridge

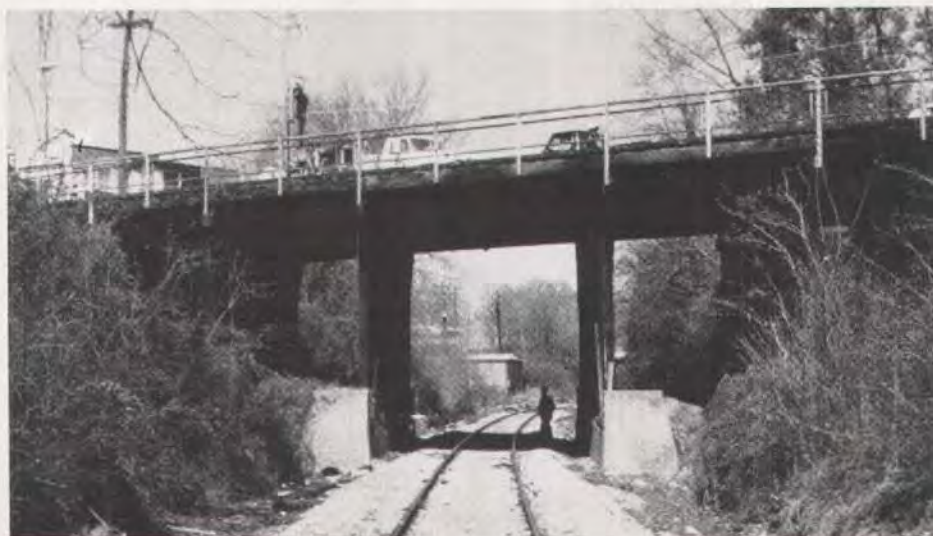
Fig. 1. Old deteriorated highway bridge.

The old structure, located in Montgomery, Alabama, was a four-lane, seven-span bridge with timber stringers, bents and timber flooring with an asphalt overlay. Over the years, significant decay and deterioration of the timber flooring, stringers and bents had occurred. The lane width was also insufficient, being narrower than the street.

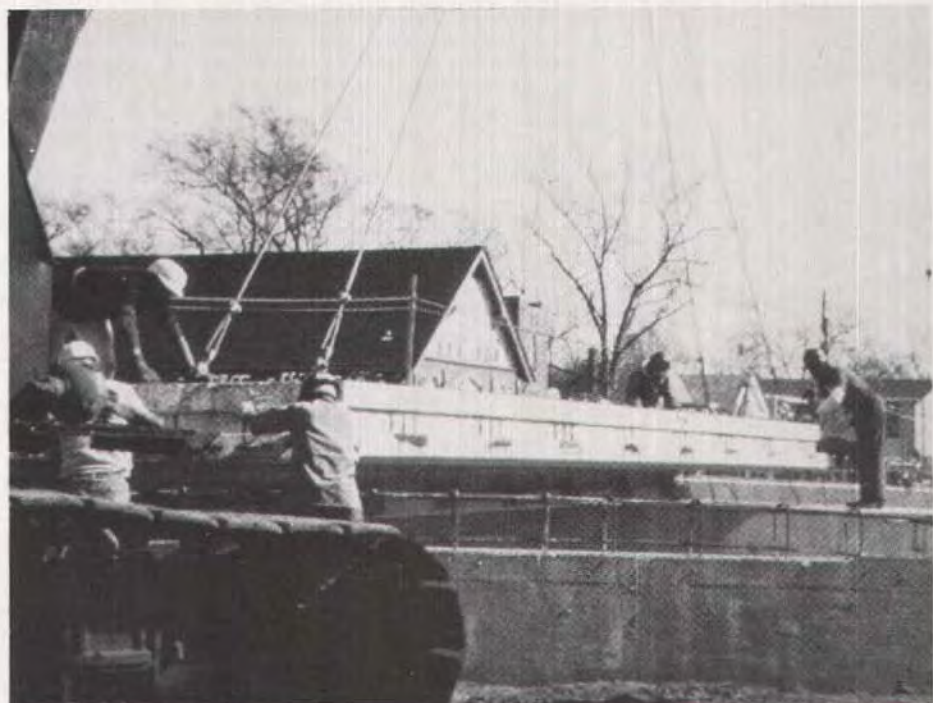
Fig. 2. Placement of voided slabs.

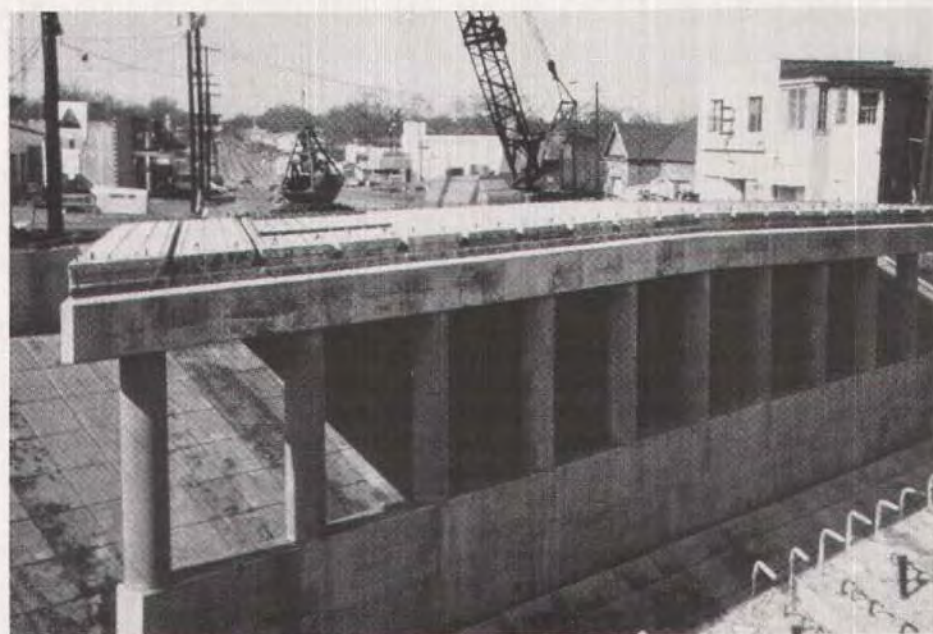
Fig. 3. 35 ft (10.7 m) span on the west side of new bridge.

The span lengths were set at 35 - 50 - 35 ft (10.7 - 15.2 - 10.7 m) for an overall span of 120 ft (36.6 m). The bridge width was 80 ft (24.4 m).

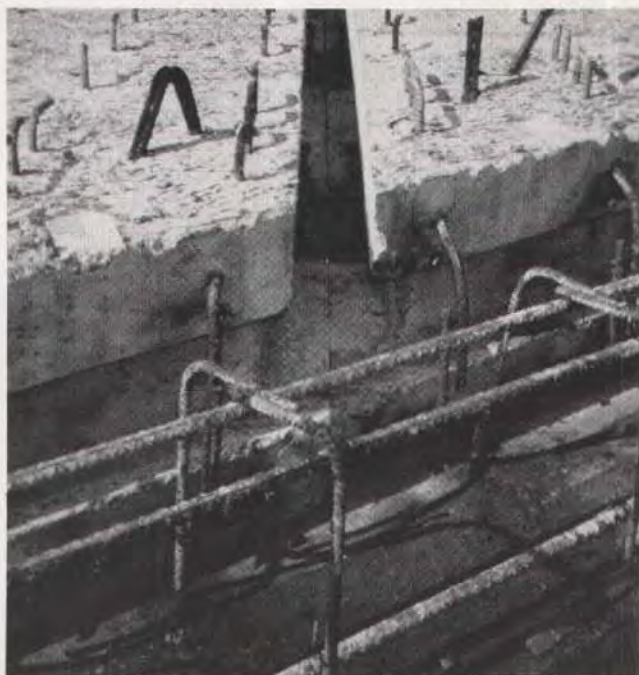
Fig. 4. Adjoining slabs prior to placement of reinforced concrete overlay.

asphalt overlay and subsequent expensive patch and repair efforts. On this structure, the shear transfer between precast units proceeds through larger reinforced concrete shear keys assisted by the transversely reinforced overlay.

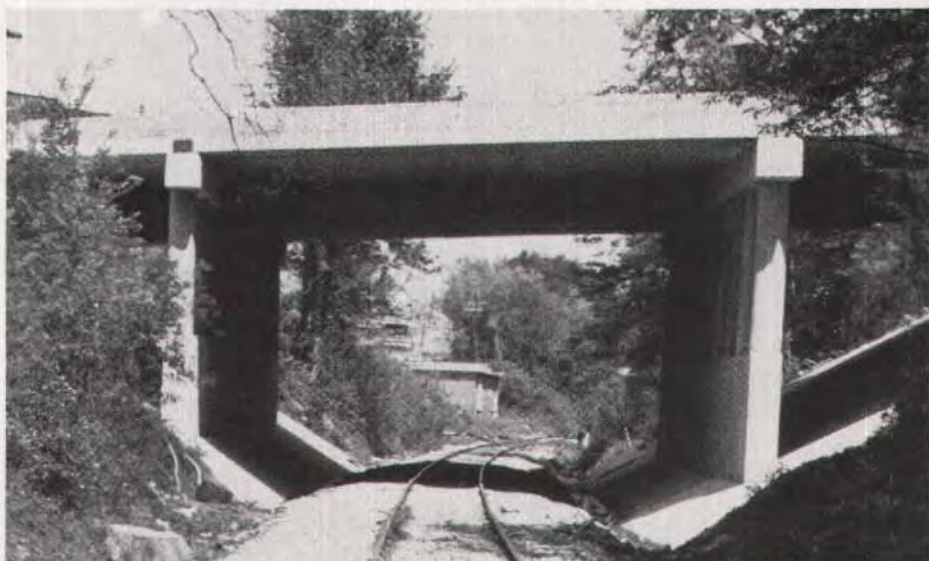
Fig. 6. Improved clearances with new precast prestressed bridge.

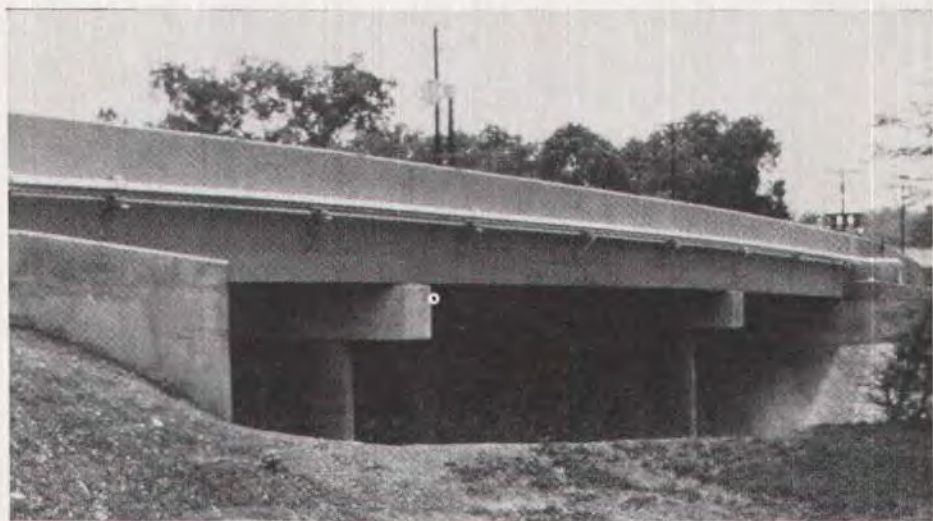
Fig. 7. Completed bridge.

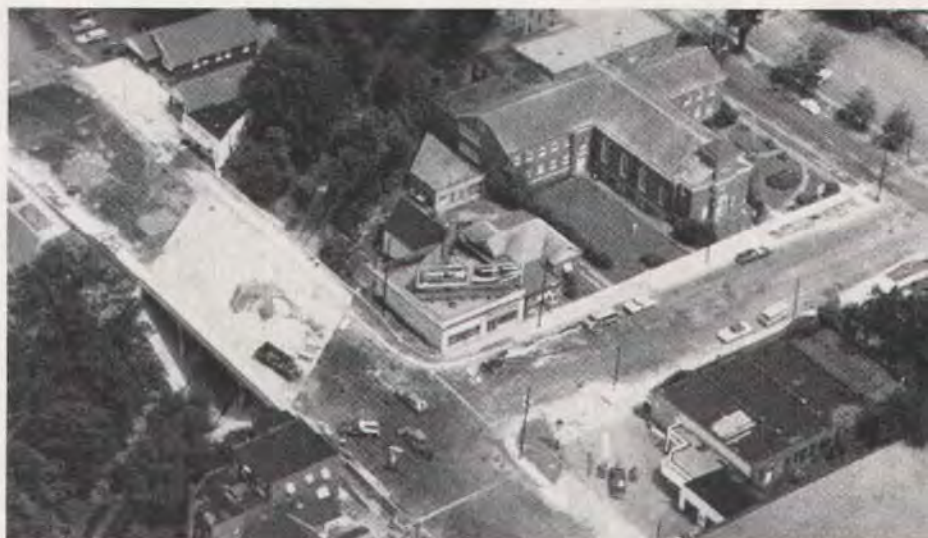
Fig. 8. Aerial view of the new bridge and roadway (during construction).
