# Seismic Performance of Precast Segmental Bridge Superstructures with Internally Bonded Prestressing Tendons

*A research project is currently in progress to investigate the seismic performance of segment-to-segment joints of precast segmental concrete bridges. This paper presents the experimental and analytical results of two large-scale tests which model the superstructure response of a prototype precast segmental bridge, post-tensioned with internally bonded tendons, under fully reversed vertical cyclic displacements. The joints of the first test unit were epoxy bonded with no reinforcement crossing the joints other than the prestressing steel. The second test unit had a reinforced cast-in-place deck closure with the remaining portions of the joints connected by epoxy. Both test units were subjected to fully reversed cyclic loads simulating earthquake vertical motions. It was found that both test units could undergo significant seismic displacements, but their failure modes were considerably different. The paper also presents results from nonlinear finite element modeling of the simulated seismic response of the test units. The results showed that segment-to-segment joints coul

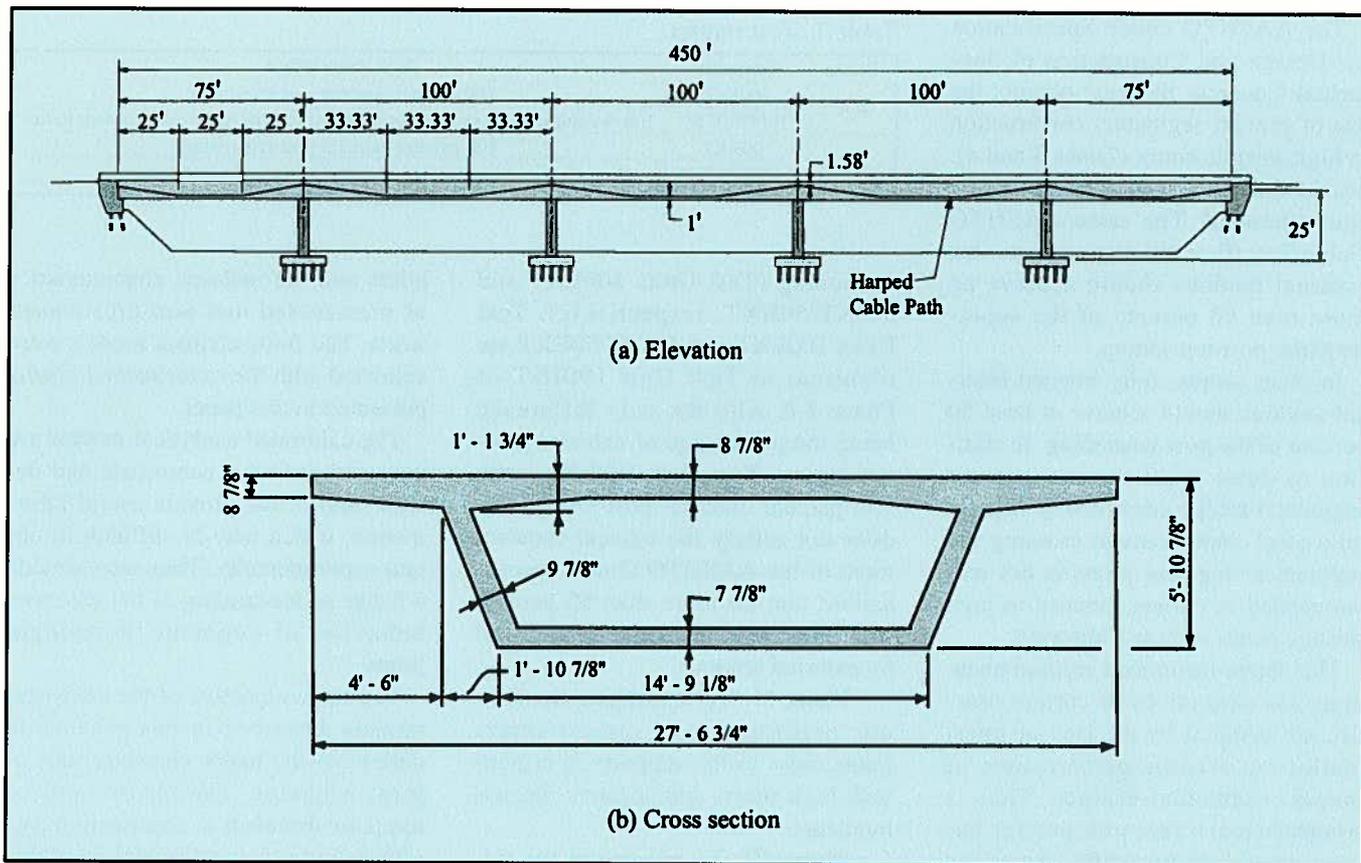
Fig. 1. Prototype structure: (a) Elevation; and (b) Cross section.

Because of its short spans, the prototype structure is constructed using the span-by-span method. Fig. 1b shows the cross section of the prototype superstructure.

middle third of the prototype span in which the tendon is horizontal (see Fig. 1a). For the laboratory tests, they were designed at two-thirds scale of the prototype structure.

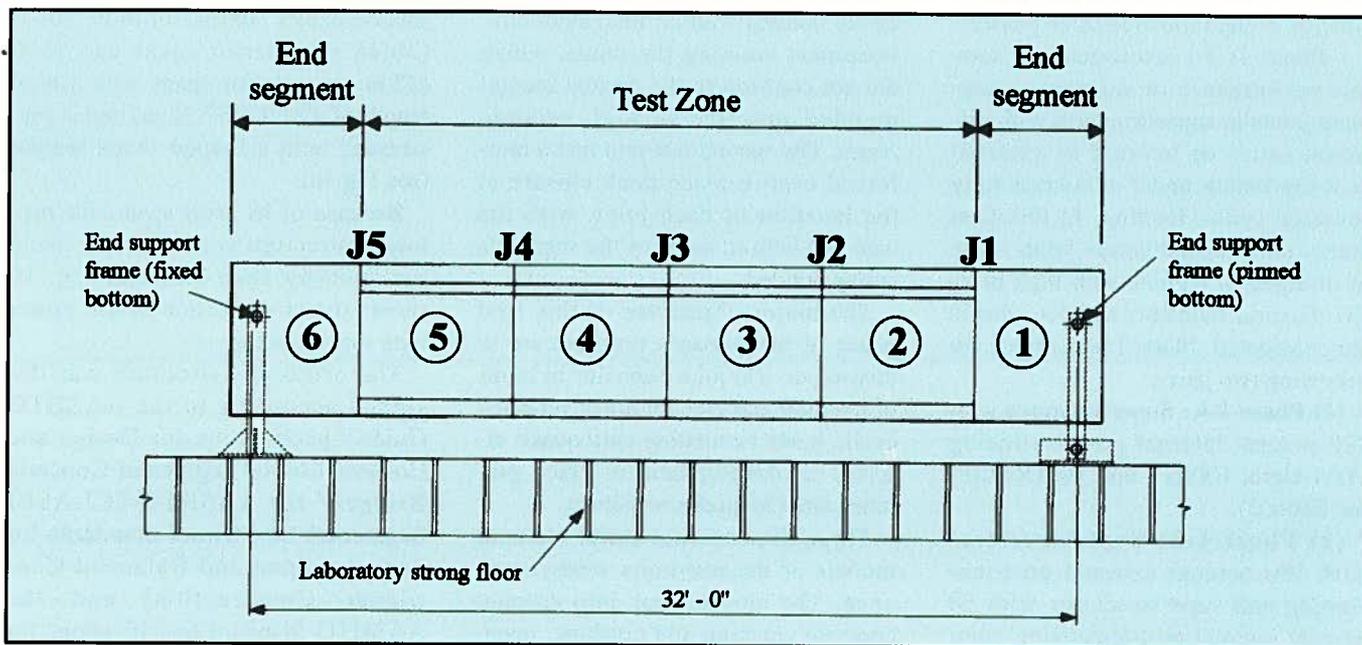
Fig. 2. Joint and segment numbering of test units.

ply supported at its ends. The test zone had a total length of 24 ft (7.32 m), which represented the center one-third portion of the prototype span. This test zone consisted of four 6 ft (1.83 m) long by 4 ft (1.22 m) deep precast segments (Segments 2 to 5 in Fig. 2). Each test unit was supported at its ends through precast end segments (Segments 1 and 6 in Fig. 2).

**Test Unit 100INT** — The first crack occurred during downward loading at the midspan joint (Joint J3, Fig. 2) during the first displacement cycle to 0.25 in. (6.35 mm) amplitude (see Fig. 9). The opening of Joint J4 (see Fig. 2) also occurred during the same displacement cycle.

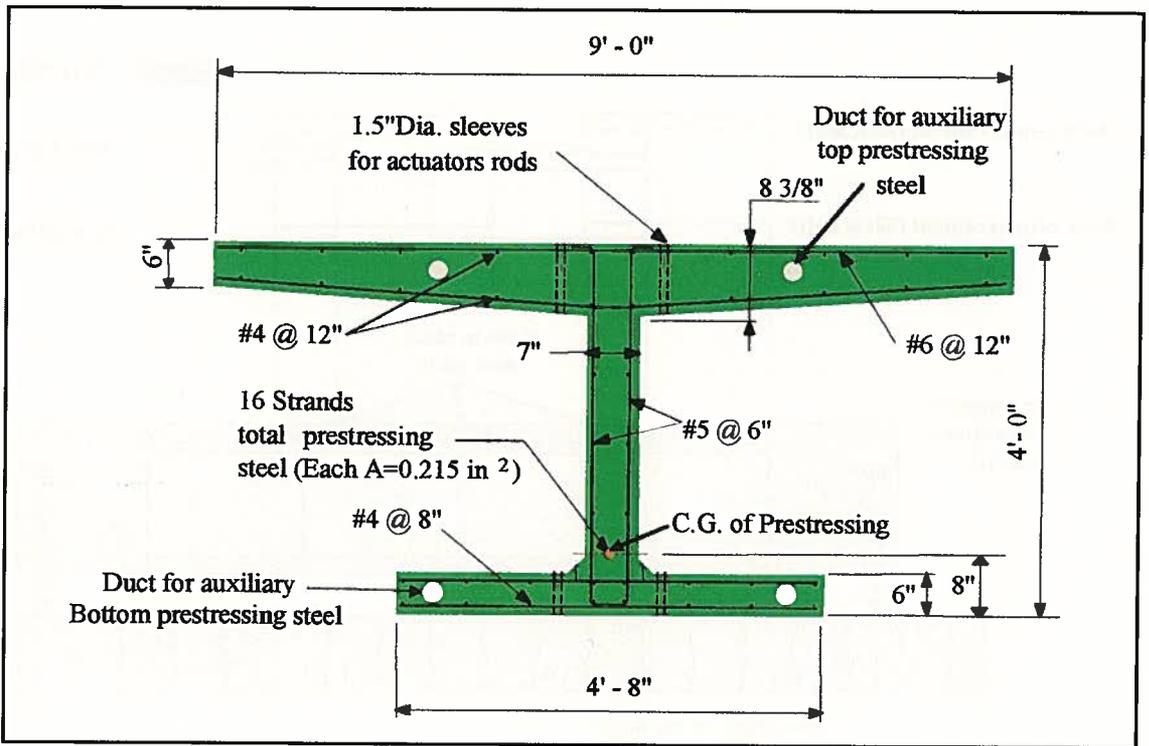
Fig. 3. Cross section of test units.

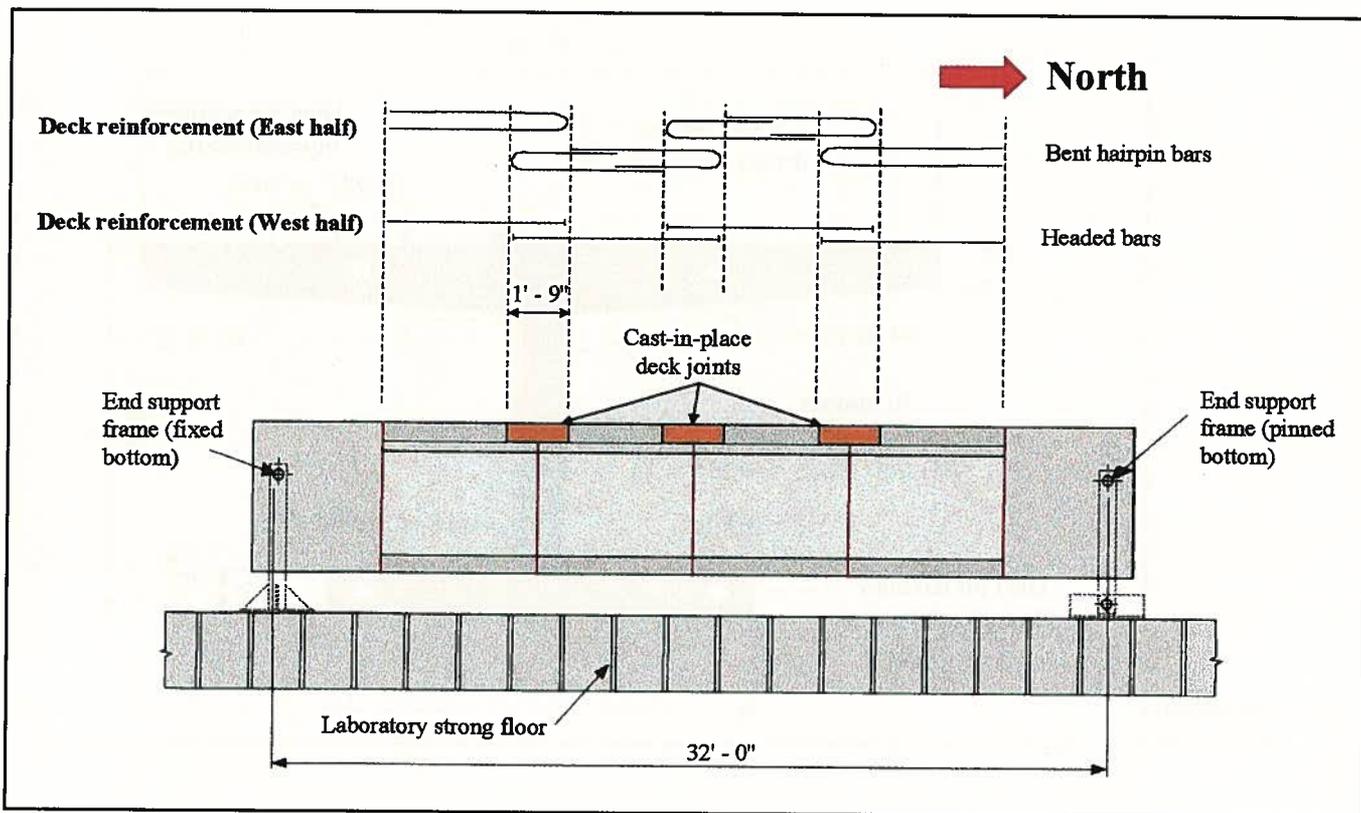
Fig. 4. Reinforced cast-in-place deck joints of Test Unit 100INTCIP.

As mentioned earlier, two different details were used for the reinforcement of the cast-in-place deck joints (see Fig. 4) of Test Unit 100INTCIP. Bent hairpin bars were used on one-half of the cross section whereas bars with mechanical anchors (welded heads) at their ends were used in the second half. Widths of cracks in the

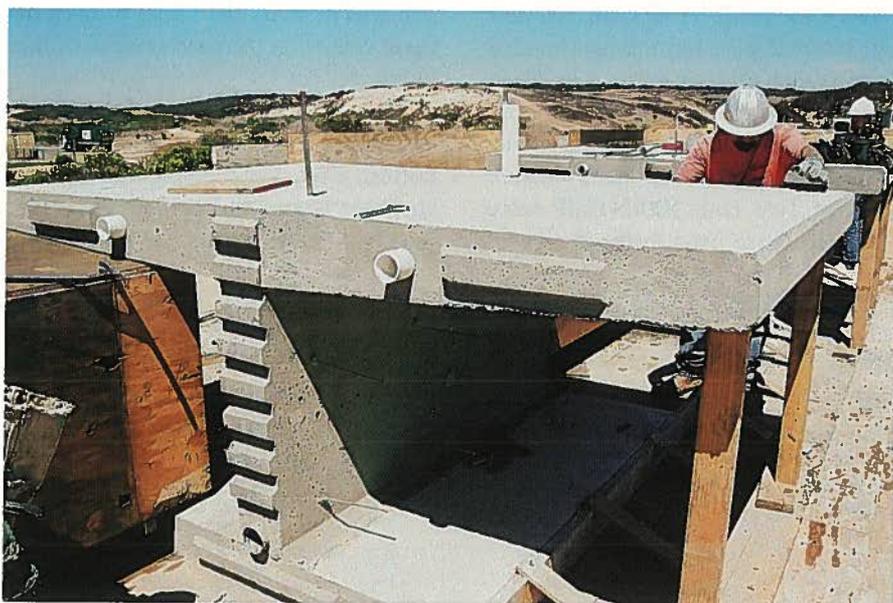
Fig. 5. A precast segment from Test Unit 100INT.

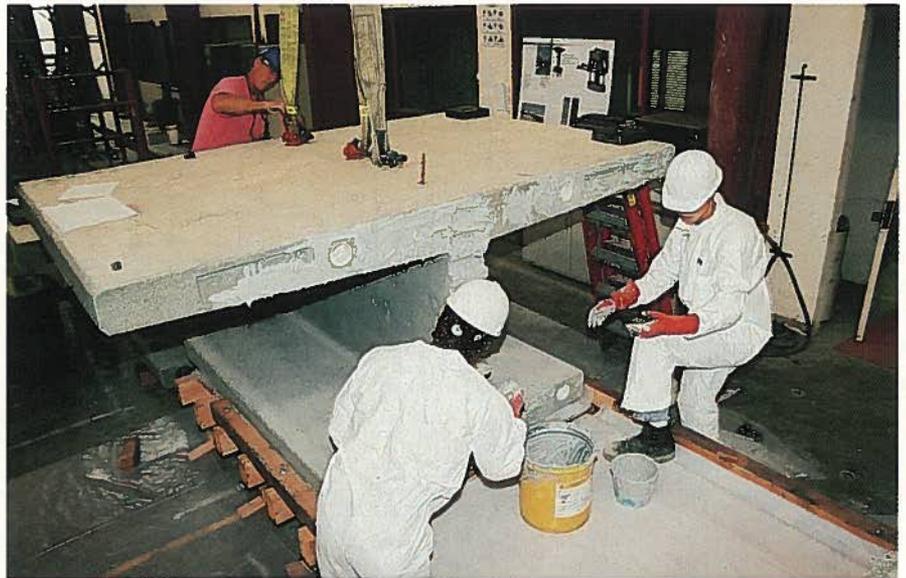
Fig. 6. Application of epoxy to the joint surface.

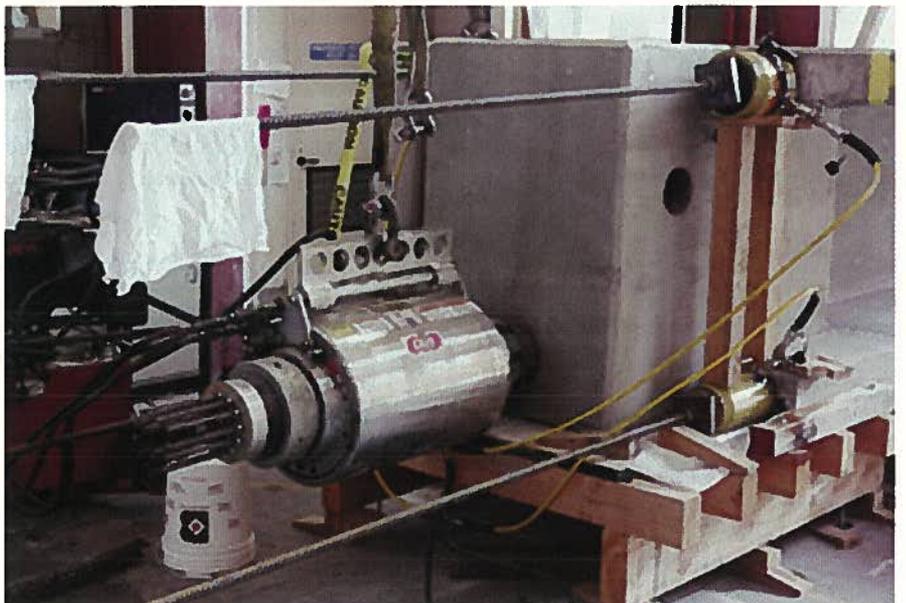
Fig. 7. Post-tensioning of test units.

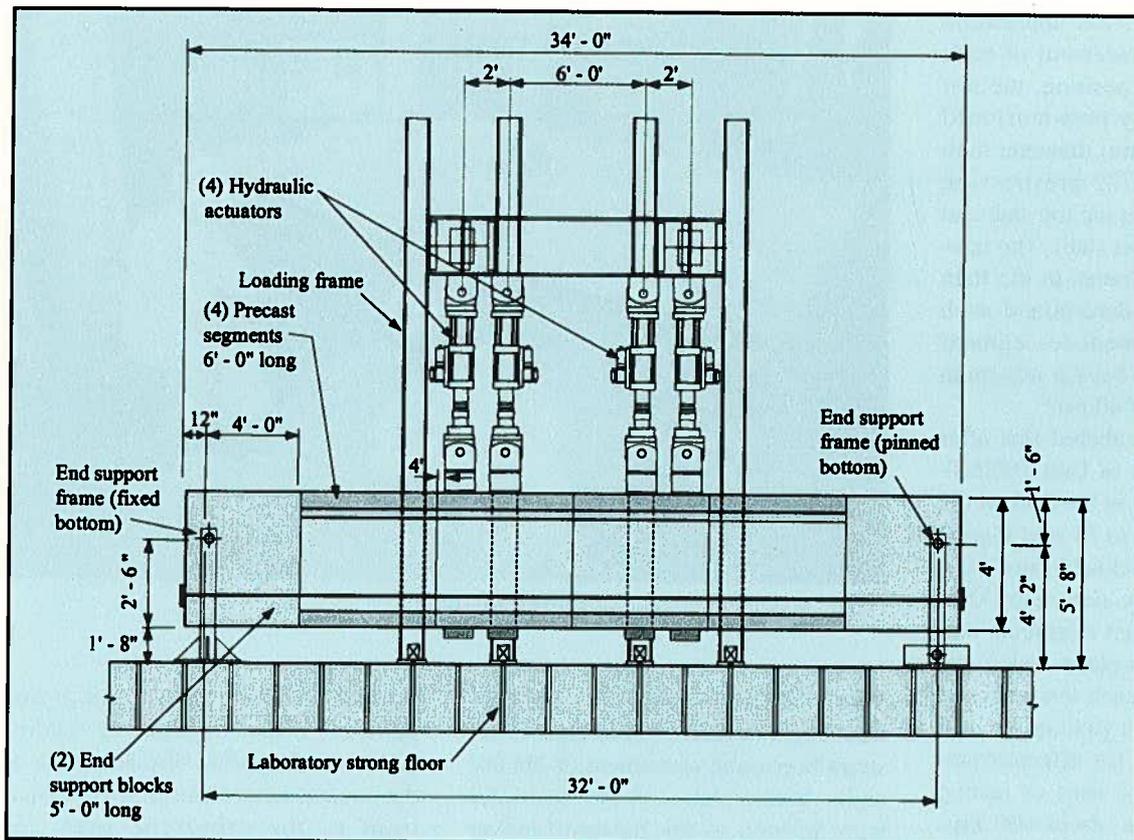
Fig. 8. Test setup.

Fig. 8 shows the test unit and the load frame. Each test unit was simply supported by a steel pin and steel links

at its ends. At one end, the steel links were fixed at their bottom ends to restrain horizontal movement of the test units. At the other end, the steel links were pinned at the bottom (rocker links) to allow rotation of the frame legs and horizontal movement of the test units. The loads were transferred from the test units to the steel links by means of steel pins inside horizontal steel pipes cast into the end segments at the neutral axis of the test units, allowing the ends of the test units to rotate freely.

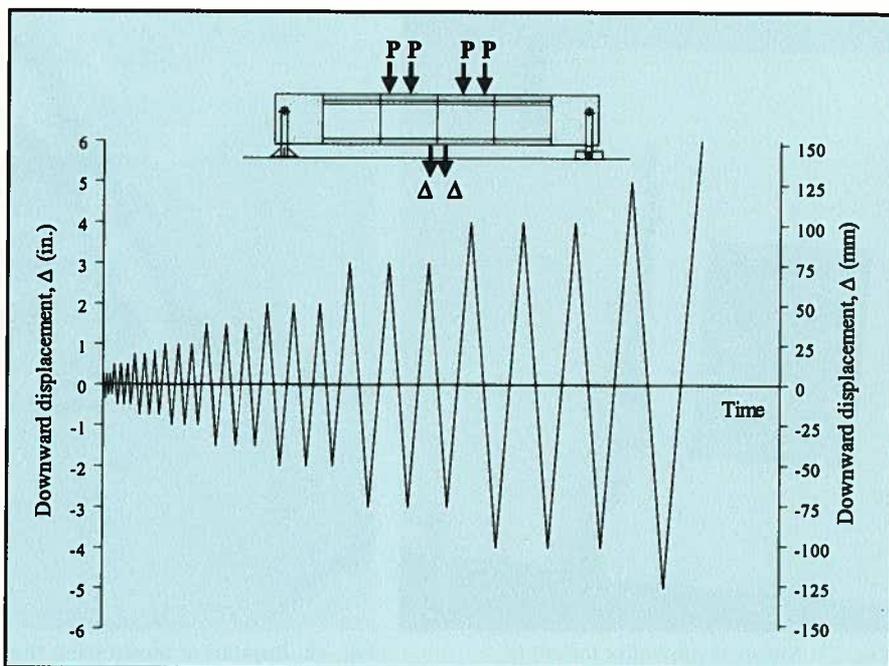
Fig. 9. Loading protocol of Test Stage II.

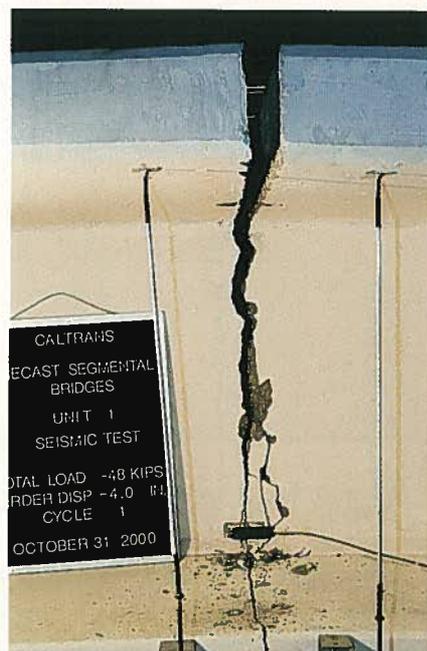
Fig. 10. Midspan joint at maximum upward displacement before failure of Test Unit 100INT.

The midspan Joint J3 was the only joint that opened during upward loading of Unit 100INT. Joint J3 opened during the 0.5 in. (12.7 mm) displacement cycle. Because Unit 100INT did not have any mild steel reinforcement crossing the joints, the opening of midspan Joint J3 increased significantly under upward loading during subsequent displacement cycles. Fig. 10 shows the midspan joint during the last displacement cycle in the upward loading direction before failure of Test Unit 100INT.

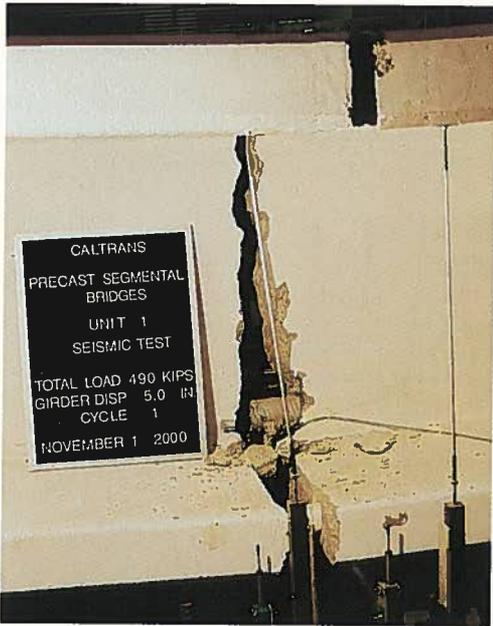
Fig. 11. Midspan joint after failure of Test Unit 100INT.

Under downward loading, the midspan Joint J3 opened significantly with increased applied displacement until rupture of the prestressing strands at the midspan joint at a displacement of about 4.8 in. (122 mm) and a total load of 490 kips (2180 kN). Fig. 11 shows the midspan joint after failure of Test Unit 100INT. Fig. 12 shows a closeup view of the ruptured strands.

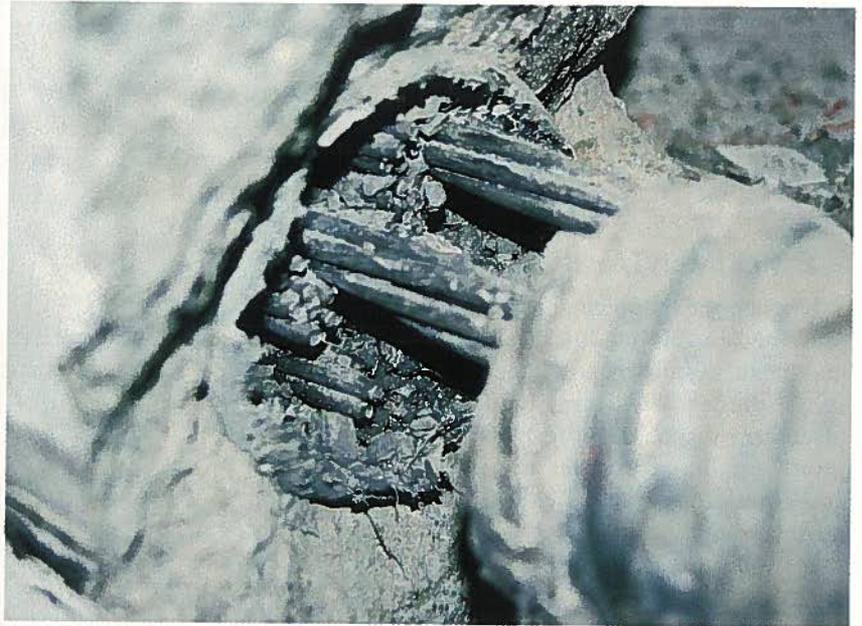
Fig. 12. Rupture of prestressing strands of Test Unit 100INT.

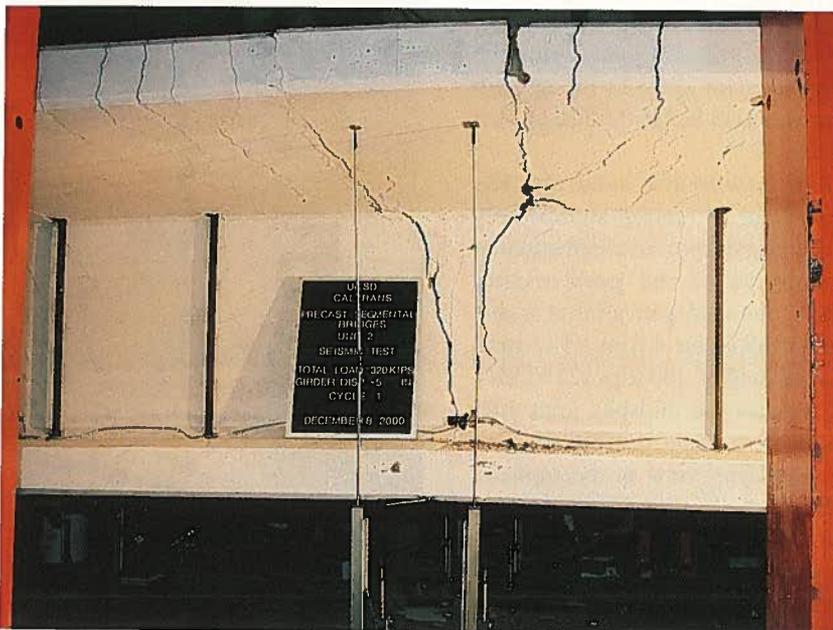
Fig. 13. Midspan joint at maximum upward displacement before failure of Test Unit 100INTCIP.

Fig. 13 shows the midspan joint at the last displacement cycle in the upward loading direction before failure of Test Unit 100INTCIP. The figure shows the major crack which occurred at the interface between the precast concrete and the deck closure joint; this crack propagated in the web at an angle towards the bottom soffit of the

test unit to join the crack which occurred at midspan under downward loading. The midspan joint opening increased significantly under increasing downward displacements.

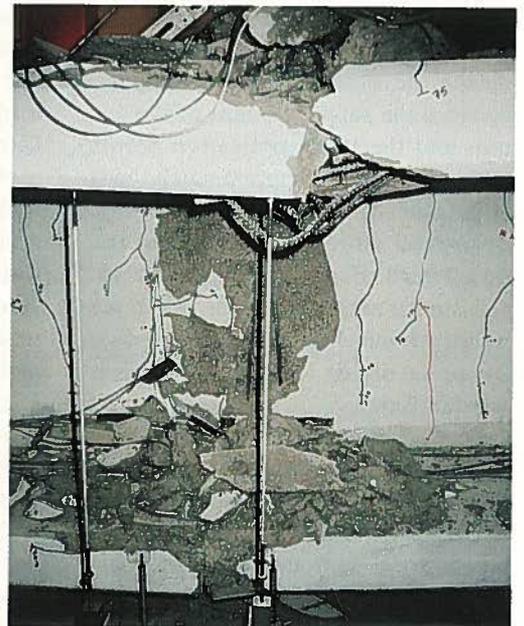
Fig. 14. Compression failure at midspan joint of Test Unit 100INTCIP.

Reversed cyclic loading of the deck reinforcement, across the midspan joint, resulted in longitudinal cracks in the cast-in-place concrete, which was followed by buckling of the cast-in-place deck reinforcing bars at a downward displacement of about 3 in. (76.2 mm).

With the concrete severely weakened by reversed cyclic loading, the bars experienced significant buckling and pushed the cover concrete away, which resulted in reduction of the compression area and capacity of the deck. Buckling of the deck reinforcing bars continued until compression failure of the deck at a downward displacement of about 5.85 in. (149 mm); the peak total load of Unit 100INTCIP was 480 kips (2135 kN). Fig. 14 shows the midspan joint and buckling of the deck reinforcing bars after failure of Test Unit 100INTCIP. It is believed that Unit 100INTCIP could have sustained further loading if buckling of the reinforcing bars was prevented; this could have been achieved by providing closed stirrups around the deck top and bottom reinforcement.

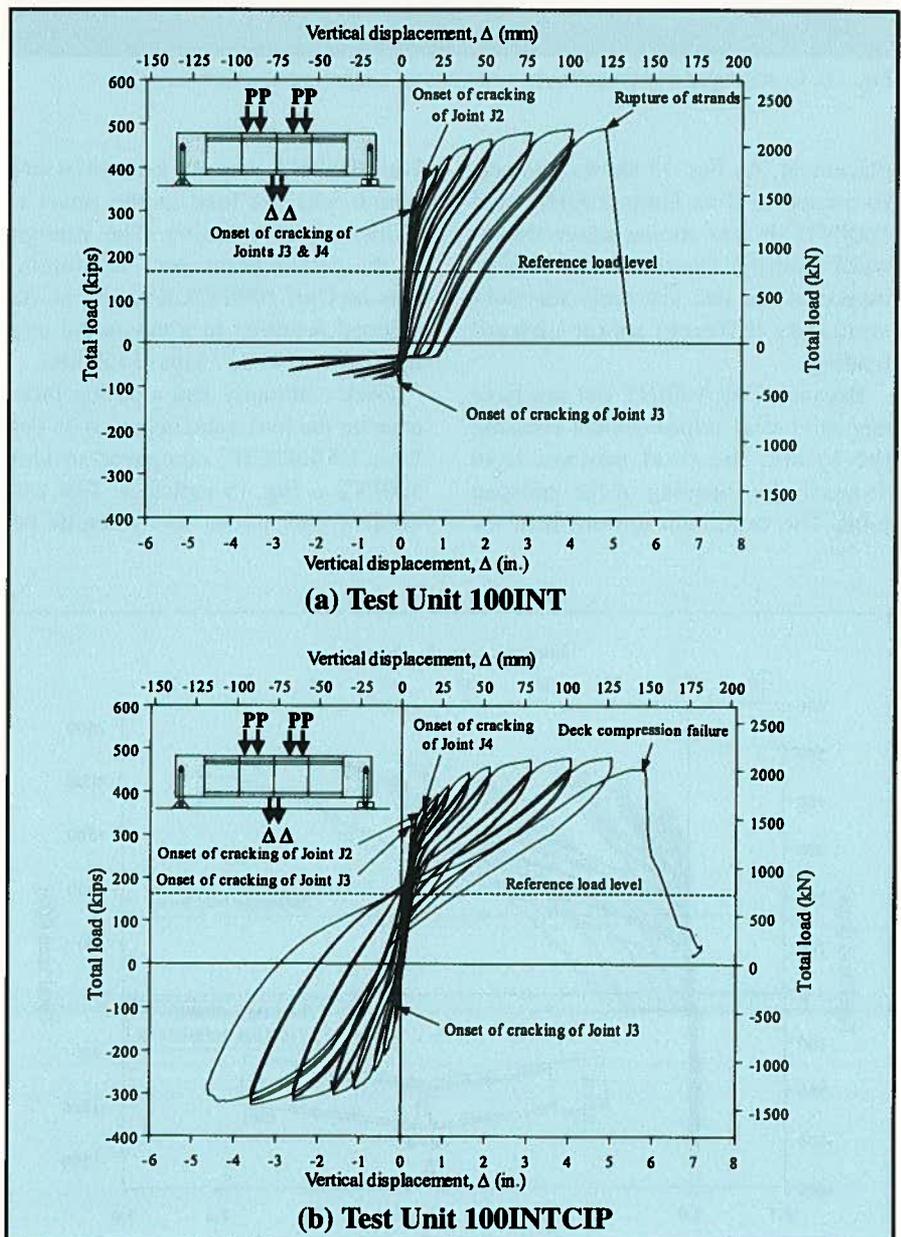
Fig. 15. History of the total load versus vertical displacement measured at 6 in. (152 mm) from midspan of the test units: (a) Test Unit 100INT; and (b) Test Unit 100INTCIP.

Figs. 15a and 15b show the history of total applied load versus vertical displacement measured at 6 in. (152 mm) from midspan of Test Units 100INT and 100INTCIP, respectively. The sign convention in Fig. 15 is positive for downward loading and dis-

placement. As Fig. 15 shows, the performance of Test Units 100INT and 100INTCIP was similar under downward loading. However, the performance of the two test units was substantially different under upward loading.

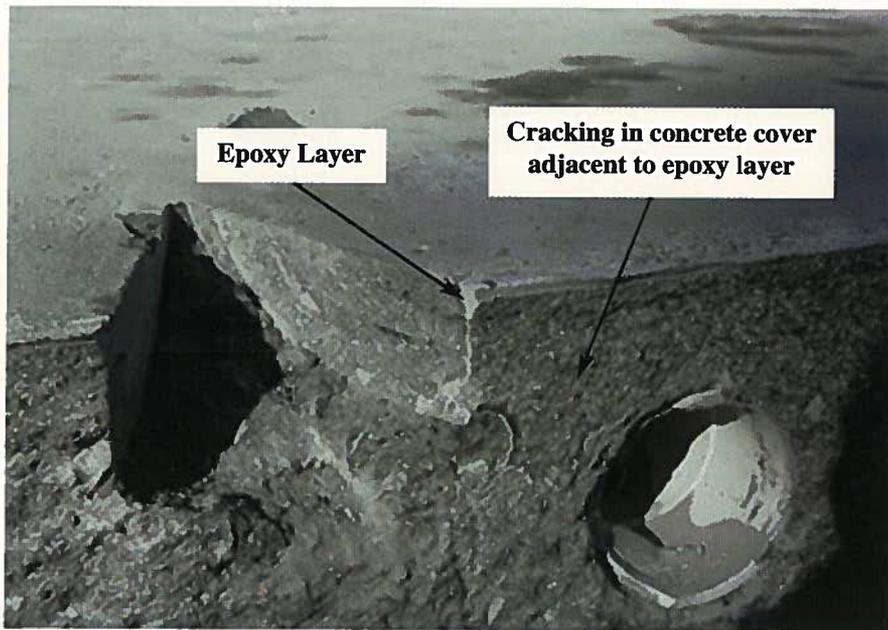
Fig. 16. Cracking of concrete cover adjacent to a segment-to-segment joint.

After termination of Test Stage II of Unit 100INT, one segment was cut as shown in Fig. 16 to investigate the opening of the epoxy joint versus cracking of the adjacent concrete cover. Fig. 16 shows the epoxy layer and the failure surface in the adjacent concrete cover. The dominant flexural crack adjacent to the joint occurred through the alignment and shear keys.

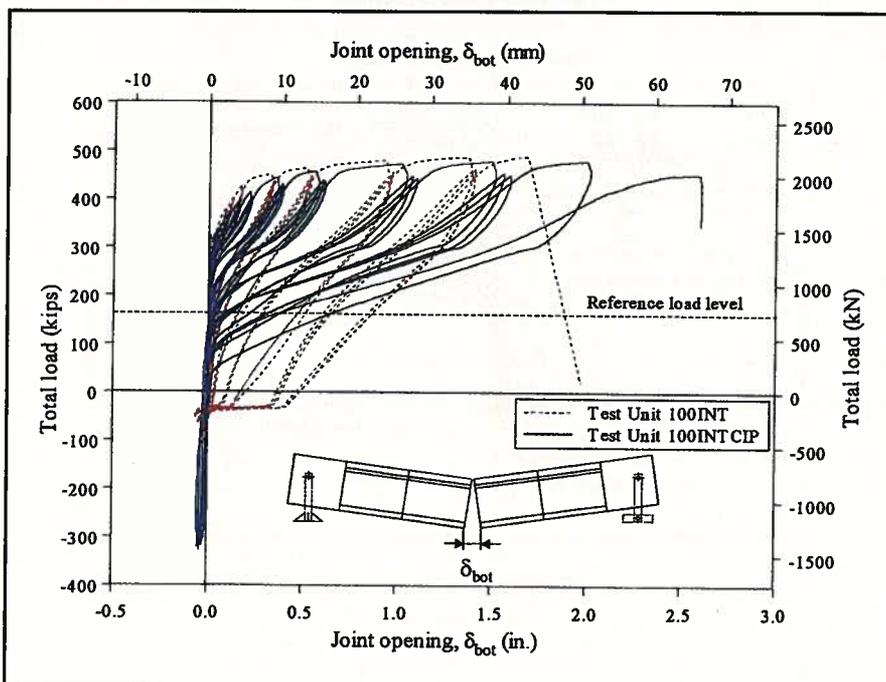
Fig. 17. Opening of midspan joint measured at bottom surface of the test units.

As mentioned earlier, Joints J2, J3 and J4 opened during downward loading of Test Units 100INT and 100INTCIP. Under upward loading of Unit 100INT, only J3 opened, whereas Test Unit 100INTCIP had several closely spaced cracks. Cracking of the concrete cover adjacent to the joint

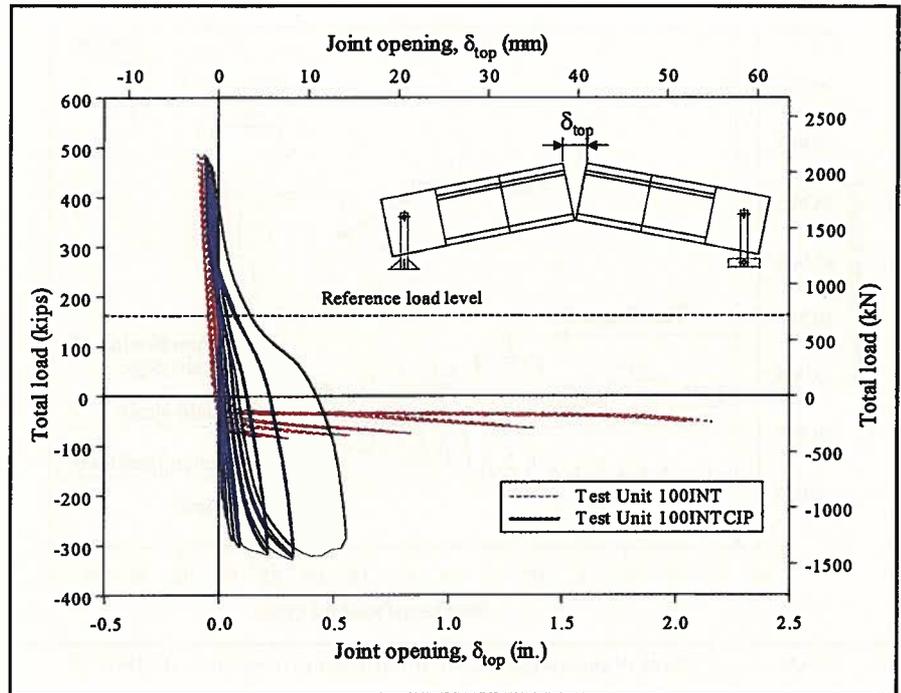
Fig. 18. Opening of midspan joint measured at top surface of the test units.

The effect of deck continuity on joint opening is more pronounced in Fig. 18, which shows the history of joint opening measured at the top surface of Units 100INT and 100INTCIP. Because Unit 100INT did not have any continuous mild steel reinforcement in the deck, the joint opening was significant. Despite its wide opening, the midspan joint of Unit 100INT was closed completely upon unloading during each displacement cycle. Fig. 18 shows the effect of continuous deck reinforcement in controlling the widths of cracks.

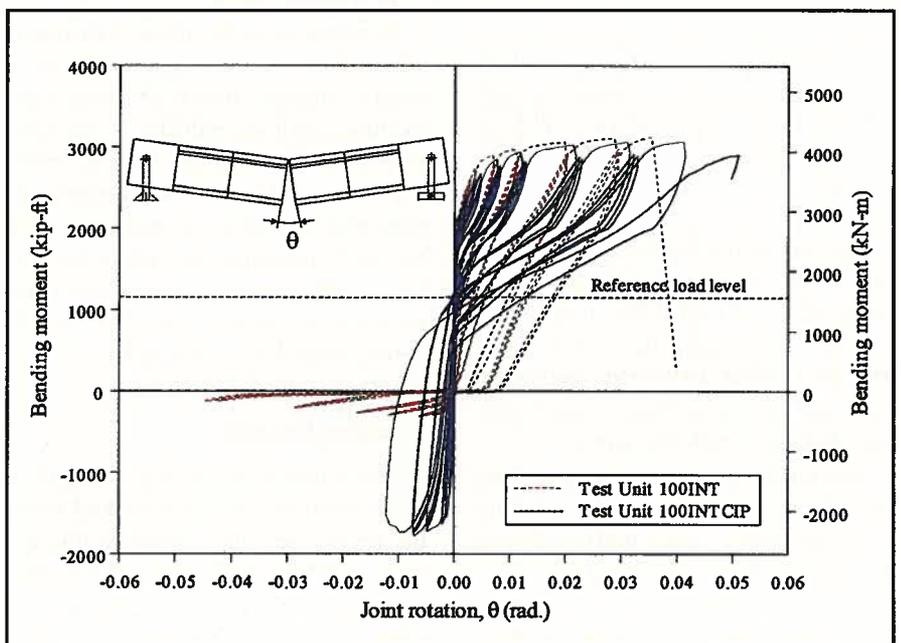
Fig. 19. History of midspan joint rotation versus bending moment.

Fig. 19 shows the history of bending moment versus midspan joint rotations measured for Test Units 100INT and 100INTCIP. The joint rotation was obtained from the joint openings measured at the top and bottom surfaces of the test units. The maximum rotations of the midspan joint before failure of Test Units 100INT and 100INTCIP were 0.035 and 0.051 radians, respectively.

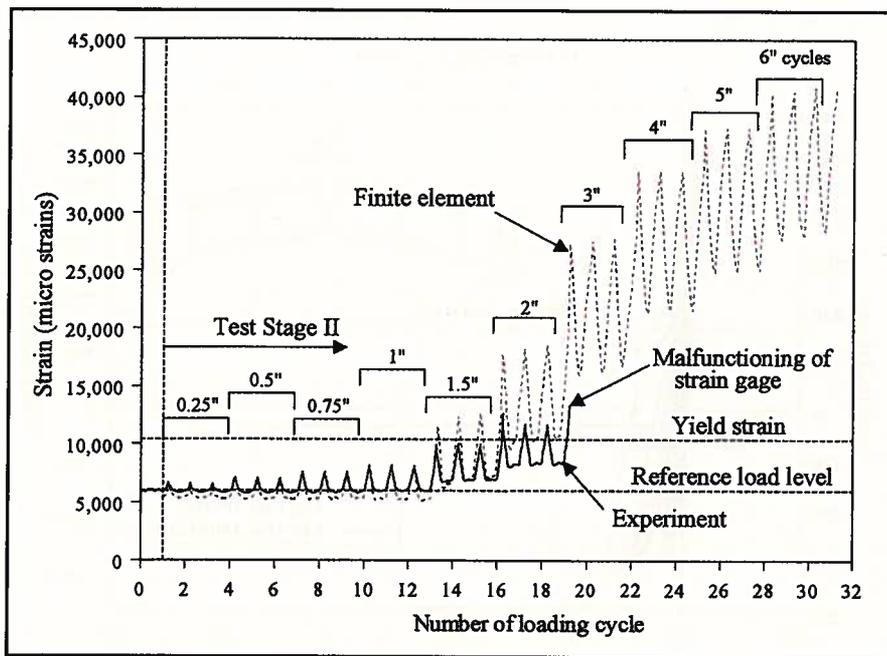
Fig. 20. History of strain in prestressed steel at midspan of Test Unit 100INTCIP.

the prestressing steel at midspan of Unit 100INTCIP. The strain is plotted versus the number of loading cycles. In Fig. 20, Cycle 1 represents the time during which the strains were recorded before starting Test Stage II. Fig. 20 also shows the strain in the tendon at midspan of Unit 100INTCIP as obtained from the finite element analysis.

by a horizontal dashed line in Fig. 20, corresponds to the 0.2 percent offset yield strain definition. The strain in the tendon,  $\epsilon_{ps}$ , measured just before starting Test Stage II was about 5900 micro strains. The corresponding stress,  $f_{ps}$  (ksi), is calculated from the following equation<sup>7</sup> (assuming elastic modulus,  $E_{ps} = 29000$  ksi = 200 GPa):

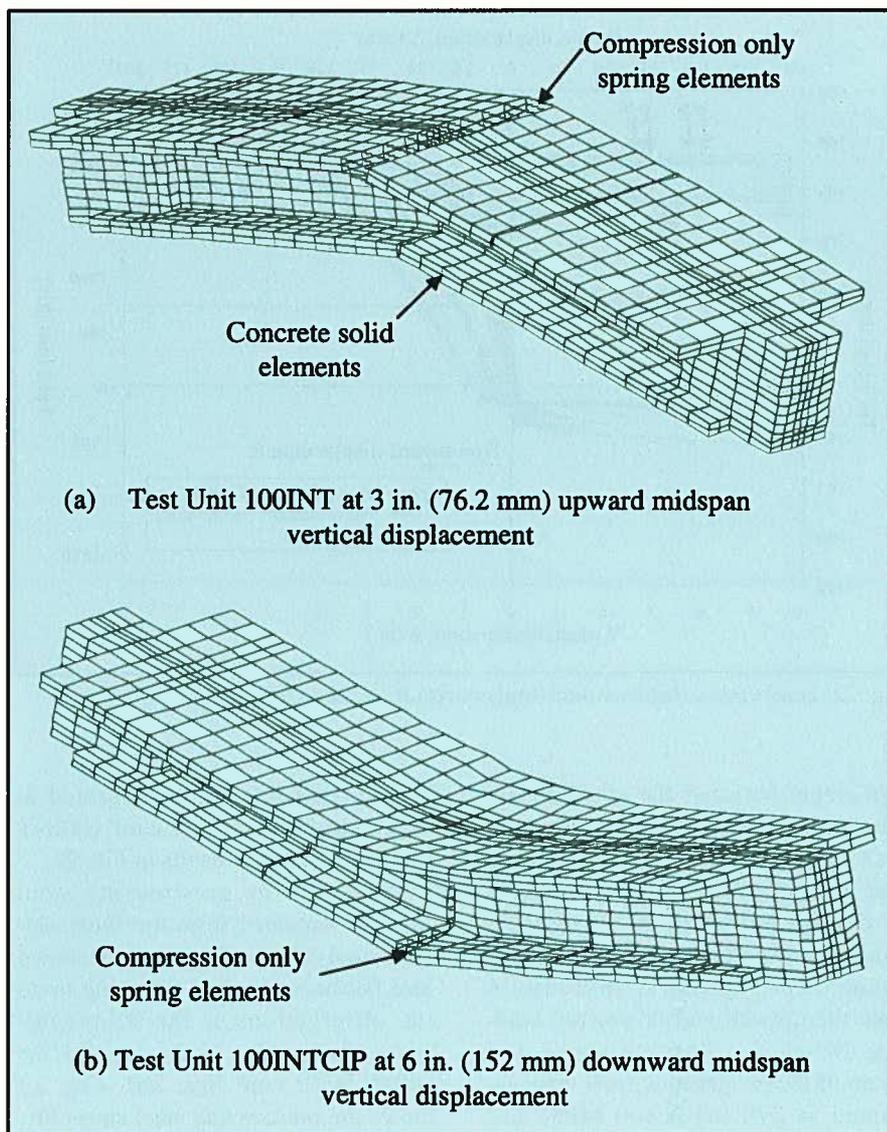
Fig. 21. Finite element models and deformed shapes of the test units: (a) Test Unit 100INT at 3 in. (76.2 mm) upward midspan vertical displacement; and (b) Test Unit 100INTCIP at 6 in. (152 mm) downward midspan vertical displacement.

The concrete was modeled as 3-D, eight-node, solid brick elements with strain-hardening and strain-softening capabilities in compression, and tension cutoff with cracks that do not close upon closure.<sup>9</sup> Confinement effects were assumed to be negligible and the unconfined concrete strength was taken as 7.5 ksi (51.7 MPa). The model was developed in a similar way to the test units, with no solid elements crossing the joints between the precast segments and no connection between solid elements on either side of the joints.

only springs at all nodes in the cross section at locations of joints. Prestressing steel was modeled by truss elements and connected to the concrete nodes at each 12-in. (305 mm) cross section, representing bonded strands. All mild steel reinforcement was modeled as 1-D sub-elements in the solid concrete elements.

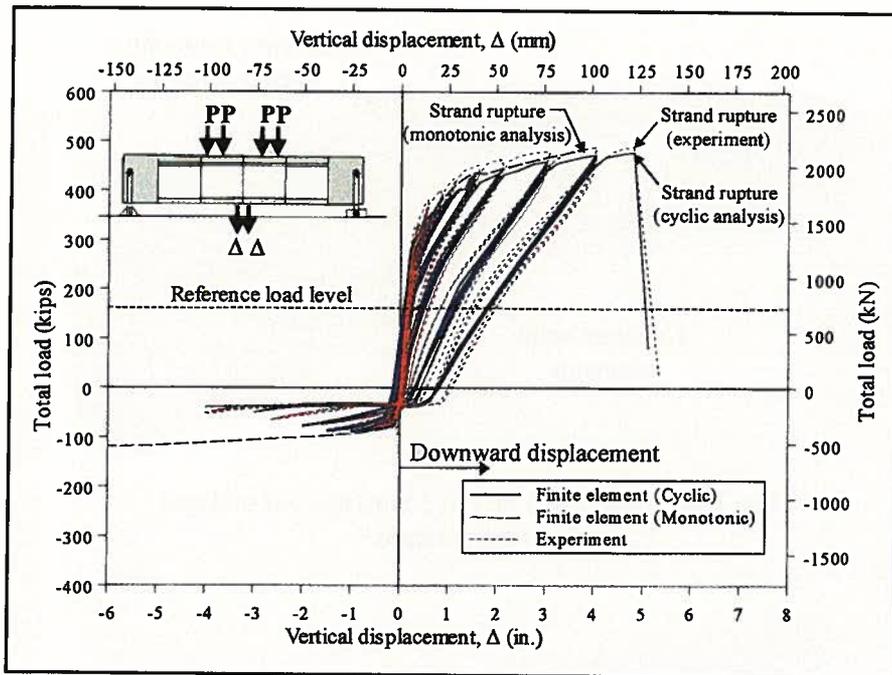
Fig. 22. Load versus displacement analysis results of Test Unit 100INT.

**Test Unit 100INT** — Analysis results of Unit 100INT are given in Figs. 22 and 23. There was very close

agreement between the analysis and measured load-displacement responses (see Fig. 22). Analysis results showed that the model behaved very similarly to the test unit in terms of ultimate load, displacement at failure, and shape of the hysteretic response in both the upward and downward loading directions. Rupture stress and strain of the prestressing steel were assumed as 270 ksi (1860 MPa) and

0.04, respectively, which appeared to be reasonable based on Unit 100INT load-displacement results in Fig. 22.

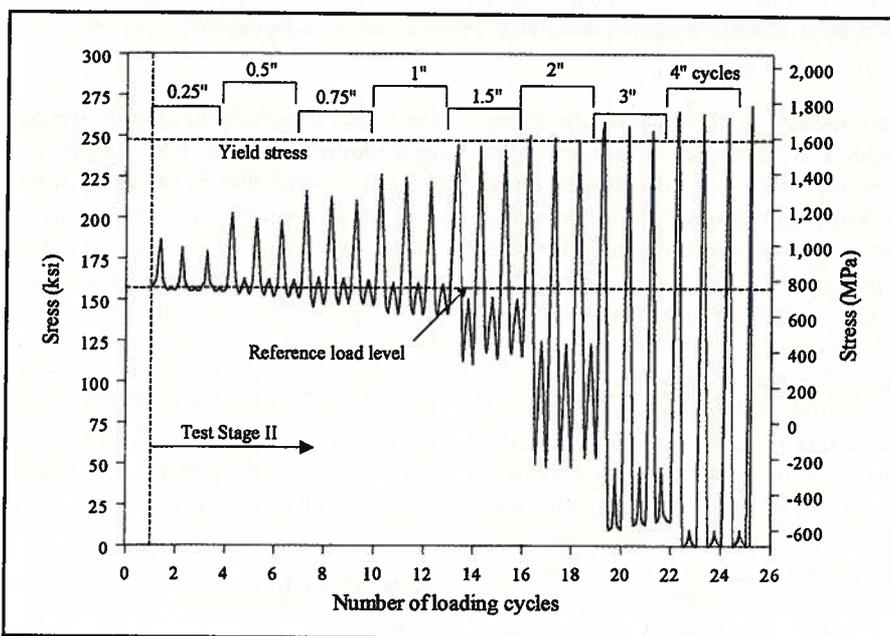
Fig. 23. Stress history analysis results of prestressing steel at midspan of Test Unit 100INT.

tory (stress versus loading cycle number) at midspan (Joint J3, see Fig. 2) from the analysis of Test Unit 100INT. Plastic deformations of the tendon occurred beyond the 1 in. (25.4 mm) displacement cycle. Of interest with the permanent plastic deformations is that with increasing, unrecoverable, strains, the initial prestress force was lost (see Fig. 23).

It is clear from Fig. 23 that beyond 1 in. (25.4 mm) displacement, the initial prestress force started to reduce significantly, and was completely lost (at zero displacement, or at the reference load level) following 4 in. (102 mm) of downward displacement. This may have important consequences in the design of precast concrete structures, where under a severe earthquake the prestressing force is diminished or lost altogether before rupture of the strand.

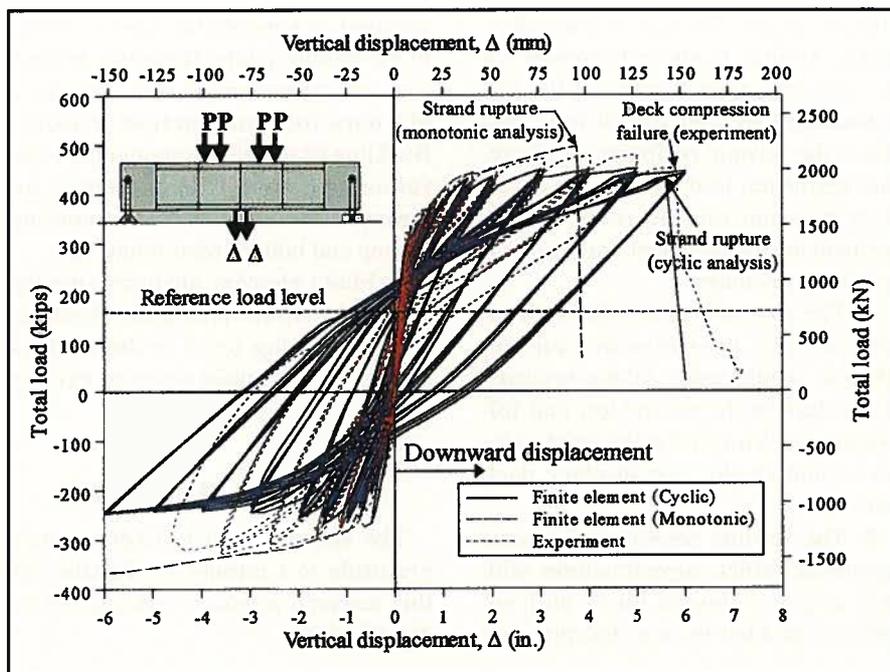
Fig. 24. Load versus displacement analysis results of Test Unit 100INTCIP.

**Test Unit 100INTCIP** — Samples of analysis results of Test Unit 100INTCIP are given in Figs. 20 and 24. Although the shape of the monotonic load-displacement results for the upward and downward loading directions matched the test results very well, the cyclic analysis results did not follow as closely. Failure from both monotonic and cyclic analyses was from rupture of the prestressing steel, whereas the observed collapse during the experiment was from compression failure of the deck at the midspan cast-in-place joint.
