Strengthening of a Long Span Prestressed Segmental Box Girder Bridge

The Grand-Mère Bridge in the province of Québec, Canada, is a 285 m (935 ft) long, cast-in-place, segmental box girder bridge that experienced several problems which resulted in distress characterized by an increasing deflection combined with localized cracking. These defects were due mainly to insufficient prestressing causing high tensile stresses in the deck and possible corrosion of the prestressing steel. To remedy this situation, the Québec Ministry of Transportation strengthened the bridge by adding external prestressing equivalent to 30 percent of the remaining internal prestressing. The paper describes the causes of the distress and focuses on the assumptions adopted in the analyses to determine the current state of the bridge. The technique and design criteria used in strengthening the Grand-Mère Bridge are described. Also, the construction aspects and the various problems met during the external prestressing operation are discussed. The new technology and experience gained in strengthening this structure can be applied to both pretensioned and post-tensioned concrete bridges.

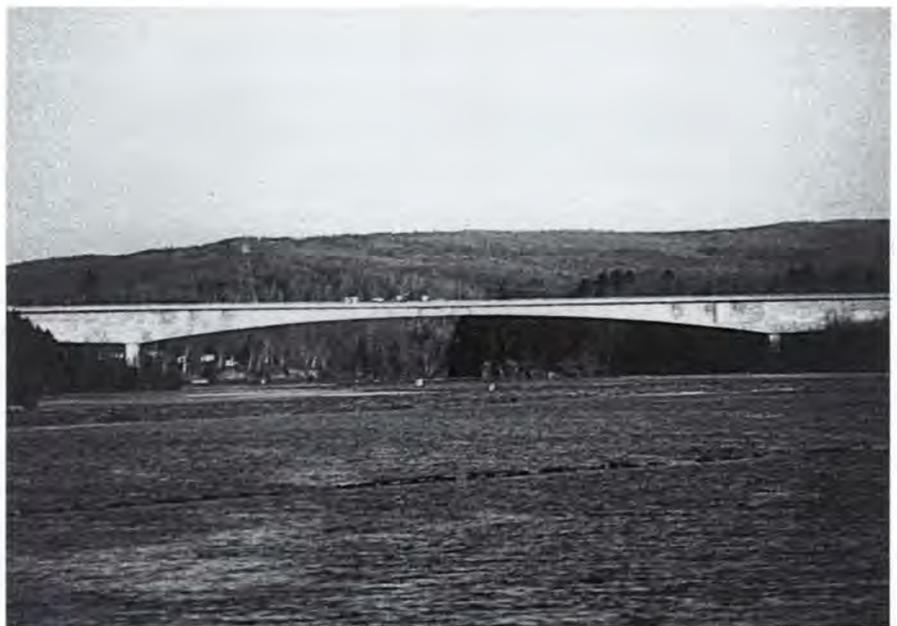
Fig. 1. The Grand-Mère Bridge.

The Grand-Mère Bridge, a 285 m (935 ft) long, cast-in-place, post-tensioned segmental structure built in 1977 (Fig. 1), consists of a single-cell box girder. It is located 200 km (125 miles) northeast of Montréal on Highway 55, where it crosses the St. Maurice River near the town of Grand-Mère.
