RICHMOND SAN RAFAEL BRIDGE PROJECT— SPliced GIRDER CASE STUDY

Tim Holien, PE, Pomeroy Corporation, Petaluma, CA
Craig Chatelain, PE, DMJM Harris, Sacramento, CA

The Richmond San Rafael Bridge Western Approach Trestle Replacement, consists of two independent structures, with a combined overall length of 6500 feet of new precast/prestressed concrete spliced girder. The innovative spliced girder structure was developed to allow removal of two 50-foot spans and erection of one 100-foot span during each night-time traffic closure. After four new spans are erected, concrete closure pours are placed and continuity post-tensioning is completed to yield a four-span continuous frame. During construction, closure pour cracking required modifications to the construction procedures and typical closure pour details. The unique structure type and the closure pour details created a challenge and a learning experience for the Contractor, Caltrans, and the Design Team.

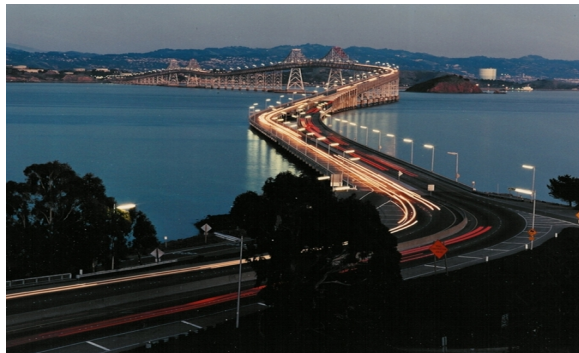
Figure 1 Richmond San Rafael Bridge

The Richmond San Rafael Bridge, designed in the early 1950s, carries four lanes of Interstate 580 over the southern end of San Pablo Bay between the cities of San Rafael in Marin County and Richmond in Contra Costa County. One of five toll bridges scheduled for seismic retrofit in the Bay area, the bridge consists of the following structure types:

- Two single-deck, reinforced concrete approach trestles with 50-foot spans and a combined length of approximately 6,500 feet
- Built-up steel-girder spans at both ends of the bridge
 - Spans convert from single-deck to double-deck structures
 - Combined length is 3,600 feet
 - Typical spans are 100 feet long
- Two variable-depth, double-deck cantilever-truss-type structures spanning the navigational channels, with 537.5-foot anchor spans and 1,070-foot center spans
- Constant-depth, double-deck trusses that span the distances between the two cantilever structures and between the cantilever structures and the approaches
 - Typical spans are approximately 292 feet long
 - Combined length is approximately 10,600 feet

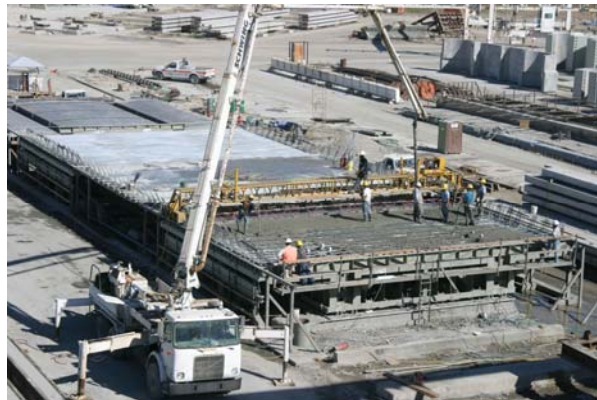
Figure 3 Precasting Double Tee Girder

In order to facilitate the offsite precasting and handling of the girders, the girders were broken up into a center 40'-0" long pretensioned middle unit and two 30'-0" end segments that were match-cast simultaneously against the previously cast middle unit. Additionally, the deck portion of the girder was transversely post-tensioned before being removed from the casting forms. The middle unit was cast in a single purpose, self-stressing form that accommodated the twenty 0.6" pretensioned strands. Once the middle segment reached sufficient strength, it was removed from the form and placed into the match-casting position. The end segment reinforcing and post-tensioning ducts were placed in the second casting area and the forms hydraulically closed for casting both ends. Upon completion, the three segments were water cured in storage for seven days. The precasting operation produced a complete 100' girder on a weekly cycle.

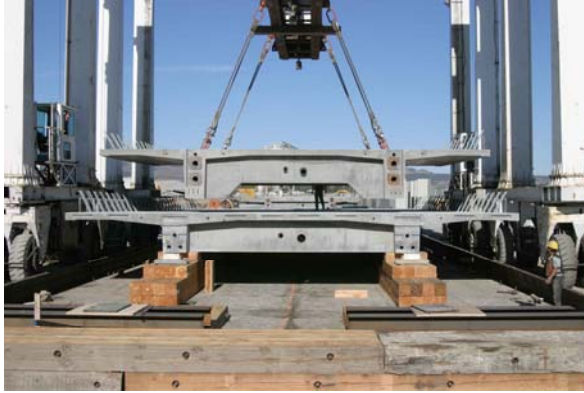
Figure 4 Loading Girder Segments on Barge

After curing, the three segments were loaded onto a barge for post-tensioning together to complete the 100' simple span girder. The match cast faces of the girder segments were coated with segmental bridge adhesive just prior to beginning the simple span post-

tensioning operation. The delivery barge was outfitted with four temporary, fixed dunnage points for the middle segment while the end segments were temporarily supported by large rollers near the match cast joints and greased bearing surfaces at each end. The four simple span tendons were sequentially stressed to pull the three segments together.

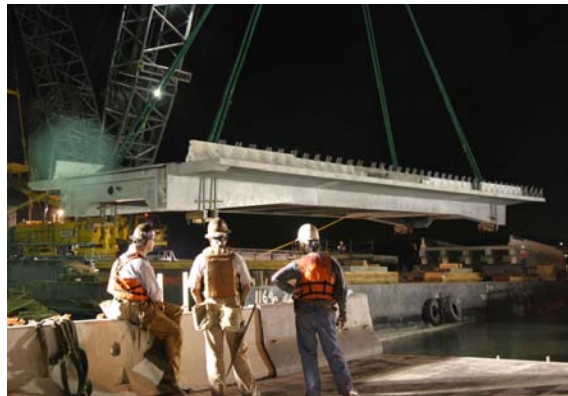
Figure 6 Lifting New 100-Foot Span

Originally, the Contractor had anticipated being able to remove two existing fifty-foot spans and install one new 100' girder during each night's bridge closure. It should be noted that the new girders were immediately opened to two lanes of traffic loading the morning following installation. All of the trestle material handling was done using a nine hundred ton, barge

mounted crawler crane that the Contractor had specifically purchased for this project. At erection, the 100' girders weighed approximately 500 tons. As installation progressed, the Contractor was actually able to routinely replace two hundred feet of trestle during the ten-hour closure window. This outstanding success was due to the coordinated efforts of the entire construction team.

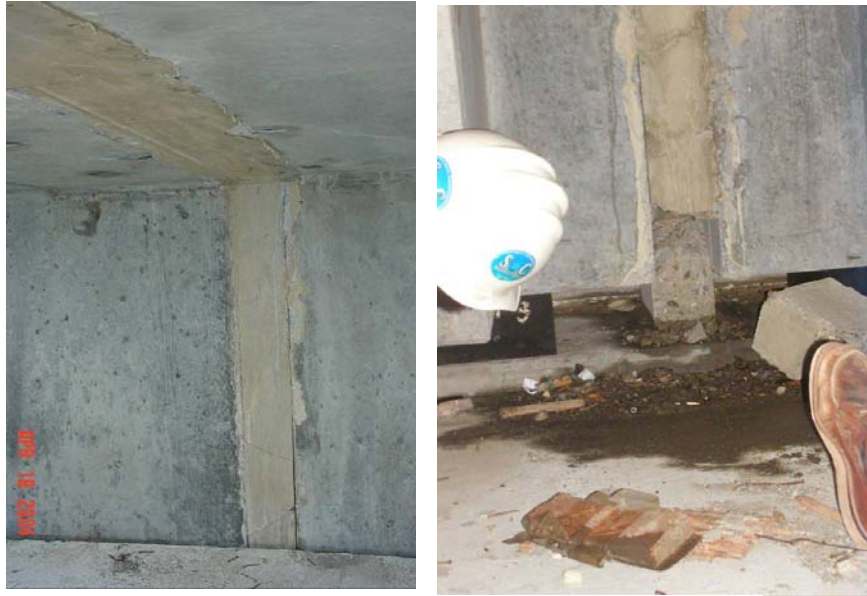
Figure 9 Closure Pour Cracking

Immediately after the first closure joints were constructed in April 2004, cracking was observed along the bottom of the vertical interface between the closure pours and the girder ends.

Initial review by the design team determined several construction modifications were not adequately accounted for, the initial design had little conservatism in the design of the joints, and the unique structure type and traffic constraints made the construction of the closure joints a challenge.

- Continuity stressing causes the bottom of the girders to rotate and move apart.
- The original joint design which required auxiliary bonded 6 - #6 U-stirrups and shear keys was reduced.

- Use of steel shims as temporary closure joint blocking was not allowing the closure concrete to see full compression.
- Time-dependent effects due to creep and shrinkage significantly impact concrete stresses.

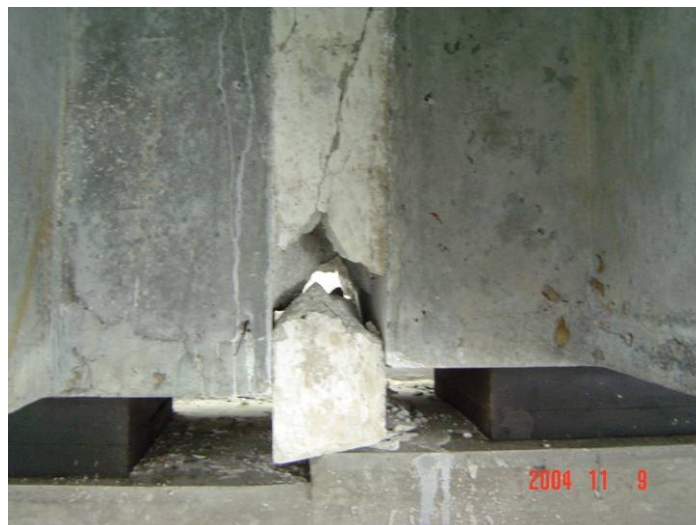
Figure 14 High Side Cracking

In November of 2004, approximately one month or more after construction of the new two stage closure joints had been completed, cracking of the closure joints was again observed. This time cracking appeared to be significantly lessened when compared to the single stage pour. In fact, some joints had only one of two web areas cracked.

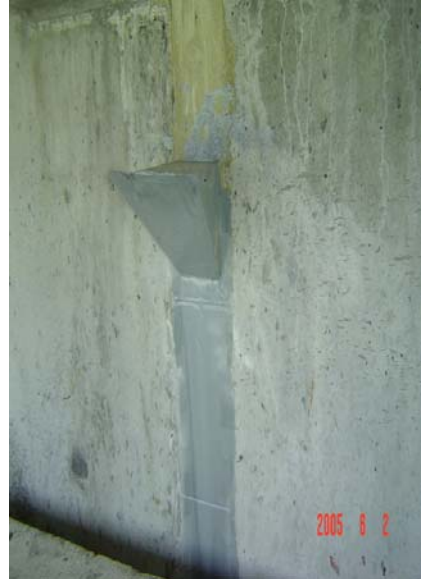
Figure 19 Second Stage Closure Pour with Elastomeric Concrete

Using elastomeric concrete in the area of the new or repaired Stage 2 closure pours provided a more durable concrete for structure traffic vibrations, alleviated the corrosion concern, and

minimized the required traffic closures and working days required to complete the additional closure joint work.

The long term solution using elastomeric concrete in the closure pours, closure joint bolsters, and additional stressing alleviated the closure pour cracking. While closure pours over pier caps in segmental construction are typically deemed to be of little complexity, the lessons learned from the unique structure type and traffic constraints associated with the Richmond San Rafael Bridge Retrofit are expected to impact segmental design and construction considerations on future Caltrans projects.
