NEW HAMPSHIRE'S FIRST USE OF FULL-DEPTH PRECAST CONCRETE DECK PANELS

David L. Scott, PE, NH Department of Transportation, Concord, NH

Jason A. Tremblay, PE, NH Department of Transportation, Concord, NH

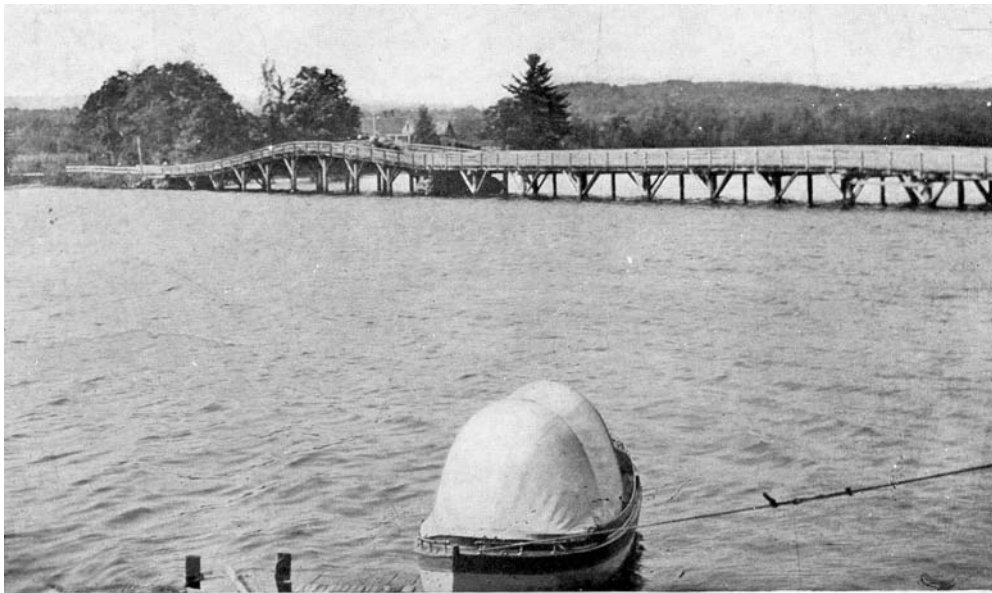
Fig. 1 Original Mosquito Bridge

The Mosquito Bridge, so named because of the unique shape of the original structure that carried US Route 3 over Winnisquam Lake, from 1850-1916 (see Fig. 1), carries 20,000 vehicles per day at the peak of summer vacation season. The deck of this 4 span bridge was in need of replacement, and New Hampshire Department Of Transportation (NHDOT), desiring to minimize traffic disruption, decided to use this site to examine the benefits and test the efficiency of full depth precast prestressed concrete deck panels.

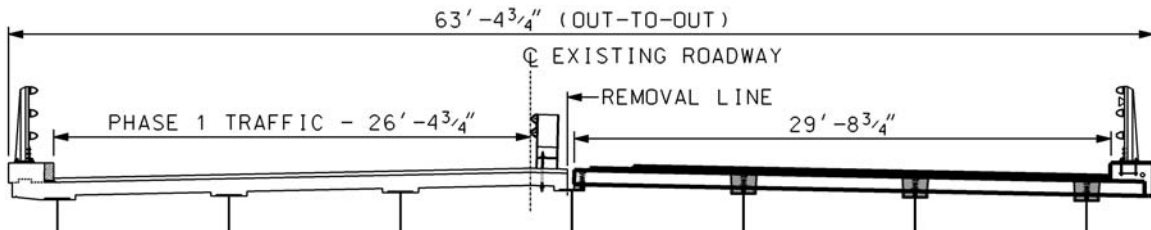
Due to the generous width of the bridge, the deck replacement project was built in phases. Alternating two-way traffic was placed on two 11 ft (3.4 m) lanes during each phase of construction. The construction joint between phases was placed directly over the middle girder (see Fig. 2). The curbs were cast-in-place, to provide a continuous seal over the ends of the panels. A closure pour was required at each end, to encase the ends of the panels. The completed bridge was topped with a torch applied waterproofing membrane, and a bituminous wearing surface.

Fig. 2 Cross-Section During Phase 1

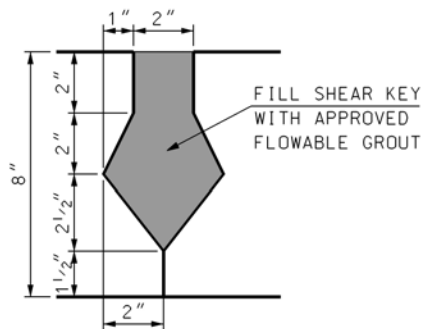
Grouted shear keys – The fabricator was given a choice as to the shape of the shear keys (see Fig. 3). The actual constructed shear key is shown in Figure 4. There is a foam backer rod placed in the ¼ in. (6 mm) gap between the bottom panel edges to prevent leakage of the grout. All transverse joints between panels are filled with a high strength non-shrink grout. The sequence of construction requires this grout to achieve a strength of at least 1,500 psi (10 MPa) prior to post-tensioning of the longitudinal strand. Specifications require a strength of 6,000 psi (40 MPa) at 7 days.

Fig. 3 Shear Key Alternative

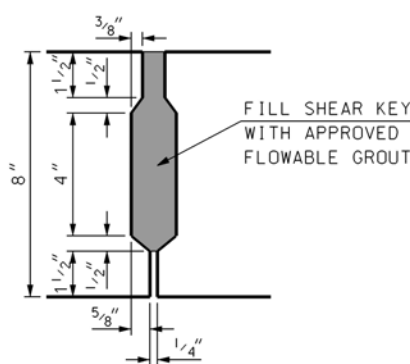
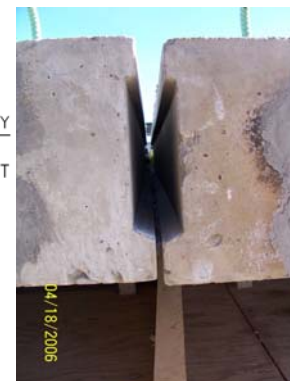
Fig. 4 Shear Key

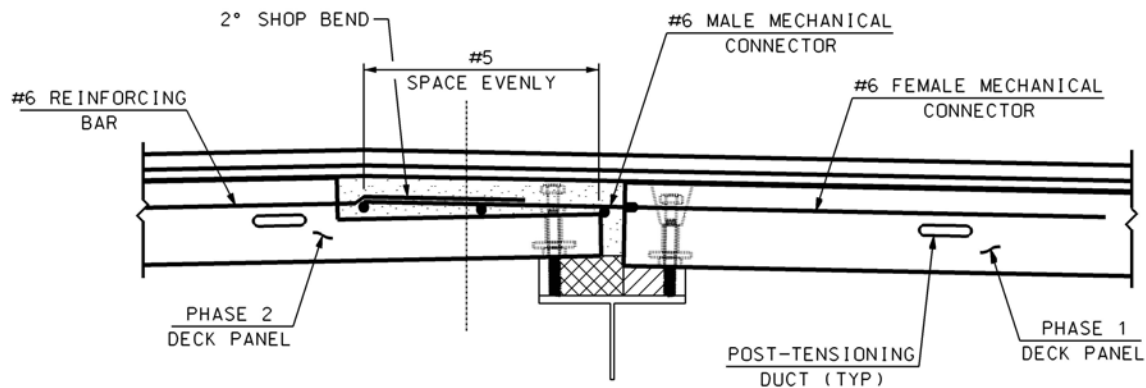
Longitudinal panel closure pour – Phases 1 and 2 meet directly over the middle girder, which has a 1’-2” (0.36 m) wide top flange. To create negative moment capacity in this region, mechanical connectors were included in the Phase 1 panels, and a notch with embedded shop-bent reinforcing steel was provided in the Phase 2 panels (see Fig. 5). The mechanical connector and embedded bar allowed the bars from the two panels to each have adequate development length. These bars carry their load in a manner similar to any cast-in-place deck and were spaced according to NHDOT standards for CIP decks.

Fig. 5 Closure Pour Detail

Phase 2 of the work progressed similarly to Phase 1, with the biggest delay being caused by difficulties with the installation of the longitudinal post tension strands. One unique feature of the Phase 2 work was the closure pour between the phases. The detail shown in Figure 5 worked well, except that some of the Phase 2 panels were too thick over the middle girder, so that the contractor had difficulty installing the threaded mechanical connector reinforcing into the Phase 1 panel. Also, the transverse #6 reinforcing bars that extended from the Phase 2 panel were not bent sufficiently at the fabrication shop; the contractor needed to bend each bar downward in order to adequately provide concrete clear cover. The insufficient bend was an issue because the closure pour is located along the bridge crown line and because the Phase 1 and Phase 2 panels are placed along opposing 2% slopes to create the roadway crown.

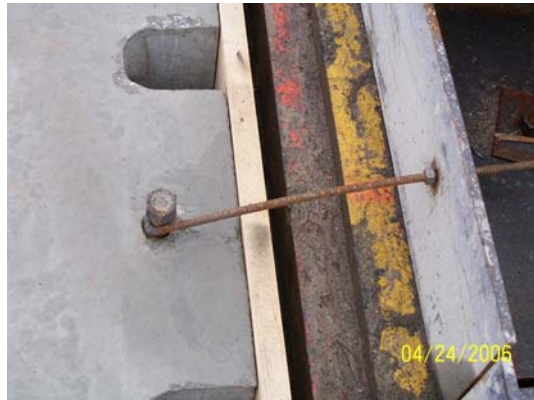
As deck panels were being fabricated, hairline cracks were noticed at the corners of shear connector blockouts at the splice over the middle girder. (See Fig. 6 for the half oval blockout at the splice, although hairline cracks are not visible in the photo.) Discussions with the fabricator led to several different reinforcing details to attempt to minimize this cracking. No detail thoroughly eliminated it, but the longitudinal post-tensioning, applied at the end of each phase, closed the cracks and made them essentially unnoticeable.

Fig. 6 Blockout along Middle Girder

The contractor post-tensioned the strand on May 10, 2006 (see Fig. 12). This decreased the overall length of the deck and, as mentioned earlier, caused all hairline cracks at the shear connector blockouts over the middle girder to disappear. Post tensioning did not induce any cracks into the panel ends nor did it cause any adverse differential movement between the panels and the girders.

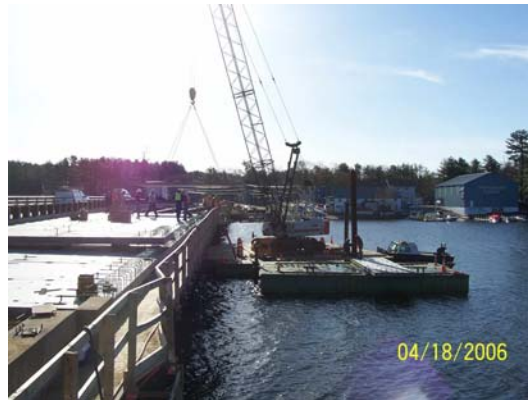
The contractor placed the temporary rail on March 21, 2006, which allowed him access to the roadway in order to begin saw cutting for the Phase 1 portion of the deck work. Next, steel K-frames were disconnected from the middle girder, and the deck removal began. This was complete on April 14, 2006, and deck panel installation then commenced. The first eleven panels were placed by crane from the end of the bridge, and all remaining deck panels were placed using a barge-mounted crane. The Phase 1 panels were completely set on April 21, 2006 (see Fig. 7). At this point the deck panels had not been adjusted, grouted, or post-tensioned.

Fig. 7 Panel Erection From Barge

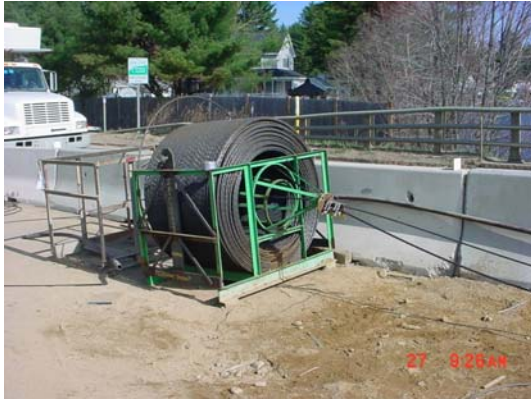
The next step in the project was to install the longitudinal post-tensioning strand. This was done by drawing strand from a coil (see Fig. 8) into a hydraulic feeder (see Fig. 9) that pushed the strand into the duct at a high rate of speed. The shop drawings had detailed the post-tensioning duct in a manner identical to the NHDOT plan details. This consisted of two oval ducts between each pair of girders that would each hold four 0.6 in. (15.2 mm) diameter post tensioning strands. This detail proved difficult to construct since it did not allow much additional annular space for installing the strand (see Fig. 10). Duct misalignment from precast panel to precast panel added to the difficulty, which may have been exaggerated by the presence of the vertical curve of the roadway profile. In order for the contractor to install the strand, he needed to install 0.5 in. (12.7 mm) diameter strand with the feeder for half the length of the bridge. He then installed 3/8 in. (9.5 mm) strand from the opposite end of the bridge. Next, he welded the two strands at the center of the bridge and pulled the smaller strand with a front-end loader in order to get the larger strand into the duct for the entire length of the bridge. Then he welded the 0.6 in. (15.2 mm) strand to the 0.5 in. (12.7 mm) strand and pulled the 0.5 in. (12.7 mm) strand in order to get the larger strand into the duct. The task of installing the strand in the ducts was expected to take one day per phase, however, due to the difficulty in inserting the strand through all deck panels over the full length of the bridge, the task took a total of eight working days for Phase 1.

Fig. 8 Coil of Strand

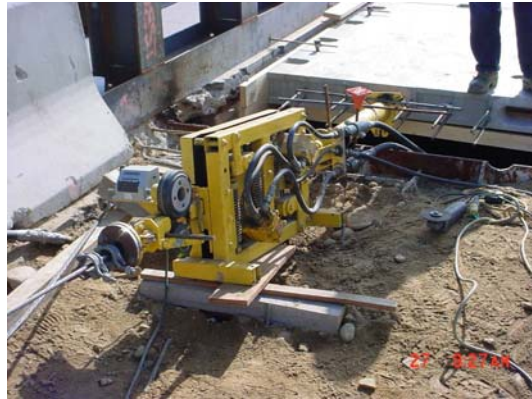
Fig. 9 Hydraulic Strand Feeder

Based on discussions after the project was completed, it is believed that the contractor specified such tight duct spacings on the shop drawings because he thought the dimensions that detailed the post tensioning ducts were prescriptive rather than conceptual. Additional annular space and better duct alignment would have allowed this process to proceed more smoothly and in a more timely manner.

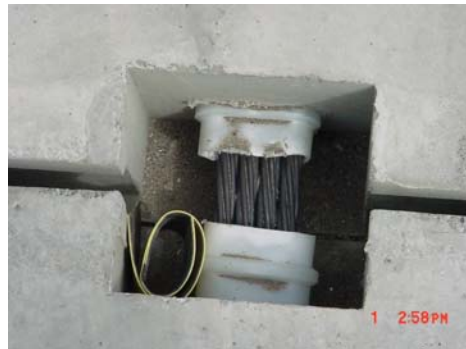
Fig. 10 Longitudinal Post-Tensioning Strand

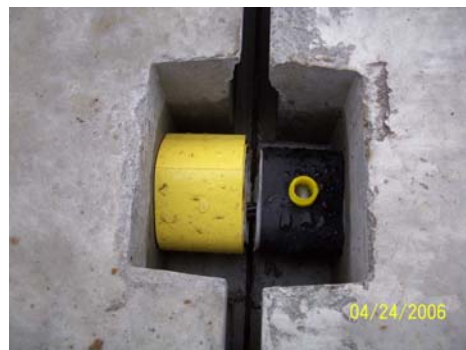
After all strands were inserted in a duct, it was sealed between each panel to prohibit the transverse joint grout from filling the duct, which would prevent effective grouting of the post-tensioning strands. The contractor used heat activated shrink wrap tape to seal these joints (see Fig. 11 for tape pulled back from joint at a duct with a grout injection port) and then grouted the transverse joints with Sure-Grip High Performance Grout by Dayton Superior. By May 5, 2006, the transverse joints had all been grouted for Phase 1.

Fig. 11 Shrink Wrap Tape At Duct Joint

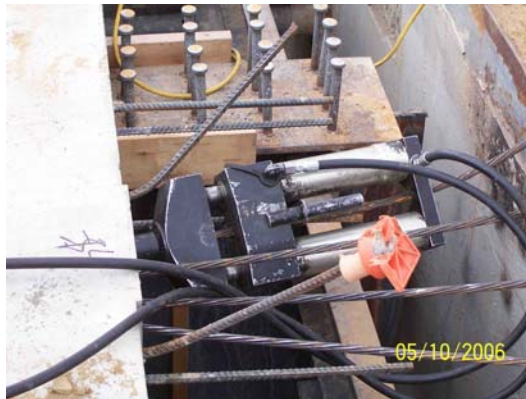
Fig. 12 Jacking of Post Tensioning

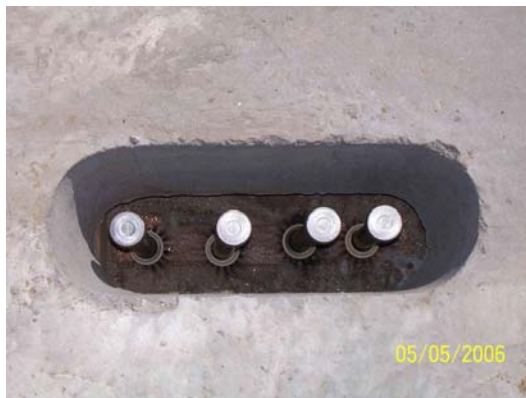
Shear connectors were then installed on the girders, with four in each blockout (see Fig. 13). Inspection of the shear connectors could only be done by sounding the studs with a hammer. Replacing inadequately welded studs is problematic due to the difficulty in working within the confines of the blockout.

Fig. 13 Shear Connectors

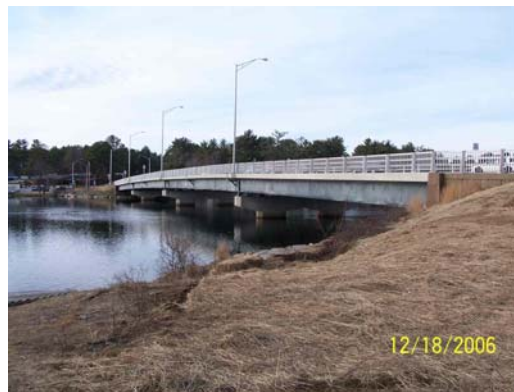
The Phase 2 work was completed on August 31, 2006 (see Fig. 14). Due to difficulties experienced by the contractor and the associated delay to the construction schedule, the Department and contractor are still discussing the amount of the disincentive to be assessed.

Fig. 14 Completed Bridge
