CONCRETE REPAIR AND CATHODIC PROTECTION OF CORRODED REINFORCED CONCRETE STRUCTURE

Adel ElSafty, Ph.D., P.E., P.Eng., Assistant Professor, School of Engineering, University of North Florida, Jacksonville, FL, USA

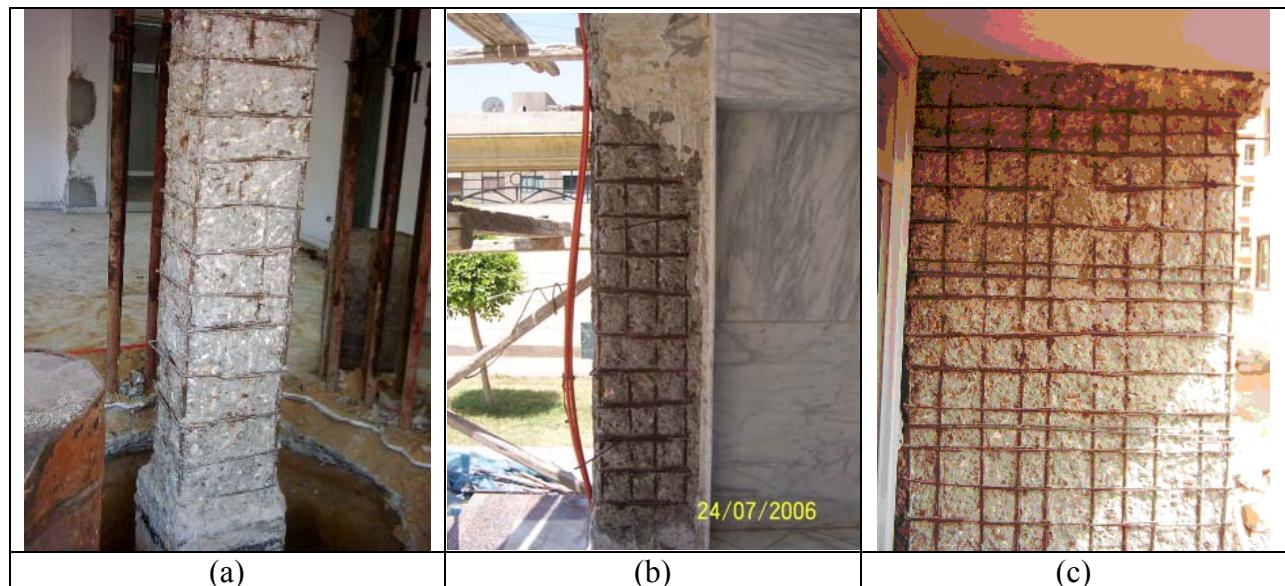
The initial survey of visual inspection was conducted to identify the extent or the repair work prior to any decision of repair. Moreover, a more extensive concrete investigation was conducted to accurately identify the cause of deterioration and potential damages. The initial building inspection revealed serious defects; thus an extensive concrete investigation was conducted. The investigation included visual examination, hammer tapping survey of the structures, covermeter survey, half-cell testing, depth of carbonation, steel reinforcement inspection, cement/alkali, and chloride content. The investigation showed concrete and steel damage and corrosion-related problems, as shown in Figures 1(a), (b), and (c).

Fig. 1 Corroded Steel reinforcement (a) interior column, (b) exterior column, and (c) exterior column

For corroded steel reinforcement, the average corrosion and the average loss of yield stress were almost 30% of the steel area in several areas in the columns. Table 1 shows the average elongation loss of about 55%. Table 2 indicates the Cl⁻ ion concentration in columns.

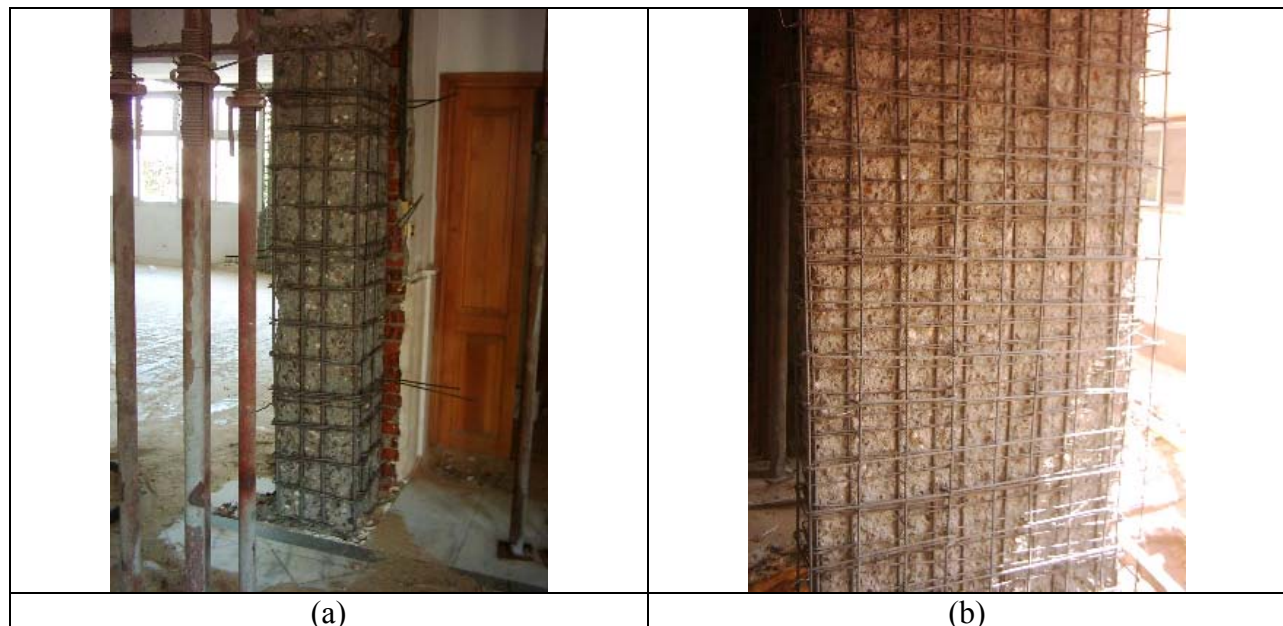
Fig. 2 Sand blasted steel and new steel (a) interior column, (b) exterior column

Work proceeded in two main stages. The first stage involved repair of columns according to the level of corrosion. The second stage involved electrochemical protection. The repair work ranged from just sand blasting the reinforcing steel and restoring the concrete cover for less corroded elements to adding a new reinforcement and concrete jacket for medium and highly corroded elements, as shown in Figure 2. In all cases, polymers were not allowed, and two steel stirrups were welded to the longitudinal reinforcement of each column, one leg of a stirrup is projected outside the column.

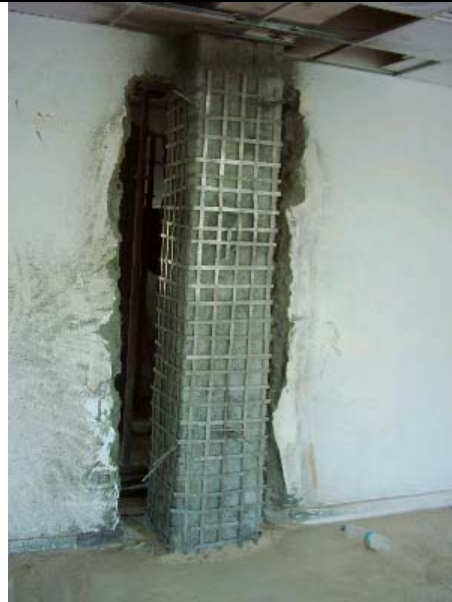
Fig. 5 Grouting and zinc mesh installation

In the second stage, a zinc mesh was installed at the surface of column, as shown in Figures 3, 4, and 5. A strip was bent to project outside the column. A plaster layer, 15 mm thick is applied over the zinc mesh. An impressed current was then applied; the zinc leg was connected to the positive pole and the stirrup leg to the negative pole of a DC power supply. The columns surfaces were held moist during current application for 7 days. The potential difference of the current flow was monitored using half-cell as shown in Figure 6c.
