NEW HAMPSHIRE'S SECOND USE OF FULL-DEPTH PRECAST CONCRETE DECK PANELS

David L. Scott, PE, NH Department of Transportation, Concord, NH
Jason A. Tremblay, PE, NH Department of Transportation, Concord, NH

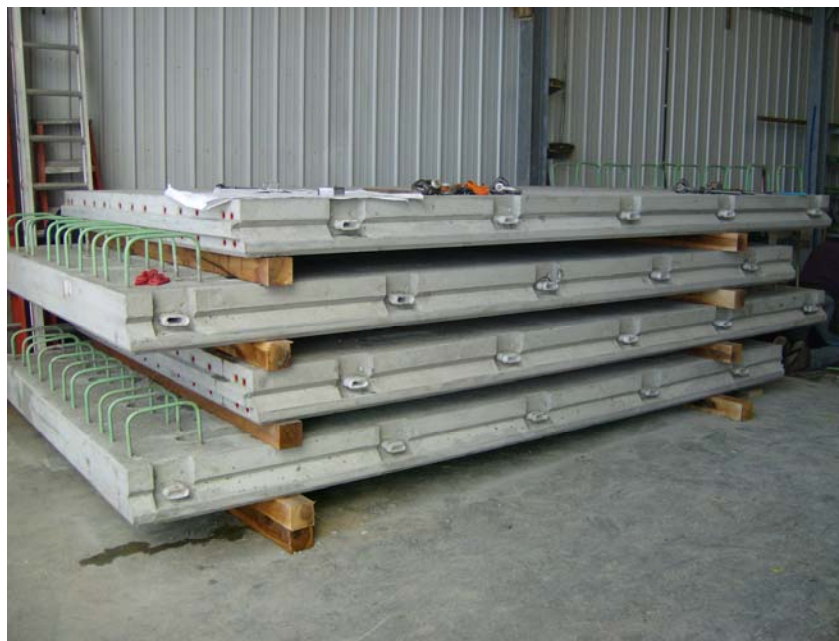
Fig. 7 Precast Deck Panels (at fabricator's plant)

The full depth panels for this project used mild reinforcing for the main steel and therefore did not require any pretensioning. Ducts were cast into the panels for longitudinal post-tensioning strands (see Fig. 7). The fabricator used two by fours placed inside the duct, which were ultimately removed, as well as a #5 reinforcing bar on top of the duct to hold the duct in place while casting the panels. Visual inspection from one side of the panel to the other showed that the ducts were straight and true.

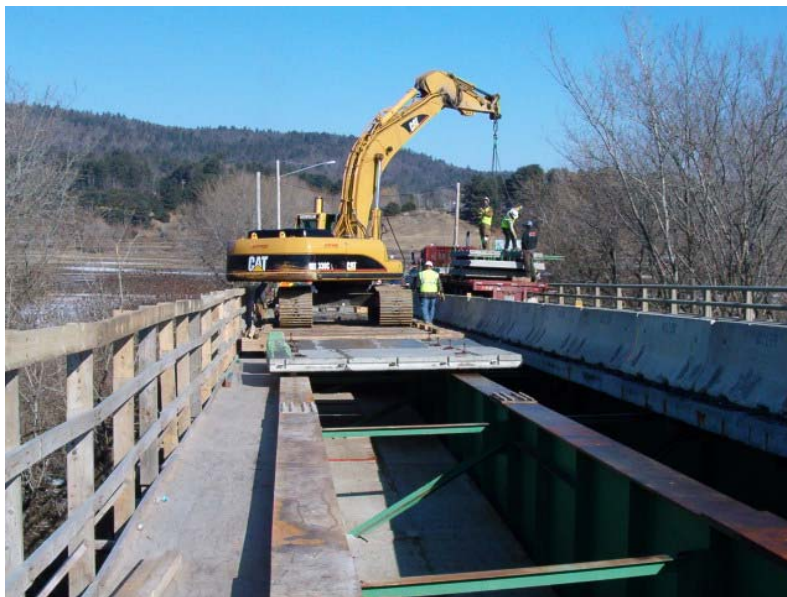
Fig. 8 Placement of Deck Panels

On April 7, 2008 the Contractor placed the first 18 panels (see Fig. 8). 30 panels were placed the following day and the remaining 11 panels were placed on April 9, 2008. At this point the deck panels had not been adjusted for grade, grouted, or post-tensioned.

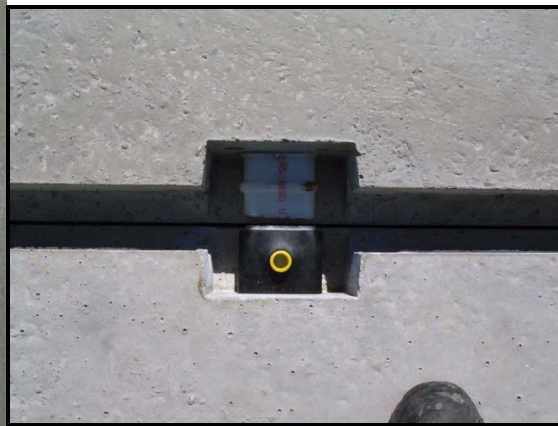
Fig. 10 - Aligned Ducts in Handhole

For Phase 1 panels, this was not an issue. Installation of prestressing strand in Phase 1 post-tensioning ducts was started and completed on April 14th. This task went much smoother than the Mosquito bridge project due to better duct alignment and panel dimensional tolerances (see Fig. 10). Strands were pushed through the ducts. Per contract provisions, panels were not to be post-tensioned until they had aged a minimum of 45 days. This was to limit shrinkage once the panel is set and grouted into place.

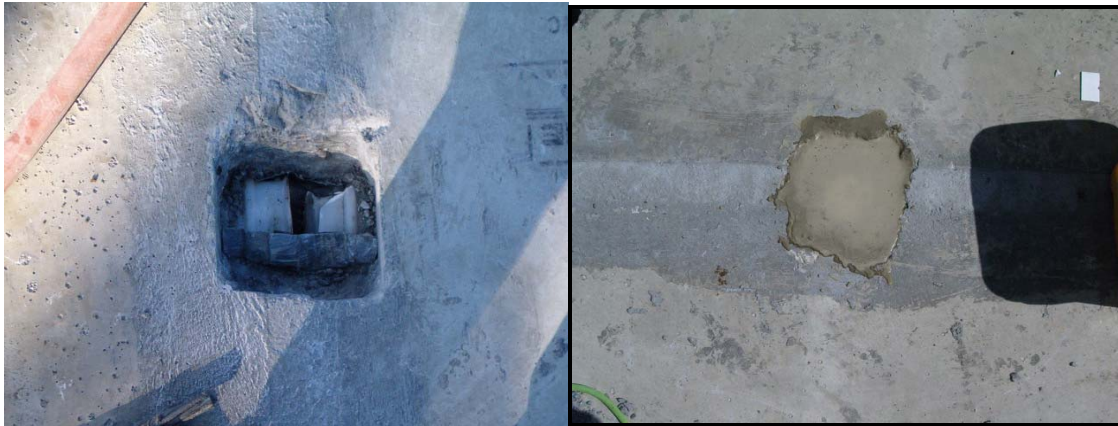
Fig. 11 - Misaligned Ducts in Handhole

Fig. 12 – RegROUTed Handhole

With less than two months to go before the Haverhill Fair incentive deadline on July 23rd, the Phase 2 deck removal was completed on May 31, 2008. All 59 panels were set on June 4, 2008 and leveled to grade on June 5th. The Contractor once again grouted the shear keys before placement of the post-tensioning strand. Strand placement commenced on June 10, 2008. The first several ducts went smoothly but in the third duct the strand could not be pushed the entire length of the duct. Since the hand holes were already grouted, the Contractor could not see what was blocking the strand. The Contractor measured the length of the strand that went into the duct and removed the grout from the hand hole at that length to identify the problem. Due to slight misalignment of the ducts the strand had broken through the splice at the hand hole and could not continue along the duct. The Contractor had to remove the grout from the affected hand holes, align the

ducts so the strand could be installed smoothly and regROUT the handhole (see Fig. 11 and Fig. 12). So instead of the strand installation taking one day to complete, as in Phase 1, it required 3 days.

One example that occurred on this project was grouting the shear keys before placing the post-tensioning strands. The Contractor thought that he was saving time by grouting these first. This approach would have allowed the post-tensioning Contractor to thread and tension the strand at the same time. However with the problem with installing the strand that arose in Phase 2, the post-tensioning Contractor was on the site two days longer than necessary, while waiting for the Contractor to correct the duct alignment problem.

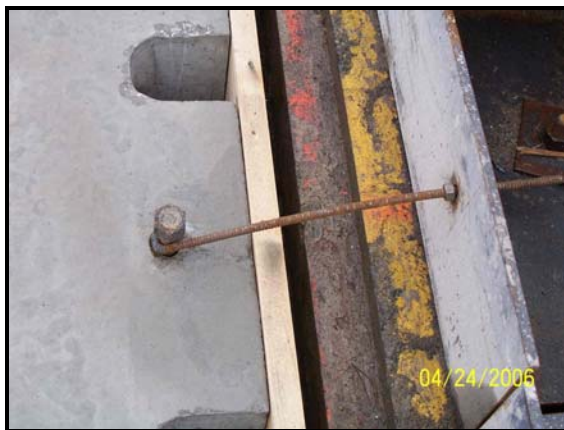
Fig. 13 - Shear Connector Half Blockout
(Mosquito Bridge)

One issue identified from the Mosquito bridge project was the presence of hairline cracks at the corners of shear connector blockouts. This was noticed at the half blockouts for shear studs that were required over the center girder (see Fig. 13). This was most likely due to inadequate reinforcing around the blockout as well as the stress from the pretensioning strand.

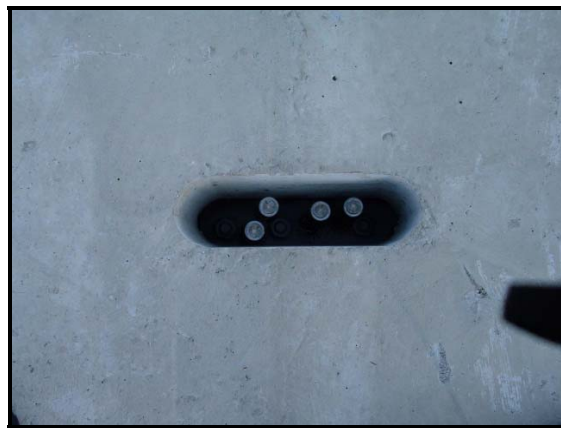
Fig. 14 - Shear Connector Blockout
(Haverhill-Newbury)

This project did not have half blockouts for shear studs since the closure pour was between girders as opposed to over the center girder (see Fig. 14). So while avoiding the problems of the closure pour being located over a girder, a new problem arose from the closure pour between girders.
