TOWARD A MORE REALISTIC INTERFACE SHEAR STRENGTH EQUATION FOR COMPOSITE MEMBERS

ABSTRACT

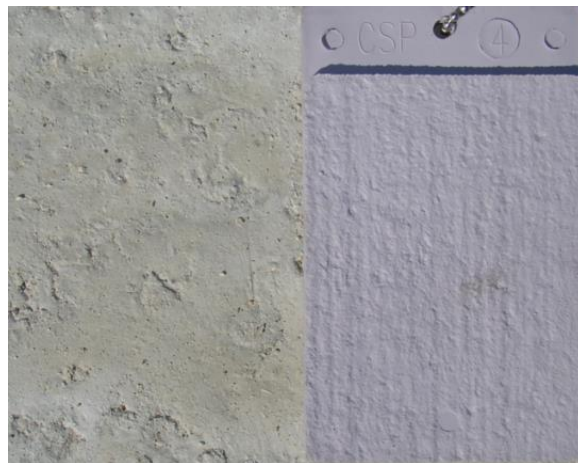
Fig. 2 Surface finish on SCC slab beams (approximately corresponding to CSP4; does not meet 0.25-in. amplitude)

An effective means to improve the horizontal shear resistance is to specify a rougher finish (i.e. amplitude of roughness greater than 0.25-in.) on top of the beam to improve horizontal shear capacity. Although AASHTO recommends a cohesion factor of 0.28 ksi for a surface roughened to an amplitude of 0.25-in., it does not address the fact that a smoother interface (Figure 2) may result from the use of self-consolidating concrete (SCC). Figure 2 shows the smooth surface of the SCC beam, even the workers used the same finish technique (wood float) that is used for conventional concrete. No other means were used by the workers to increase the roughness. Consequently, there is no cohesion and friction factor suggested in the case where SCC is used. Although an experimental study carried out by Saemann and Washa⁶ postulated that increasing the surface roughness leads to an increase in the horizontal shear strength, Walraven and Reinhardt⁷ showed that an increase in surface roughness resulted in an increase in crack width. Therefore, testing SCC beams would provide valuable information to determine the effect of a much smoother interface on the horizontal shear resistance.

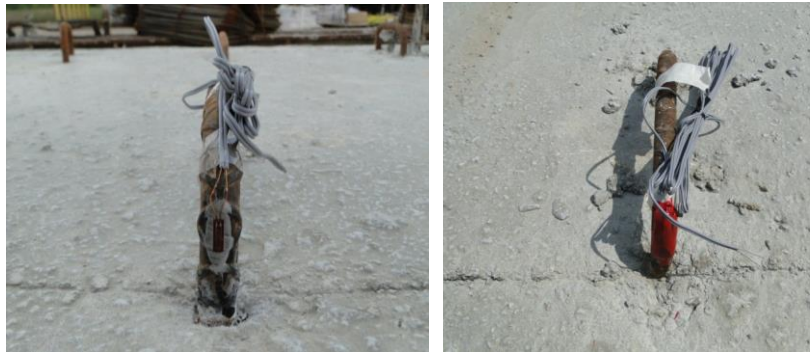
Fig. 6 Strain gauges installation on horizontal shear reinforcements

4SB12#2, 4B20#1 and 4B20#2 whereas a wood float finish was provided on 4SB12#3, 4SB12#4 and 4B20#3. Strain gauges were installed on the horizontal shear reinforcement prior to casting of the CIP slab (Figure 6). The foam tape was then placed on the surface of the beams with reduced interface thereby intentionally reducing the interface area (Figure 7). The interface area of the slab beam was reduced from 47.75-in. to 12-in., and the interface area for the box beam was reduced from 43.75-in. to 14-in. The foam tape was placed in two layers to guarantee that no tear will occur during casting of the CIP slab. The CIP part of the specimens was cast with concrete Class “S” as shown in Figure 8.

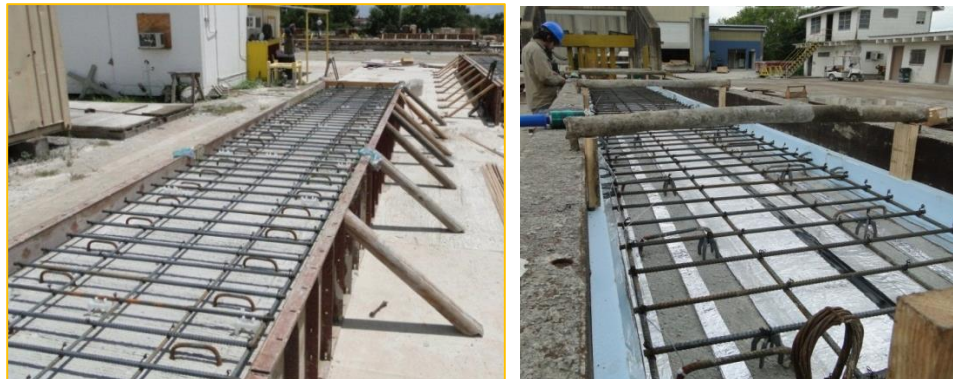
Fig. 7 Interface (a) without and (b) with foam tape on interface

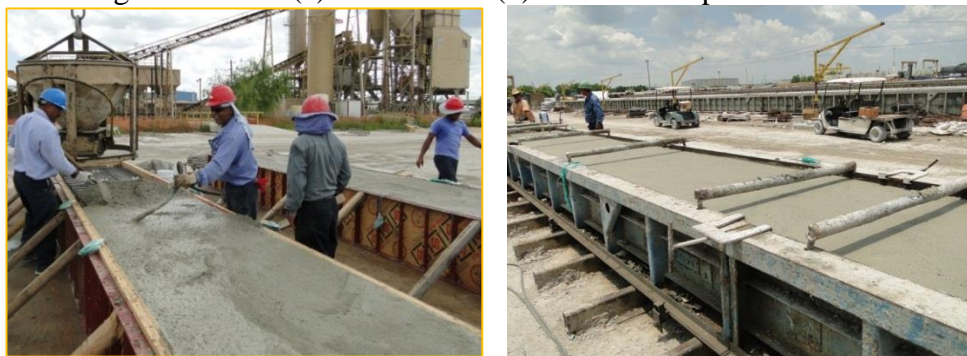
Fig. 8 Finished CIP slab

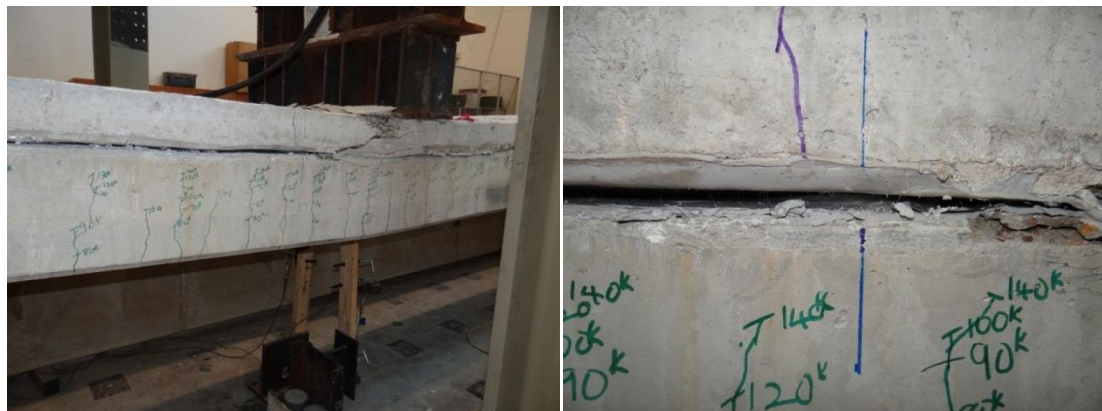
Fig. 12 Beam 4SB12#3 at failure showing separation of the interface

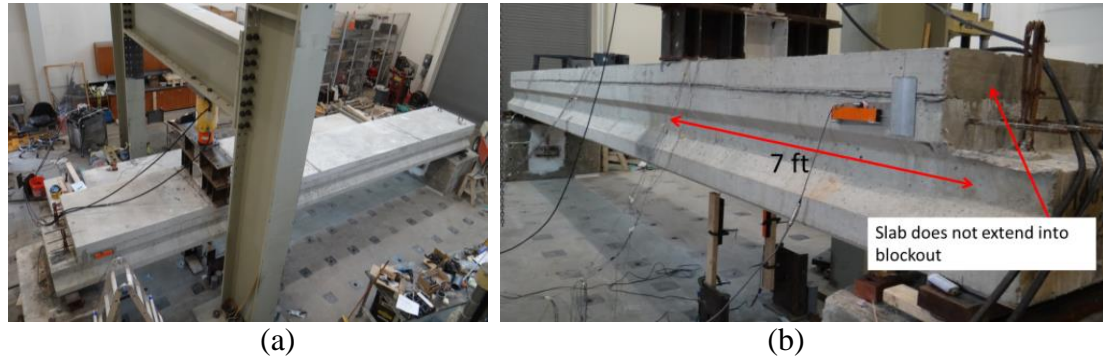
Fig. 14 Beam 4B20#3 (a) top view and (b) side elevation of test set-up

Beam 4B20#3 was loaded at 7 ft. away from one end of the beam. Load was applied at intervals of 10 kips until the first flexural crack was observed at a load of 160 kips. At 190 kips, more flexural cracks formed along the beam length. Very small strain was recorded from the horizontal shear reinforcement at this point. At a load of 247 kips, a cracking noise was heard and the load dropped to 225 kips as evident from the load vs slip plot in Figure 15. Interface slip was recorded to be 0.024-in. at that instance. Strains in the horizontal shear reinforcement also began to increase. Cracks on the CIP slab began to appear at a load of 250 kips. These cracks were observed not to have originated from the flexural cracks on the precast beam. Interface cracks widened markedly with a slip of 0.08 in. being recorded. Yielding of horizontal shear reinforcement close to the end of the beam occurred at a load of 263 kips with a slip of 0.09-in. The crack at the interface widened to 0.06-in.. With an increase in load to 270 kips, the crack at the interface widened to 0.05-in. Flexural failure occurred at 287 kips with a deflection of 5.4-in. Crushing of concrete was observed on both the CIP slab and the

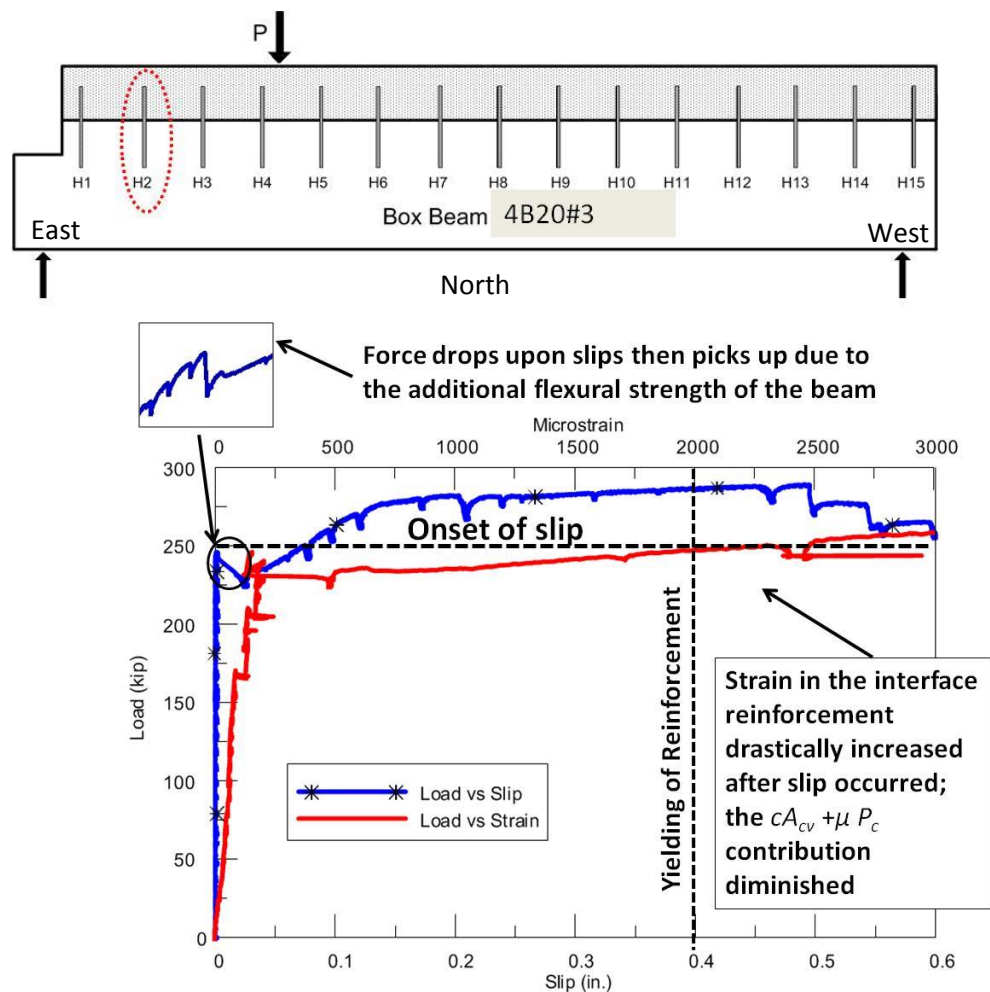
Fig. 15 Load-slip and load-strain plot for box beam 4B20#3

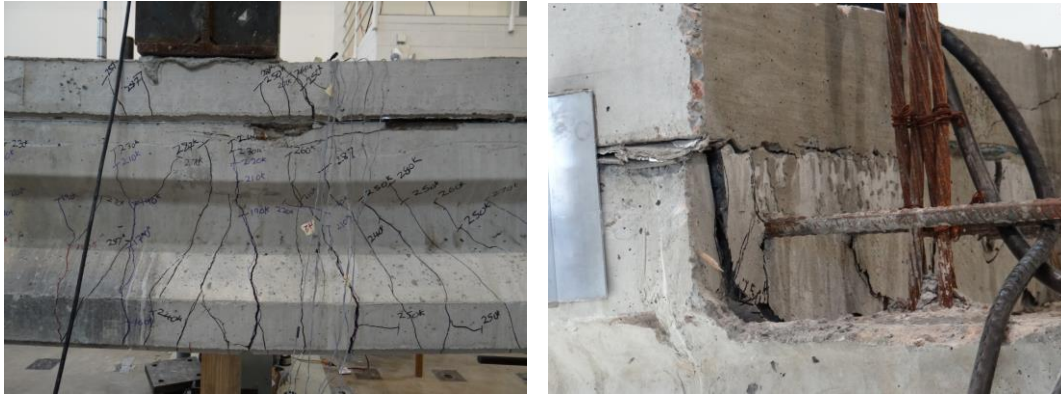
Fig. 16 Beam 4B20#3 at failure with concrete fracture at the east-end

precast beam. A slip of 0.60-in. was recorded at the end of the test. Severe concrete fracture was observed on the east end of the beam as seen in Figure 16 near the interface. A large separation along the interface was also observed (Figure 17) as well as a noticeable slip at the beam end.

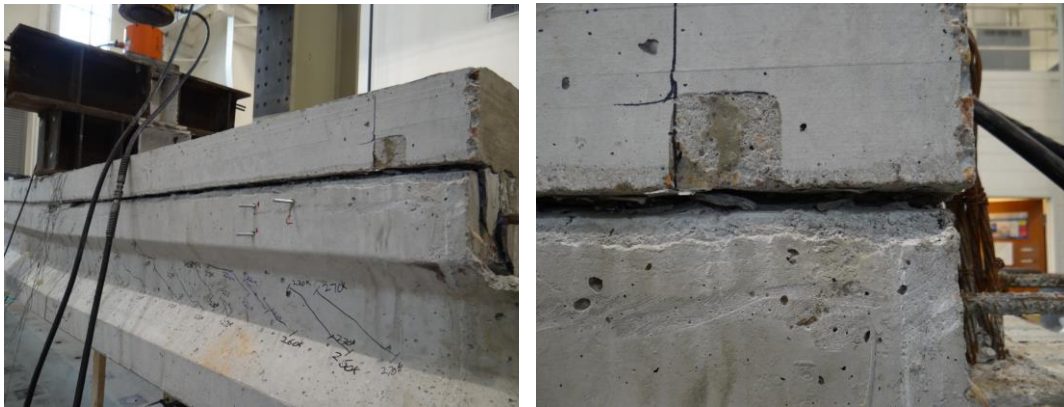
Fig. 17 Separation between the CIP slab and precast beam on beam 4B20#3 at failure

It is important to note the majority of horizontal shear strength before the onset of slip can be attributed to the cohesion and friction of the concrete. Figure 17 shows how a separation at the interface looks; such a separation can trigger a load drop after the onset of slip. The separation indicates the diminished contribution of cohesion and friction, and the engagement of the horizontal shear reinforcement—signified by an increase in strain up to yielding of the horizontal shear reinforcement (as slip is reached at 0.4-in.) as shown in the load-strain plot. This may suggest that the AASHTO (2014) horizontal shear equation does not accurately predict the true behavior of composite beams. Indeed, Eq. 1 assumes that the peak strengths of cohesion, friction, and dowel (yielding) occur simultaneously.

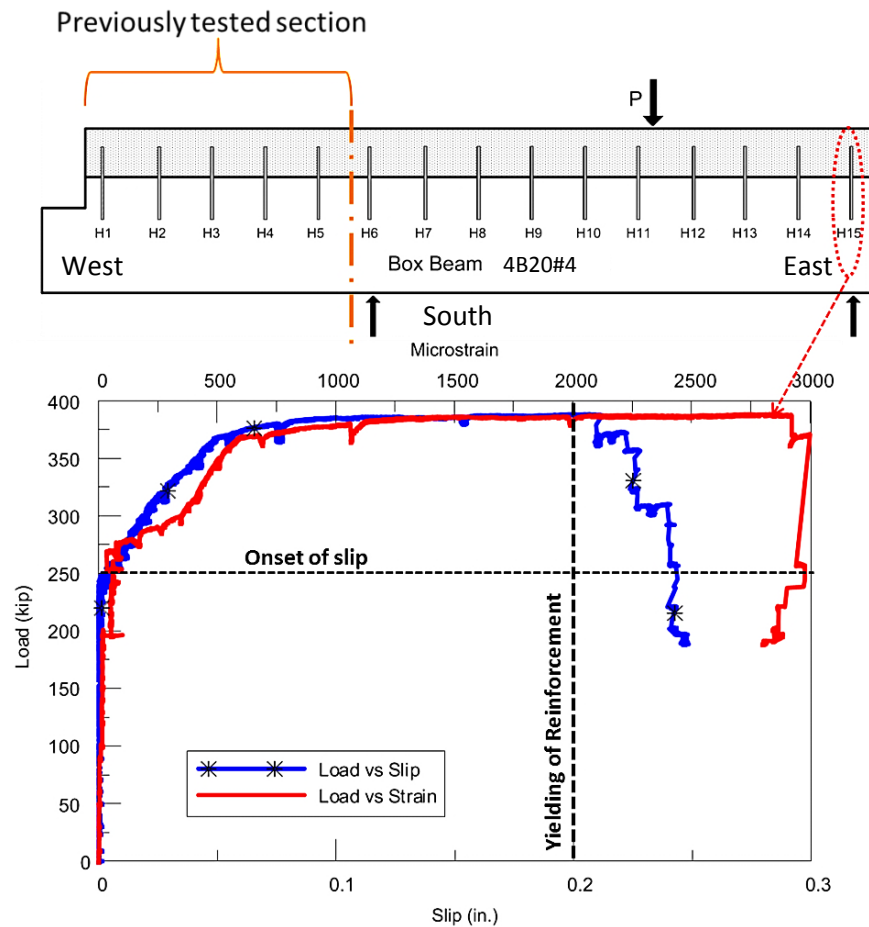
Fig. 18 Load-slip and load-strain plot for box beam 4B20#4

Figure 18 shows the load-slip and load-strain plots for the box beam 4B20#4. It is important to note that the strain in the horizontal shear reinforcement did increase until close to the onset of slip, after which the strain continues to increase up to yielding. The strain in the horizontal shear reinforcement at the onset of slip is observed to be $500 \mu\epsilon$ which then rapidly increases to yielding ($2000 \mu\epsilon$) with increase in load after slip (0.2-in.) occurs. This observation is consistent with that observed on 4B20#3.

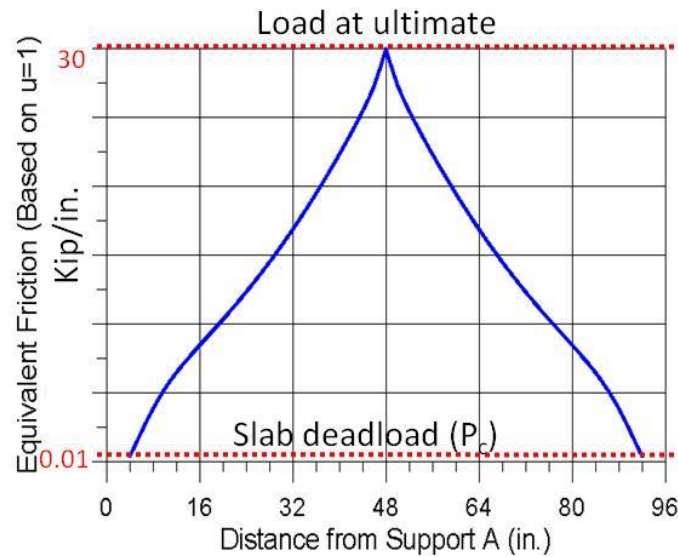
Fig. 20 Compressive stress vs distance from support plot

The compression stresses along the entire beam were analyzed as shown in Figure 20. The interface stresses were also analyzed and the compressive stresses along the beam plot. It is clear that the compressive stresses are highest near the loading point and gradually reduce (almost linearly) towards the support. These results support our hypothesis that the high compressive stresses at the loading point keep the interface crack from opening at that point; hence, lower strains were recorded in the horizontal shear reinforcements. Note that the resulting friction can be much higher than just using the permanent dead load. Experimental results in Figure 20 also show that while local slips could occur, no slips could happen in the vicinity of the loading region, which maintain the composite behavior of the entire beam.

FE analysis also supports this finding as shown earlier whereby the compressive stresses at the interface are seen to be high and decrease almost linearly towards the supports. In actual bridges, the increased friction could cover a wider range of the span because the
