# COMPARISON OF FLEXURAL CRACKING IN REINFORCED CONCRETE BEAMS WITH DIFFERENT REBAR COATINGS

**Aaron Murphy**, Clemson University, Clemson, SC  
**Sachin Sreedhara**, Clemson University, Clemson, SC  
**Amir Poursaee**, Clemson University, Clemson, SC  
**Brandon E. Ross**, Clemson University, Clemson, SC

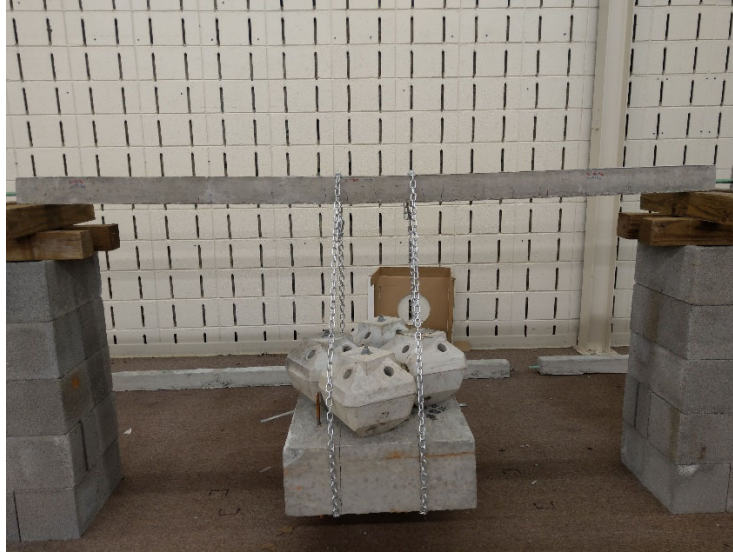
Each beam was subjected to a sustained load in 4-point bending for one week. The beams had a clear span of 86 inches (2180 mm) and were loaded 41.5 inches (1050 mm) from each end with a total load of 700 lbs. (3.1 kN). Figure 3 shows the setup for the test.

Figure 3: Picture of Sustained Load Setup

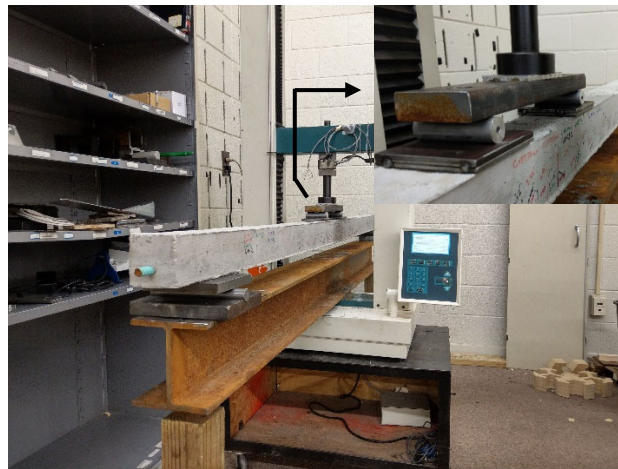
A steel I-beam was placed in the UTM and the beam supports were positioned on each end. The stiffness of the steel I-beam was an order of magnitude greater than the specimen. Hence displacement of the I-beam did not significantly impact the displacements measured from the UTM. The setup for the load-displacement test is shown in Figure 6. Each beam was loaded until it failed. In all cases, failure consisted of concrete crushing at the top of the beam.

Figure 6: Overall View of Load-Displacement Test Setup

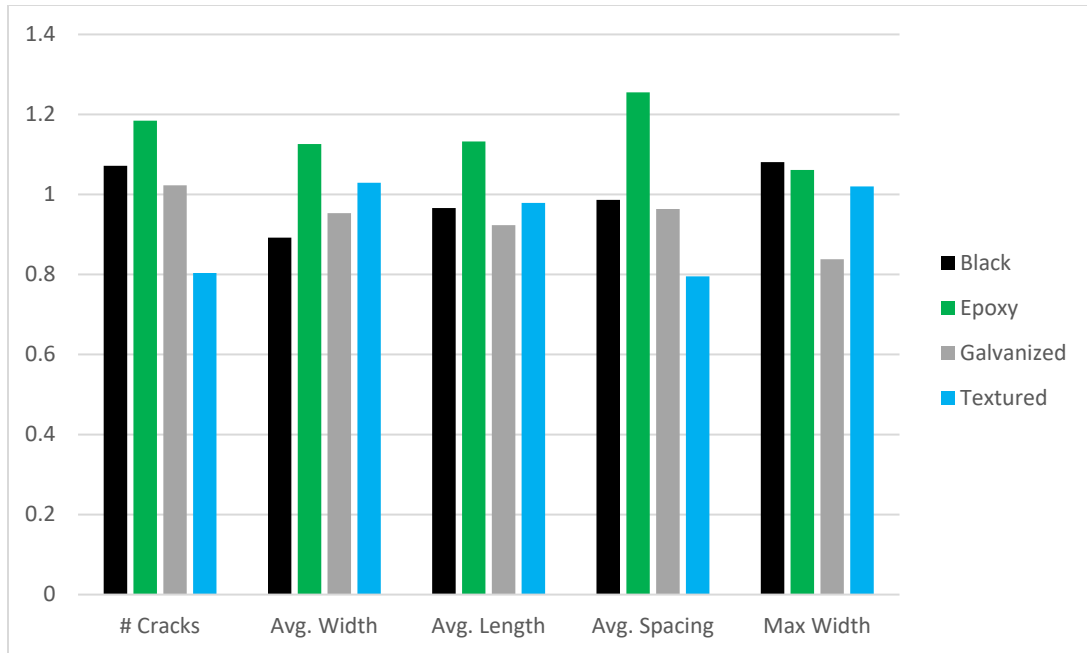
In the sustained load test, the total number of cracks, the average width of all the cracks, the average length of all the cracks, the average spacing between each crack and the maximum average crack width were measured. In the case of “# Cracks” the data are presented as the inverse of the comparison index from Equation 2. This is because increased crack quantity is associated with better bar-concrete bond and a higher number of cracks is desirable. In contrast, for all other measures a smaller number/measurement is desirable. Figure 7 and Figure 8 show the results of the four beams in each series.

Figure 8: Comparison of Series 2 Crack Data

The number of cracks indicates the distribution of stress between concrete and steel along the beam (Wight 2016). In both series, the textured-epoxy bar resulted in the most cracks and the epoxy bar tended to have the least number of cracks. This result is attributed to superior bond for textured-epoxy bars and worse bond for the traditional epoxy bars.

When the bond is weaker, fewer cracks appear, but these cracks tend to be larger. The average crack width, average crack length and maximum average crack width metrics show how big the cracks tended to be on the beams. The epoxy beams had the highest average crack width in each series. The textured-epoxy and galvanized were fairly similar, except the textured-epoxy bar had a slightly larger average crack width in series 2. The epoxy beams had the greatest maximum average crack width in each series. The average length of the cracks in the epoxy beams was typically the largest. Although, the average crack length in the textured-epoxy beams was similar for series 1. The epoxy reinforcement led to larger cracks meaning that the stress was not distributed as effectively, most likely because of a deterioration in the bond of the reinforcement and the concrete.

The spacing metric measures a similar behavior as the number of cracks on the beams. If there are less cracks, then the spacing between the cracks is larger. This thought follows the data as the epoxy beams had the least number of cracks and also the highest spacing. The spacing of each crack was measured directly on the beam with a measuring tape and then averaged together for each beam in each series.

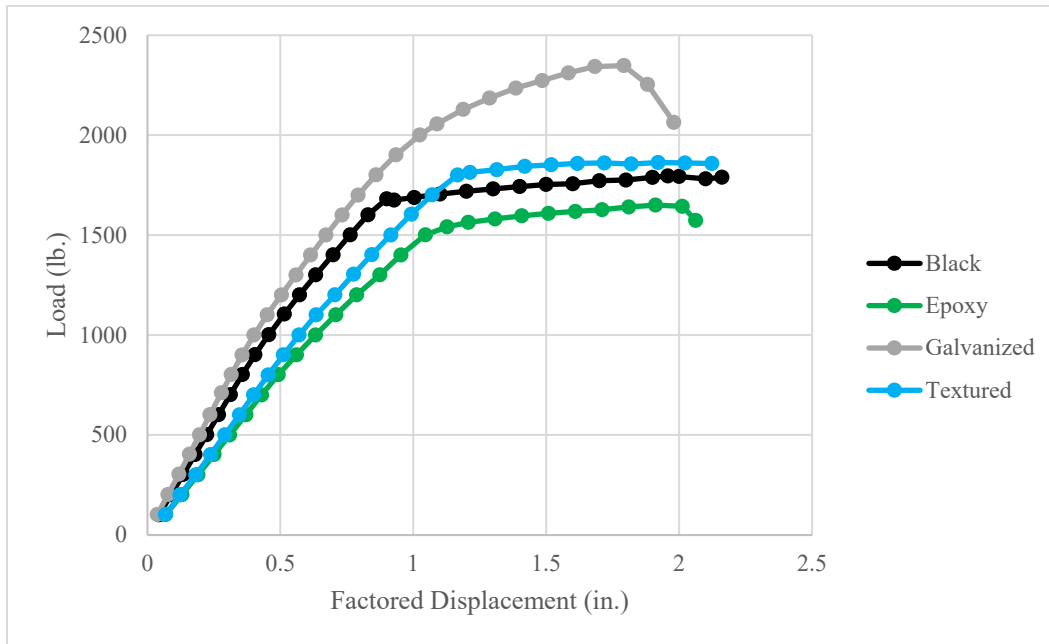
Figure 9 and Figure 10 show the comparison of load-displacement behavior of the beams. In each series, the galvanized beams had a greater maximum load, and the epoxy beams supported the lowest load. The differences in maximum load are attributed to yield strength of the reinforcement not to the bond performance.

Figure 9: Series 1 Load-Displacement Plot

When the bond between the steel reinforcement and the surrounding concrete begins to deteriorate, the stress cannot be transferred from the steel to the concrete as effectively. This results in a loss of stiffness in the beam. The epoxy beam showed the least amount of stiffness compared to the other beams. The beams were already cracked prior to flexural testing in the UTM so the stiffness observed in the tests reflected the existing cracks.
