Precast's Durability Helps Bridges Resist Fire Damage

A major bridge fire doesn't necessarily mean the structure must be replaced; precast concrete designs can help keep bridges open even after intense blazes

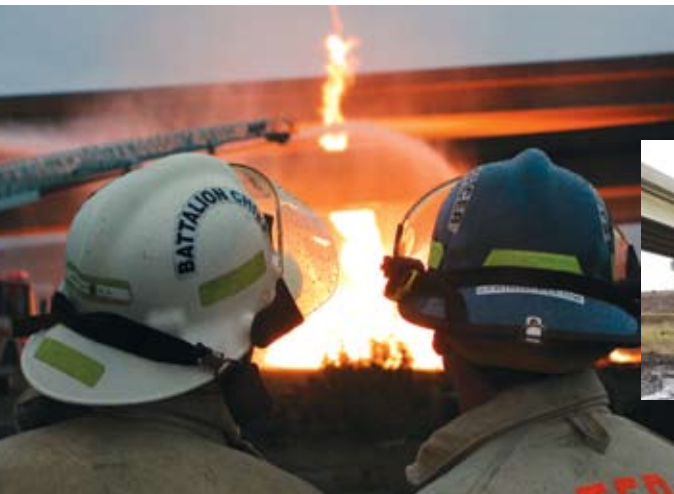
Although flame temperatures at this methanol-fueled tanker fire in Puyallup, Wash., reached 3,000 °F, the precast concrete bridge was reopened to traffic the next day.

Following an in-depth inspection, the precast concrete bridge was reopened to traffic immediately after the fire.

The fire was fueled by 30,000 gallons of methanol and engulfed the eighth span of the bridge, maintaining a high flame temperature for about one hour, says Stoddard, who inspected the bridge. Engineers estimated that flame temperatures approached 3,000 °F and surface temperatures on the soffit of the prestressed girders may have reached 1,700 °F. Internal temperatures in the bottom flange and webs ranged from 500 °F to 1,100 °F.

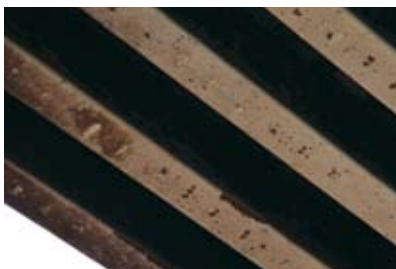
The heat from the Puyallup bridge fire was intense enough to cause some spalling, which left some exposed strands, but it left them undamaged.

To be sure, the heat caused significant heat damage in some areas. The impact was most critical in one key span, where the concrete in the girders suffered extensive spalling. Both columns supporting the span had 2-inch-deep concrete spalls that exposed spiral reinforcement for the pier's full height, Stoddard says. Some delaminations also occurred within the concrete core. Crossbeams at this point showed concrete spalling to depths of ½ inch, but no reinforcement was visible. The flanges in all 15 lines of girders in the span turned a whitish-gray, and those

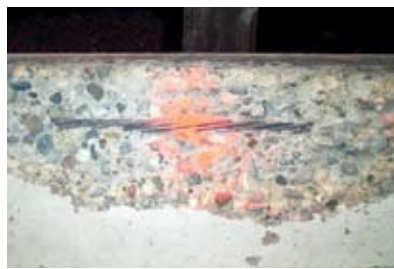
The pink color shown in this girder from the Puyallup bridge fire indicates that the concrete was exposed to temperatures higher than 500 °F.

A visual inspection can quickly determine if any spalling or other changes have occurred following a fire, especially through color change. A pink/red color appears when the precast component has been exposed to heat above 500 °F, and a purple-gray color begins to appear above 900 °F. The concrete won't show signs of melting until the heat reaches 2,200 °F or more (see the sidebar for more details).

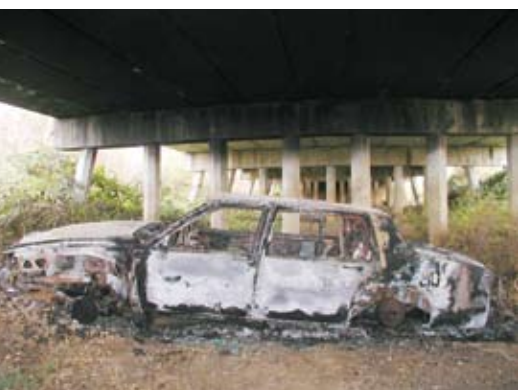
(Photo-Top) A blazing car fire caused damage to a bridge in Washington County, Ore., but the effects were minimal and the bridge was reopened to traffic after an inspection.

A similar result occurred at a precast concrete bridge in Washington County, Ore., in November 2004. A derelict car was abandoned in an area beneath the bridge and set on fire, causing charred concrete on the bridge above and disruption to traffic. The damage occurred at about mid-span on a 375-foot span of 18-inch-deep voided slabs. "The fire was hot enough to melt aluminum and leave it puddled on the ground nearby," reports Greg Clemmons, operations engineer for the Washington County Land Use & Transportation Department.

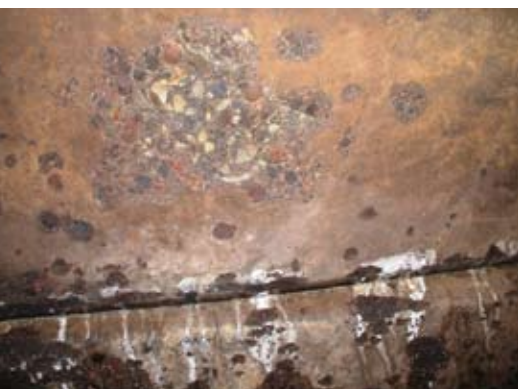
(Photo-Bottom) Some spalling and exposed aggregate was noted during the inspection of the Washington County, Ore., fire, but it was not sufficient to even require repairs.

An inspection of the bridge showed that spalling occurred in an approximate 2-foot-square area that was about 1/2 to 3/4 inch deep. In several areas, the concrete also turned pink, indicating it had been exposed to heat of at least 500 °F. Following pressure-washing to remove soot, a detailed inspection took place, including hammer tests at various locations.

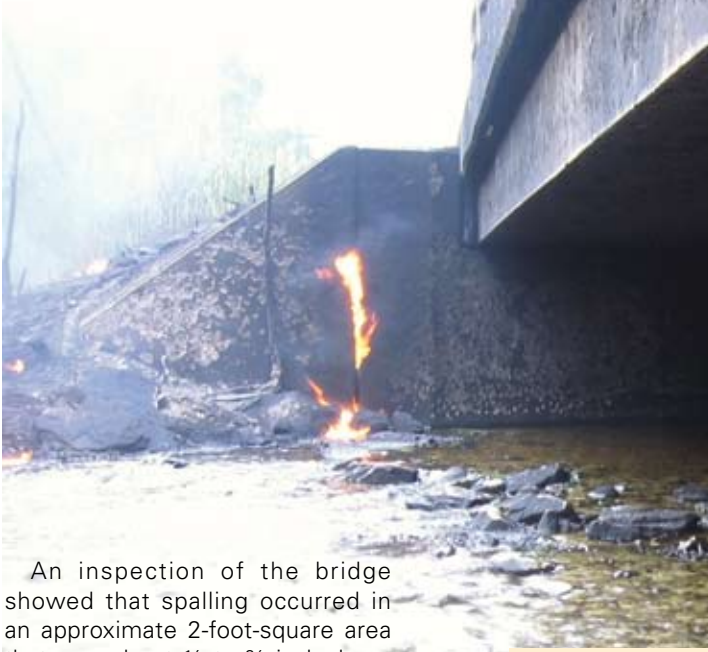
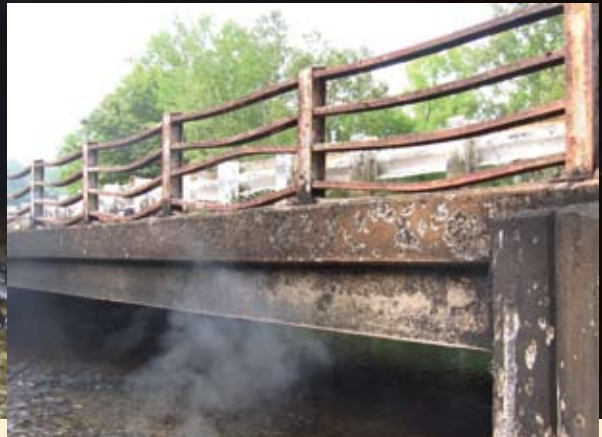
Gasoline that spilled from the tanker-truck accident on the bridge over the Norwalk River near Ridgefield, Conn., caused spalling on the precast concrete but left it in "reasonably good shape," engineers reported.

The 50-year-old bridge, one of the first precast concrete bridges ever built in the United States, suffered significant amounts of spalled concrete on its beams, reports Arthur Gruhn, chief engineer. Reinforcing was exposed in a number of locations. "We really had no idea of how strong the bridge still was," he says. Despite its age, the bridge had been in good condition, and there had been no plans to replace it.

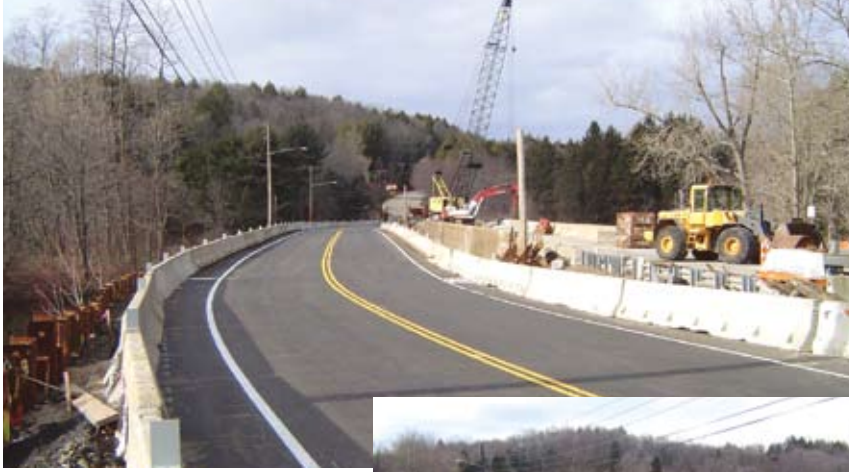
Using temporary precast adjacent box beams offers a number of advantages for bridge construction.

"Using temporary precast adjacent box beams offers a number of advantages for bridge construction," says Michael P. Culmo of CME Associates Inc. in East Hartford, Conn., who worked on the project. The beams don't require a concrete deck, which eliminates the need for forming, casting and curing that material. Construction and removal of the bridge can be completed quickly, and the bridge components are durable and can be re-used for future temporary bridges, cutting costs.

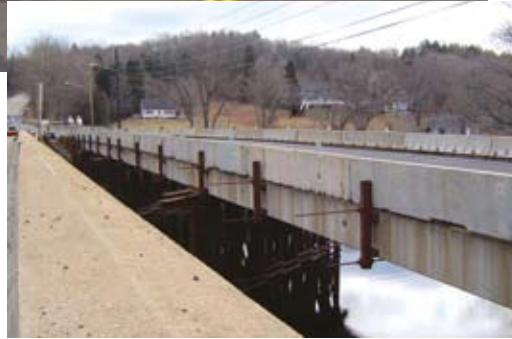
A temporary bridge in Connecticut made use of precast concrete adjacent box beams that had been stored for more than 10 years after earlier use for another temporary bridge.

The original temporary beams that were fabricated now are being used for a bridge carrying Route 151 over the Salmon River in East Haddam, Conn. The existing three-span steel through-girder structure had had a history of scour problems, but replacing it required a 17-mile detour. To avoid that, DOT officials decided to create a temporary bridge adjacent to the original while construction was underway and to use the existing precast concrete beams for the temporary design.

The span lengths coincided, but the East Haddam bridge featured a significant skew of 45 degrees, compared to no skew at the earlier project for which the temporary girders had been built. To re-use the beams, a system of external post-tensioning was developed to accommodate the different skew. This focused on creating a framing layout that featured a saw-tooth end pattern. The detailing of the abutment backwalls was modified to accept the saw-tooth beam configuration.

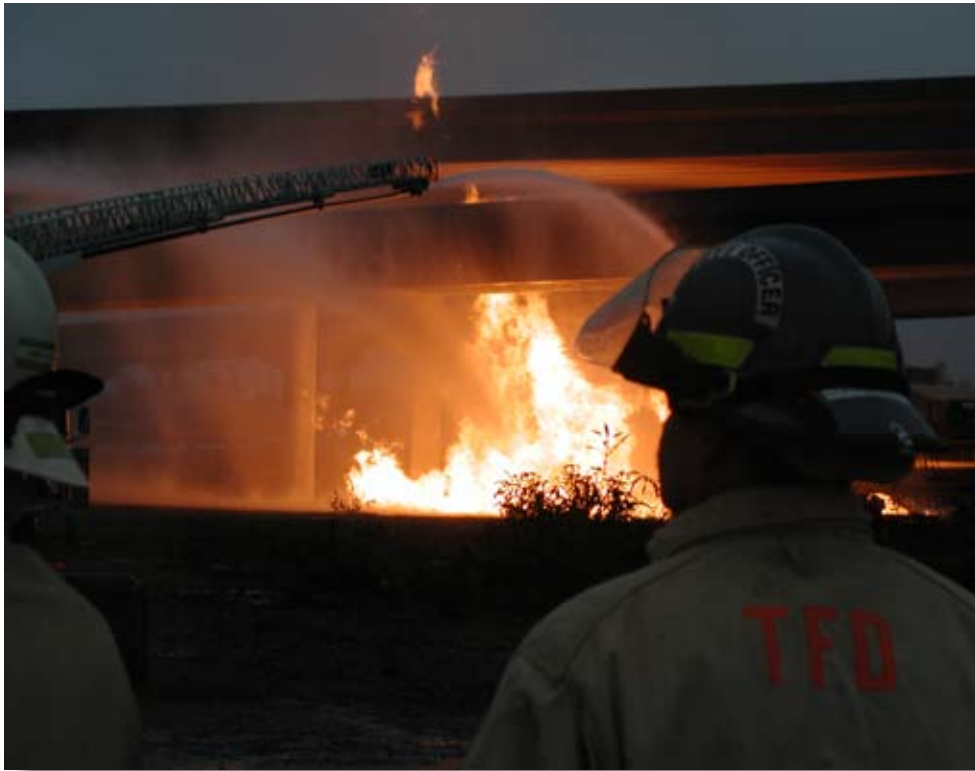
Flame temperatures beneath the precast concrete bridge approached 3,000° F.

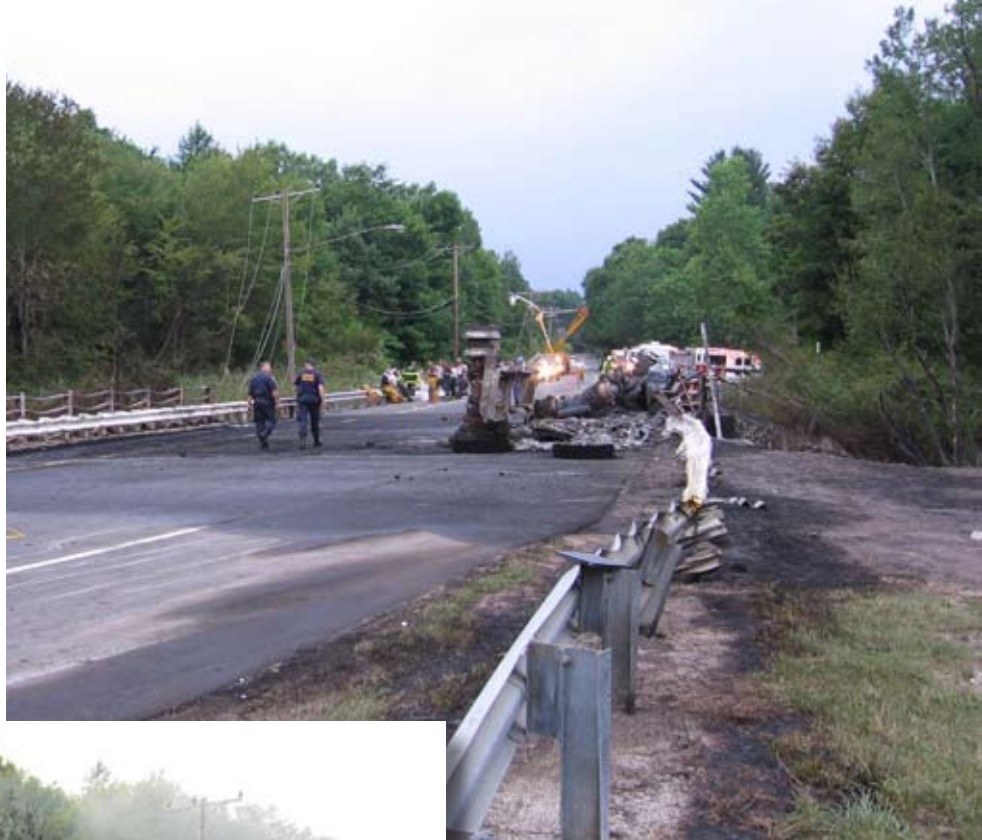
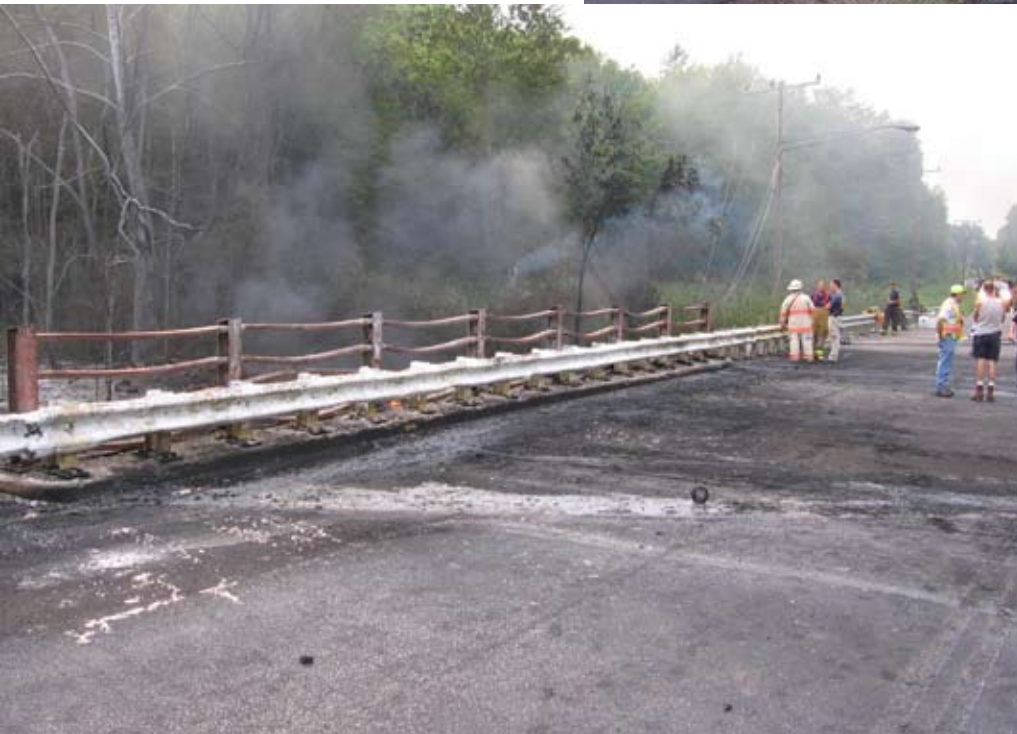
Gasoline that spilled from the tanker-truck accident on the bridge over the Norwalk River near Ridgefield, Conn., caused spalling on the precast concrete but left it in "reasonably good shape," engineers reported.

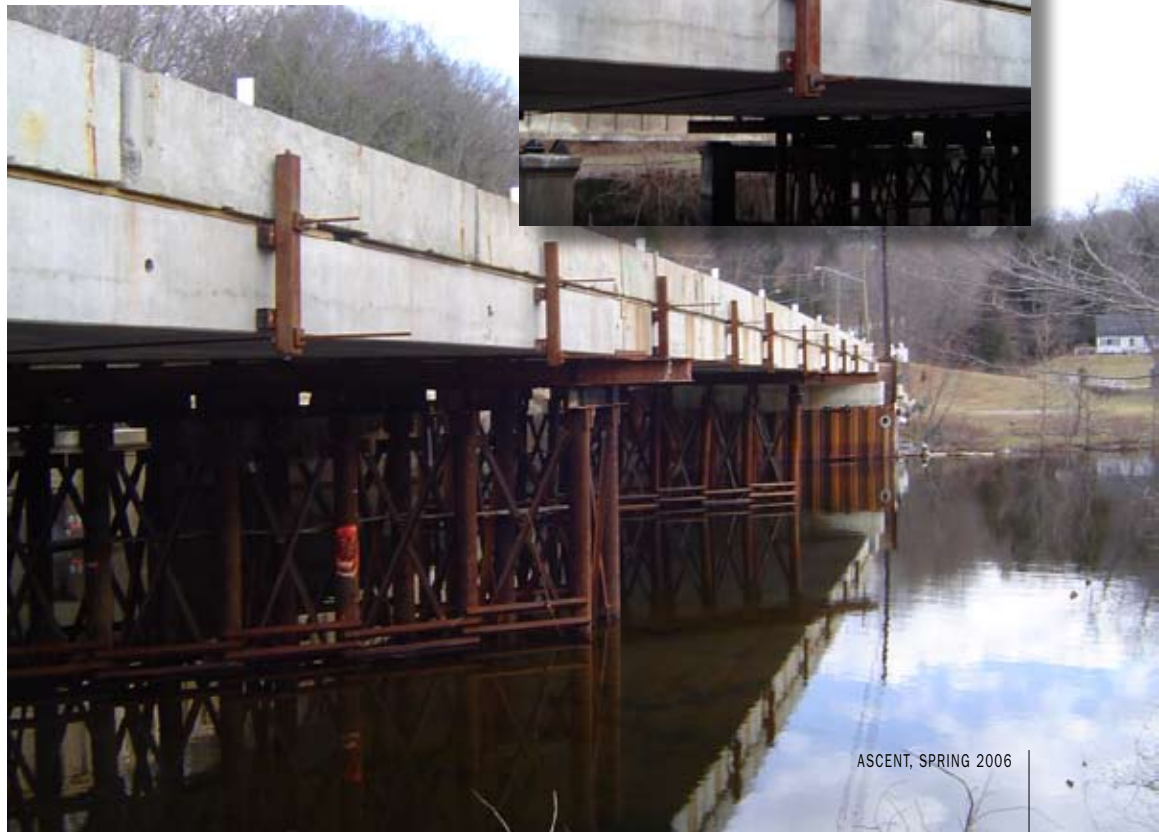
Temporary Bridge, Connecticut

A temporary bridge in Connecticut made use of precast concrete adjacent box beams that had been stored for more than 10 years after earlier use for another temporary bridge.
