Resiliency in Action

Projects around the country show precast concrete's ability for ensuring structures withstand the worst nature can create

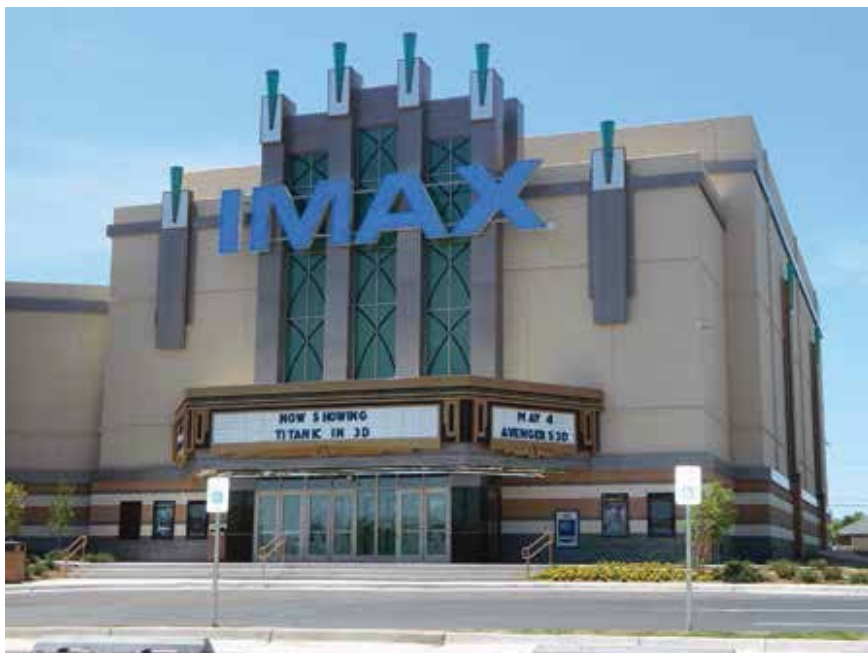
A number of factors allowed the precast concrete panels on the Imax Theater addition to the Warren Theater in Moore, Okla., to survive intact when tornadoes hit the area in May. Patrons survived without injury, and the theater was turned into an emergency center. Photos: Coreslab Structures (OKLA), Inc.

The Warren Theatre's IMAX addition stood in the path of an EF-5 tornado that tore through Moore, Okla., on May 20, 2013. The destruction around the theater from the tornado, whose winds reached as high as 200 mph, was near total. But the theater itself withstood the barrage and offered a safe haven for about 50 patrons, then served as an emergency rescue center afterward.

The structure features wall panels as tall as 57' 4", some of which had clear spans exceeding 54 feet. The size was required to provide the sight lines and height required for the large IMAX movies, Morris explains. The majority of the structure was constructed with load-bearing wall panels to support the steel-framed roof, while a handful of the wall panels were nonload-bearing panels.

3. Tall walls. One of the major design changes to make the panels more resilient was the way they were connected to each other, he explains. This was done both to meet seismic needs but especially due to the tall clear spans that were needed. Most of the wall panels were cast with pilasters on each side, which created C-shaped cross-sections. The panels were 6 inches thick, with the 12- by 16-inch rectangular pilasters flanking them for nearly their entire height.

4. Prestressing. In addition to creating the secure connection system, the precaster prestressed the panels to provide added strength. The goal was to prevent any bowing or cracking over the length of the clear span, but it also provided durability that hadn’t been planned. “The prestressing is a huge reason the panels performed so well,” he says. “It made them virtually impact resistant.”

“There’s no doubt the panels were impacted by debris, but it appeared, upon visual inspection, that none of the panels had even cracked. The pilaster system and the prestressing in particular gave the panels the extra out-of-plane bending resistance they required.”

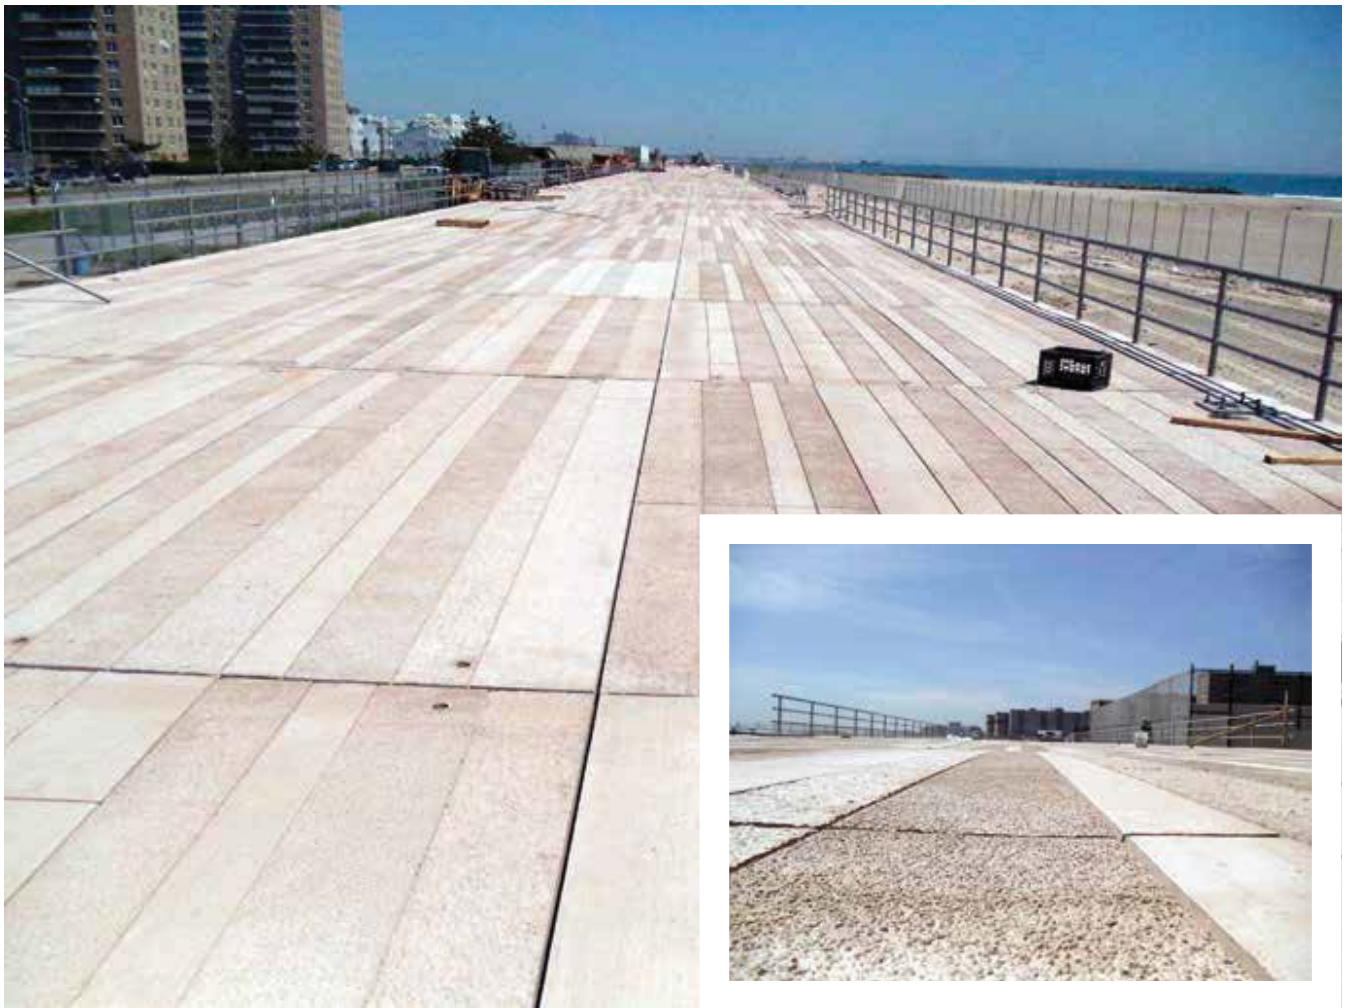
Precast concrete panels, formed to resemble five textured planks, were used in rows of five to produce an upgraded 10,000-linear-foot boardwalk in Queens, N.Y. The panels withstood Hurricane Sandy, the only portion of the boardwalk to remain intact. Photos: Steve Kenepf, U.S. Concrete Precast Group.

The boardwalk features 8- by 20-foot precast concrete planks with four alternating textures created with formliners within each panel to mimic the variety found on a traditional wooden boardwalk. Five panels were needed to span the 40-foot-wide boardwalk.

The panels were designed as miniature double tees, with two stems projecting from the underside. The stems were slid over the pile caps, fasteners were drilled into the cap, and the plank was bolted to it. "It was a fairly simplistic system, but it worked very well," Sa says. "The pieces were installed very quickly with this design."

The resulting boardwalk was the only part of the structure to survive. It remained intact after the hurricane passed. "Cracks developed in a few of the panels, but they were easily repaired," Sa says. None of the panels had to be replaced. Not only did that allow the boardwalk to survive, but it prevented any part of it from adding

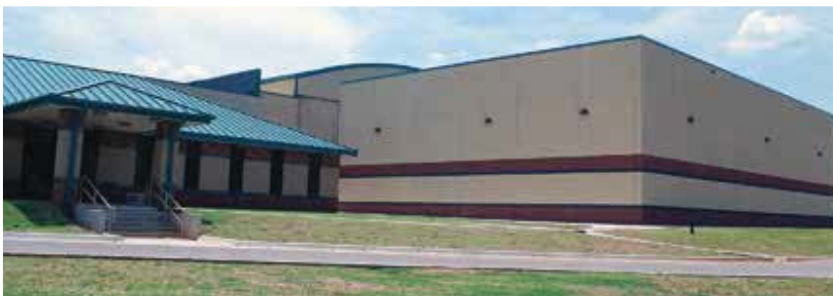
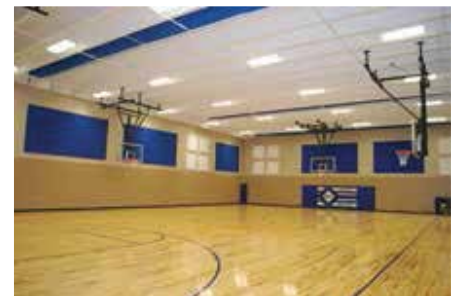
The Oakdale High School in Oakdale, Okla., was designed with a total-precast concrete system, including double tees spanning 68 feet and 12-inch insulated precast concrete sandwich wall panels, which included 2 inches of insulation. Using 12-foot-wide wall panels and 8-foot-wide double tees allowed every third double tee to cross the wall joint and lock the panels together, reducing connections to resist loads across the joints. The building meets FEMA standards for safety.
