# 1300-Ton-Capacity Prestressed Anchors Stabilize Dam

by A. Eberhardt and J. A. Veltrop\*

## SYNOPSIS

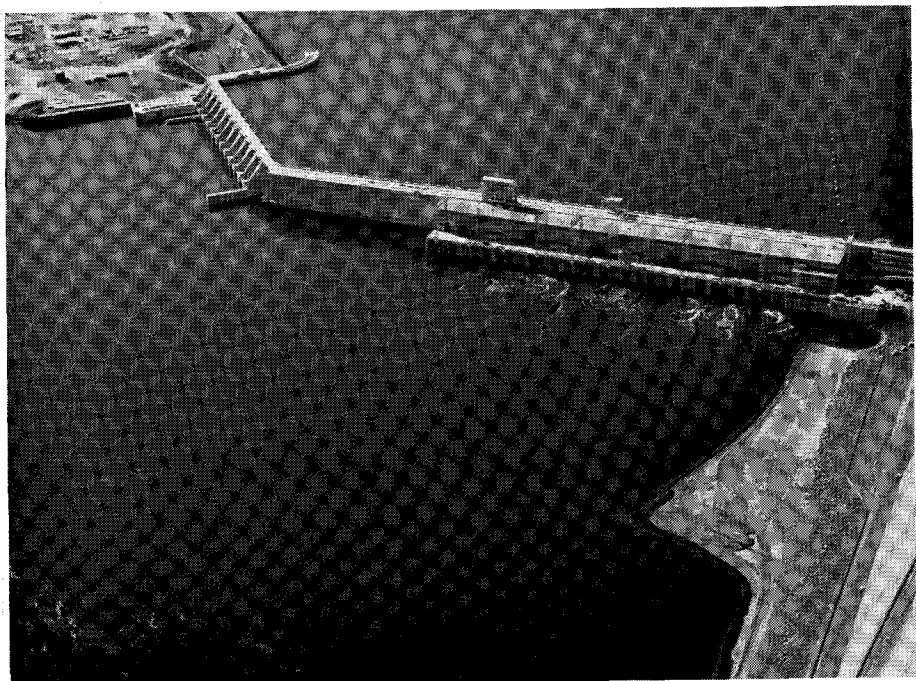
The Wanapum Project is on the Columbia River, about 415 miles north from the mouth, in central Washington. It consists of earth embankments and concrete structures: a gated spillway and a powerhouse with an integral intake (Fig. 1).

Fig. 1—Wanapum Hydroelectric Project

The powerhouse structure, 1540 feet long, contains 10 generating units, an erection bay, and the intakes for an additional six units to be installed in the future (visible between the powerhouse and the spillway in Fig. 1). Each generat-

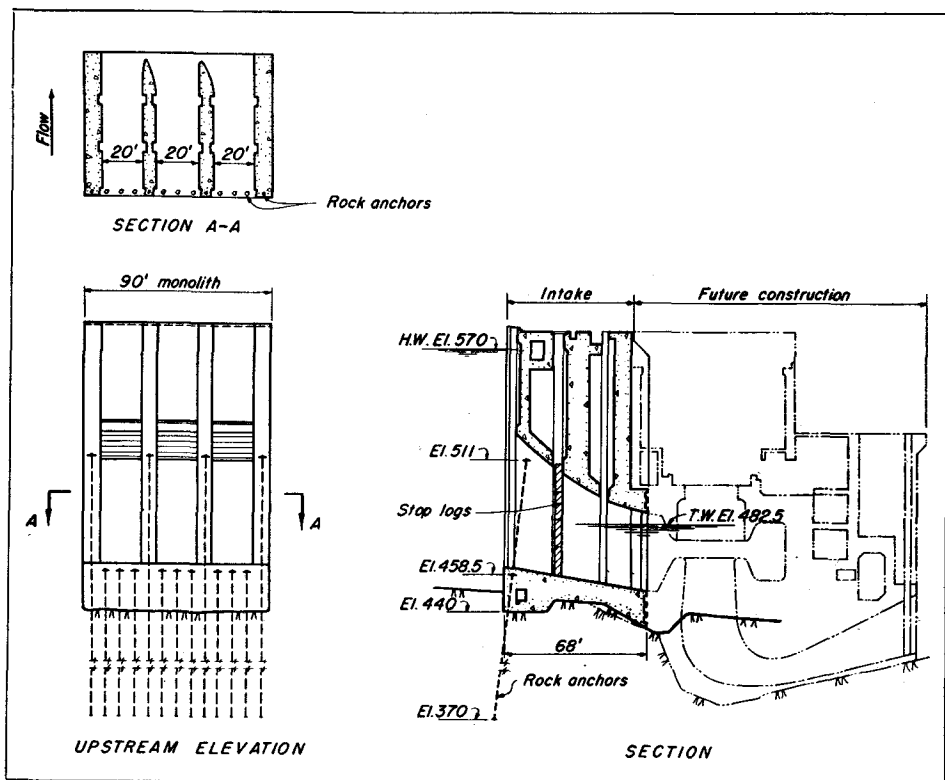
The design of the six intakes for the future units, however, presented a problem because of their narrow 68-foot base and inherent lack of stability (Fig. 2).

Fig. 2—Future Unit Intake

The 18 openings, each 20 feet wide (Fig. 2), of the six intakes provided ample capacity for low flow season diversion when the construction of the left earth embankment was to block the river permanently. The actual headwater rise experienced during the diversion was only a little over two feet for a maximum flow of 120,000 cubic feet per second.

The necessary anchorage for each intake monolith was provided by 13 anchors extending deep into the basalt foundation. Nine of them anchored the floor slab of the intake; the remaining four extended upward, anchoring the individual piers (Fig. 2). The design load per anchor was 2540 kips or nearly 1300 tons.

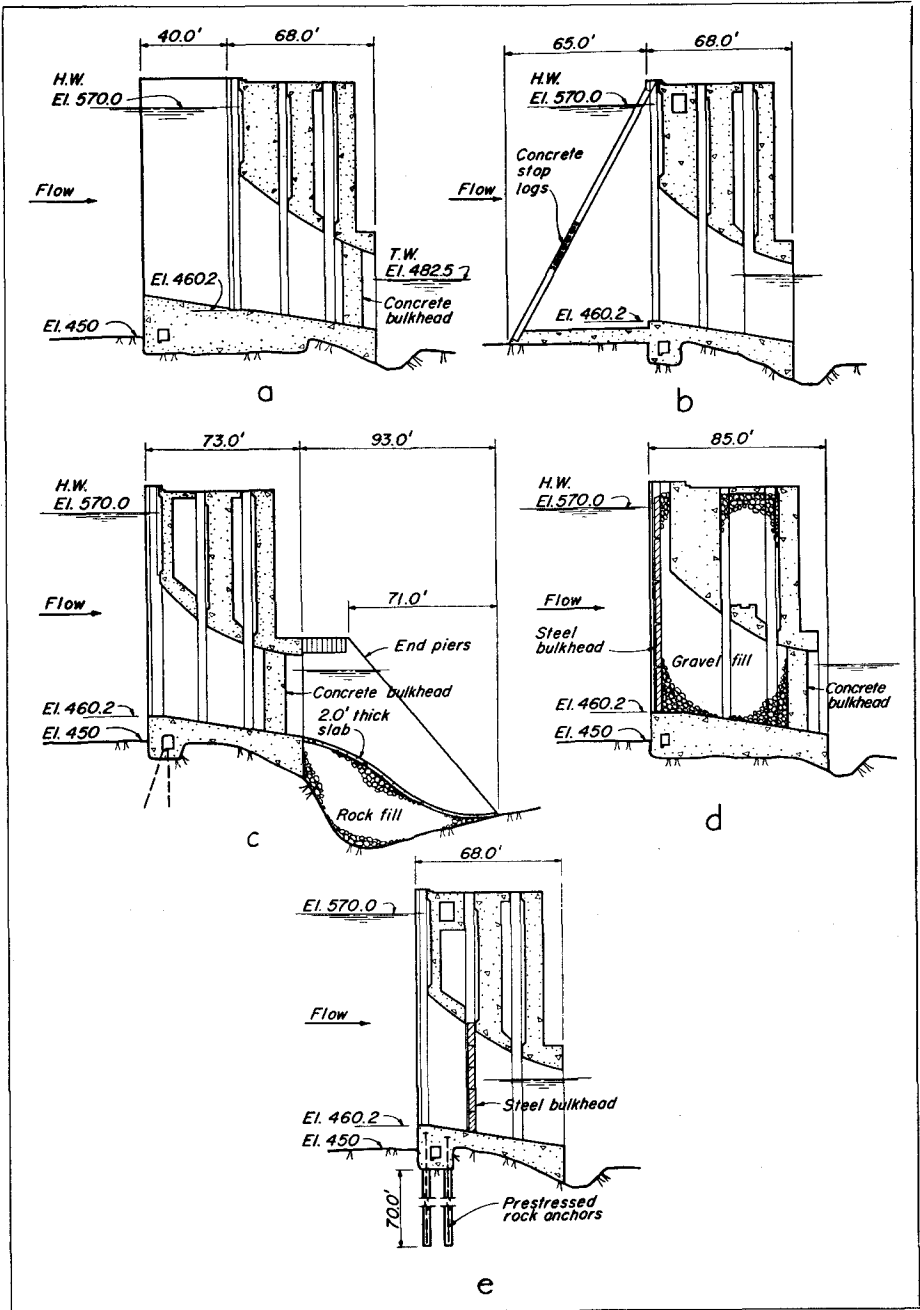
The study of ways to stabilize the narrow intake structure produced five different schemes. They were as follows (Fig. 3):

- a. Extending all piers and the floor slab upstream.
- b. "Buttress dam" scheme: piers extended upstream supporting an inclined deck composed of precast elements.
- c. Extending the two end piers of each intake monolith downstream.
- d. Weighing down the intakes with gravel fill.
- e. Anchoring down the intake with deep, prestressed rock anchors.

Fig. 3—Alternate Design Studies

Cost estimates revealed that schemes *c* and *e* were the least expensive and about equal in price. Scheme *e*, however, represented the "cleanest" design, while various objections could be raised against other schemes.

Extending the piers upstream, as in schemes *a* and *b*, was undesirable for several reasons: (1) probable adverse effect on the approach flow to the spillway; (2) interference with the usual construction plant layout—whirley crane tracks

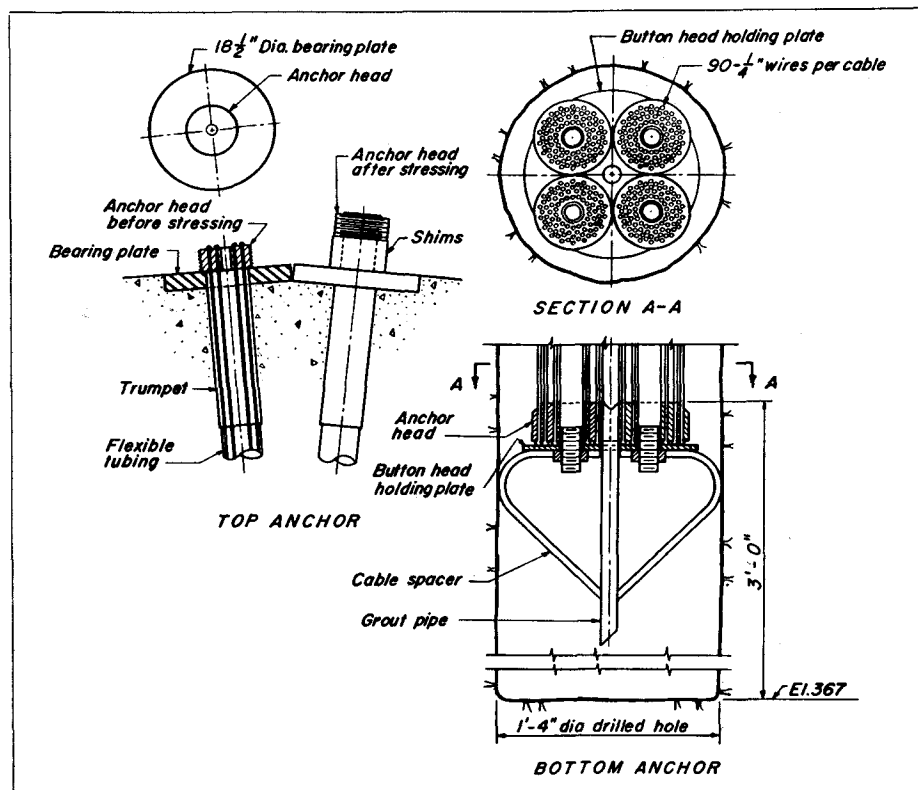
the United States some time ago. The BBRV system uses parallel wires with cold formed button heads at the ends bearing on a perforated steel anchor head. Each anchor proposed for Wanapum consisted of four parallel cables, each cable composed, in turn, of 90 ¼-inch-diameter wires (Figs. 5 and 6). At the top end, the four cables, each of 635 kip design capacity, flared out toward individual anchor heads 7.875 inches in diameter. Each anchor head rested, in turn, on an 18.5-inch-diameter bearing plate 2.5 inches thick.

At the bottom end, the wires were threaded through four anchor heads, each 5.75 inches in diameter. A thinner, single, holding plate supported the bottom ends of wires and

Fig. 5—Rock Anchor Details

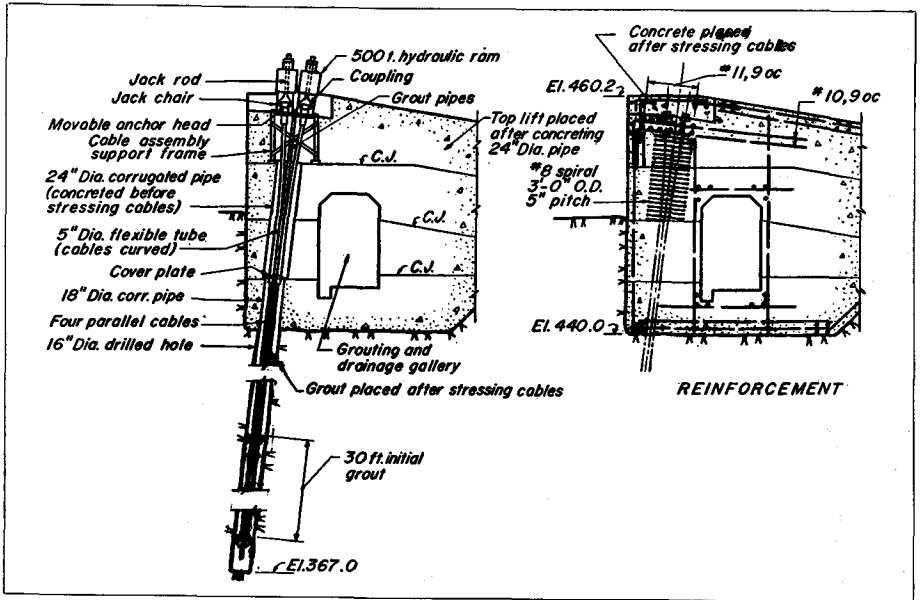
Fig. 6—Rock Anchor and Intake Floor

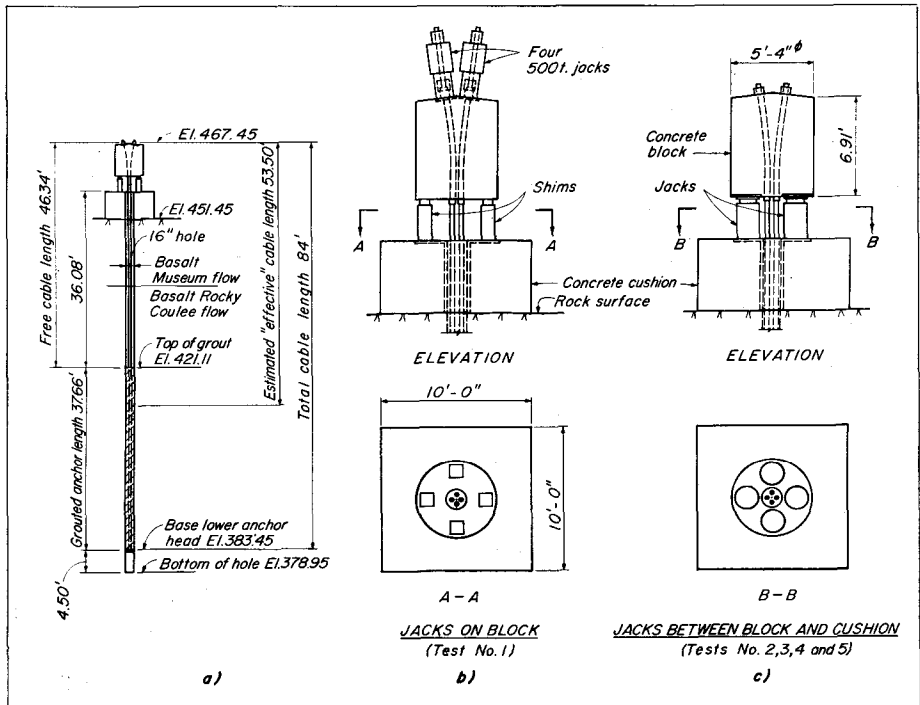
The over-all test setup is shown in Figure 7a. From top to bottom it consisted of the following features: a circular, heavily reinforced, movable, concrete head block resting, via four steel shims or four jacks, on a square, moderately-reinforced concrete cushion which transmitted the anchor force to the supporting rock. The jacks could be placed either on top of the concrete block (Fig. 7b), or below it (Fig. 7c). The 16-inch-diameter hole extended to a depth of 72.5 feet below the rock surface. The 84-foot-long cable passed through the head block and cushion into the hole to a depth of 68 feet below the top of the rock surface. The grouting of the lower end of the cable extended to a height of 37.66 feet above the base plate.

Fig. 7—Anchor Test Set-Up

Two tests were conducted on May 10, 1960. In Test 1, the jacks were placed on top of the head block as shown on Figures 7b and 8. This test was discontinued due to failure of one of the pull rods at about 35% of the ultimate strength. The results are shown on Fig. 9.

For Test 2, the jacks were placed between the concrete head block and the concrete cushion as shown on Figure 7c. The change in setup from Test 1 to Test 2 has no effect on the loading of the test cable and grout anchor; it did, however, eliminate the possibility of further checking on pull rods and nuts. Though not essential for the pull-out test itself, these loading devices were to be used for stressing all cables

A detailed analysis was necessary to explain the non-linear load-deflection relationships in various parts of the curves shown on Figs. 9 and 10. In the Appendix, it is concluded that these non-linear elongation increments cannot be explained satisfactorily by an increase of the effective length of the steel cable due to deformations within the grouted end, effective length being defined as the sum of the free length as shown on Figure 7, and a certain, unknown portion of the grouted

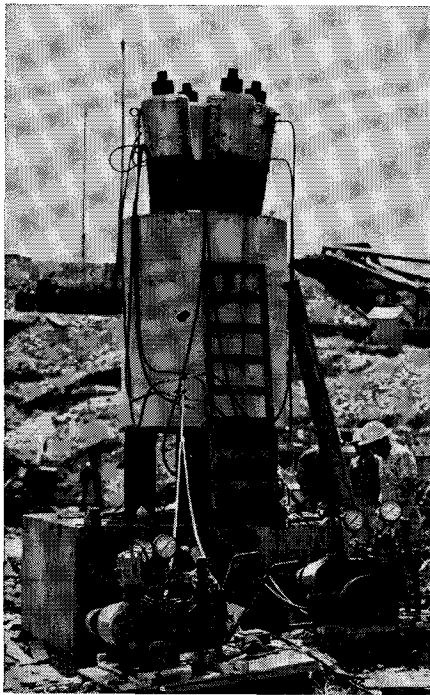
Fig. 8—Rock Anchor Pull-Out Test

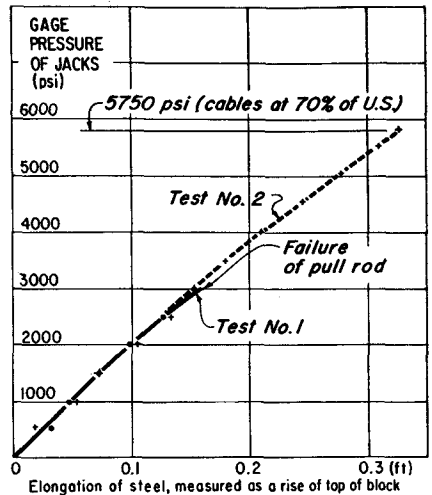
Fig. 9—Pull-Out Test Results No. 1 & 2, May 10, 1960

The results of this test are plotted on Fig. 9 together with those of Test 2. The data show a distinct curvature which could be due to gradual increase of effective length with increased load, or could be caused by non-linear behavior of the steel wires in the cable. The elongation may also be influenced by any one or a combination of the following factors: closing of fissures in the rock, deformations in the grout, and flattening of slight curvature in some shim plates.

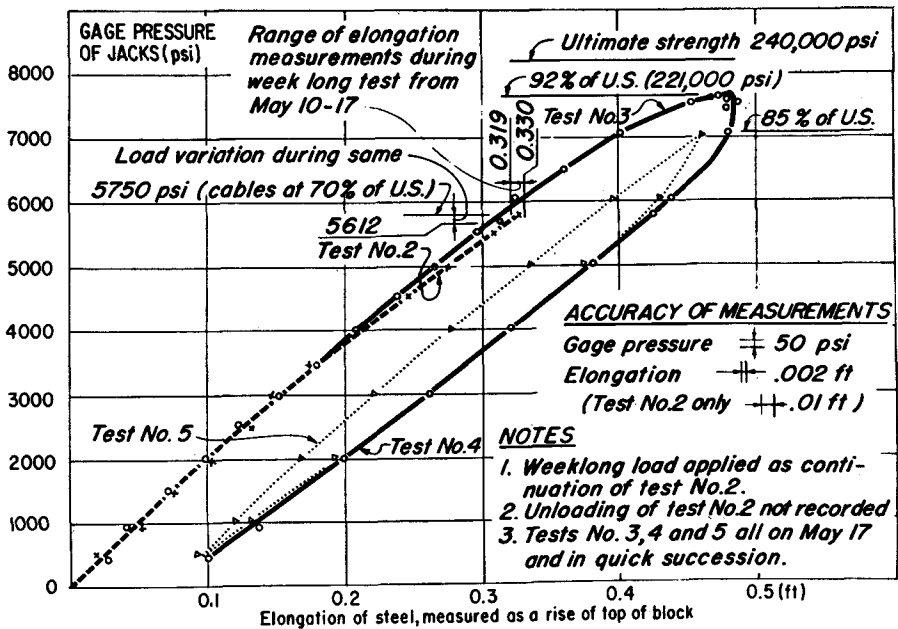
The time-duration test, Test 2, was performed during the week of May 10-17, 1960. Throughout this period, elongation and load measurements were recorded. The range of elongations under constant load is shown on Figure 10. It amounted to only 0.011 foot.

On May 17, 1960, after unloading the time test, two complete loading cycles were performed. In the first, called Test 3, the load was first brought up to 70% of the ultimate strength and then increased to 92% of the ultimate strength. At this point the pumps reached their capacity. This load was sustained for about two hours during which the elongation increased slightly, as shown on Figure 10. No other ef-

Fig. 10—Pull-Out Test Results No. 2, 3, 4 & 5, May 10-17, 1960

2. Plastic deformations, starting for this high-strength steel at 70-80% of ultimate strength—There is no definite yield point. The large elongation of Test 3 at the higher loads, as shown on Fig. 10, is explained this way.

The effective length computed from Tests 1 and 2 differ considerably, especially when it is known that the free length of the cable is 46.34 feet. The first observations in Table 1 result in effective lengths which are smaller than this free length, which is of course absurd. Disregarding the length of 93.1 feet for Test 1 because of failure, one can still explain the two highest values for Test 2 as an increase of effective length, perhaps due to slip of the wires near the top of the grout. Comparison of these latter data with the results of Test 3 at the same pressures, however, can only lead to the conclusion that effective length increase is not the explanation for the highest values attained in Test 2. This difference is also shown clearly on Fig. 10. If there was such an increase, the effective length in

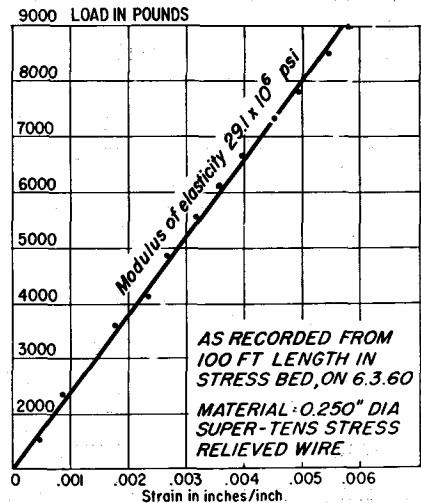
Fig. 11—Data from American Steel & Wire Div., U.S. Steel Corp. Laboratory Test

The actual characteristics of the high-strength steel wires used for the pull-out test were determined separately in the Cleveland Research Laboratories of United States Steel. The modulus of elasticity is  $29.1 \times 10^6$  psi. Individual readings as recorded on the chart (Fig. 11) indicate the small curvatures mentioned in Point 1 above. The hysteresis phenomenon, plastic deformation, and raising of the yield point are demonstrated on Figure 12. It is of interest to note that such a correlation between field and laboratory tests was also established for the pull-out test performed for Steenbras Dam in South Africa (see Ref. 9).

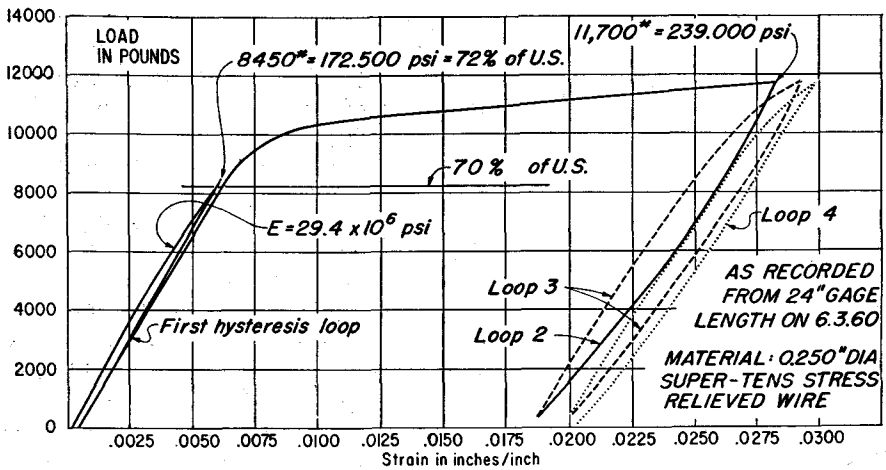
Fig. 12—Data from American Steel & Wire Div., U.S. Steel Corp. Laboratory Test

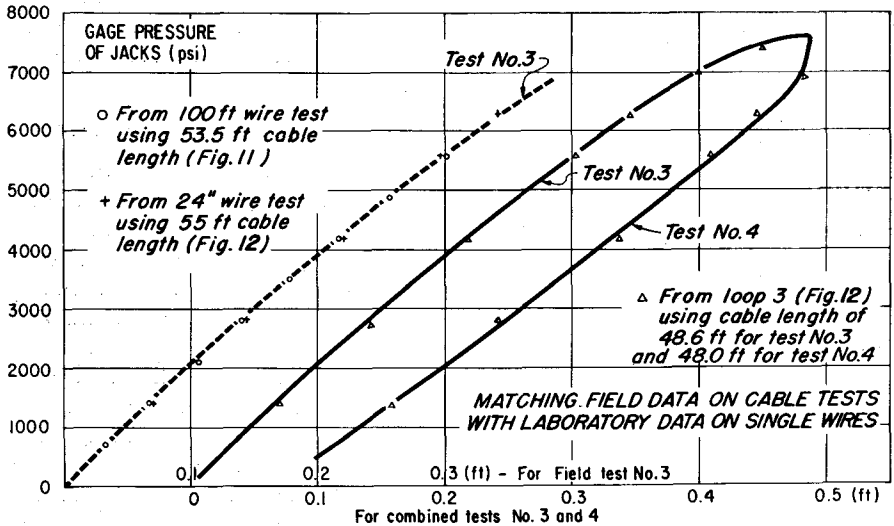
Fig. 13—Pull-Out Test, May 17, 1960

ratory data. Several such procedures are discussed in the Appendix and, as shown on Figure 13, result in an effective length of approximately 53.5 feet. With a free cable length of 46.34 feet, this leads to an effective embedded length of 7.16 feet. If it is assumed that strains in the cable decrease linearly from a maximum at the top of the grouted end equal to the strain in the free cable,

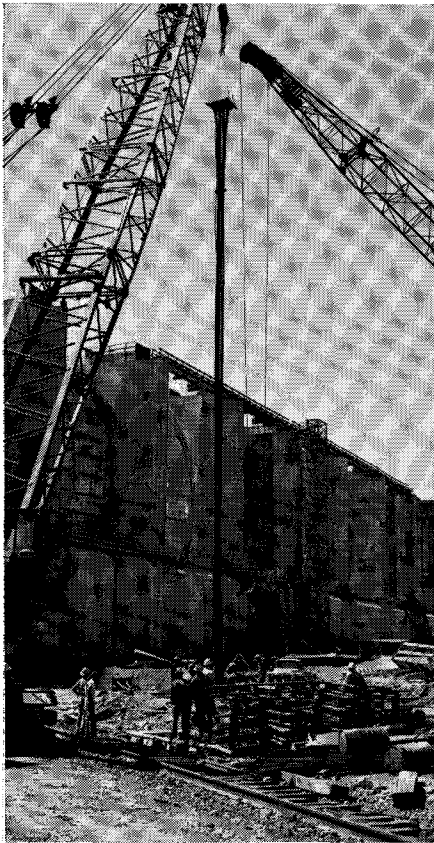
Each four cables were pre-assembled into a single anchor, lowered into the hole as a unit (Figures 14 and 15), and the bottom 30 feet of the hole grouted. Grout was designed to develop a strength of 4000 psi in 14 days at which time tensioning would start. It was similar in composition to the grout used in the pull-out test. It was also required that the intake concrete at the bearing plates of the anchor heads would

Fig. 14—Crane Lifting an Anchor

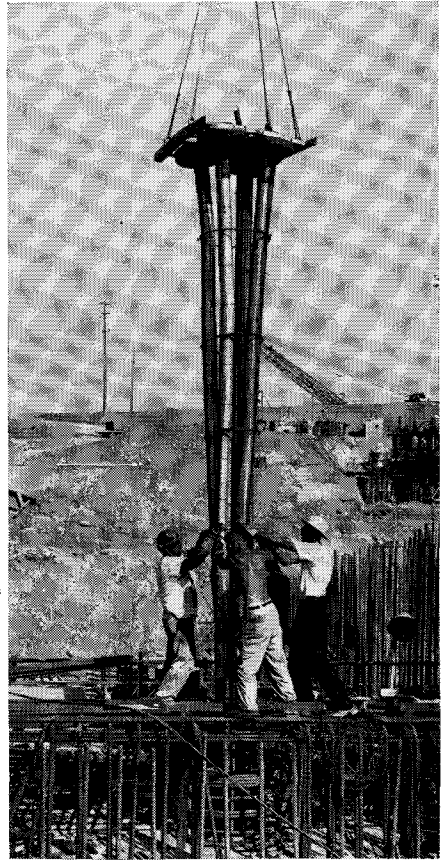
Fig. 15—Lowering an Anchor

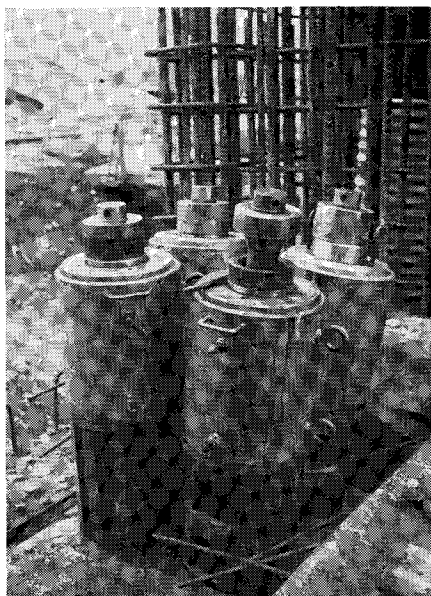
Fig. 16—Four 500-Ton Jacks for Stressing an Anchor
