# Design and Construction of the Houston Ship Channel Bridge

Describes the major design and construction highlights of the \$60 million Houston Ship Channel Bridge, a prestressed concrete segmental structure having a record length 1500 ft (457 m) main span. The approach spans use Texas DOT standardized prestressed I-beams.

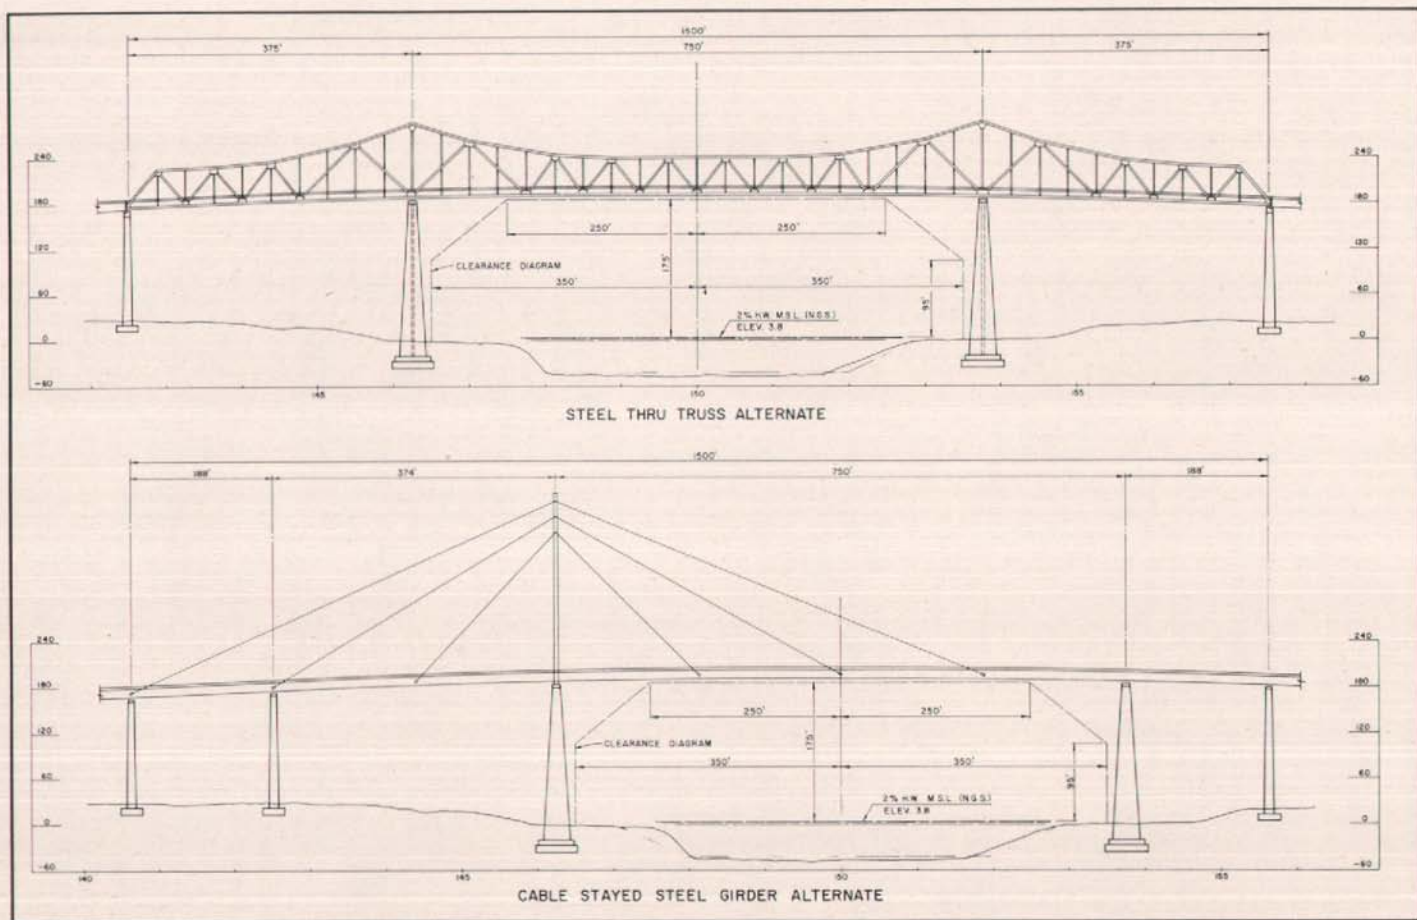
(c) Steel cantilever through truss, concrete and steel cable-stayed girder.

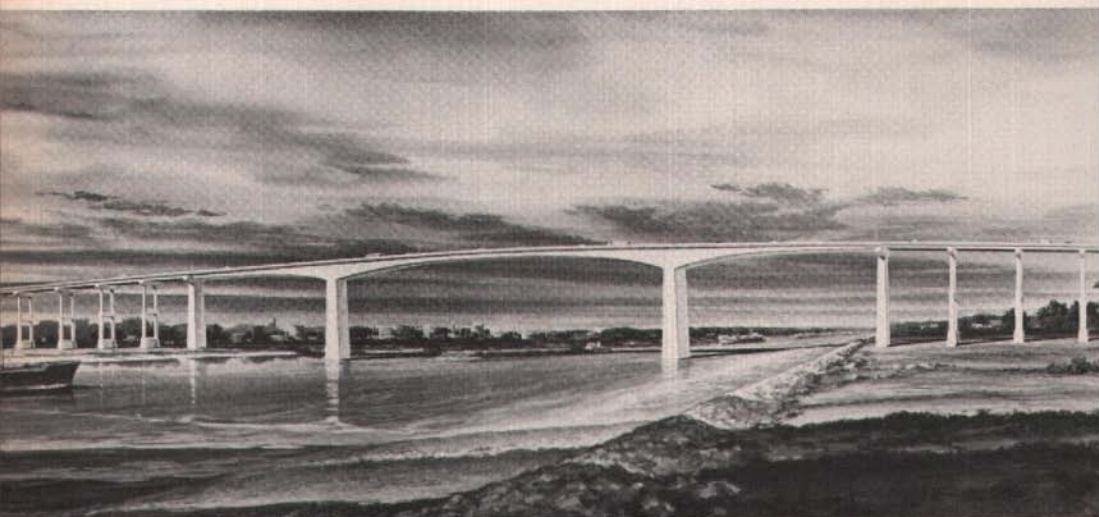
Fig. 6. Artist's rendition of Houston Ship Channel Bridge.

The shape of the soffit haunches was changed from circular to parabolic with a deeper section at the piers but the general longitudinal shape differed too little to be visually apparent (see Fig. 6).

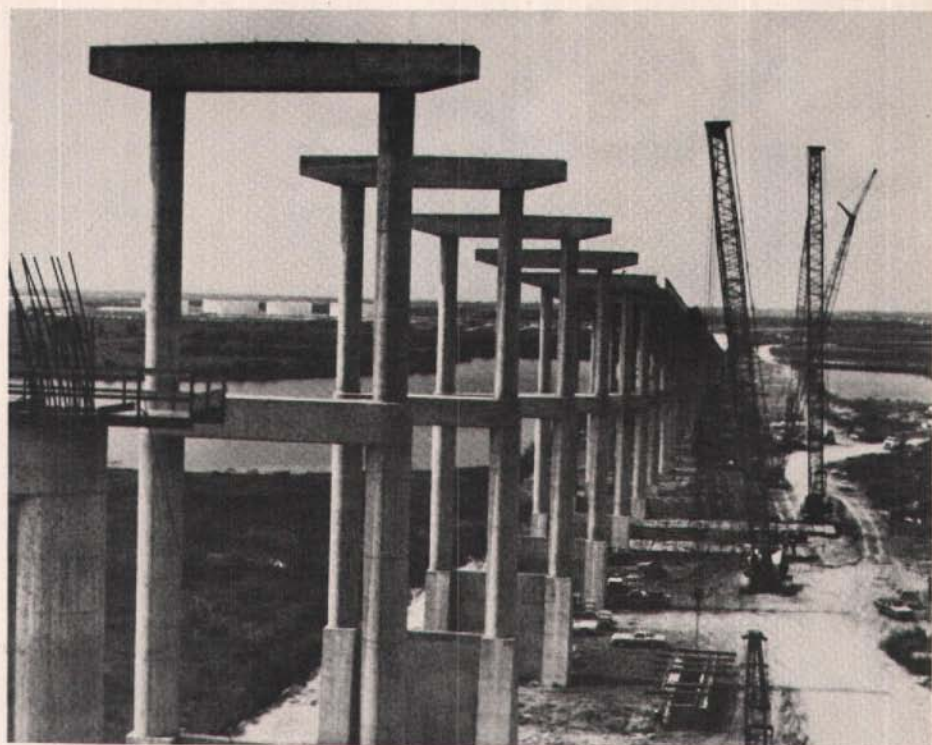
Fig. 7. Piers on land approaches.

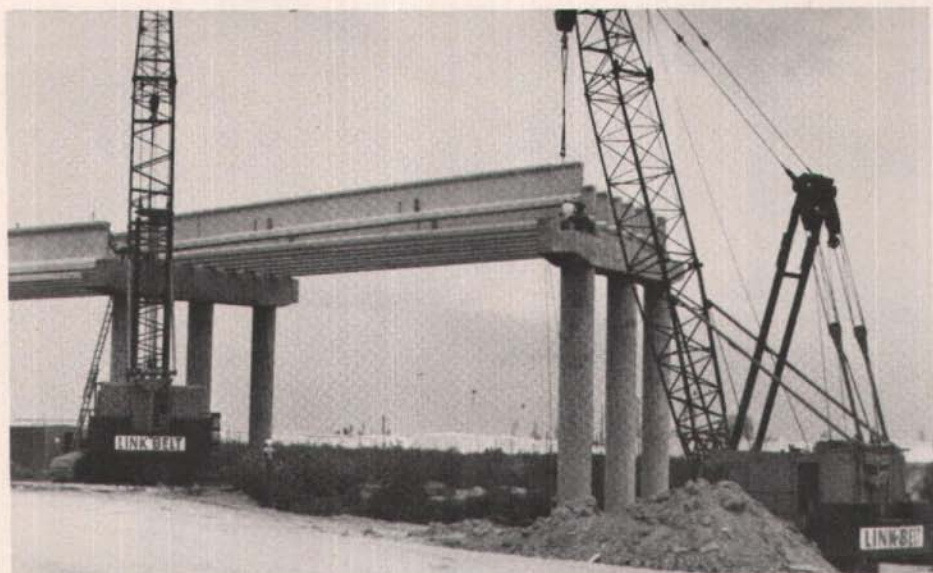
Superstructure construction started with beam erection. On this project 54-in. (1.37 m) AASHTO type beams for the 120-ft (36.6 m) spans were set on elastomeric bearing pads. Each contractor had his own method of setting beams. Most contractors utilized two cranes in setting beams, as shown in Fig. 8. One contractor developed a delta frame consisting of tubular steel for the delta and flat plates for stiffeners. This approximately 25-ft (7.6 m) lifting frame permitted him to lift most of the beams with a single crane. Steel diaphragms were used to provide stiffness and lateral support during construction.

Fig. 8. Placing AASHTO type beams on land approaches.

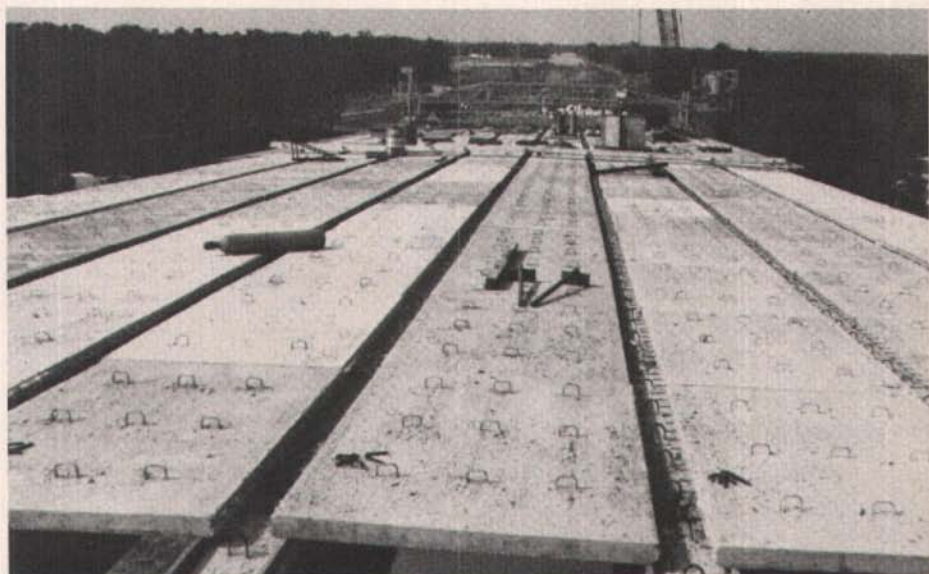
Similarly, some contractors elected to use precast prestressed concrete deck panels in lieu of conventionally placing the deck (see Fig. 9). These 4-in. (102 mm) panels were prefabricated on site and put into place with a 3½-in. (89 mm) cast-in-place deck placed on top of them. This composite deck panel eliminated the wood formwork. Finally, after the decks were placed, the median and parapets were placed. The parapet was a conventional "Jersey Barrier" type. It was, however, 1 ft (0.3 m) higher than the conventional barrier and heavily reinforced. On some contracts this barrier was cast in place in conventional forms, on others it was slipformed. The median was either precast, poured in place in forms or slipformed, depending on the contractor.

Fig. 9. Precast prestressed concrete deck panels used on land approaches.

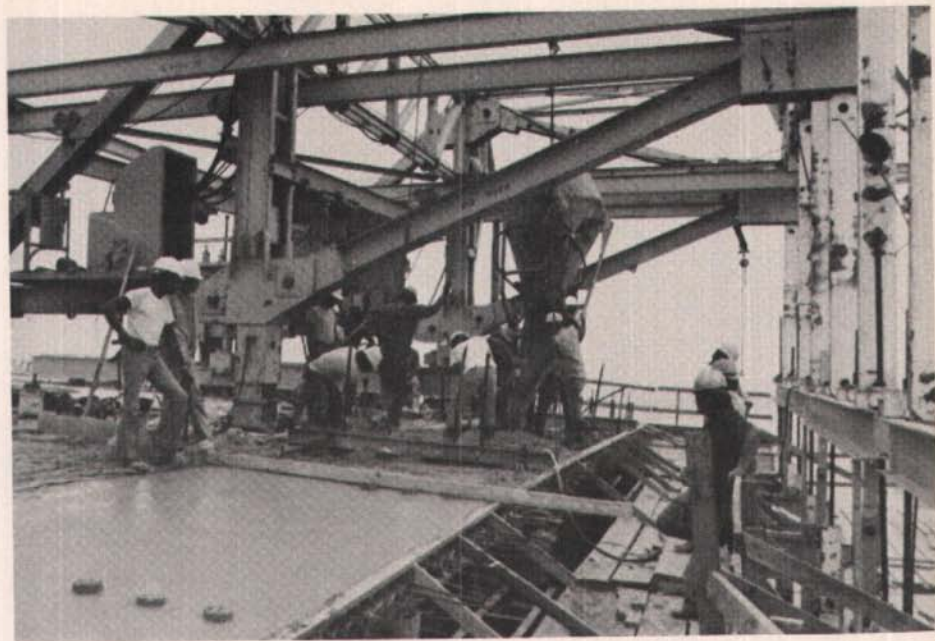
Fig. 16. Concrete placement with crane and bucket.

The tower crane for the project was capable of directly serving only 20 of the 58 segments to be placed (see Fig. 16). Beyond the reach of the tower crane the contractor devised a system of lifting the 2 cu yd (1.53 m<sup>3</sup>) bucket to the top of the pier, unloading approximately 7 cu ft (0.2 m<sup>3</sup>) to a motorized buggie, running the buggie to a ramp and dumping it into a conveyor which took the concrete into the forms. This was later modified to a forklift operation which eliminated the ramp and motorized buggie (see Fig. 17). This modification reduced the concrete placing time from 12 hours to 7 hours and greatly enhanced the quality of the concrete poured.

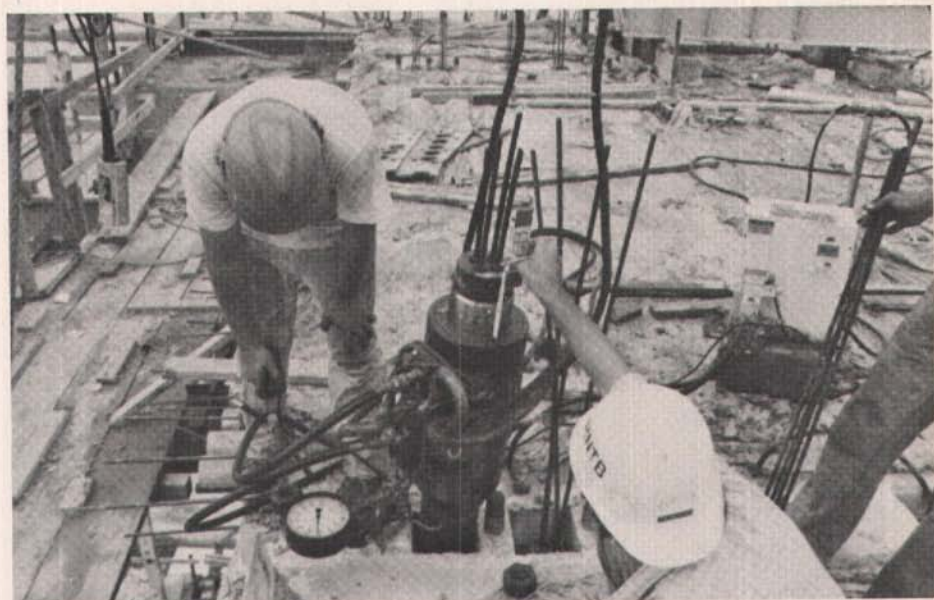
handled with extreme caution. The stressing of the 270 ksi (1860 MPa) low relaxation strands was controlled on this project by achieving the desired elongation of the strand within the limits of force allowed in the specifications as measured by the jacking pressures. In order to minimize differential stress on the structure, simultaneous stressing was required in the longitudinal tendons when stressing the large tendons. This required two-way communication between the contractor's personnel and the inspection team. Because of the amount of friction losses, dead-end stressing was a necessity. Stressing was a complex operation that required close monitoring by the engineer and a thorough knowledge of the forces and reactions involved in every phase of the stressing operation (see Fig. 18).

Fig. 18. Stressing of vertical tendons.
