Tests of 24 in. Square Prestressed Piles Spliced With ABB Splice Units

Static load tests were conducted on nine 24 x 24 in. (610 x 610 mm) pretensioned concrete piles which were made from two segments joined by ABB pile splices. Three spliced piles were tested in tension, three in bending, and three in compression. The purpose of the investigation was to confirm that large size splices can be designed efficiently and to show that the splice can be applied confidently with a 24 in. (610 mm) square pretensioned pile.

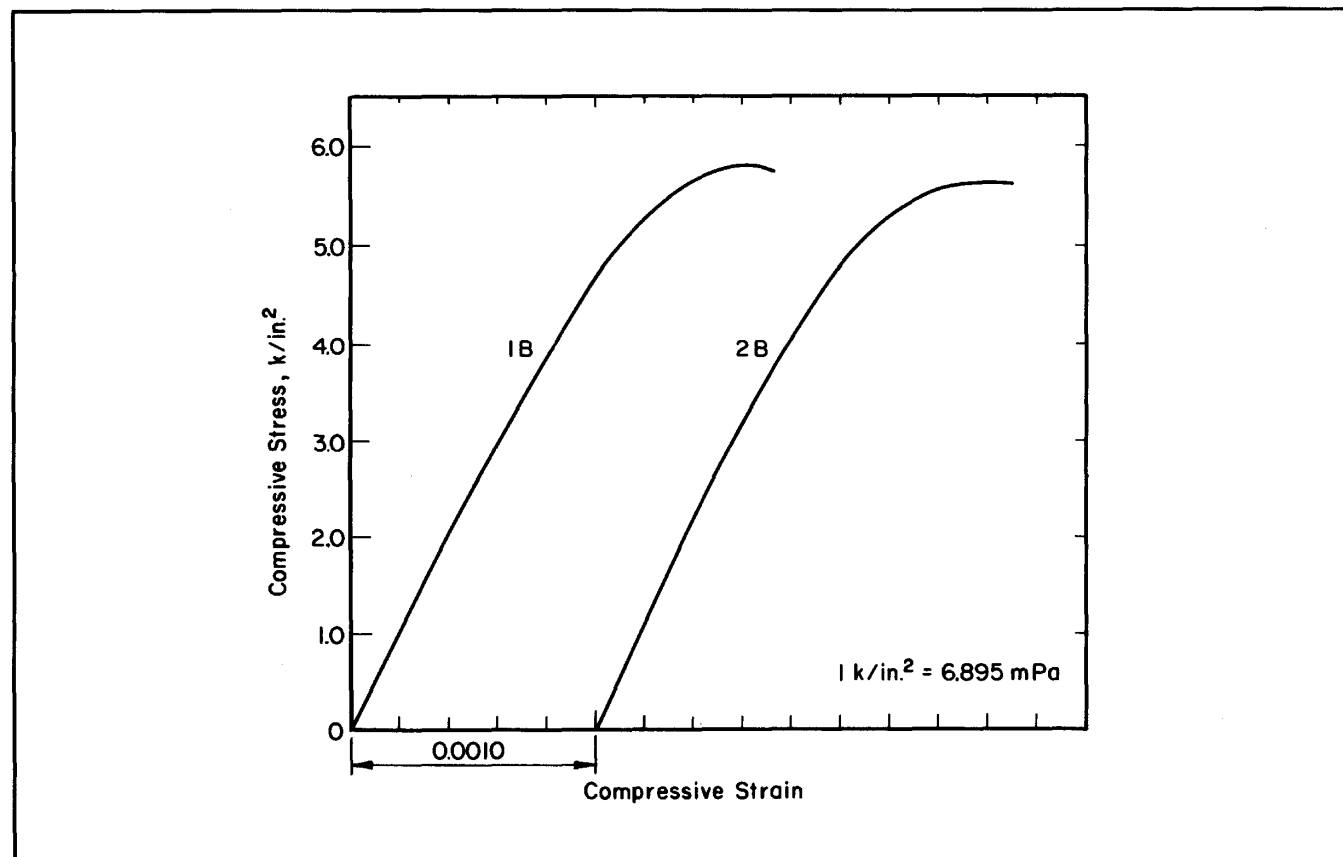
Fig. 4. Measured stress-strain curves for pile concrete.

The compressive strengths of the 6 x 12 in. (150 x 300 mm) cylinders, at the times of the various tests, are summarized in Table 1. Fig. 4 shows measured stress-strain curves from two of the cylinders tested when Specimen B-1 was tested. The peak stresses were reached when the strain was about 0.0016. The initial tangent modulus values were 5.5 to 6 x 10⁶ psi (37.9 to 41.4 GPa).

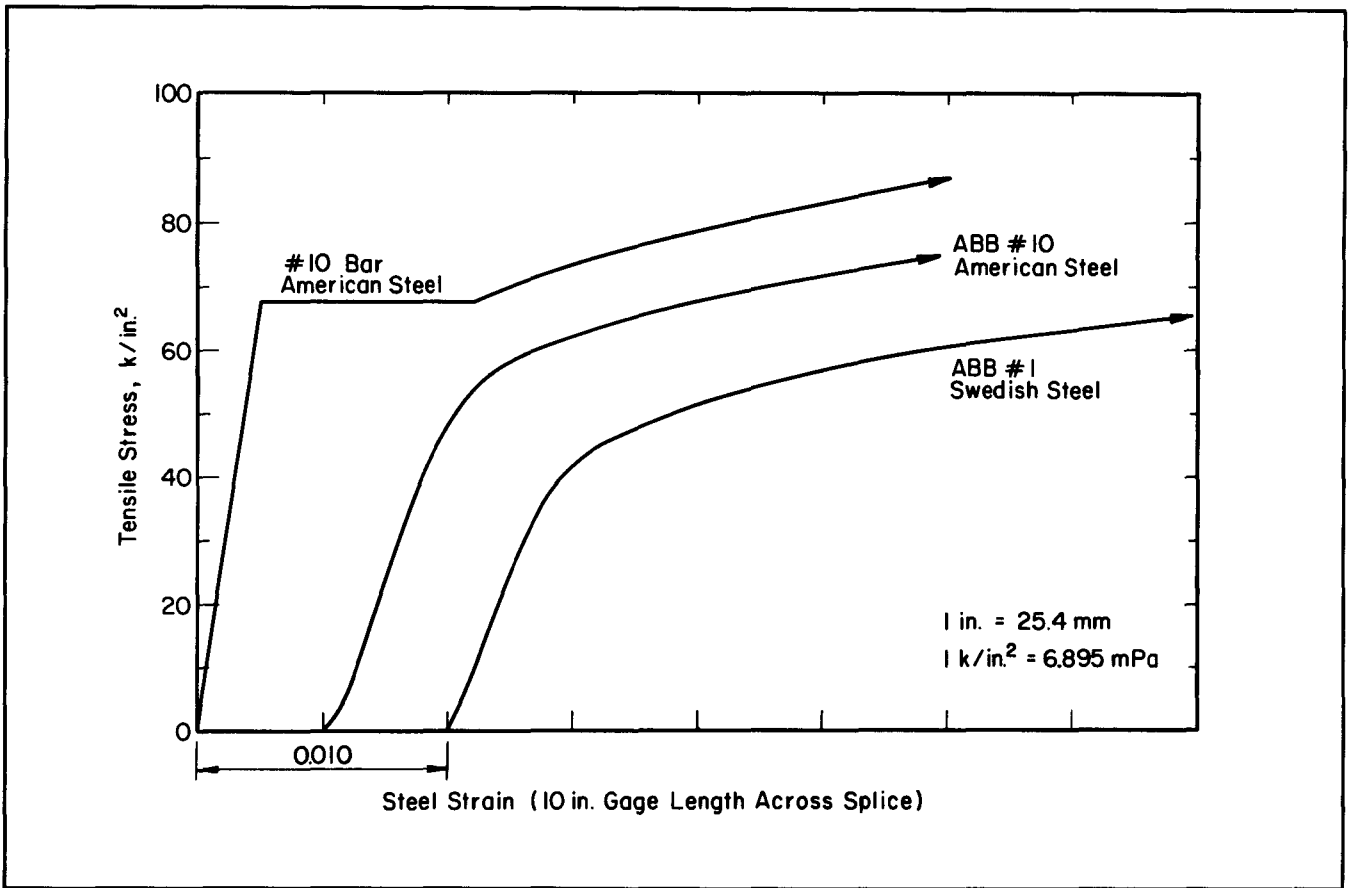
Fig. 5. Stress-strain curves for reinforcing bar and splice units.

shear pins were tested in air, as was a length of the #10 (32.3 mm) reinforcing bar. The results of three of the tests are shown in Fig. 5. The strains were measured with a 10 in. (254 mm) gage length extensometer.

after the extensometer was removed, and ABB-#1 failed at a nominal bar stress equal to 75.4 ksi (520 MPa). ABB-#1 failed abruptly after large visible deformation of the shear pin, and appears to have broken the shear pin, in pure shear, at its inner end. ABB-#10 failed at 91.5 ksi (631 MPa), with a fracture of a reinforcing bar in its threaded length.

Another limit of the strength at the splice is the strength of the section considering the stress-strain curve for the splice unit. The stress-strain curve ABB-#1 shown in Fig. 6 was used in the analysis, and with this highly nonlinear curve the moment capacity was found to be $M_n = 437$ kip-ft (592 kN-m). This is an unduly pessimistic assessment of the strength, however, since it is assumed that the entire bar has the same stress-strain curve in both tension and compression, while in the beam the actual response at the splice must be somewhere between that corresponding to the splice unit and that corresponding to the full section #10 (32.3 mm) bar.

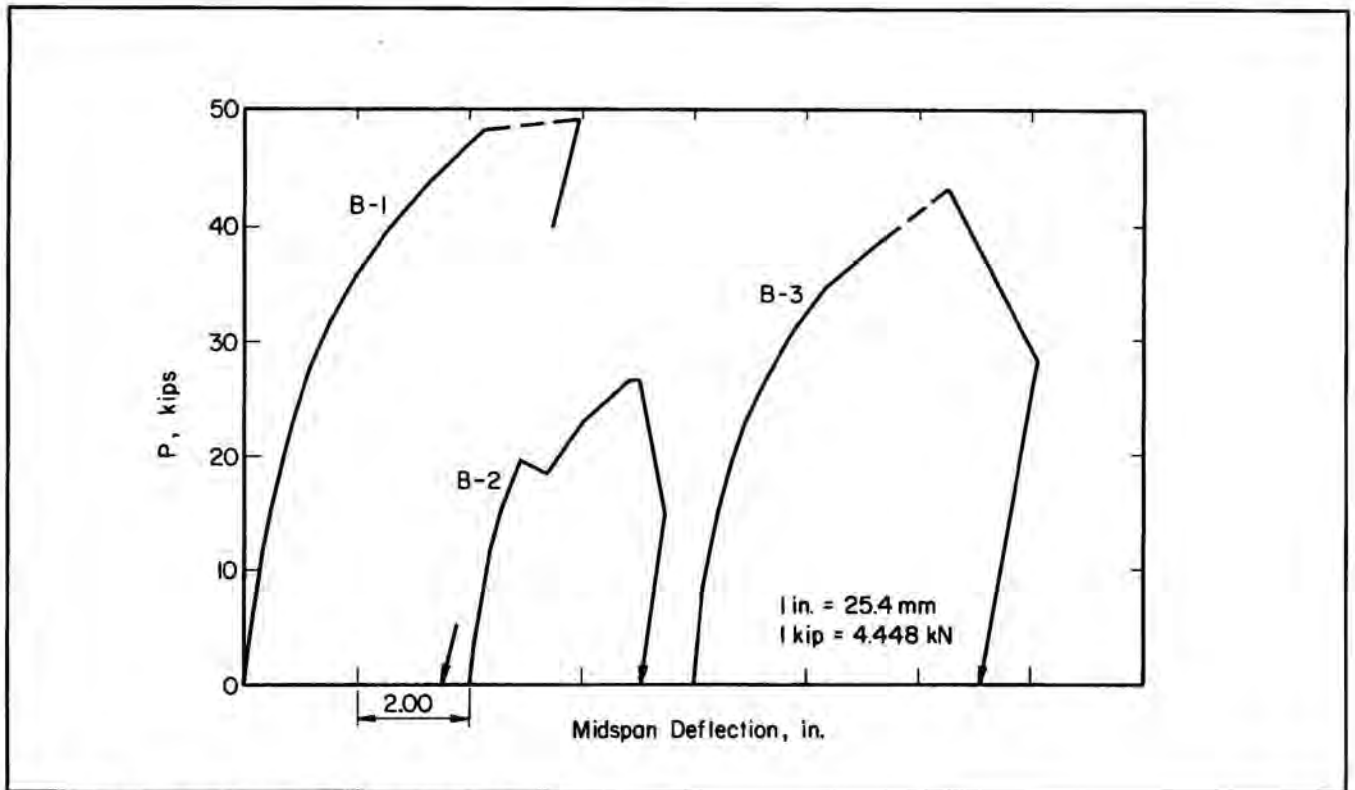
Fig. 12. Load vs. midspan deflections; bending tests.

Fig. 12 is the load-midspan deflection curve, noting that P is the total applied load from the rams at each load point, not including the weight of the loading equipment. The maximum force reached was 49.16 kips (218.7 kN) per load point, at a deflection of about 6 in. (152 mm).

Part of the load-deflection curve is shown as a broken line because of some uncertainties about the load in this region. There was a sharp increase in indicated load which apparently occurred when

the load shown at the end of the load-deflection curves. This final load was 49.16 kips (218.7 kN), and is believed to be reliable.

Fig. 12 also shows the plot of midspan deflection versus load for Specimen B-2. The load-deflection curve is quite different from that for Specimen B-1 in that the load reached 20 kips (89 kN) and then dropped somewhat, recovered, and then reached a second peak at 26.8 kips (119 kN) and then fell to a much smaller value. There were significant problems with the original assembly of this splice, and it seems likely that the first drop in load occurred when a #10 (32.3 mm) bar which had been screwed only two turns into the dowel failed by stripping of the threads.

Fig. 12 also includes the graph of midspan deflection versus load for Specimen B-3. The same problem caused by the sleeve nuts striking the double channel loading beam existed in this beam, leading to the

uncertainties indicated by the broken line. However, the decrease in load capacity from the peak force of 43.1 kips (192 kN) to the force of 28.4 kips (126 kN) was very real and was accompanied by a very loud, sharp noise from the specimen.

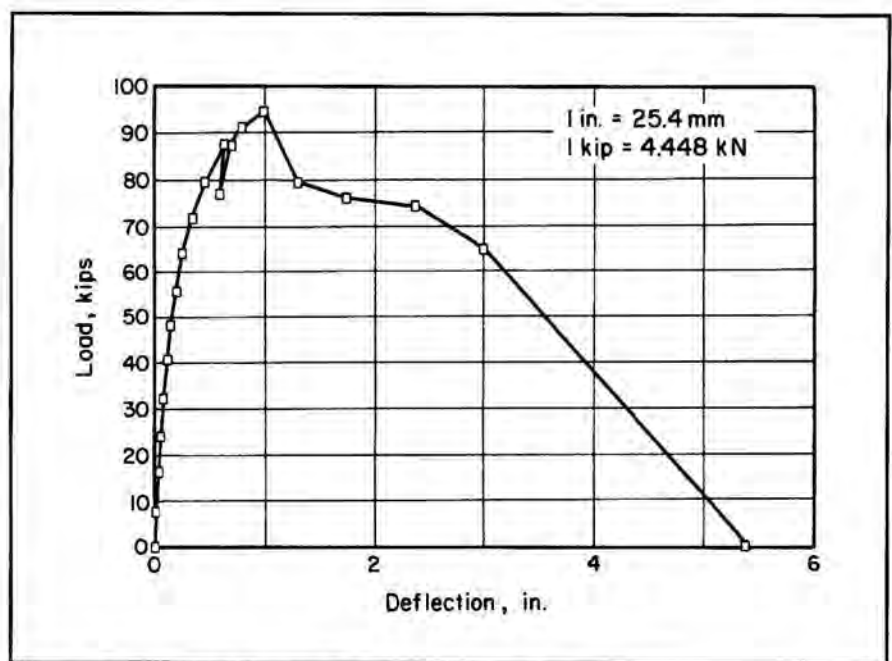
Fig. 18. Load-deflection curve for pile segment 15.

Fig. 18 shows the load-midspan deflection for Segment 15, and the others were all very similar. The curve was nearly linear to about 50 kips (222 kN) force at each load point. Previously existing cracks started reopening when P exceeded 32 kips (142 kN), and new cracks formed near midspan when P exceeded 40 kips (178 kN). Crushing

of the concrete was found when $P = 95.6$ kips (425 kN), and the load capacity then decreased to about 80 kips (356 kN) and then gradually reduced as the deformation was increased. Crushing developed to about the level of the top layer of strand and then stabilized. This stability was probably the result of relieving the remaining tension out of the upper layer of strands.

After additional deformation, several strands fractured at one section near midspan. All six tests ended with strand fracture. In most cases a few strands broke at a time, while in one case at least ten strands fractured at the same instant.

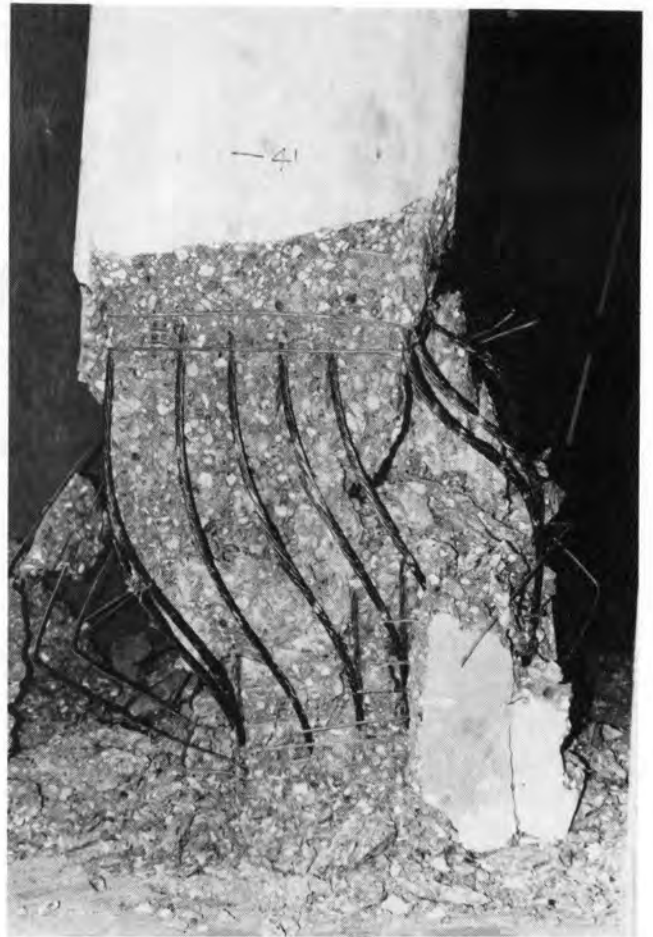
Fig. 21. Lower part of Specimen C-1.

All three tests ended with the failure of the pile section just at the ends of the embedded #10 (32.3 mm) reinforcing bars. In each case the failure was sudden, with little warning, and it was complete. The concrete cross section was completely destroyed for about 3 ft (0.9 m) of the length of the pile. Fig. 21 shows the failure section of Specimen C-1.
