# Corrosion of Prestressing Steels and Its Mitigation

**Walter Podolny, Jr.**  
**Ph.D., P.E.**

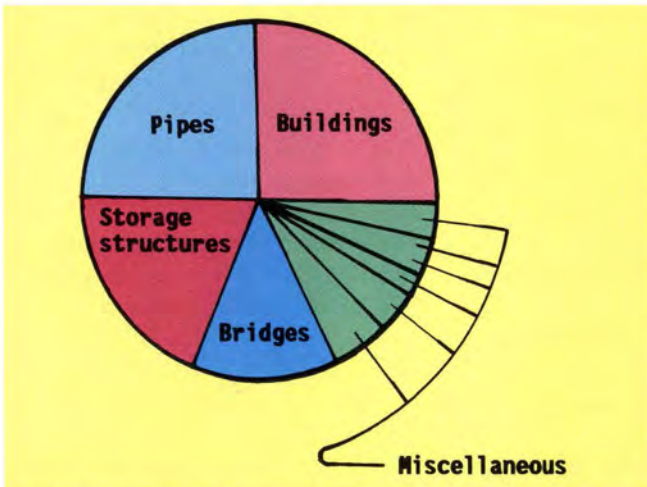
Fig. 1. Distribution of corrosion damage related to application (from Ref. 9).

Nurnberger<sup>9,11</sup> evaluated 242 incidences of corrosion damage of prestressing steel that were reported in the literature or by various governmental agencies worldwide during the interval from 1951 to 1979. Of interest in this report are the statistical evaluations of corrosion damage. A graphical depiction of the distribution of corrosion damage to prestressing steel as related to its application is presented in Fig. 1. Of the total 242 incidences, buildings, pipes, storage structures and bridges represent 27, 24, 19 and 13 percent, respectively.

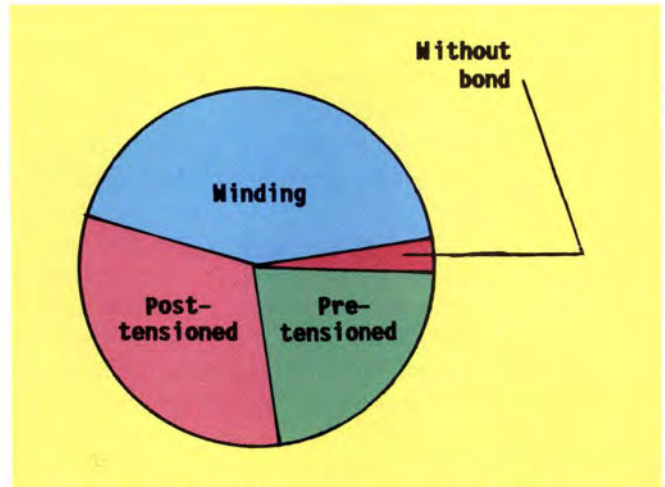
Fig. 2. Distribution of corrosion damage related to prestress method (from Ref. 9).

Fig. 2 represents the distribution of corrosion damage related to type of prestressing, that is, circular wound prestressing (pipe and storage tanks), post-tensioned, pretensioned and unbonded (post-tensioned). An indication of the distribution related to the type of prestressing steel failure is given in Fig. 3.

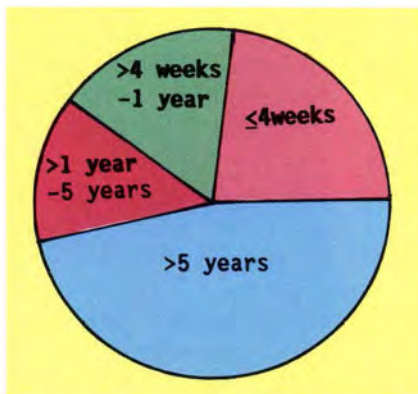
Fig. 5. Distribution of corrosion damage related to age (from Ref. 9).

neous failures” refers to post-tensioned members and members primarily under axial tension (as differentiated from flexural members). Distribution of damage to the prestressing steel element or structure failure relative to age is presented in Fig. 5.

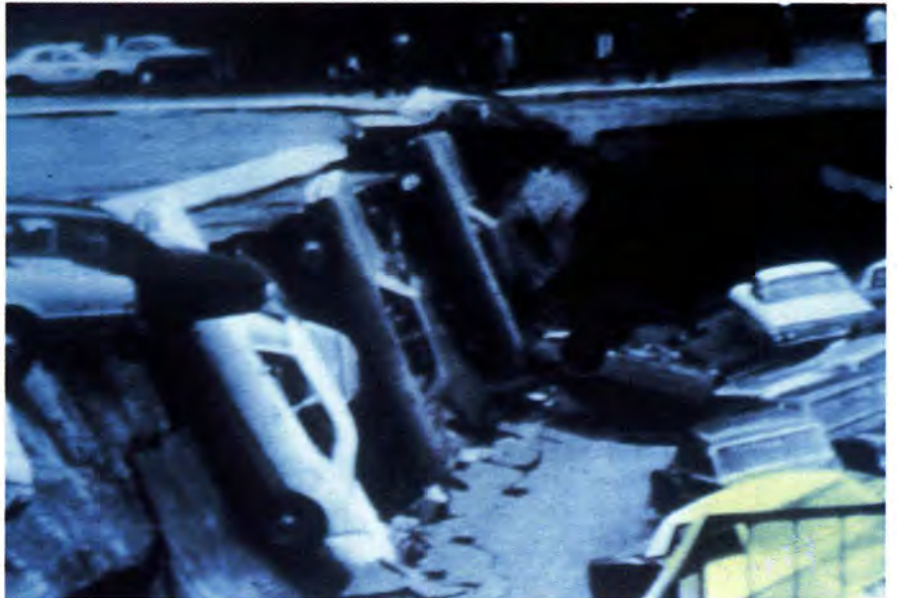
Fig. 9. Parking garage failure resulting from corroded tendons (Courtesy of Florida Wire and Cable Company).

An example of corrosion damage of prestressing steel in pretensioned I-girders of a bridge is shown in Fig. 8. A failure of a parking garage as a result of corrosion of post-tensioning tendons in the floor slab is illustrated in Fig. 9. Both failures occurred in the United States.

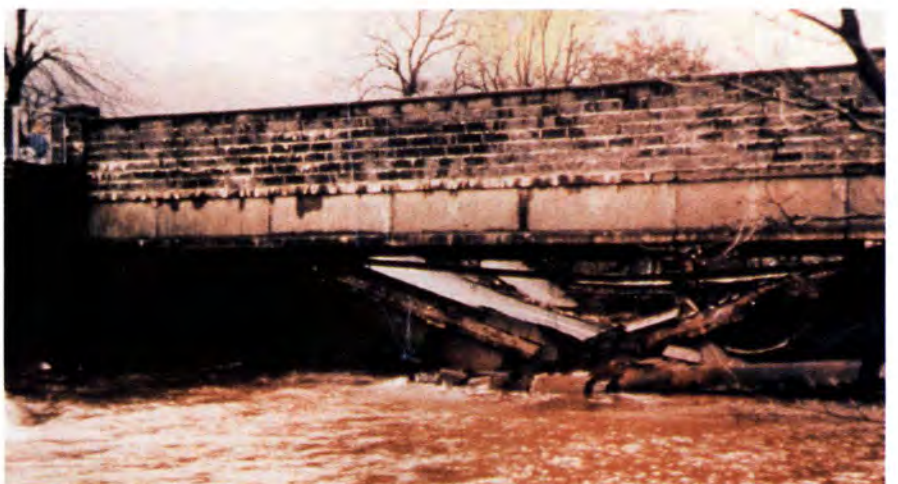
Fig. 10. Collapsed Ynys-y-Gwas Bridge (from Ref. 1).

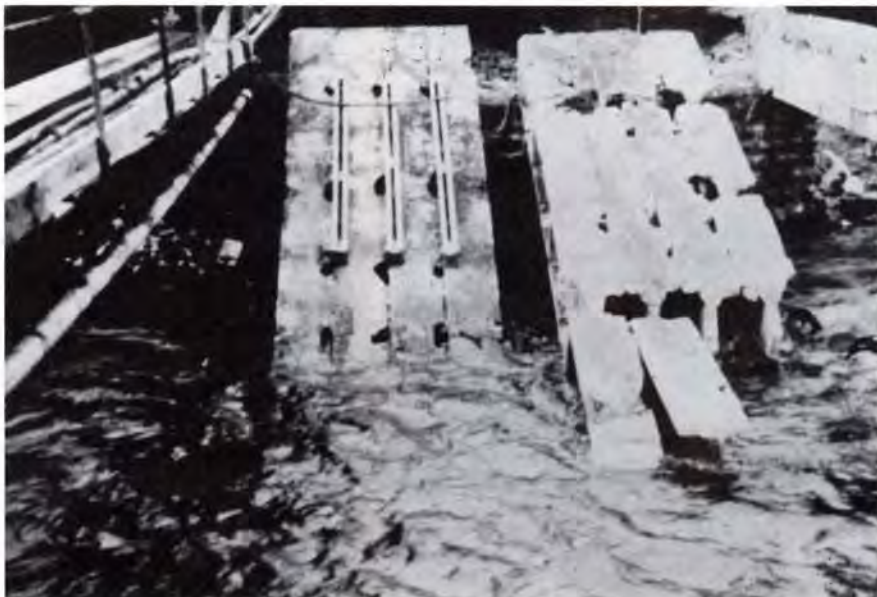
Fig. 12. Collapsed Ynys-y-Gwas Bridge.

No traffic was on the bridge at the time of collapse. All nine internal girders collapsed, but the box girder fascia beams remained in place (Fig. 12). Corroded lengths of wire from poorly grouted transverse tendons are illustrated in Fig. 13. Fig. 14 shows a transverse tendon crossing a longitudinal joint, with corrosion localized at the joint.

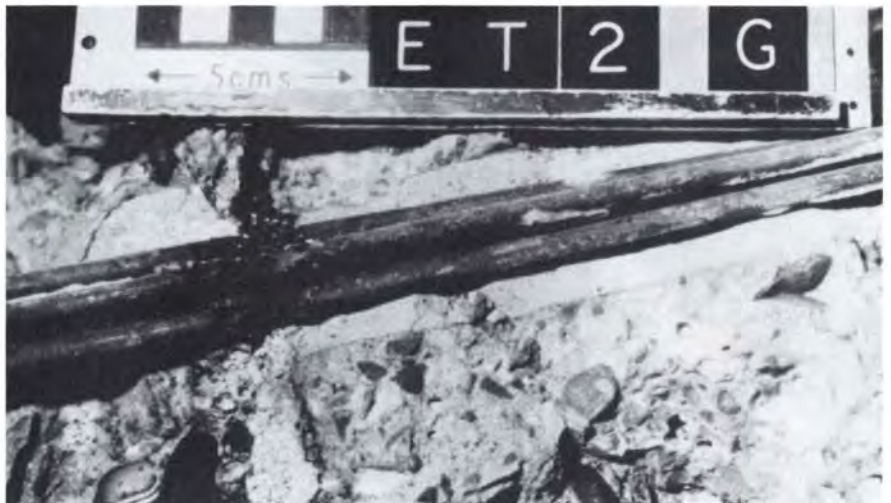
Fig. 14. Transverse tendon crossing a longitudinal joint (from Ref. 1).

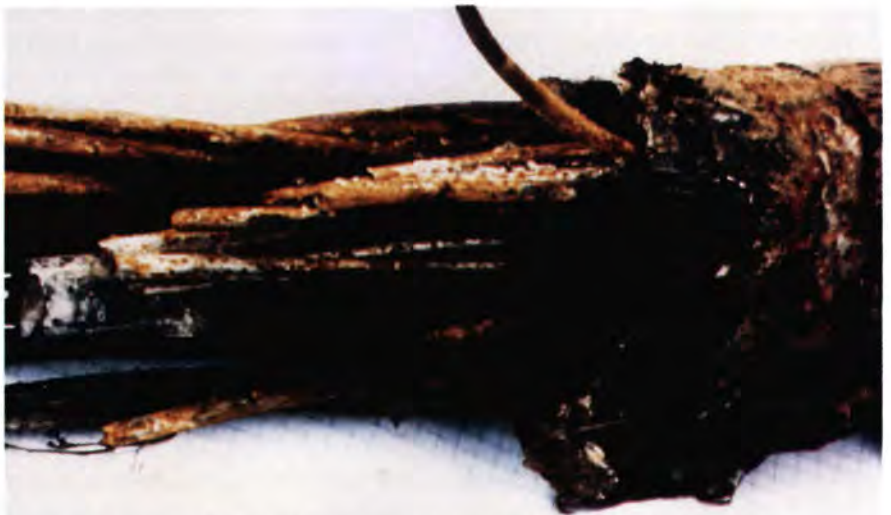
Fig. 15. Corrosion failure of a ground anchorage (Courtesy of Peter Matt).

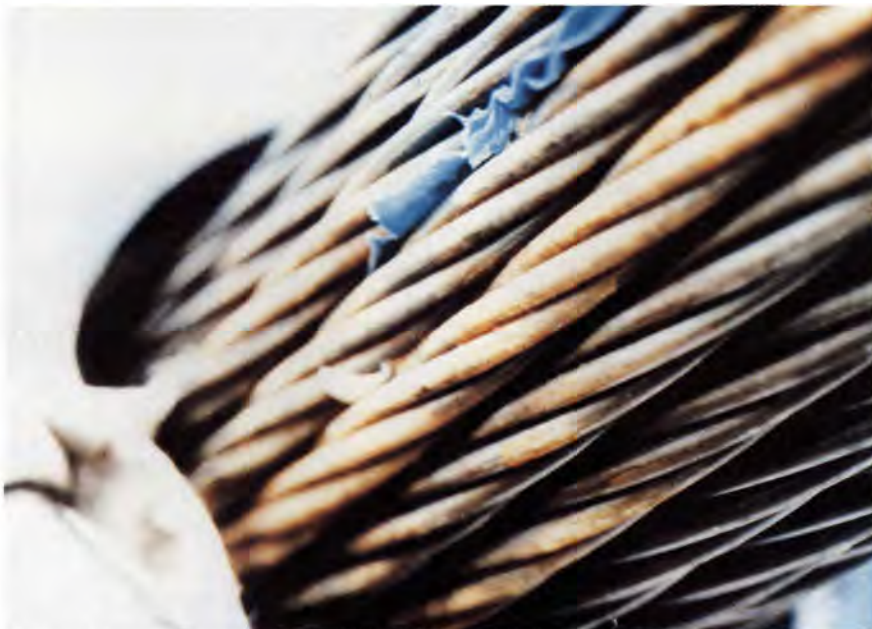
Fig. 17. Corrosion of a cable stay prior to encapsulation by grout.

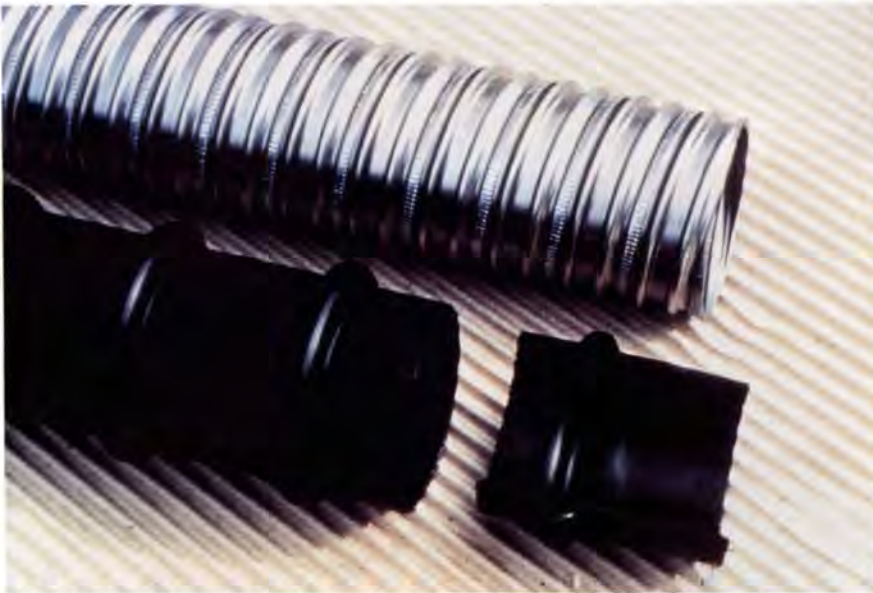
Fig. 18. Comparison of conventional metal duct and new polyethylene duct (Courtesy of VSL International, Inc.).

For this reason, a polyethylene duct with a new corrugation profile was investigated (see Fig. 18). In regions of tendon curvature, conventional corrugation can develop large stress concentrations. The newly developed profile distributes the duct material to produce a more uniform distribution (see Fig. 19).

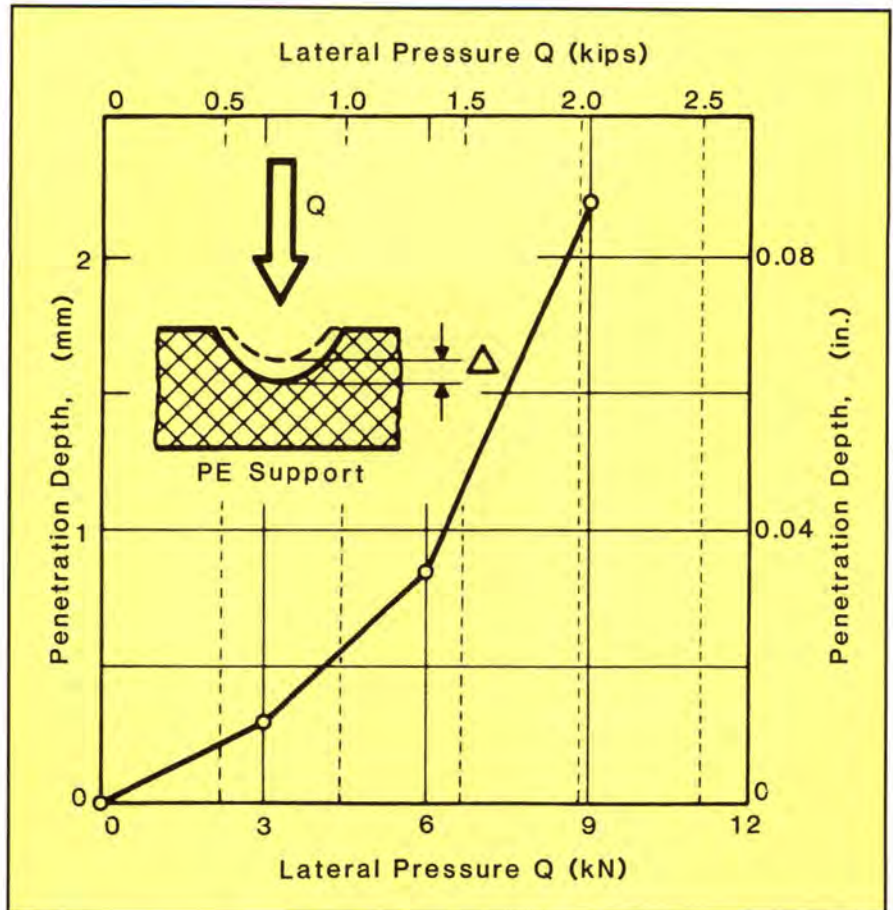
Fig. 20. Relationship between lateral pressure and penetration depth (Courtesy of VSL International, Inc.).

Wall thickness is one of the most important parameters of polyethylene ducts. The relationship between lateral pressure and penetration depth, giving the total force,  $Q$ , on a polyethylene sample of 1 in. (25 mm) contact length between strand and the polyethylene, is shown in Fig. 20. The relationship

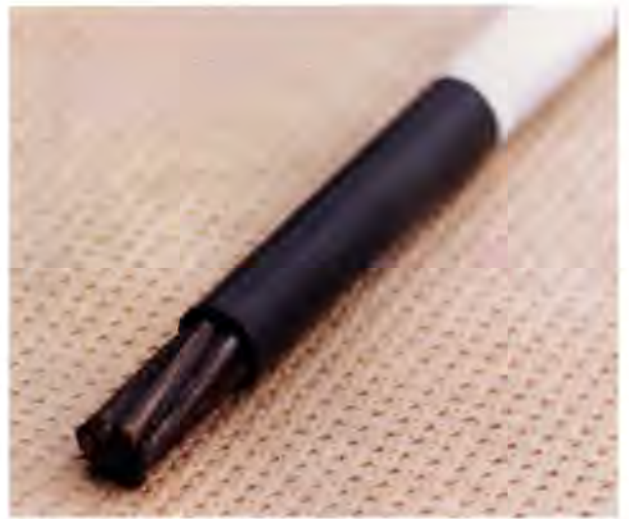
Fig. 24. Mono-strand tendon.
