# Full Depth Precast and Precast, Prestressed Concrete Bridge Deck Panels

*Since 1970, there has been a dramatic increase in the use of full depth precast and precast, prestressed concrete deck panels for the rehabilitation and new construction of bridges. In order to document the various applications of bridge deck panels in North America, a questionnaire survey was sent to the departments of transportation (DOTs) of individual states and one province. Requested information in the survey included type of construction, deck dimensions, deck supporting system, panel dimensions and reinforcement, type of connecting system between panels and supporting system, type of joint between the adjacent panels, type of bonding material used to fill the joints, problems associated with the joints, reasons for adverse results, and type of protection system. The returned questionnaires were compiled and analyzed. This paper summarizes the significant results of this survey.*

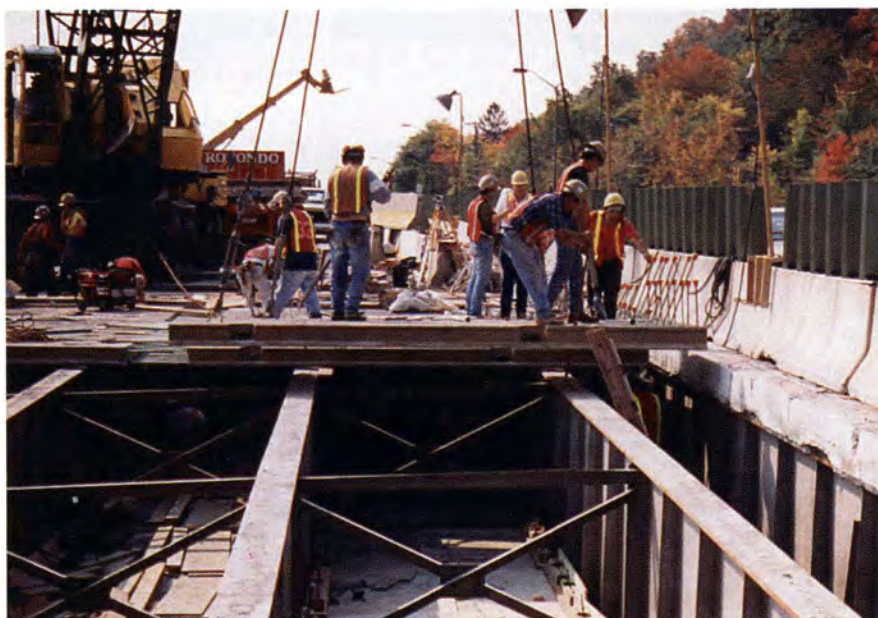
Fig. 1. View of system under construction.

A view of the system is shown in Fig. 1, where the precast concrete panels are being placed on the existing

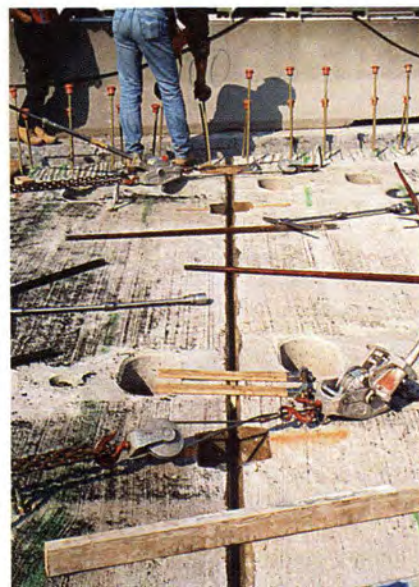
Fig. 2. Transverse joint between precast panels during construction.

supporting elements. Fig. 2 shows the transverse joint between adjacent precast panels along with the openings for the shear connector pockets.
