# Precast Prestressed Concrete — Solution of Choice for Lincoln Heights Water Tanks

*This article discusses the functional requirements, planning, design considerations, and erection aspects involved in the construction of two 10 million gallon (37.9 million liter) precast, prestressed concrete water tanks in Spokane, Washington. The tanks were designed to replace a two-basin, 5-acre open-type reservoir. A major feature of the structures is the combination of single pie-shaped tees for the roof and single tees with exposed aggregate flanges for the circumferential wall. A synthetic liner is used on the interior of the tank to ensure the structure is watertight. The authors describe the design and construction process from the perspectives of the project engineer, the owner, and the precast concrete manufacturer.*

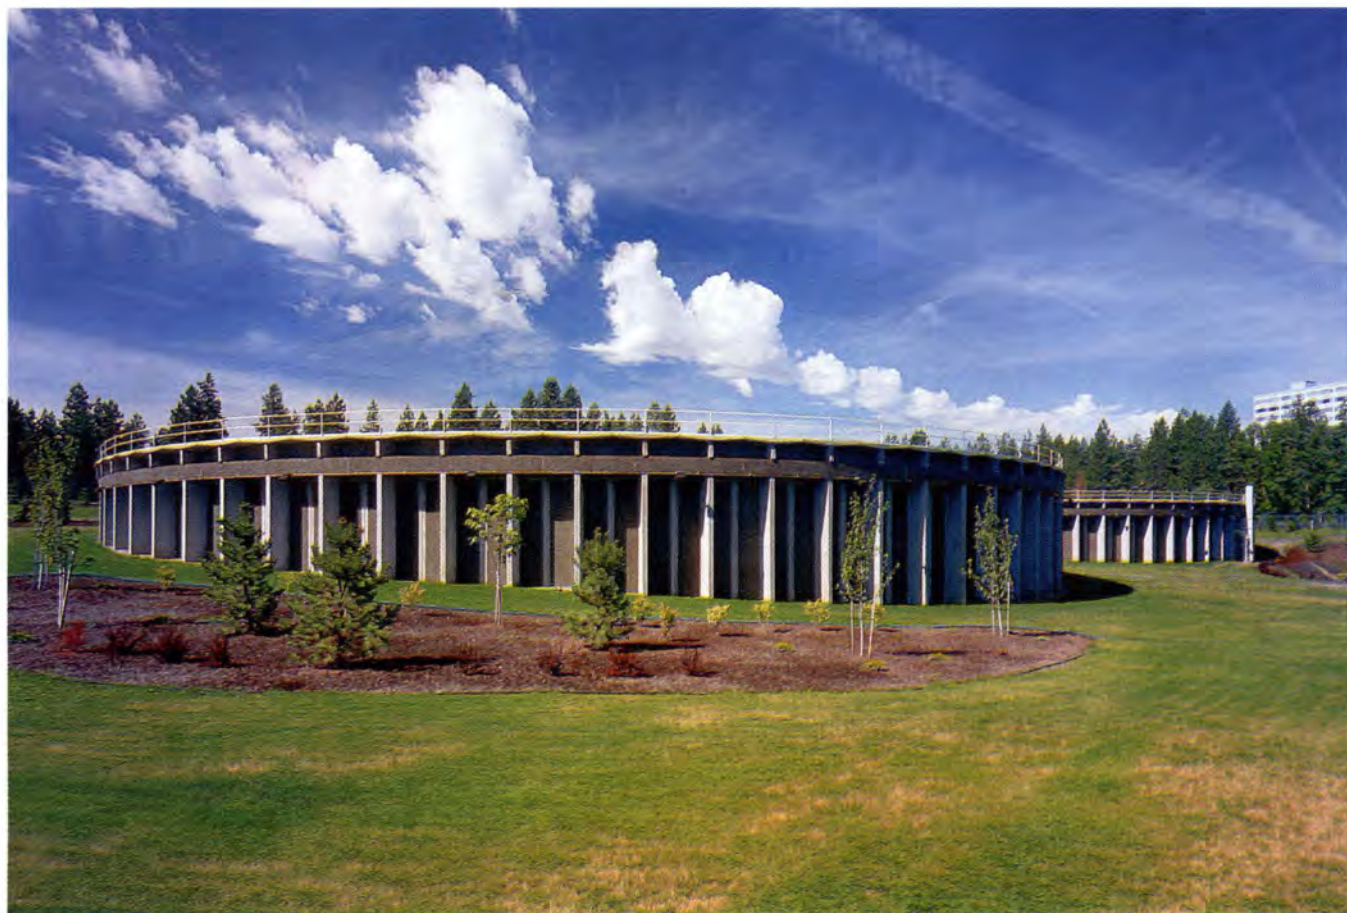
Fig. 1. The Lincoln Heights water tanks in Spokane, Washington, fit aesthetically into their environment.

tee beams were used for the wall panels. These were placed in a circular pattern with the flanges oriented towards the outside. This arrangement developed the vertical flutes that define this type of tank. By installing exposed aggregate on the bottom side of the flanges, an attractive visual contrast was developed. A flexible plastic liner was installed on the inside of the tank to hold water. Utilizing standard precast shapes for the walls saved considerable money.

The roof system is also constructed from tee beams. They are pie-shaped so that they could be placed in a radial pattern. The roof tees are supported by a column at the center of the tank. The other end of the tees are supported by the wall panels.

Substantial cost savings and enhanced appearance were achieved by partially burying the new tanks. This allowed the site to be graded at a slope that matched the original topography, giving the project a natural look and aesthetics.

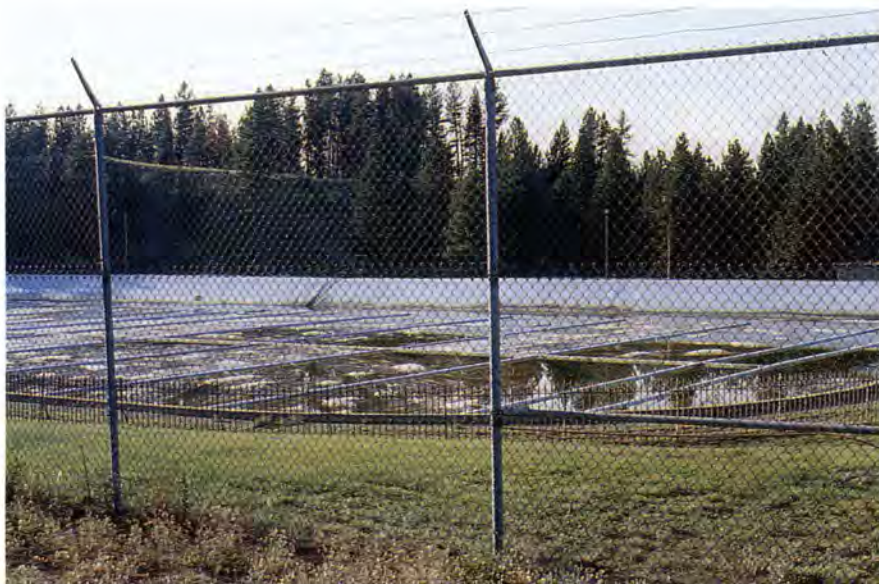
Fig. 2. The existing Lincoln Heights reservoir with deteriorating floating cover.

Although the floating cover was an improvement over an open reservoir, it did not prove to be a cure-all. The cover was subject to rips and tears, which needed patching. The problem of rips and tears became more frequent as the cover deteriorated with age.

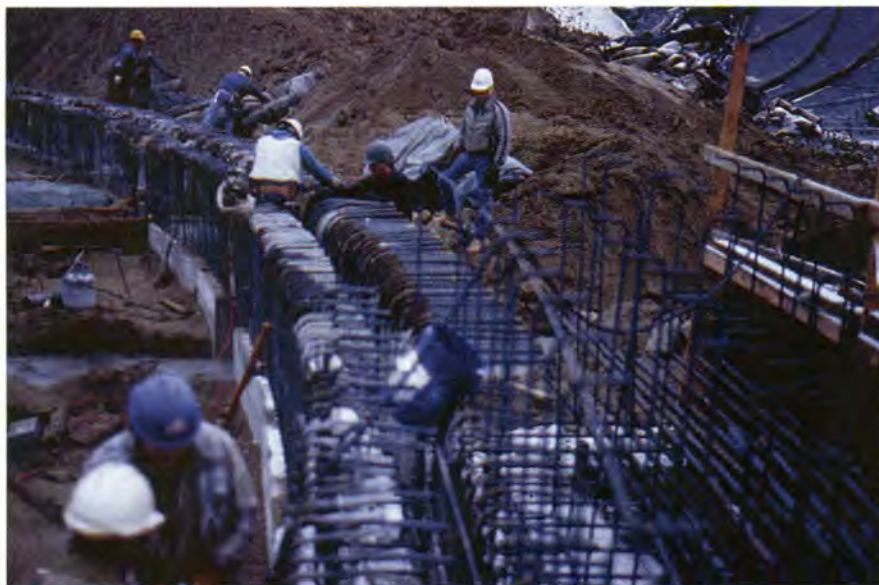
Fig. 12. Placement of reinforcing bars in footings.

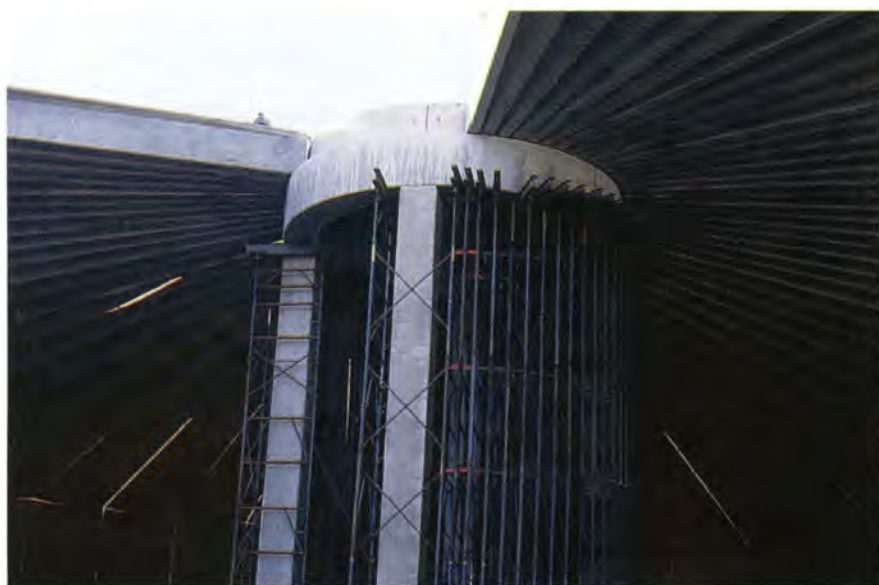
Fig. 13. Ring beam shoring for roof tee placement.

Once troughs were set, reinforcing bars were placed in them and roof erection began. Single tee roof members weighed 66,300 lbs (30070 kg) each. Setting several pieces together on the ring beam put too much load in

one quadrant, so the ring beam was shored until all roof pieces were placed (see Fig. 13). Wall tees, weighing 37,000 lbs (16780 kg) each, were delivered one per truck, erected on shims, and braced to the inside of the tank. Roof tees were delivered on steering trailers (see Fig. 14).

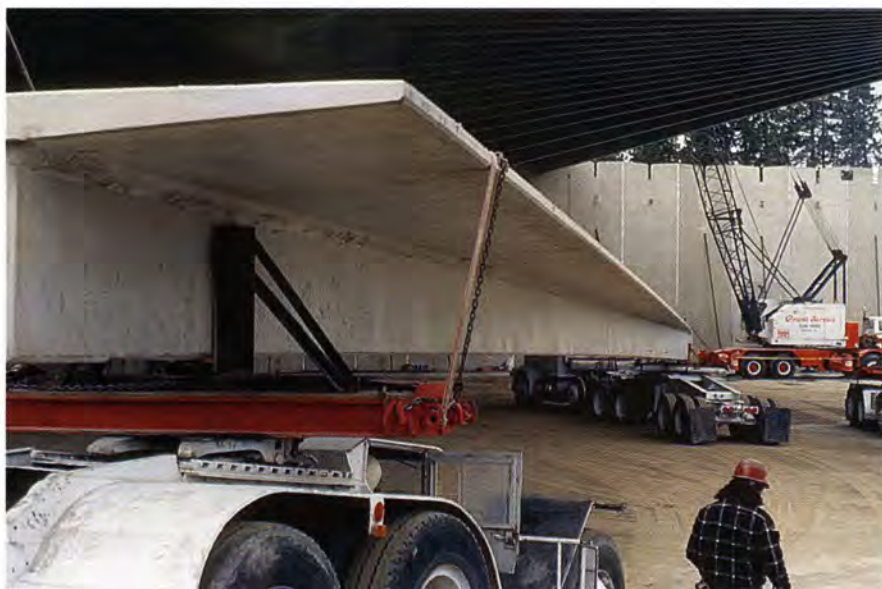
Fig. 14. Steering trailers were used to deliver roof tees to the jobsite.

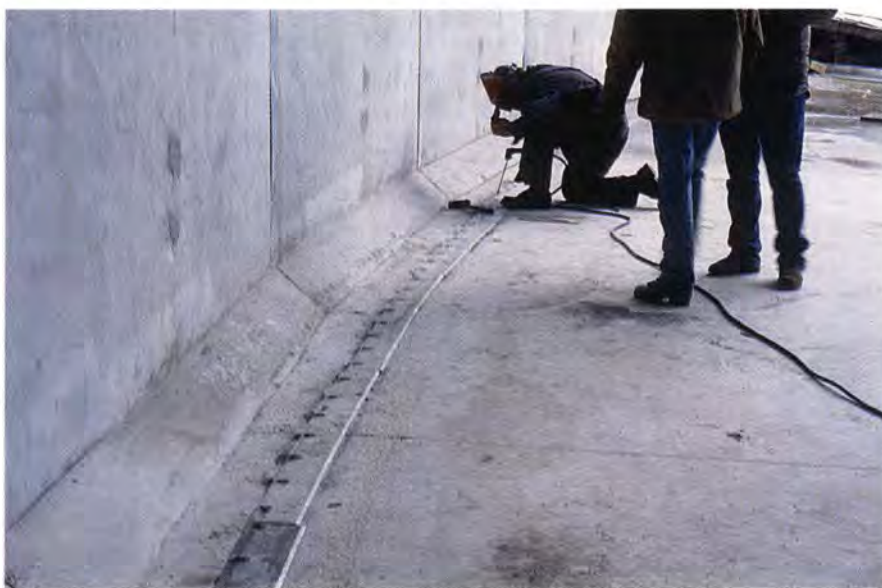
Fig. 15. A stainless steel sliding plate was welded across the joint in the bottom slab between the footing and floor.

The center column footings individually became so large, that it was decided to use a single mat footing for all four column supports. This footing and the perimeter footing were cut and cast through the existing slab. The center footing used a ribbed mat with ribs 3 ft 6 in. (89 mm) wide and 4 ft (1.2 m) deep. The perimeter footings were cast at a fixed elevation. The existing reservoir bottom was sloped, so a closure pour slab was used to provide a transition between the two elevations. Expansion of the bottom ring beam necessitated a sliding expansion joint between the slab and the footing. DEA designed a stainless steel plate

and rubber cover that could slide as movement occurred.

Concrete was placed at the wall base to form a fillet to be sure the liner did not have a sharp transition between the walls and floor. The stainless steel sliding plate was welded across the joint in the bottom slab between footing and floor (see Fig. 15). After welding, the stainless steel was covered with two layers of wax impregnated paper and a strip of used conveyor belting.

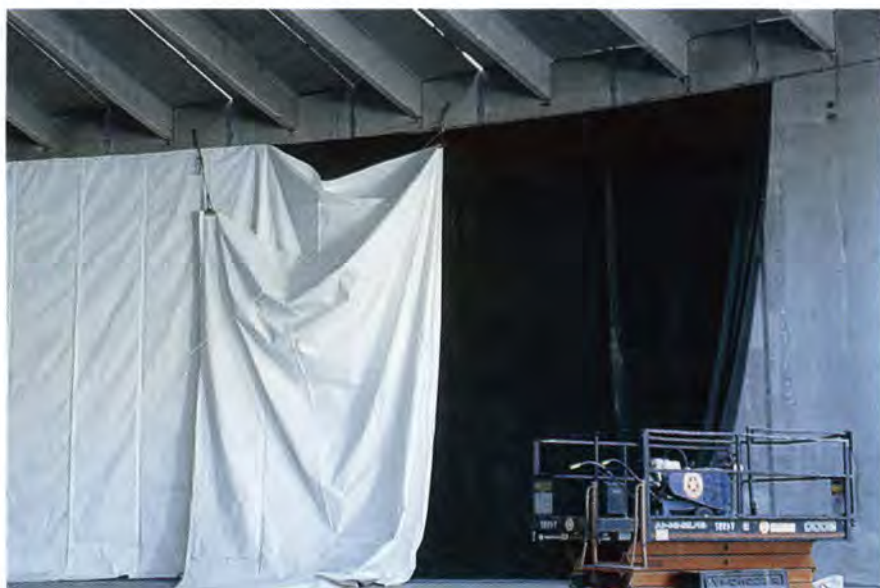
Fig. 16. Placement of geotextile material and tank liner.

The liner system uses an NSF-approved white 45-mil reinforced polypropylene liner over a 4-oz. geotextile pad. The pad is used to protect the liner from any sharp projections. All the hardware used to attach the liner to the tank wall or boot around pipes is stainless steel. Northwest Linings from Kent, Washington, was the lining subcontractor. The cost for the liner, installed, was \$0.01 per gallon.

When approximately 75 percent of the walls were erected, Northwest Linings began hanging the geotextile and liner. By leaving the tank open, manlifts could be used to hang the sheets, which was much quicker than working from ladders or scaffolding (see Fig. 16).

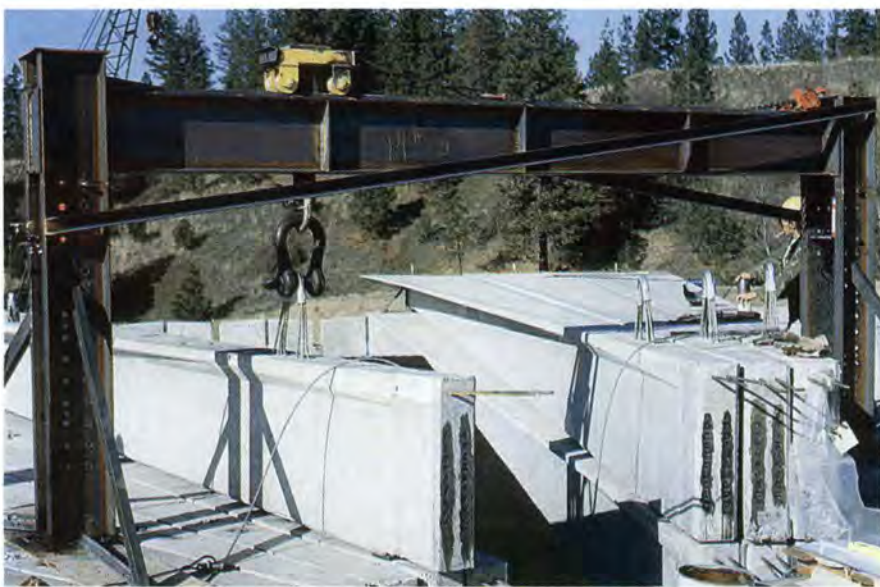
Fig. 17. A hanger and trolley system was used to position roof members.

temporary access road and erect the last of the roof single tees, a challenge presented itself to the CPPC erection crew. The last roof pieces could not be set with two cranes because the crane in the center had to come out. Bringing in a crane large enough to set a single tee from outside the tank would have been cost prohibitive.

To solve this problem, a hanger and trolley apparatus was designed to lift the narrow end of the closure roof members from their stockpiled position on top of previously set roof members (see Fig. 17). A crane outside the tank hoisted the wide end of the roof members as they were rolled into place.

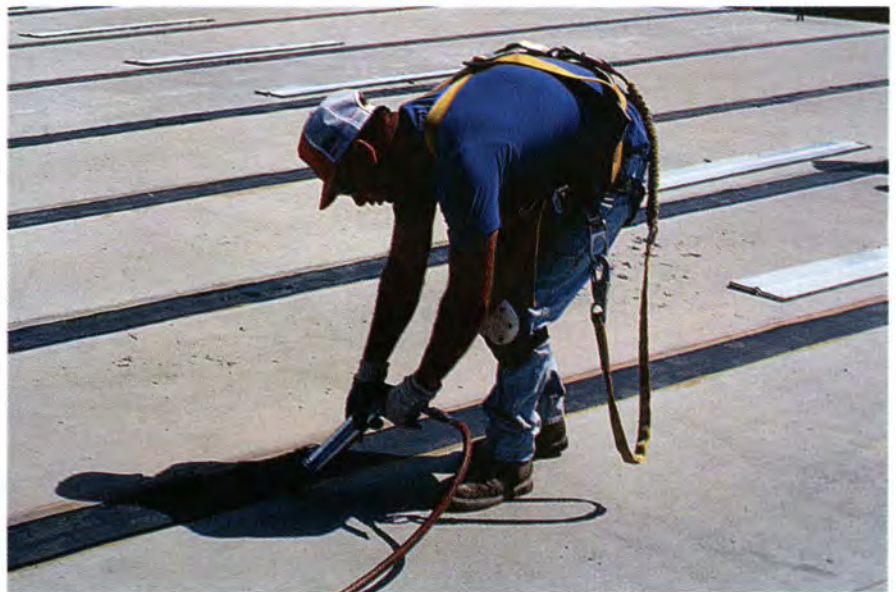
Fig. 18. EPDM placed at roof joints.

As the roof pieces were set in place, their weld ties were welded and grouted. A 6 in. (152 mm) wide 45-mil EPDM strip was bonded to the concrete and a protective stainless steel cover was attached over the

The EPDM roof seal has allowed some minor leaks to drip into the tank when it rains. Investigating the cause has been difficult, but it appears that the cement used to bond the EPDM to the concrete does not create a tight enough bond to prevent water from coming through in some locations. As a solution, it was agreed among all

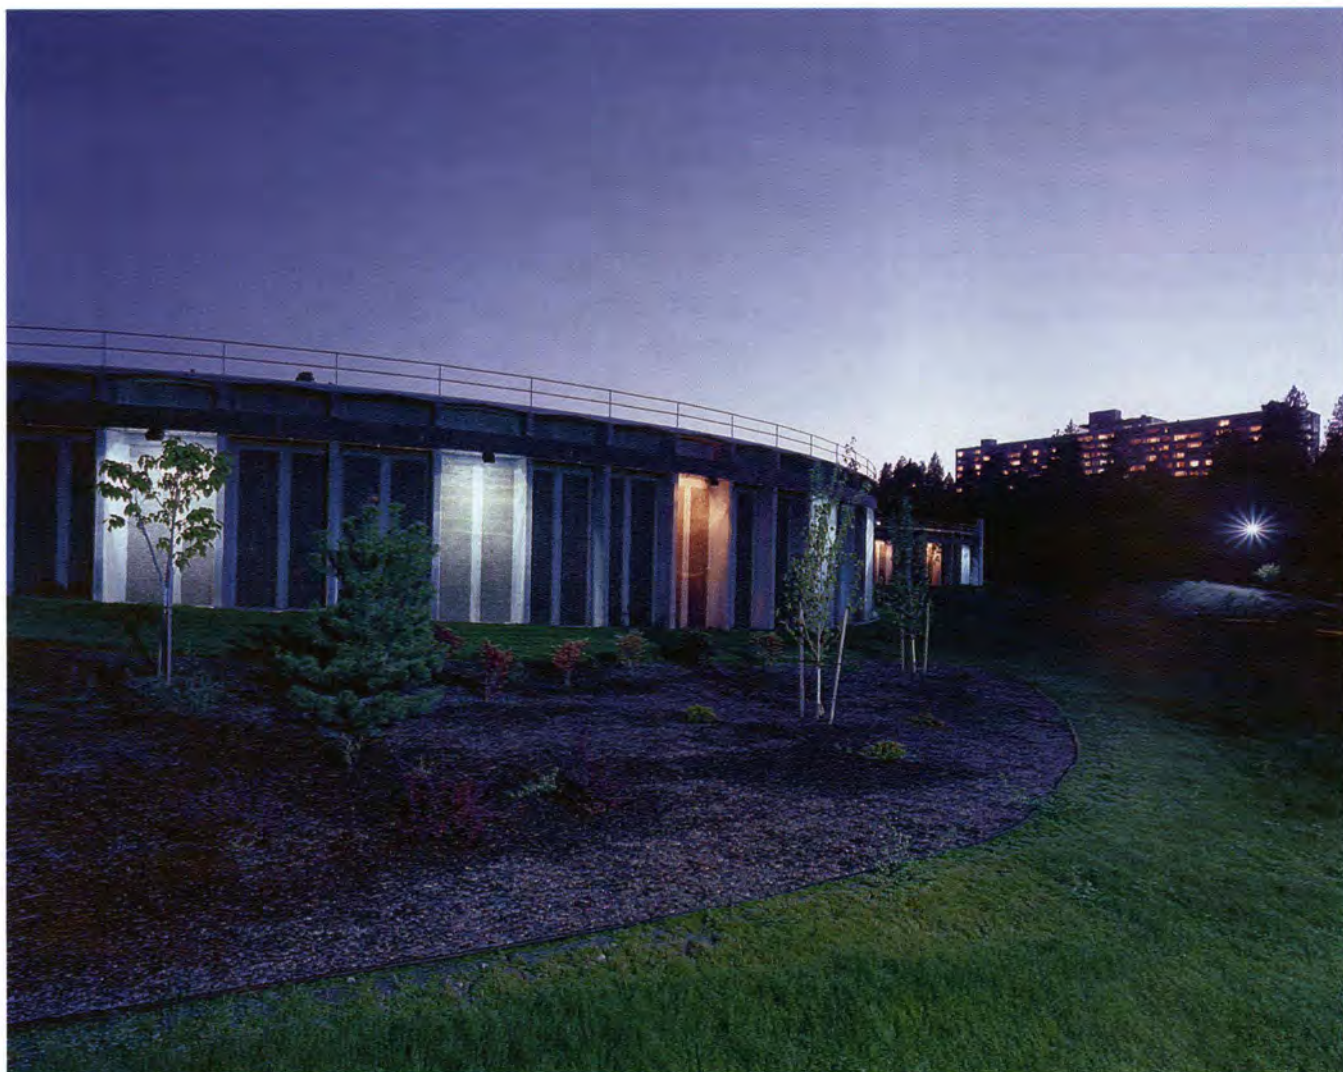
Fig. 20. Night-time view of Lincoln Heights water tanks with floodlights in place.

The roof beams are supported at one end by the tank shell and at the other end by a center concrete ring beam mounted on four concrete columns. For night-time aesthetics, floodlights were incorporated into the upper ring beam to shine down on portions of the tank shell exterior.
