Plates With Anchors Post-Installed With Non-Shrink Grout

John R. Salmons, Ph.D., P.E.

Chief Engineer
Prestressed Casting Co.
Springfield, Missouri

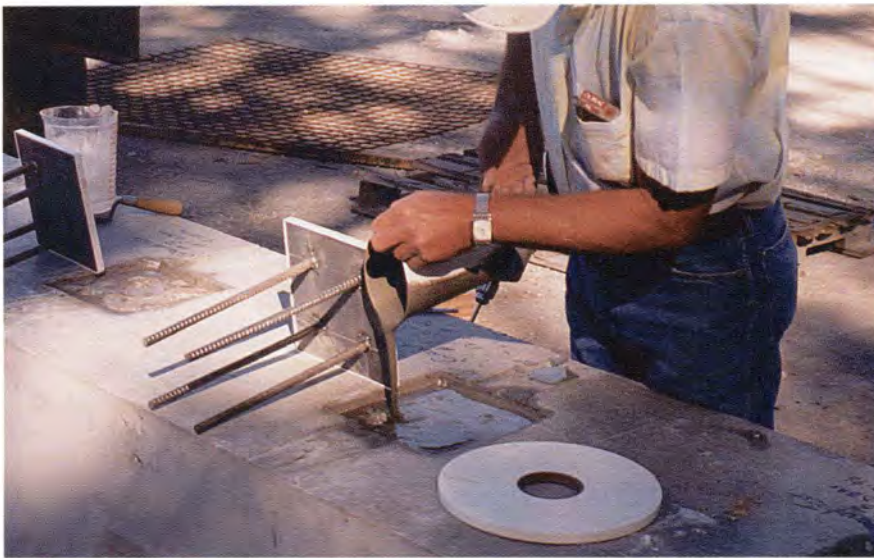
Fig. 4a. Filling void with fluid grout.

4. Mix the grout according to the manufacturer's instructions for conditions to produce a liquid state. The mixing time and the amount of water is critical to a proper grout mix. The grout is then placed into the area where the plate is to be set. Place sufficient grout to cause the void to be slightly overfilled when the plate with anchors is positioned. The plate is then set in the grout filled void and tapped with a hammer to help consolidate the grout around the studs and under the plate (see Figs. 4a, 4b and 4c).

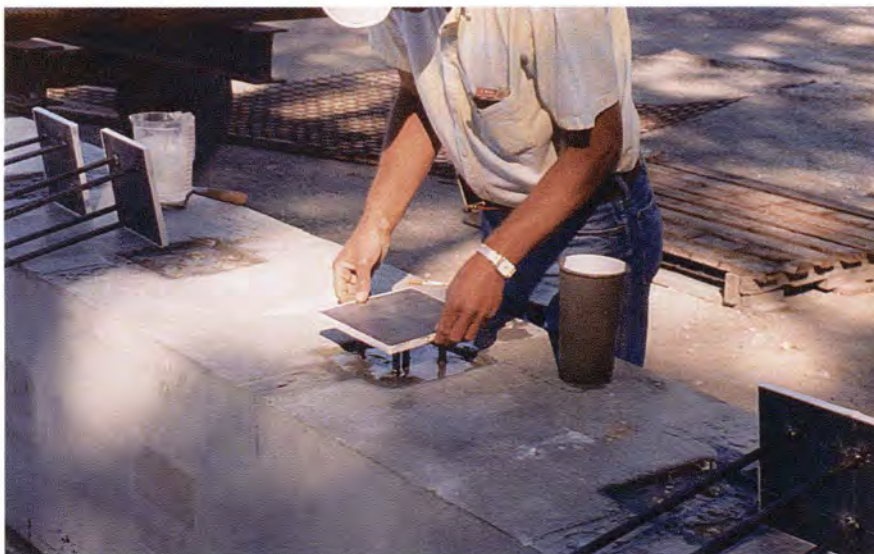
Fig. 4b. Placing plate in grout-filled void.

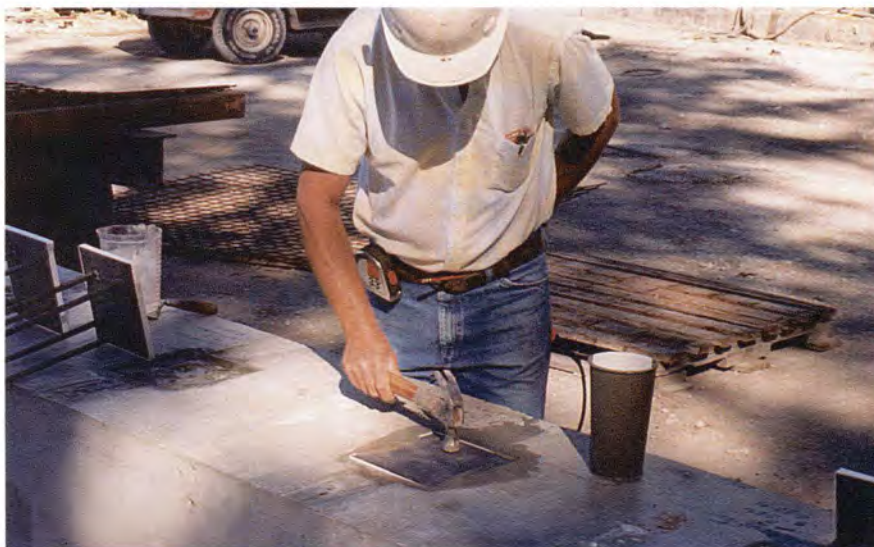
Fig. 4c. Tapping of plate to eliminate air voids.

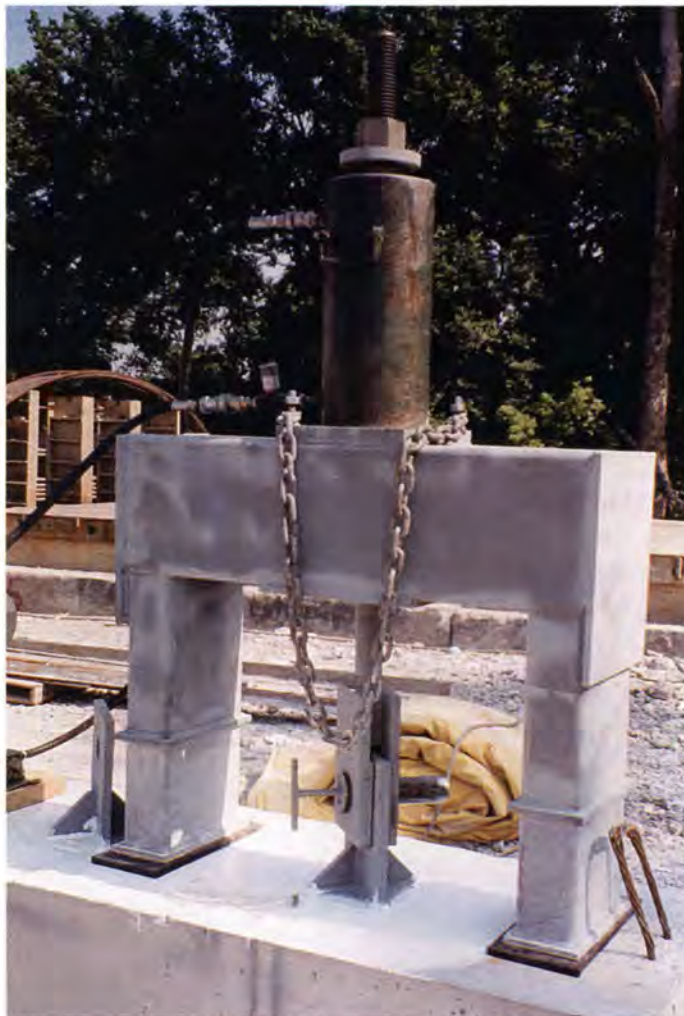
Fig. 6. Test setup.

The tests were conducted in a pre-cast plant environment. The loading head had a clear distance between supports of 27 in. (686 mm). The spacing of the support legs had little effect on the concrete failure cone. The test setup can be seen in Fig. 6. The attachment to the specimen was by a

second X-shaped plate welded to the cast/grouted-in test plate with a pin connection to a rod that passed through a center hole ram.

A groove in the concrete approximately $\frac{1}{16}$ in. (1.6 mm) deep was made around the edge of the plate to allow for expansion during the welding process. The welded-on X-shaped plate was oriented on the cast/grouted-in plate to load directly into the studs, eliminating plate bending. The pin connection to the loading rod helped to minimize the loading eccentricity.

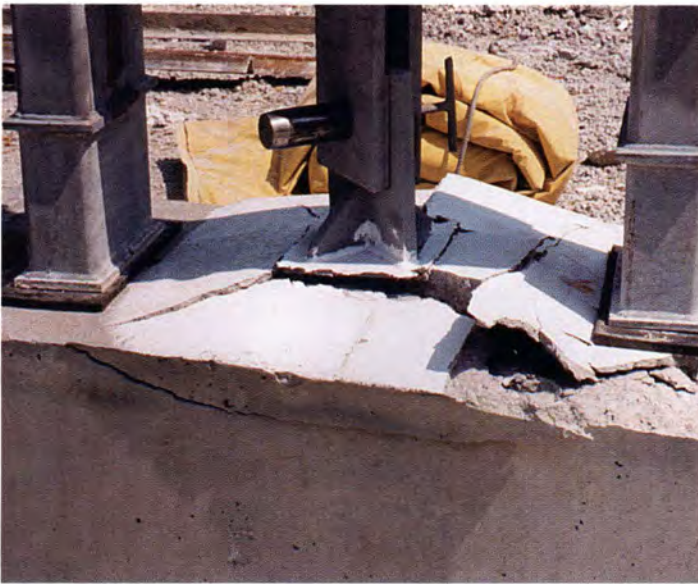
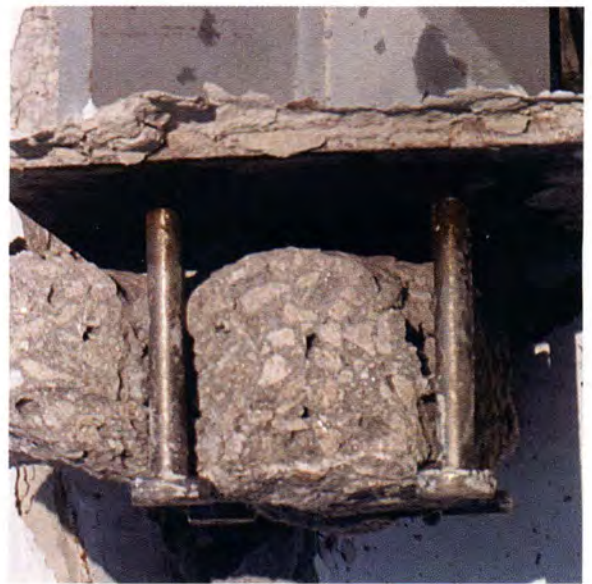
(a) Cracking pattern at concrete failure.

(b) Failure plane in concrete.

Fig. 7. Failure of cast-in plates with four 1/2 in. (12.7 mm) diameter x 4 in. (102 mm) studs.

All specimens were loaded to failure. The failure mode for all plates with studs was concrete pull-out, which was sudden and easy to determine from the load. At the failure load, the cracking of the concrete was visible. The cracking shown in Figs. 7, 8, 10 and 11 shows the failure plane development. The plate was pulled until

The mode of failure of all the plates with headed studs (see Figs. 7, 8, 10 and 11) was typically a concrete failure cone. It is interesting to note that

1. For tests with Specimens GI4S-1, GI4S-2, GI4S-3, the failure cone started from the top of the head of the studs in an identical manner to that of the cast-in plates. In Figs. 7 and 8, it can be seen that the grout-concrete areas are without discontinuity while the grout areas are quite visible.

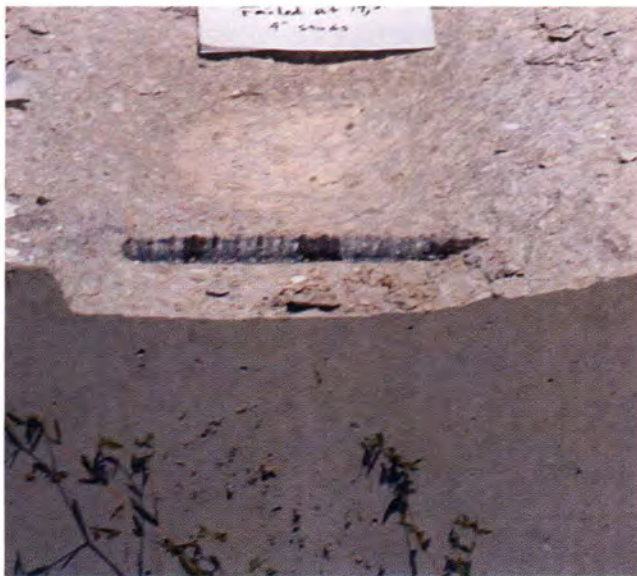
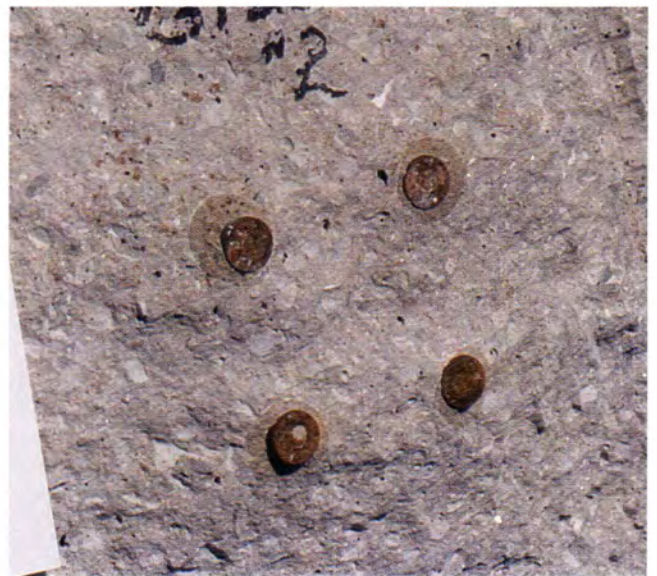
(a) Area after concrete failure cone was removed.

(b) Bottom surface of failure cone at the studs.

Fig. 8. Failure cone of grouted-in plate with four 1/2 in. (12.7 mm) diameter x 4 in. (102 mm) studs.

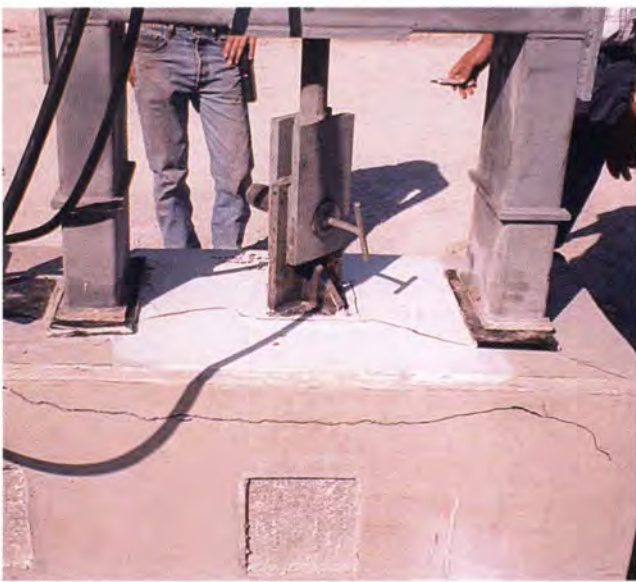
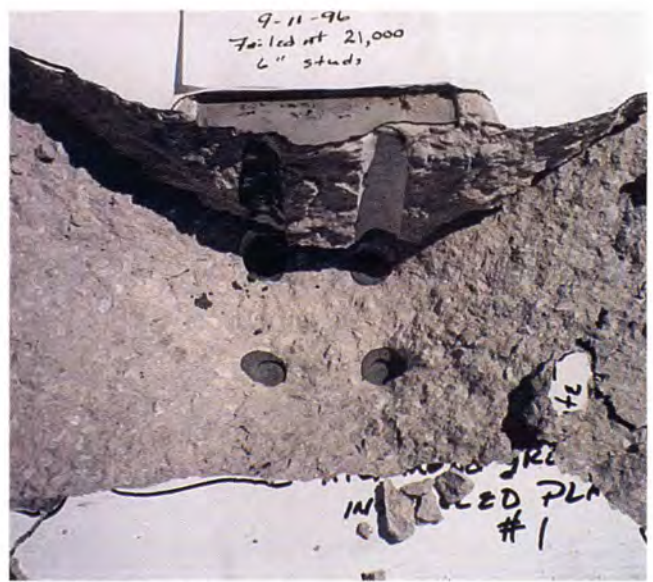
(a) Cracking pattern at concrete failure.

(b) Failure plane in concrete.

Fig. 10. Failure of first specimen with grouted-in plate with four $\frac{1}{2}$ in. (12.7 mm) diameter x 6 in. (152 mm) studs.

the concrete cone did not start at the head of the stud. The cone started approximately $\frac{1}{2}$ in. (12.7 mm) above the head on the exterior of the stud group and at the top of the head between the studs. This failure plane is illustrated in Fig. 9 and shown in Fig. 10.

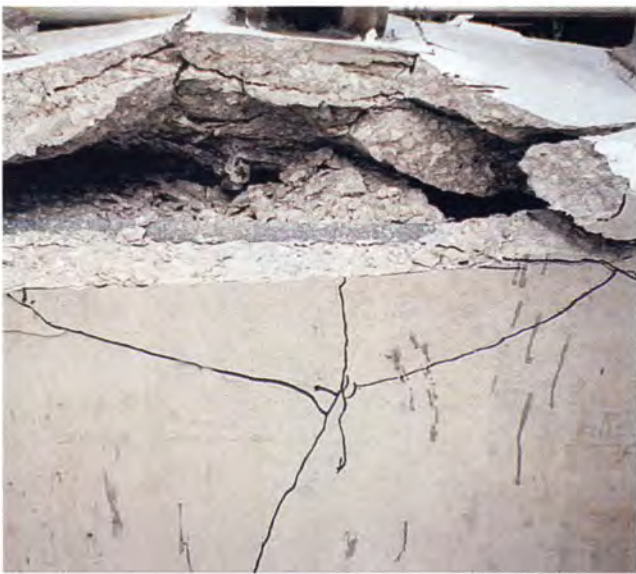
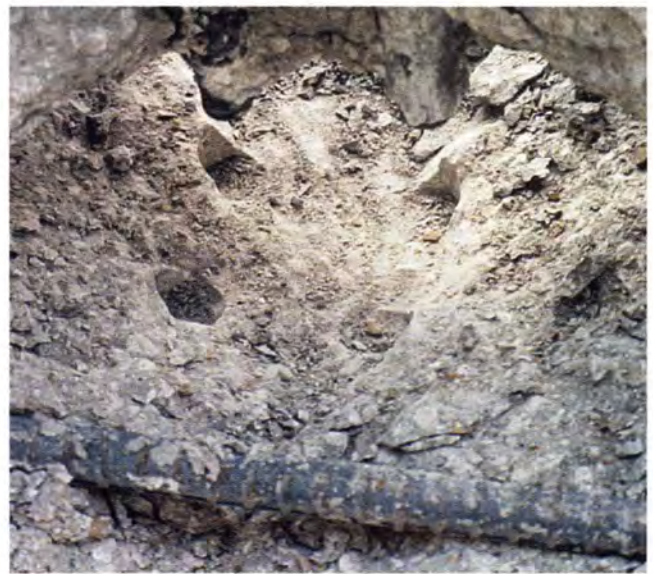
(a) Cracking pattern at concrete failure.

(b) Modified failure plane in concrete.

Fig. 11. Typical failure of grouted-in Specimens GI6S-2, GI6S-3 and GI6S-4 plate with four $\frac{1}{2}$ in. (12.7 mm) diameter x 6 in. (152 mm) studs.

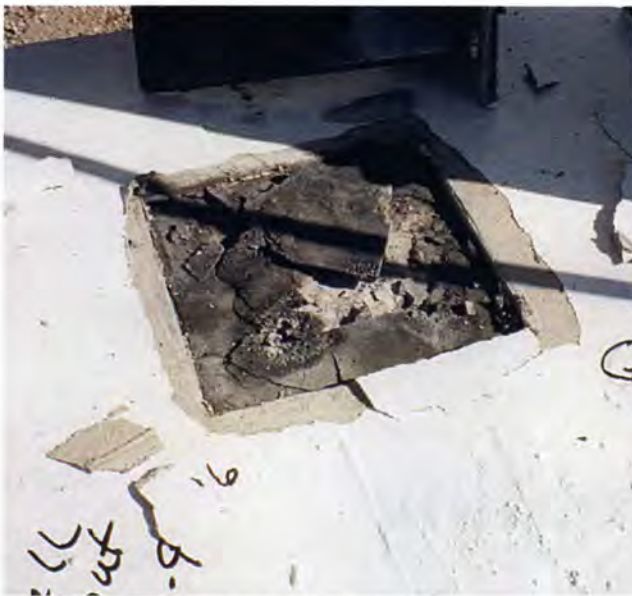
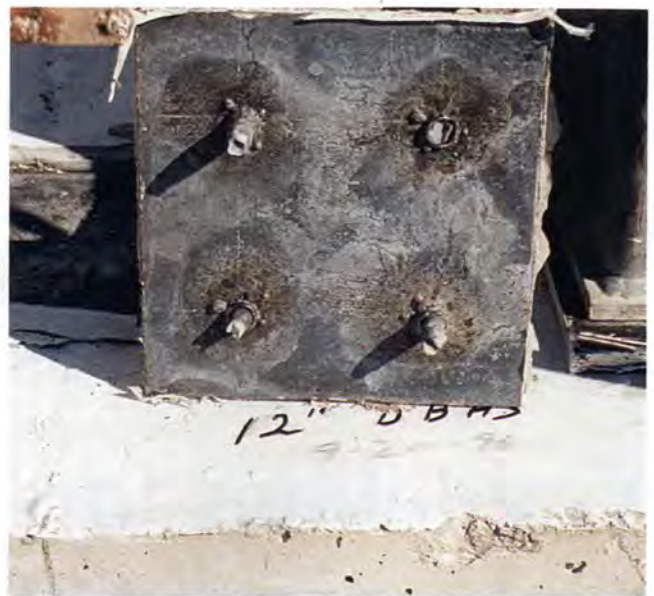
(a) Concrete in the area of the failed plate.

(b) Plate with failed deformed bar anchors.

Fig. 12. Failure of grouted-in plate with four $\frac{1}{2}$ in. (12.7 mm) diameter x 12 in. (305 mm) deformed bar anchors.

The tests of the grouted-in plates with deformed bar anchors, Tests GI12B-1, GI12B-2, GI12B-3, each resulted in loading of all bars to a level above the specified minimum yield of the bars at 60 ksi (414 MPa). At that point, one or two bars fractured at or near the weld of the bar to the plate.

There was a minimum of plate movement prior to the initial bar fracture, which would indicate a reasonable distribution of load between the bars.

The loading was continued until all the bars were fractured so the mode of failure could be examined. A failed plate with deformed bar anchors is shown in Fig. 12. Due to the type of failure (steel controlled), no additional tests with deformed bar anchors were scheduled.
