# Renovation of Poindexter Office Building Kansas City, Missouri

*Precast and prestressed concrete played a prominent role in renovating two old deteriorated buildings in Kansas City, Missouri, into a single state-of-the-art office facility. The solution required the demolition of part of one building (Gatlin Building) with a stabilizing vertical core using a precast, prestressed structural frame. When this structural work was completed, the exterior façade of the Gatlin Building was clad with architectural precast panels using a thin brick in-fill to match the building's original appearance. Note that the larger Poindexter Building required significant masonry tuckpointing on the exterior surface but no precast cladding. The precast solution saved \$750,000 on this project. The article describes the major features of the repair program.*

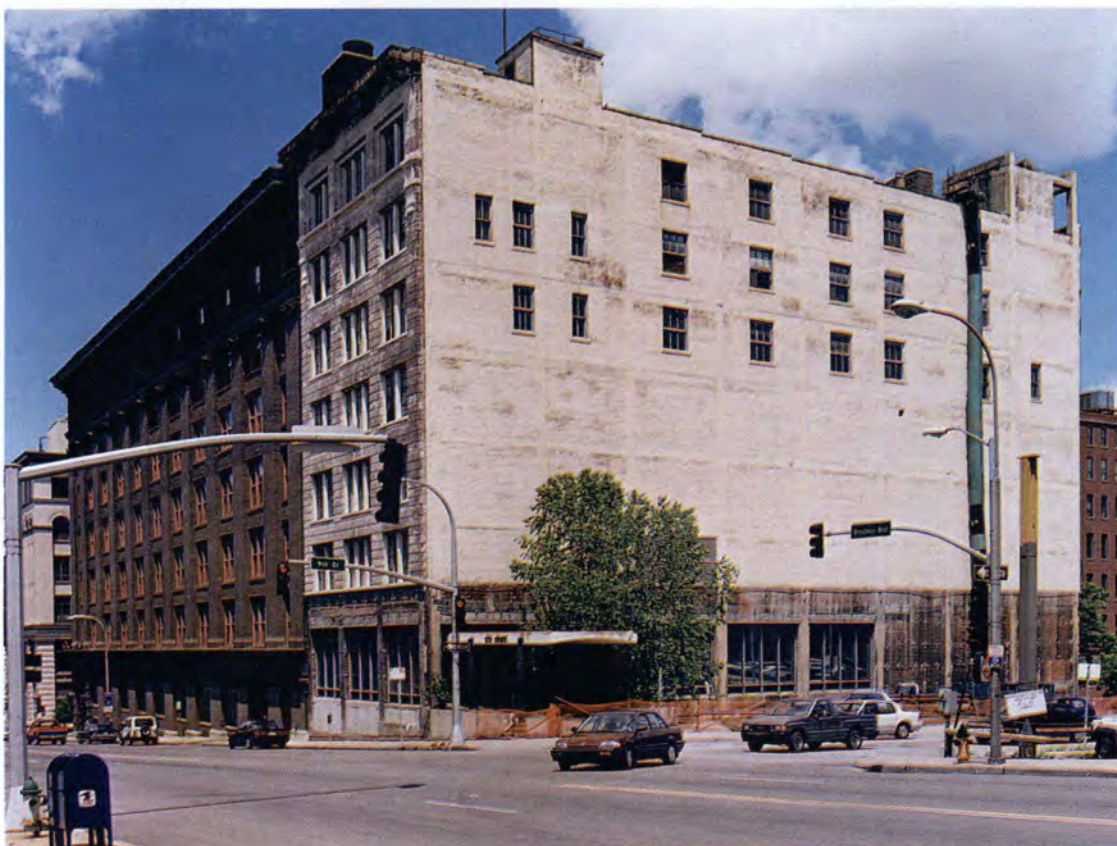
**R**epairs to the distinguished Poindexter Building (see Fig. 1) on 330 W. North Street in downtown Kansas City, Missouri, were long overdue. Built in 1901, this seven-story timber-masonry structure had deteriorated to the extent that it needed a new roof, significant timber repair, decking repair and significant masonry tuckpointing (see Fig. 2).

Fig. 2.  
Old dilapidated  
Poindexter and  
Gatlin buildings.

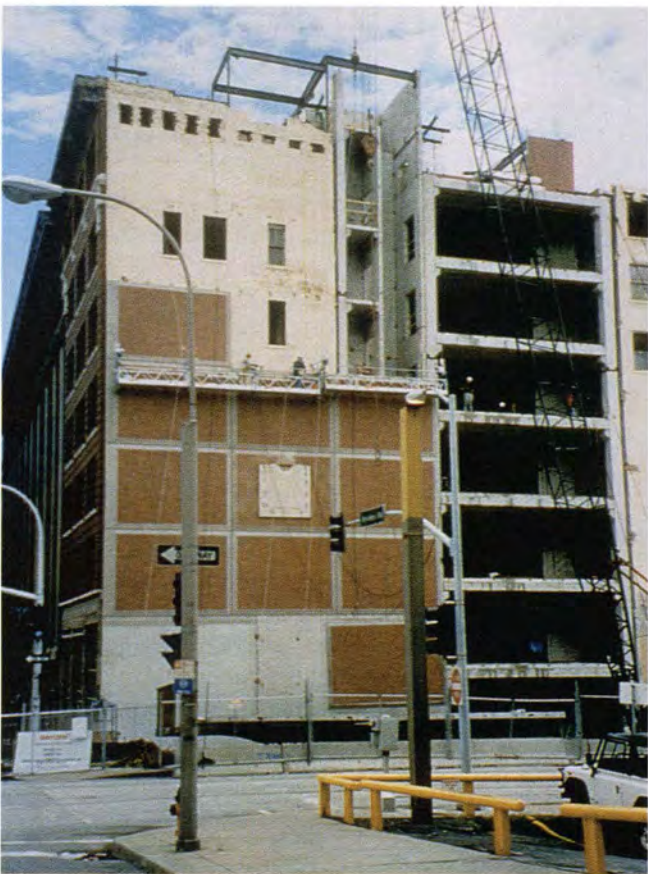
Fig. 10. Erection of precast façade.

When the designated partial demolition of the Gatlin Building was completed and the precast, prestressed stabilizing core was in place, the exterior facade of the Gatlin Building was ready to be installed. These façades were clad with architectural precast panels with thin brick to match the original picture frame appearance of the concrete frame and brick in-fill. The precast parapet cornice was designed to match the existing cornices on the building.

Figs. 9 through 12 show various shots of the erection operation.

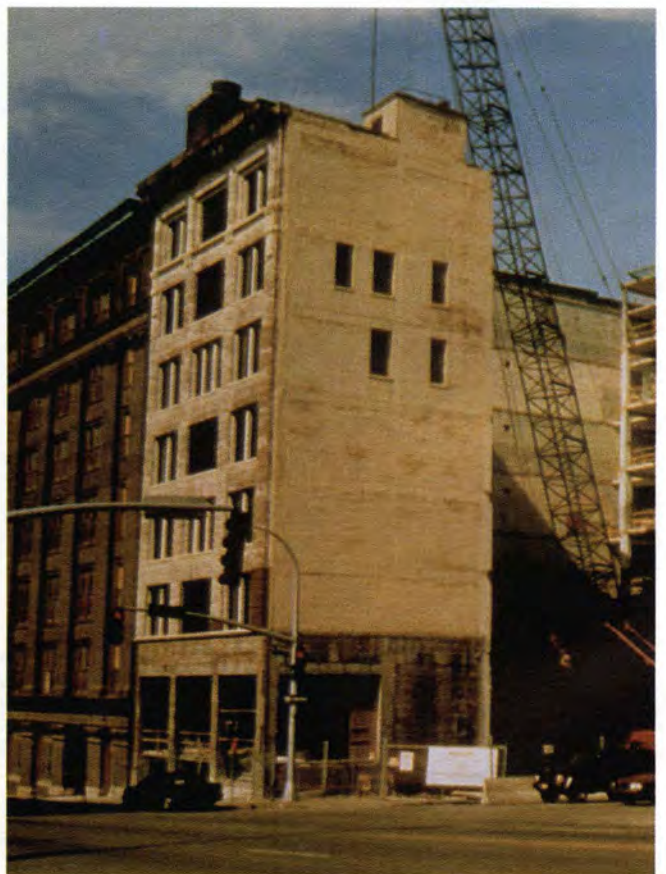
Fig. 12. Construction of Gatlin Building.

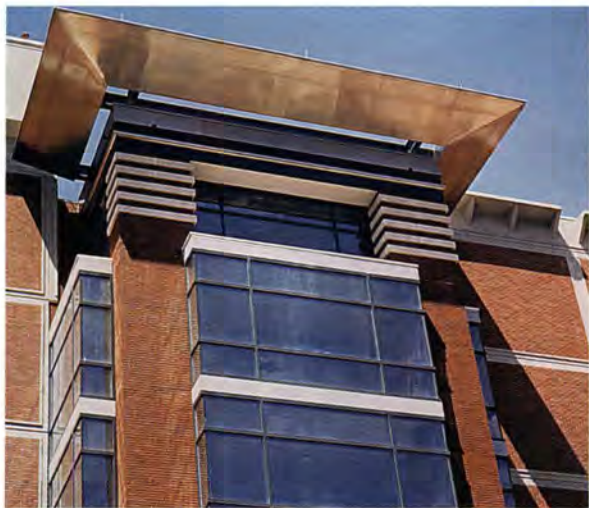
Fig. 13. Close-up of architectural detail showing eyebrow.

The Poindexter Office Building was completed in May 1997. Figs. 13 and 14 show various views of the completed project.
