# Design and Construction of the Texaco Wharf Maritime Port Facility, Puerto Cortés, Honduras

*The Texaco Wharf Maritime Port Facility is a major marine docking structure located off the northern coast of Honduras that has replaced a 1940s-era steel frame docking structure and access bridge. The structure comprises precast concrete piling and superstructure components that combine precast and cast-in-place concrete. The construction methodology almost completely eliminated the need for on-site formwork and proved to be very successful in producing a high quality docking project in a short time frame. This article presents the design parameters, construction challenges, and erection highlights of the project.*

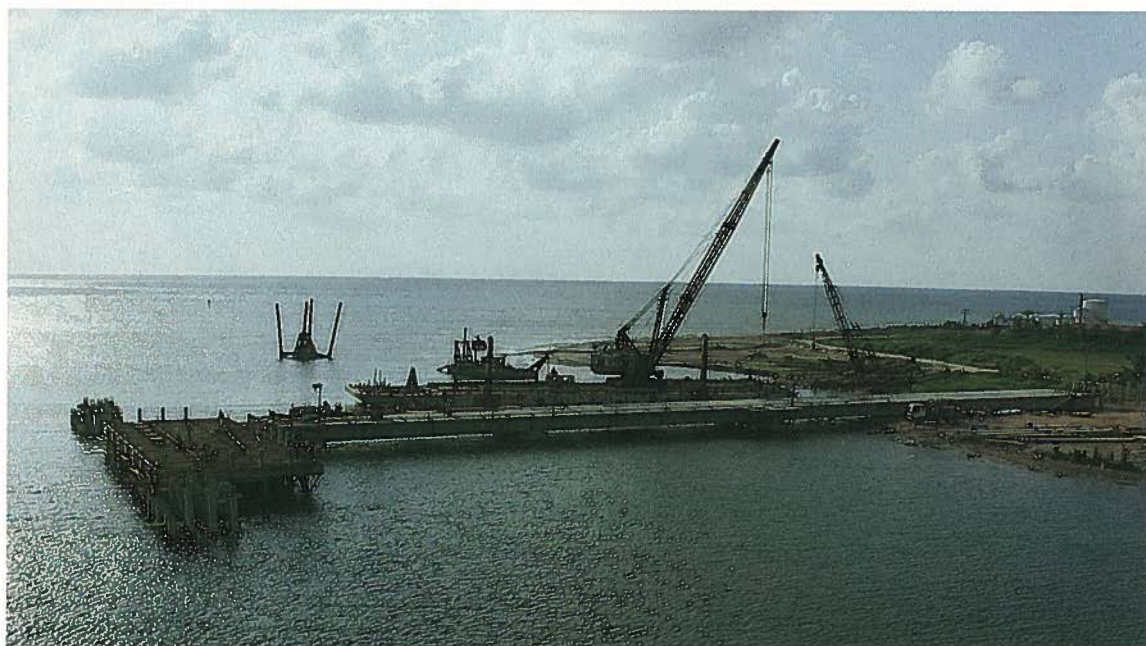
Fig. 1. Construction in progress on the Texaco Wharf Maritime Port Facility, Puerto Cortés, Honduras. A total of 533 precast concrete components were used on the project.

placed. The concrete quantities for each portion of the facility are presented in Table 1. The complex, shown under construction in Fig. 1, includes a 33.55 m (110.1 ft) long operations platform, two 10.6 m long, 6.0 m wide (34.8 x 19.7 ft) berthing dolphins (one at each end of the operations platform), four octagonal moorings for vessels waiting to dock, a 126.3 m (414 ft) long primary access

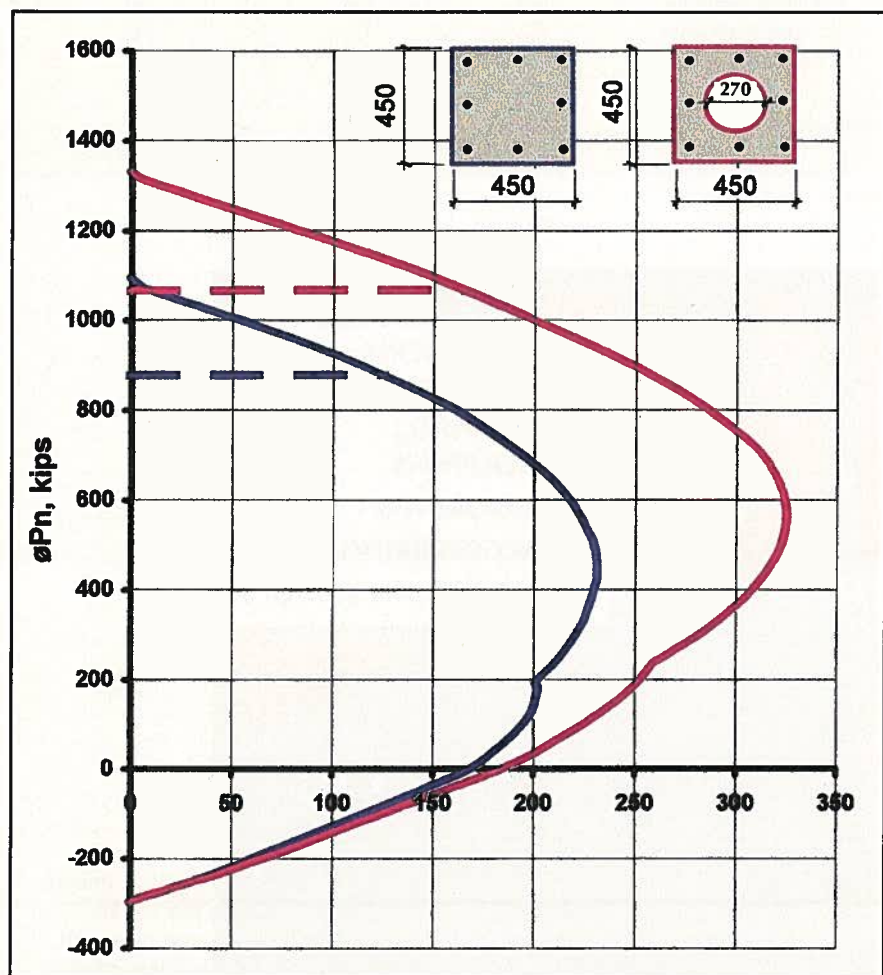
Fig. 4. The two different pile cross sections and a graphical representation of their structural capacities.

450 x 450 mm (17.7 x 17.7 in.) solid square section, and the second was a square section of the same dimensions but having a 270 mm (10.6 in.) diameter circular spun hollow core (see Fig. 4). Pile lengths ranged from 28 to 34 m (92 to 112 ft).

The structural capacities of these two pile sections differed, and the advantages of each were used to the fullest extent possible. For example, the hollow-spun piles used 28 percent less concrete than the solid square piles, yet they had a higher load-carrying capacity due to the higher concrete strength that was used. Fig. 4 presents the analytical structural capacity of the two pile types.

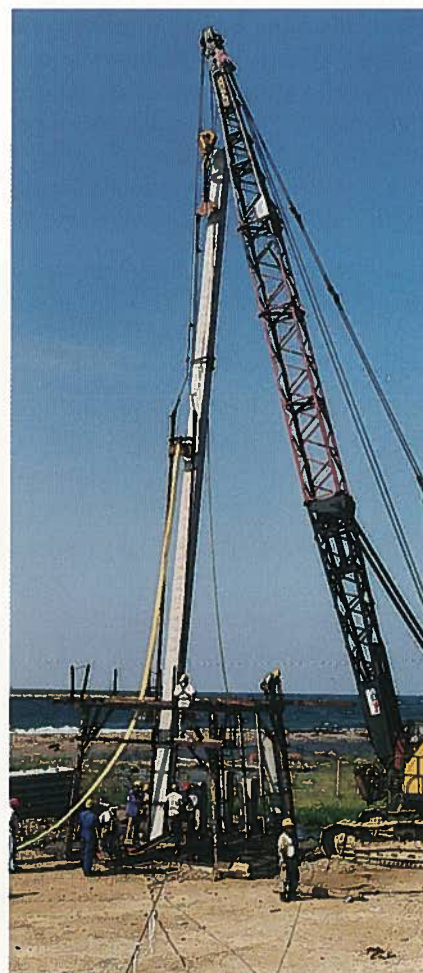
Fig. 5. A precast concrete pile being jettied down into the soil.

The piles were driven into place with a diesel-powered hammer mounted on a barge. The hammer weight was dropped from a height of 3 m (10 ft) at a rate of 59 blows per minute. The piles were first jetted down to a depth of 15 to 17 m (49 to 56 ft) before being driven to their final embedment depth of 20 m (66 ft) (see Fig. 5).

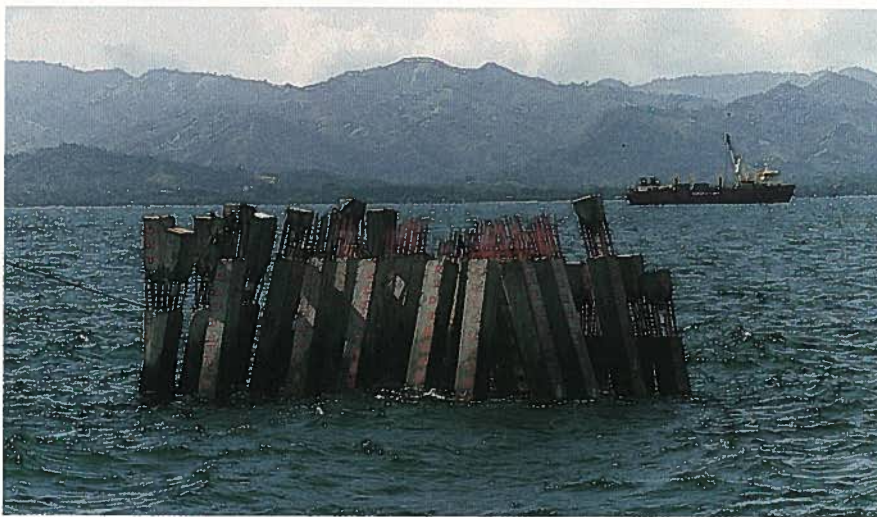
Fig. 7. A view of the piles for a berthing dolphin after being driven into position.

position and alignment had to be considered in both the design of the structure and in the construction schedule. For that reason, the superstructure was designed to fit the as-built position of the piles. Fig. 6 illustrates the design pile location and alignment for each berthing dolphin, and Fig. 7 shows these piles after being driven into position. The time-dependent dolphin pile movements at 3 and 80 days, respectively, after being driven are depicted in Figs. 8 and 9.

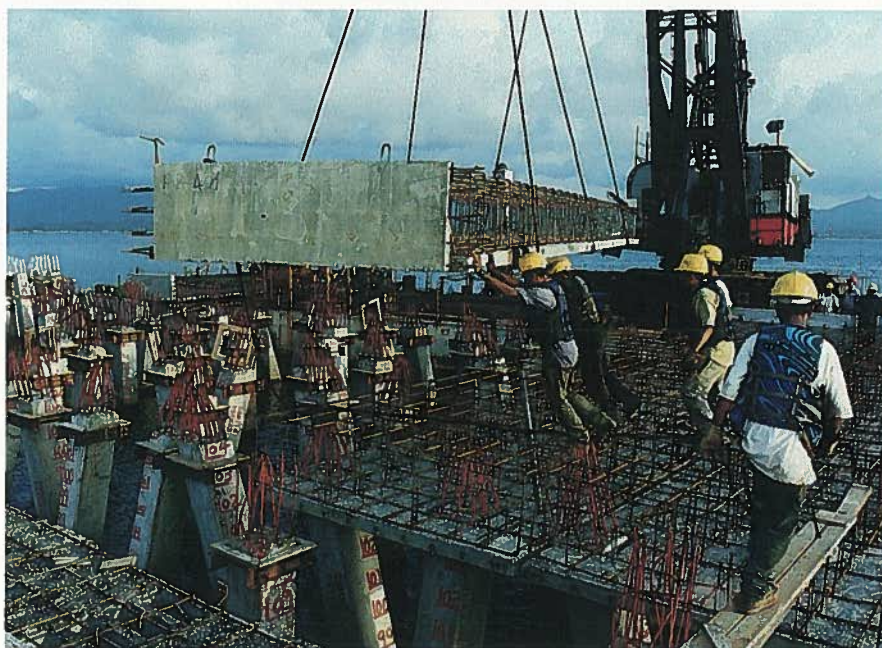
Fig. 10. Positioning one of the precast box units, with reinforcing steel cage, over the precast concrete piling of the operations platform.

The precast box units were supported on 98 piles and served as stay-in-place formwork for the placement of continuous, cast-in-place concrete within each box unit (see Fig. 10). The precast box elements were designed to act monolithically with cast-in-place concrete construction to form the completed structure.

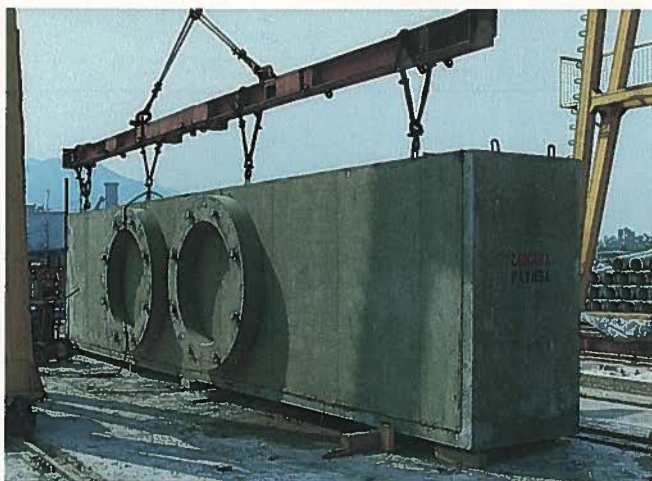
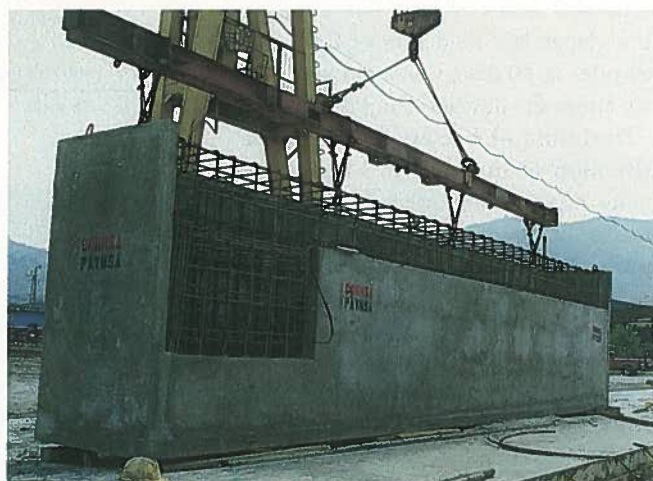
Fig. 12. Front and rear view of "Box 13," assembled at the precast plant from five precast, prestressed concrete panels and reinforcing steel cage for the cast-in-place concrete.

As with the operations platform, each berthing dolphin unit was fabricated and partially assembled at the precast plant before being transported to the site by truck and barge (see Fig. 12). The dolphin structure was completed by adding reinforcing steel between the units and pouring concrete inside the box structure. Lastly, a fender and face panel were added to the dolphin to protect it from damage during docking of large tankers (see Fig. 13).

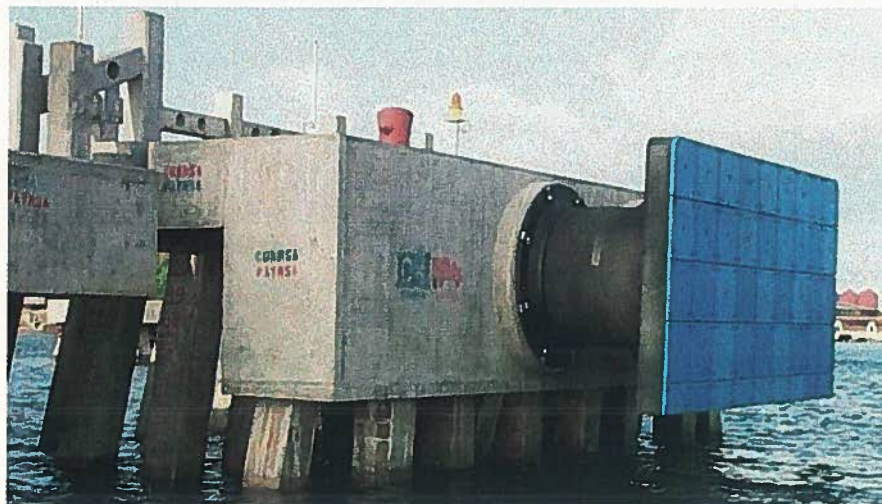
Fig. 13. View of the dolphin system complete with fender and face panel.

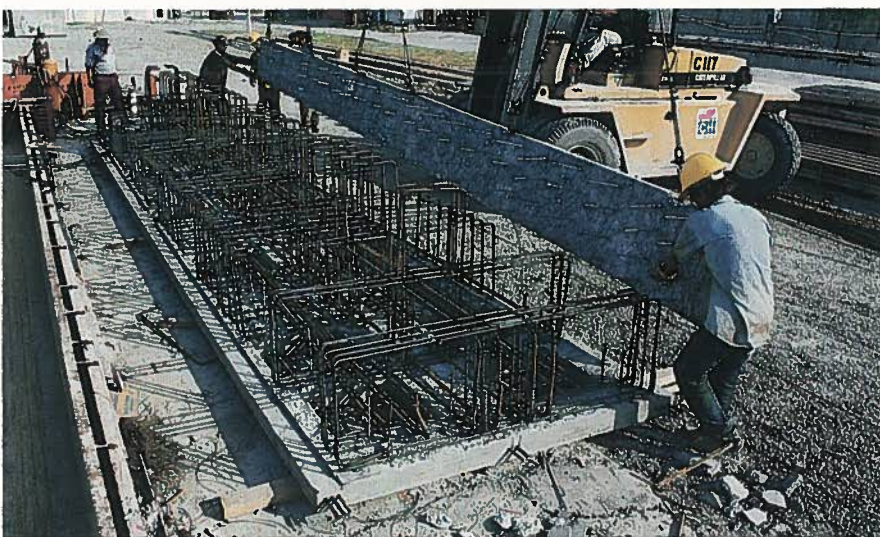
Fig. 15. The precast portion of the pier cap consisted of five individual precast panels that were fabricated and assembled together, along with the reinforcing steel cage, at the precast plant.

ing steel cage, all fabricated and assembled together at the plant before being delivered to the site for erection (see Fig. 15). After setting the precast assembly into the final position, cast-in-place concrete was poured inside it to complete the pier cap. The cap was

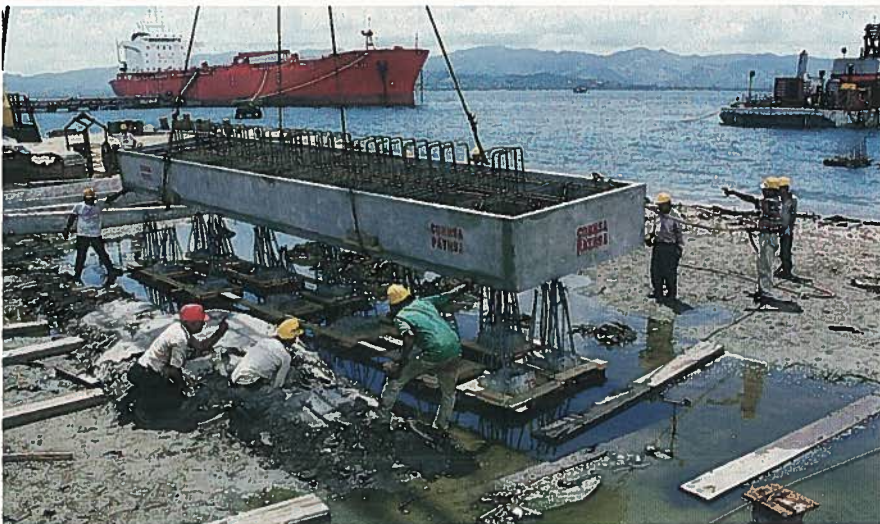
Fig. 16. A precast pier cap box unit being lowered into position atop the precast piling. Note the extension of reinforcement from the top of the pier cap.

connected to the superstructure by reinforcing steel bars that extend from the beam and into the deck (see Fig. 16).

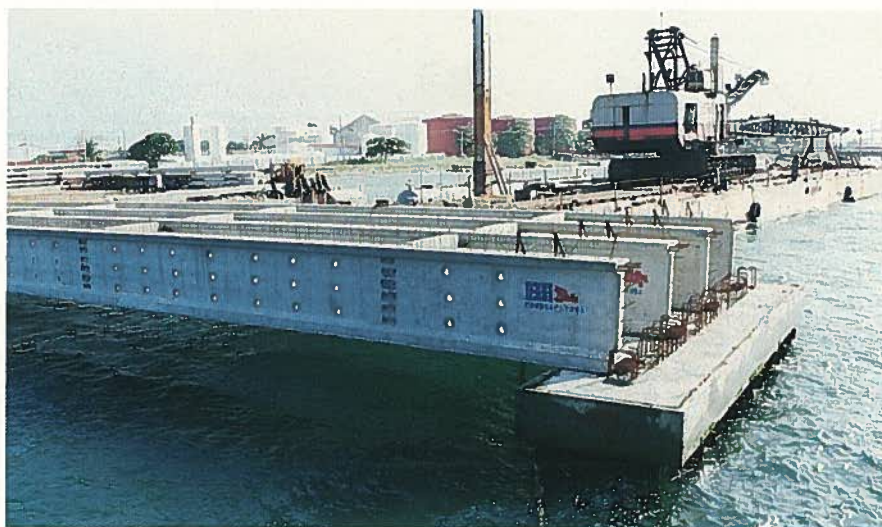
Fig. 17. Precast girders bearing on a completed pier cap.

each end of the bridge. The span length was governed by transportation and handling limitations, and the cantilever beams were specifically chosen to avoid contact with the battered piles of the operations platform (see Fig. 17).

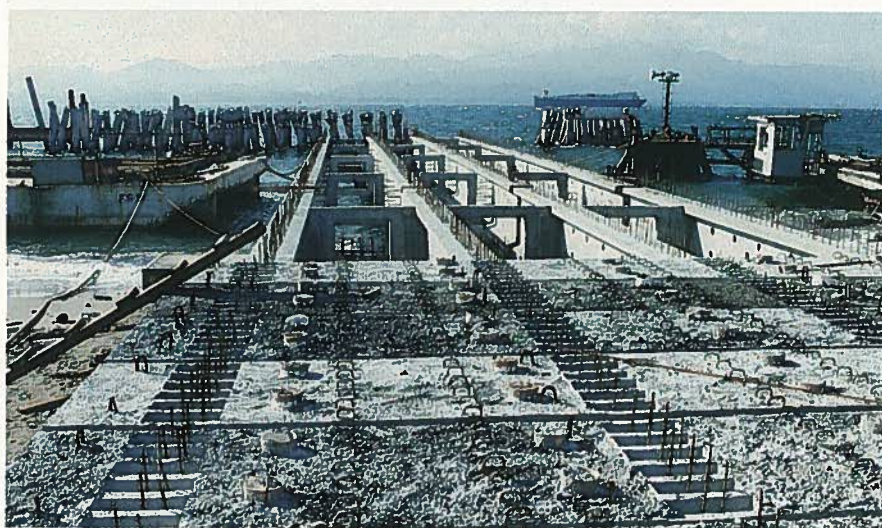
Fig. 18. A longitudinal perspective of the access bridge, showing the precast girders, diaphragms, and deck panels. Note the projection of reinforcement from the top of the girders into the deck topping.

The precast, prestressed bridge deck panels were 8.6 m long and 1.3 m wide (28.2 x 4.3 ft), with holes formed into them to allow reinforcing steel bars to project from the top of the longitudinal girders and into the deck topping (see Fig. 18). Partially prefabricated diaphragms were placed every 8 m (26 ft) along the span. Each one has a large hole and was cast-in-place at both sides.

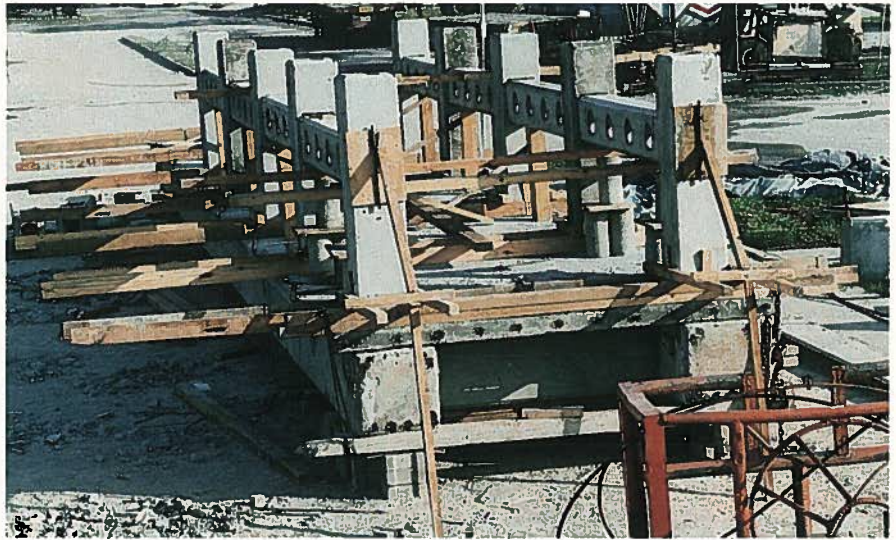
Fig. 19. Partial assembly of the western pedestrian bridge at the precast plant.

the two main beams, the deck slab, 14 railing columns, and 12 railing beams were cast as individual precast elements. Then, the two main beams were connected by six diaphragms that were cast between them. Lastly, after the railing columns and railing beams were temporarily assembled in place (see Fig. 19), cast-in-place concrete was poured into holes in the top of the railing columns. This final pour connected the railing columns to the railing beams, main structural beams, the beam diaphragms, and the deck slab (see Fig. 20).

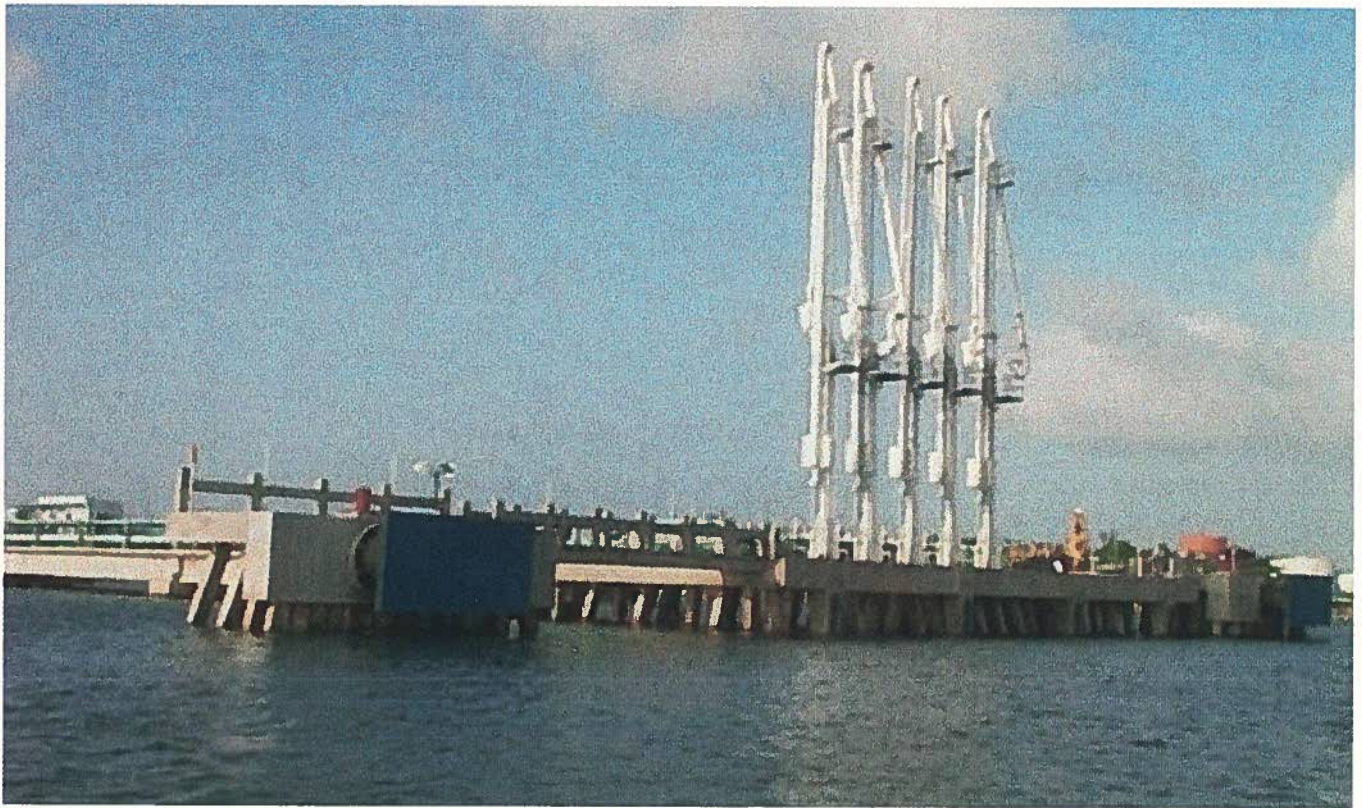
Fig. 22. View of the completed Texaco Wharf Maritime Port Facility.

In the end, precast concrete provided a finished structure of superior quality (see Fig. 22). This innovative project was completed at a low cost and on a tight construction schedule without sacrificing quality or structural integrity. The success of the project proves that the design principles applied in constructing these facilities can be adapted readily to many other types of marine and other construction.
