Architectural and Structural Precast/Prestressed Concrete Renovates Landmark Ohio Stadium

After 75 years of service, the “Horseshoe,” The Ohio State University’s historic landmark stadium, was badly in need of restoration, code-mandated modifications and expanded seating capacity. This high-visibility, \$195 million project called for a structural system that could meet the dual challenge of preserving the original classical architecture while providing uninterrupted stadium use for three football seasons during construction. Architectural precast concrete enhanced the aesthetics of the arched motif shell, giving the stadium its powerfully arcaded form. Structural and architectural precast elements composed the new lower and upper deck levels. The renovations to the entire stadium were possible only with the production predictability and design flexibility of precast/prestressed concrete components, including raker beams, triple risers and large curved architectural precast panels. This article explains how the precast concrete construction provided a highly successful, owner pleasing renovation solution.

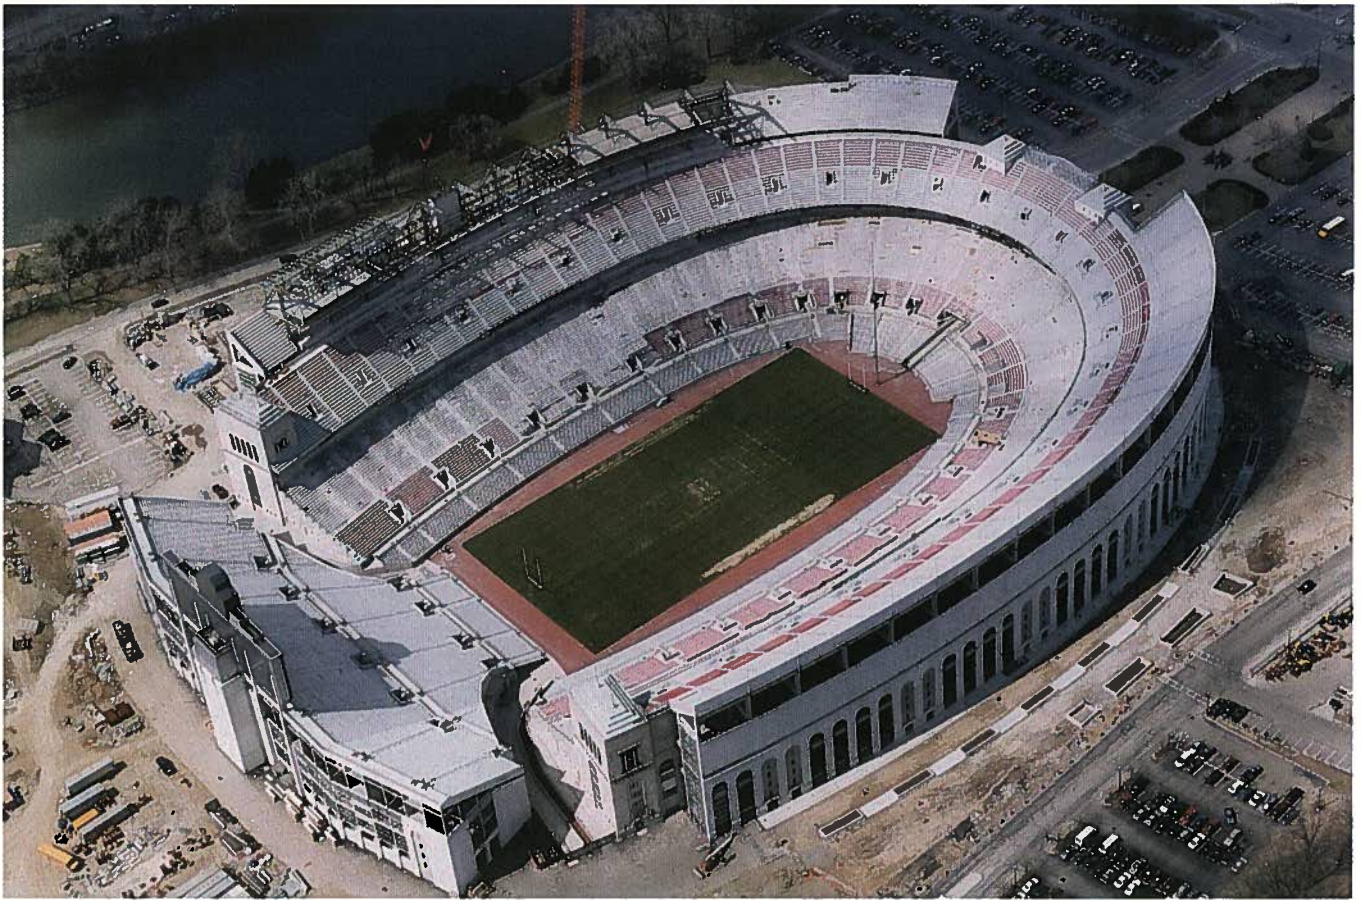
Fig. 1. The renovated "Horseshoe" retains the classical appearance of the original stadium.

The two critical concerns of the owner, Ohio State University (OSU), were to preserve the classical appearance of the Horseshoe (see Fig. 1) and to ensure that the football schedule would continue without interruption during the entire renovation period. Precast concrete construction was the only viable system that would meet the University's absolute mandate that the stadium be usable for every home football game during the four-year construction period and guarantee that the number of seats available would never be less than the 90,000 that existed at the start of the project (see Table 1).

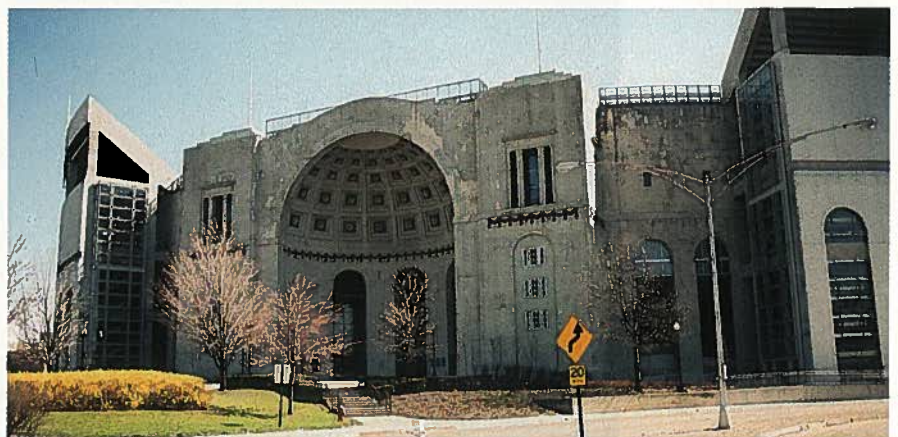
Fig. 2. Original north rotunda blends gracefully with new architectural precast out-build.

and the solid-to-void ratio that complements the original design intent. The new precast façade provides the important visual link between the new and old designs as the sandblasted precast finish clads the entire out-build structure that forms the stadium surround. The north rotunda and four cornerstone towers were retained from the original structure with appropriate restoration and repair (see Figs. 2 and 3).

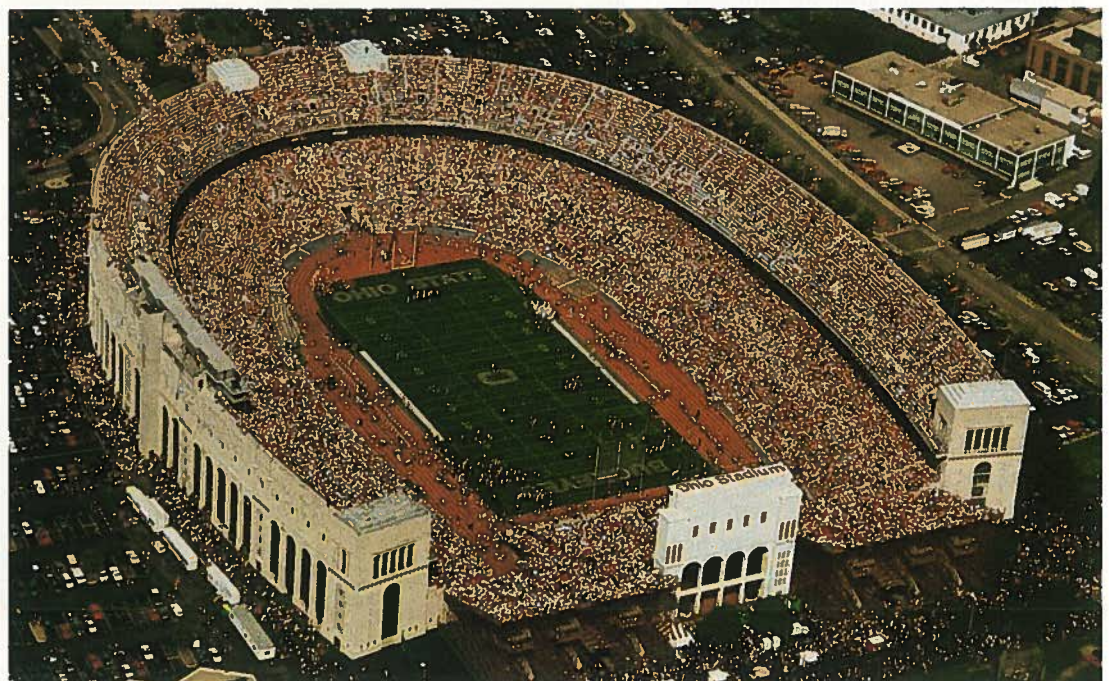
Fig. 3. Original stadium showing cornerstone towers and temporary bleachers at south end zone.

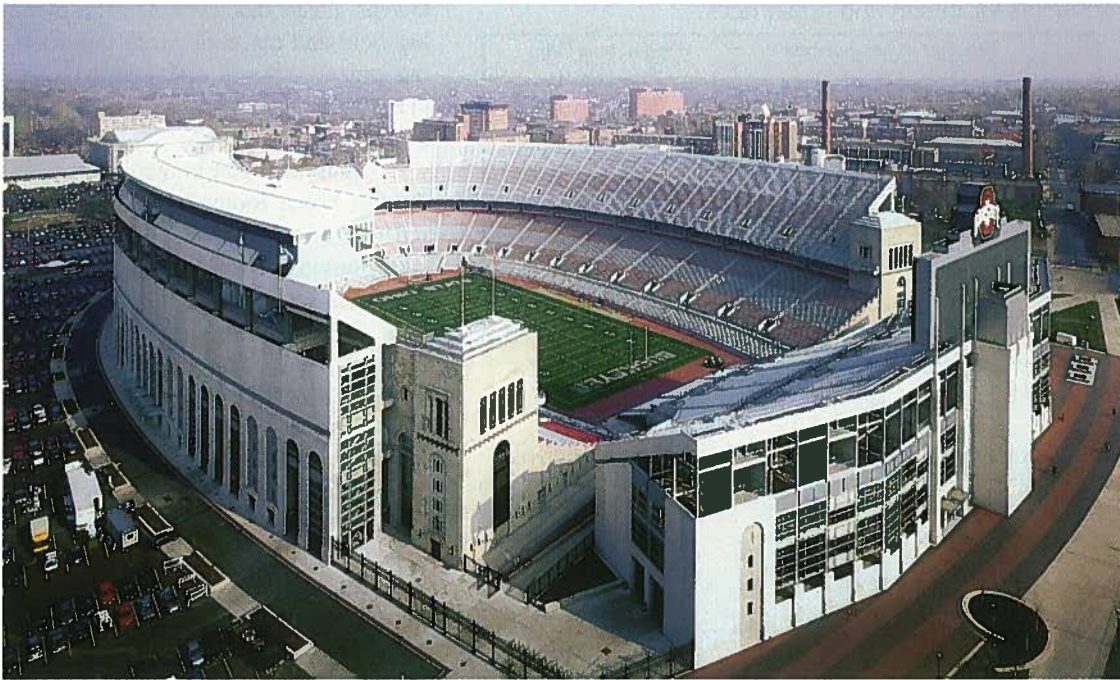
Fig. 6. The Horseshoe's original footprint is retained via an architectural break at the opening to the south end zone. (Photograph © 2002 Brad Feinknopf, Feinknopf Photography)

new construction in the south end zone establishes a visual break, or opening, at the south ends of the existing east and west sides of the stadium, leaving the horseshoe footprint intact. These openings function as entrance ramps to bring the players down from the existing grade to the new lowered playing field. Architectural precast panels, with similar historical detail as the main stadium, clad the exterior of the south end zone structure (see Figs. 5, 6, and 7). Quantities of components for the south end zone structure are provided in Table 3.

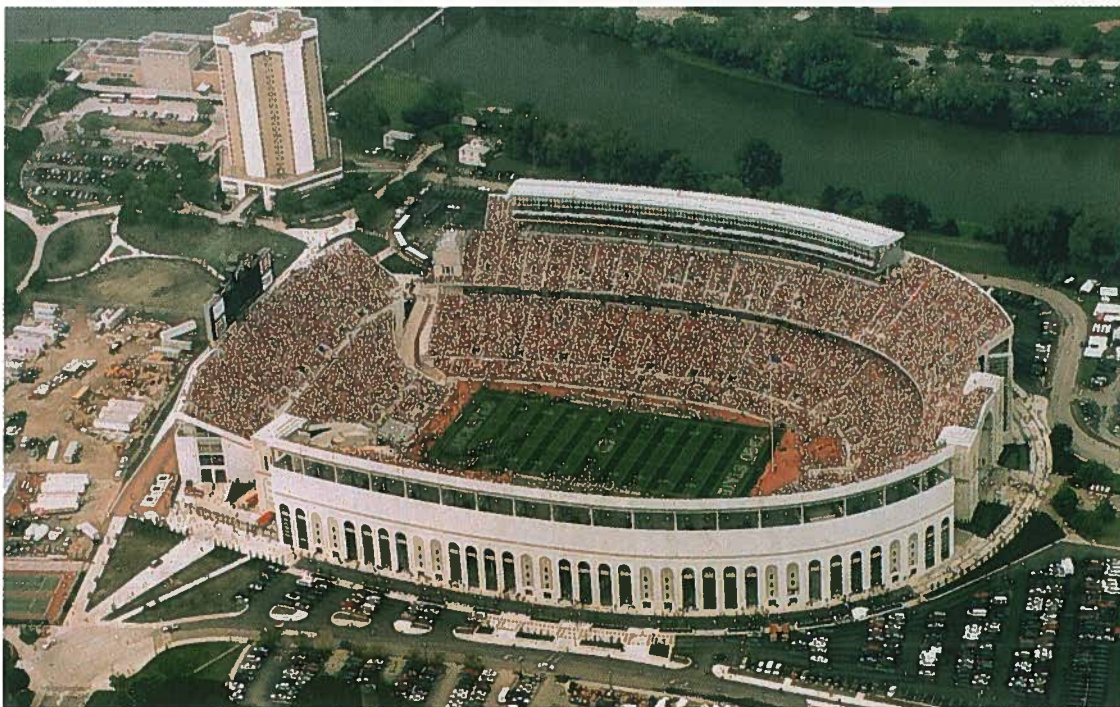
Fig. 7. Aerial view of the Ohio Stadium, looking west to the Oletangy River and showing south end zone entrance ramps and the narrow erection access on the east side of the stadium.

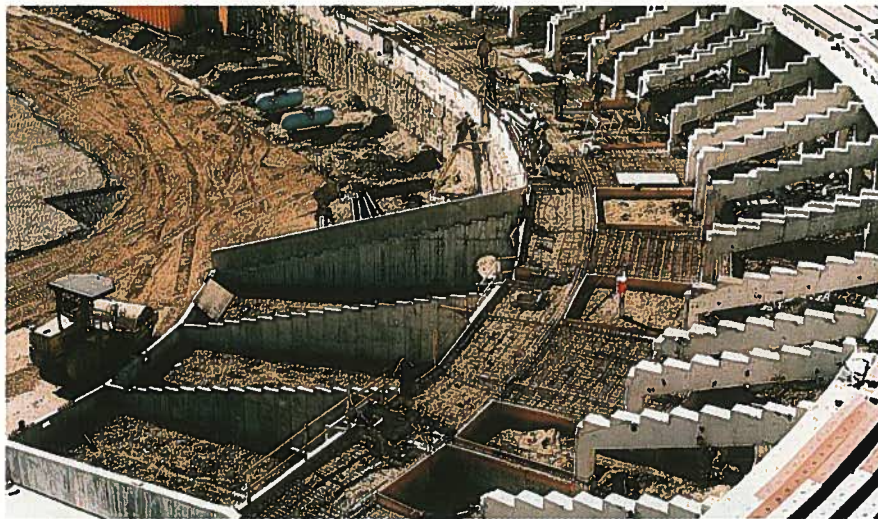
Fig. 8. Erection of the structural precast concrete raker beams at the excavated Lower AA Deck.

The designers reconfigured the seating geometry to improve sight lines for fans at all seating deck levels — namely, the new precast concrete lower deck, the new precast concrete intermediate level (replacing the existing lower deck), and the existing deck above. Precast concrete work began at the north end zone, or the closed end of the Horseshoe, and proceeded southward with both an east-side and westside crane, to speed the installation (see Figs. 8 and 9).

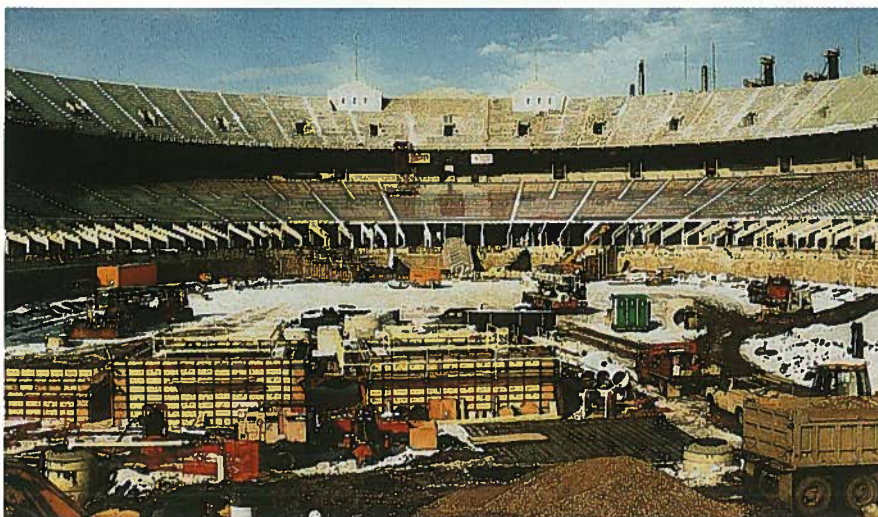
Fig. 9. Precast concrete erection moves simultaneously down from the north end zone.

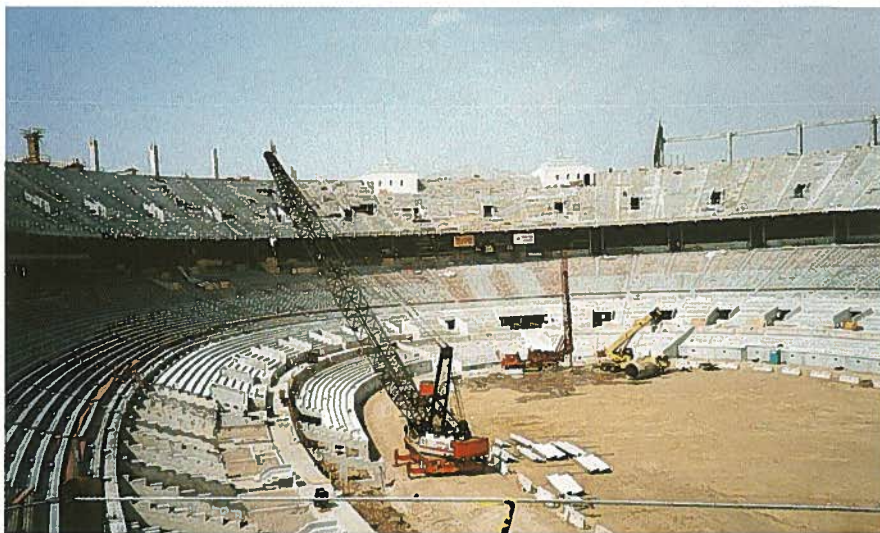
Fig. 10. New playing surface, excavated down 14 ft (4.3 m), places the playing field almost 6 ft (2 m) below the groundwater table.

With the completion of the slurry wall, demolition and cleanup crews carried out their work, and precast erection proceeded rapidly down both sides of the stadium simultaneously from the north to meet tight schedule deadlines. As precast erection proceeded, work on the engineered turf system could begin. Due to the drainage piping and turf system, no construction equipment or trucks were allowed beyond the point of the advancing precast erection (see Figs. 10 and 11).

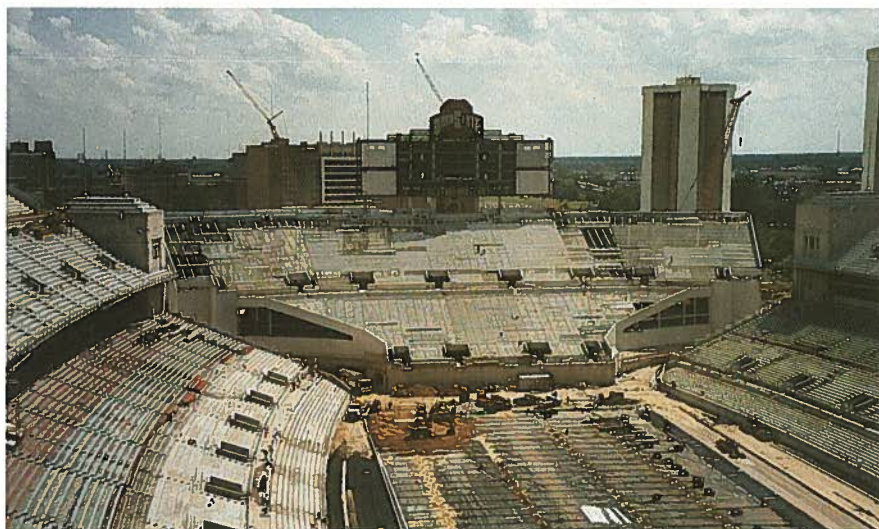
Fig. 11. Once the initial construction for the engineered turf drainage system began, no construction equipment was permitted on the stadium infield.

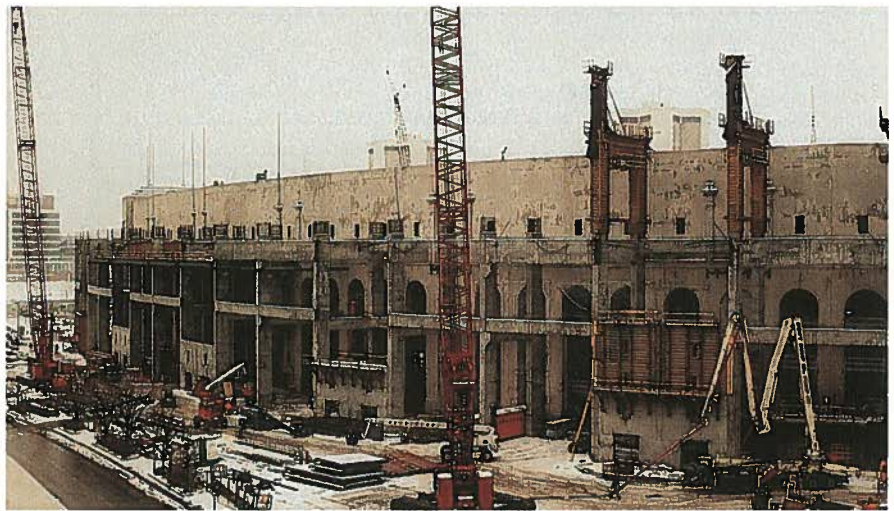
Fig. 13. Cast-in-place concrete columns and platforms provide structural support for precast expansion for the new Upper C Deck.

For the new 19 rows of seats on the east and west sides, cast-in-place concrete was used for the construction of columns and platform to the top of the existing stadium. Above this platform, precast “stepped” raker beams and triple risers were used. The upper deck was erected on the elevated cast-in-place platform. For the press box, constructed of steel framing, transverse trusses were assembled on the ground and lifted as one piece.

Erection of precast elements at the press box area on the west side proved to be a challenge. Some of the longitudinal steel bracing members had to be temporarily left out to allow for crane lines for erection of the precast risers. Balancing the necessary amount of longitudinal bracing with erector requirements was a delicate operation (see Figs. 13 and 14).

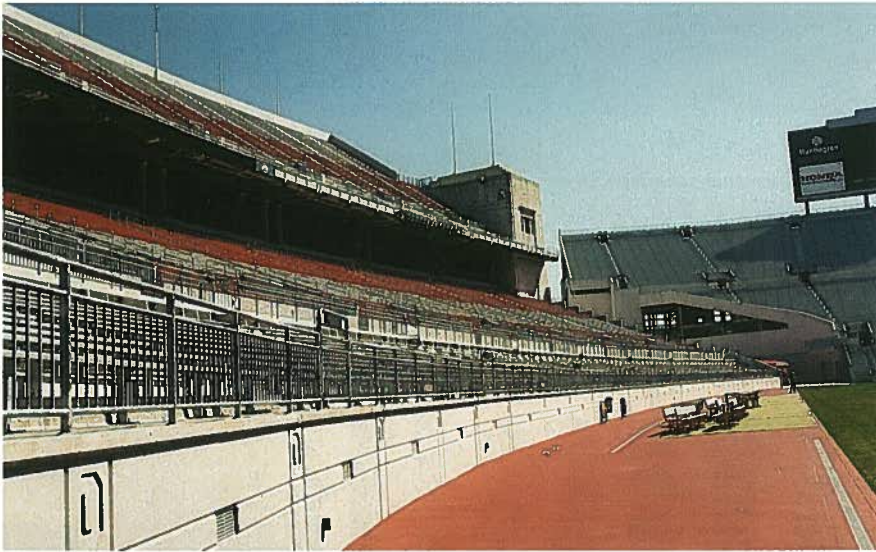
Fig. 16. Architectural precast concrete fascia walls at playing level provided owner-pleasing detailing of the OSU block "O" logo.

One of the most attractive and owner-pleasing elements of the precast panels that make up the inner perimeter fascia walls is the OSU traditional “Block O” logo cast into the pieces at every column line (see Figs. 16 and 17).

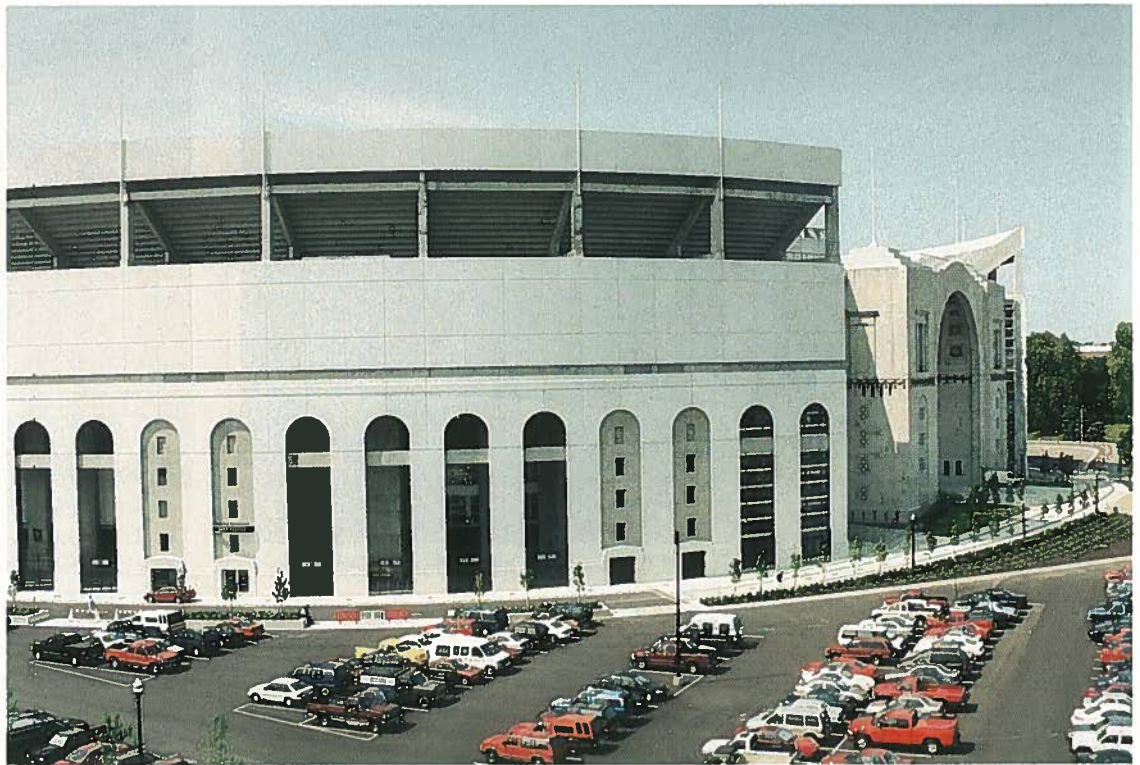
Fig. 18. New architectural precast wall panels blend the powerfully arcaded forms of the stadium expansion with the "old" architecture of the north rotunda.

The materials, textures, and finishes of the architectural precast façade achieve a monolithic, simple character similar to that of the original Romanesque exterior. The new construction intentionally does not match the original, so that the difference between old and new is clearly apparent (see Fig. 18).

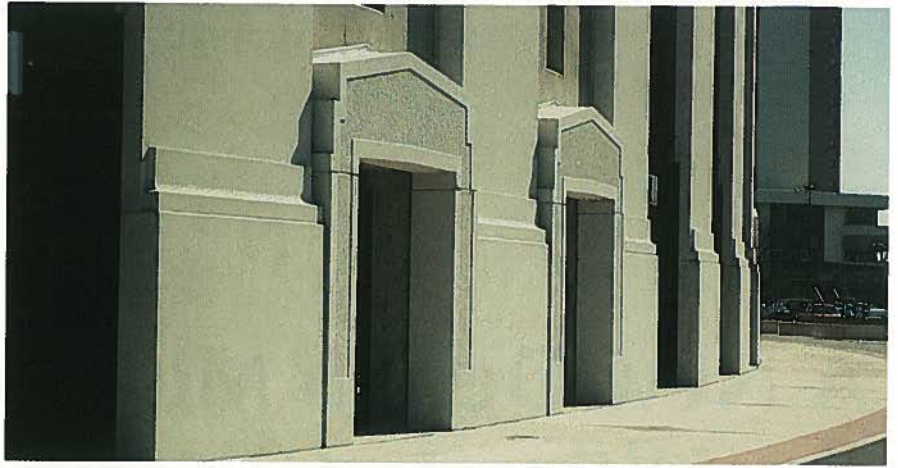
Fig. 20. Entrance portals were given a bush-hammered finish to work in aesthetic harmony with the older existing cast-in-place concrete.

Entrance portals received a “bush-hammered” finish to match the same

design appearance as the existing façade. The outer precast walls were sandblasted to blend with the existing concrete. The textured, bush-hammered precast finish works particularly well with the original historic look of the north rotunda (see Figs. 20 and 21).

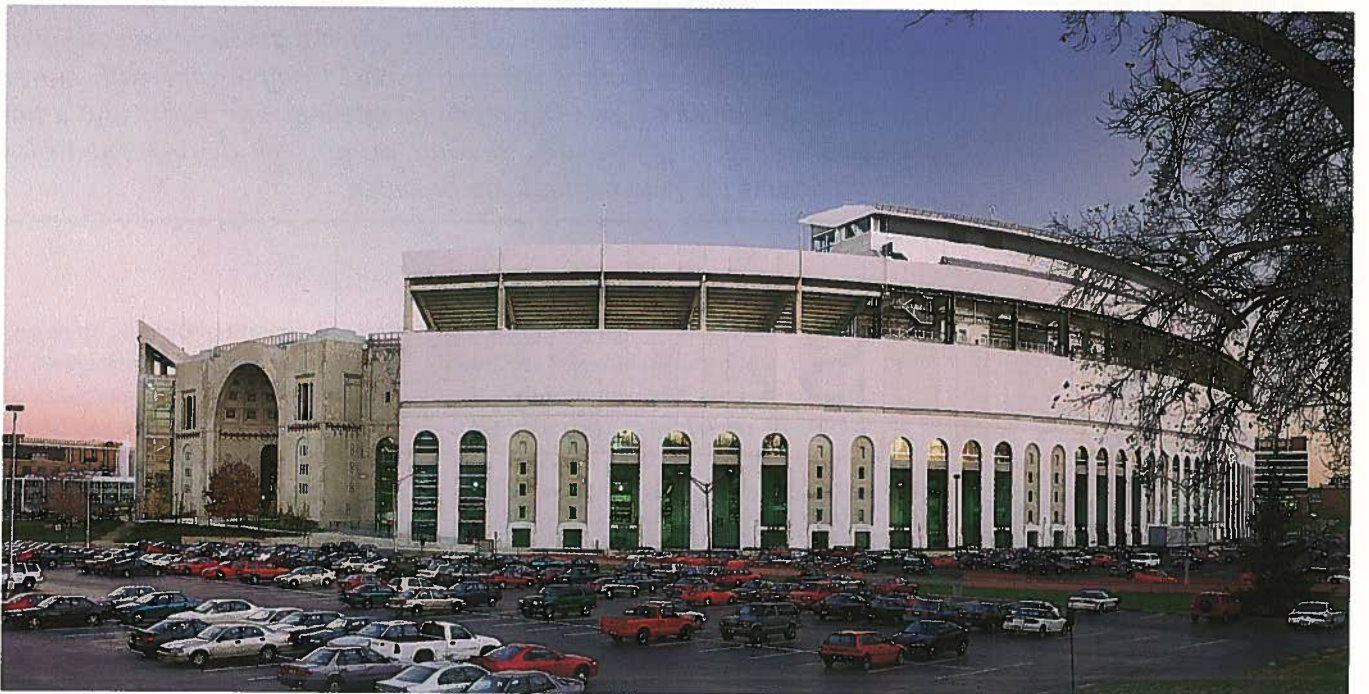
Fig. 22. The new precast exterior serves to complement, rather than compete with, the existing construction. (Photograph © 2002 Brad Feinknopf, Feinknopf Photography)

The tight schedule for completion of the initial phase of the contract had to be complete before the first home game in the fall of 2000. The overall schedule covers the activities of numerous trades and contractors. Successfully orchestrating the activities of this many contractors in a demanding and non-negotiable schedule was the accomplishment of Turner Construction Co., project construction managers, in conjunction with all of the prime contractors, particularly Kokosing/P.J. Dick (a joint venture), who was the prime contractor for the entire south end zone general trades package, and Kokosing/P.J. Dick/Baker (a joint venture), who was the prime contractor for the cast-in-place concrete for the main stadium. In the end, the owner was very pleased with the efforts of all involved on the project, and especially with the final result (see Fig. 22).
