Seismic tests of precast concrete, moment-resisting frames and connections

Weichen Xue and Xinlei Yang

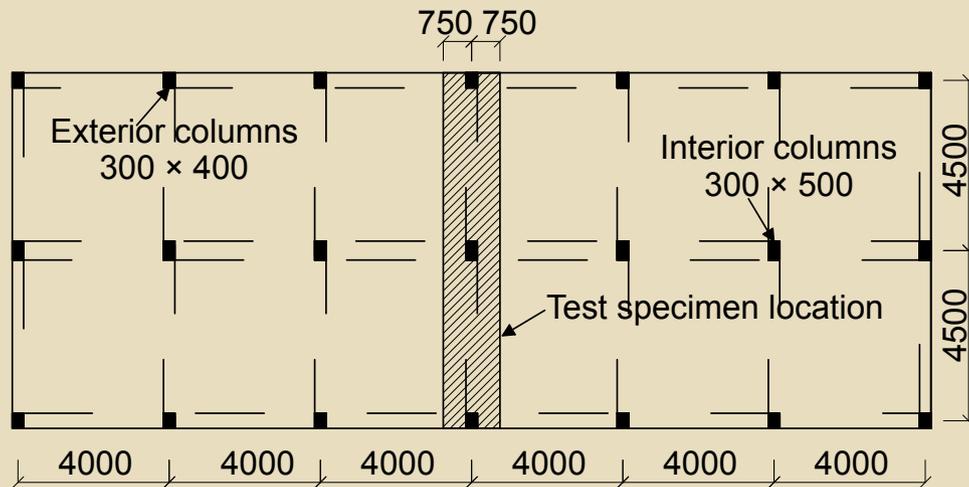
Figure 1. This diagram illustrates the structural-plan layout of the prototype frame building. Note: All dimensions are in millimeters. 1 mm = 0.0394 in.

with plan dimensions of 9 m × 24 m (30 ft × 79 ft), 4 m (13 ft) column spacing, and 2.8 m (9 ft) story height. **Figure 1** presents the structural-plan layout of the prototype frame building.

The frame model represented an inner-column strip along the south-north direction of the prototype structure (Fig. 1). The prototype frame (specimen PCF-1) was reduced to a half-scale model according to similitude law due to the experimental space constraints. In order to enhance

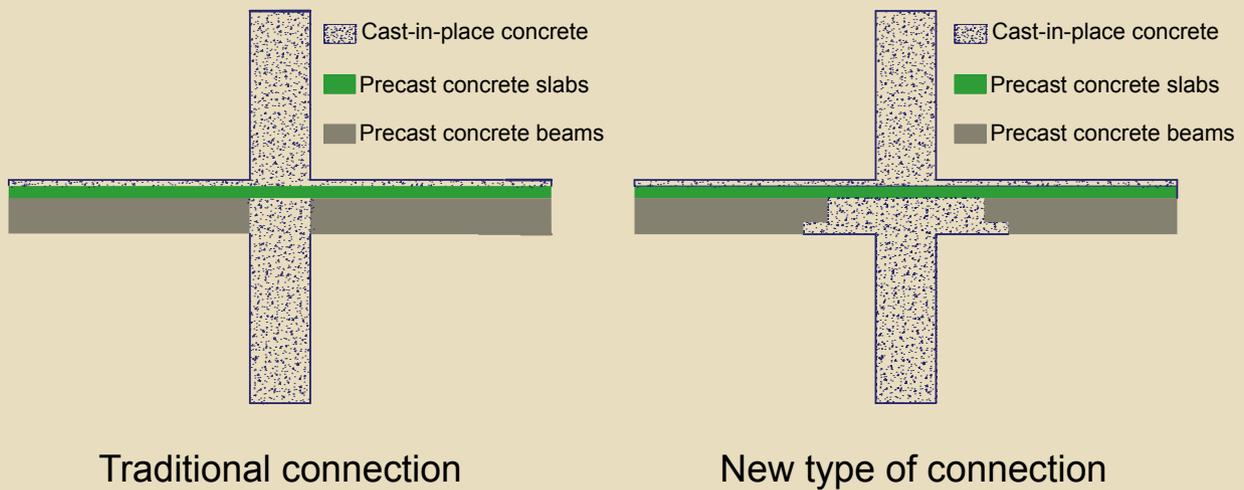
Figure 2. This schematic diagram compares the traditional connection with the new type of connection.

Compared with traditional precast concrete connections, one of the fundamental advantages of the precast concrete connections investigated in this paper (**Fig. 2**) was that the weak section in the beam was away from the most unfavorable position in which the moment and the shear were simultaneously maximum.

In each specimen, five layers of horizontal joint hoops were equally spaced at 100 mm (4 in.) between the top and bottom longitudinal beam bars to prevent joint shear failure. To enhance the integrity of the precast concrete connections, several measurements were taken. A new type of composite beam was adopted (**Fig. 3**). The precast concrete beam overlaps the cast-in-place concrete section for a distance of 450 mm (18 in.) (which is also the depth of the beam h) from the column face along the beam. The column and beam end were cast at the same time (**Fig. 2**).

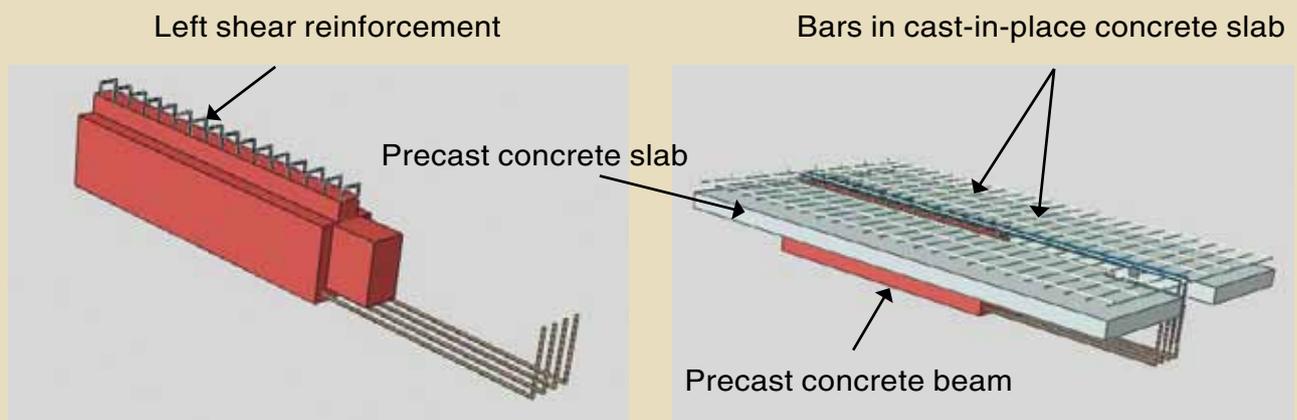
Figure 3. This schematic shows the composition of the precast concrete beam and composite beam. Note: For clarity, cast-in-place concrete is not shown.

The concrete shear key was formed at the beam end (Fig. 3), and the shear key and precast concrete slab were lightly brushed on the contact surface with an average roughness amplitude of 5 mm (0.20 in.). The notches were formed in the precast concrete slabs along the beam to place tie bars (Fig. 4), and the 560-mm-long (22 in.), 40-mm-wide (1.57 in.), 20-mm-deep (0.79 in.) notch provided enough development length for tie bars.

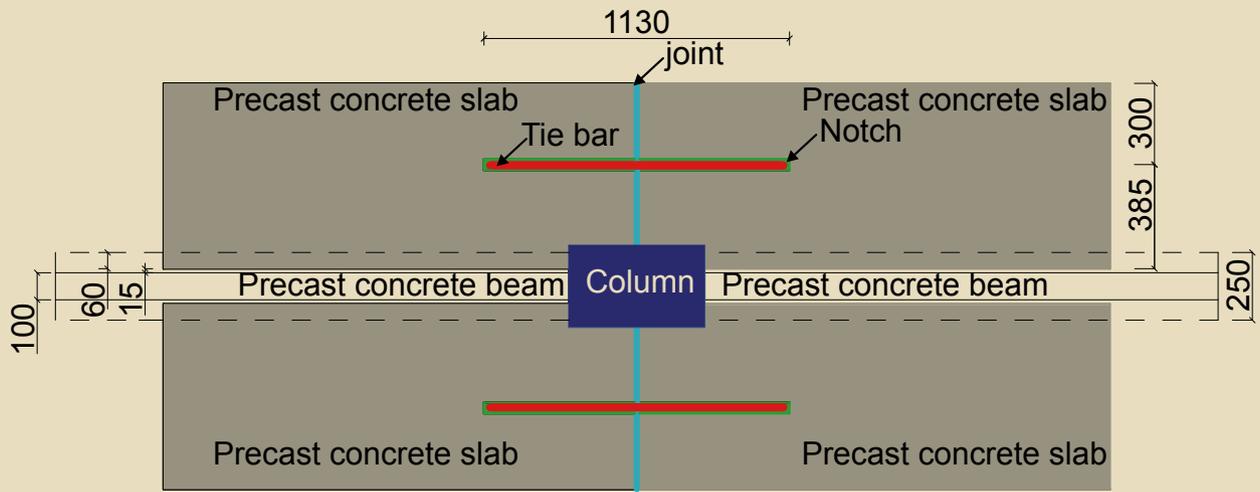
Figure 4. Notches were formed in the precast concrete slabs along the beam to place tie bars. Note: All dimensions are in millimeters. 1 mm = 0.0394 in.

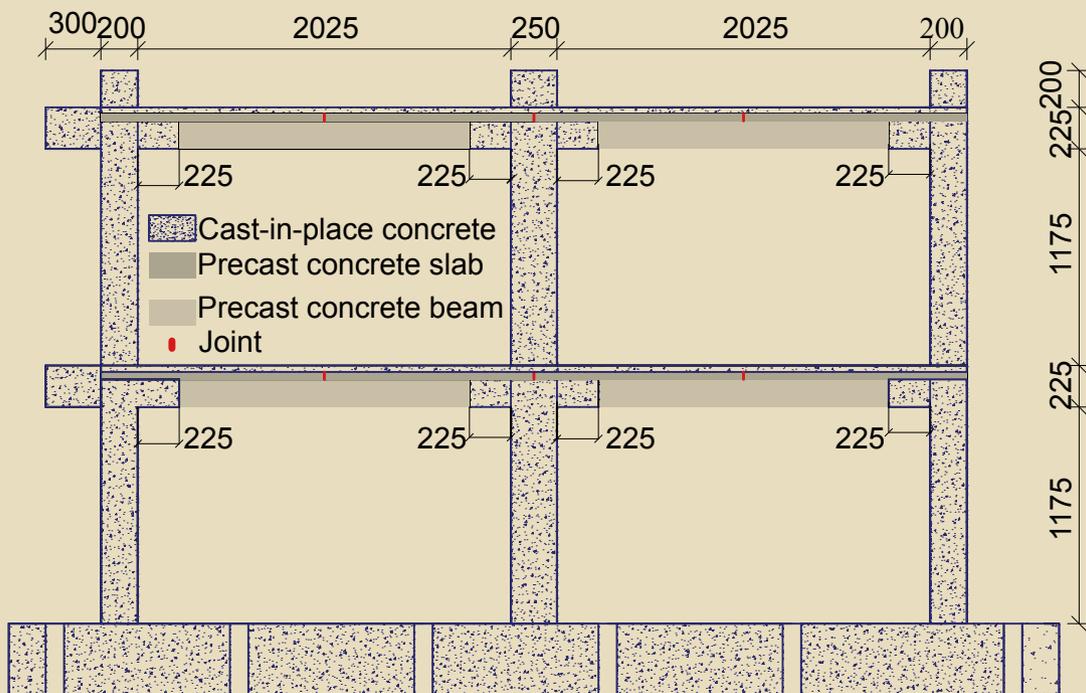
Figure 5. This schematic shows the locations of the precast concrete beams and slabs in the frame model. Note: All dimensions are in millimeters. 1 mm = 0.0394 in.

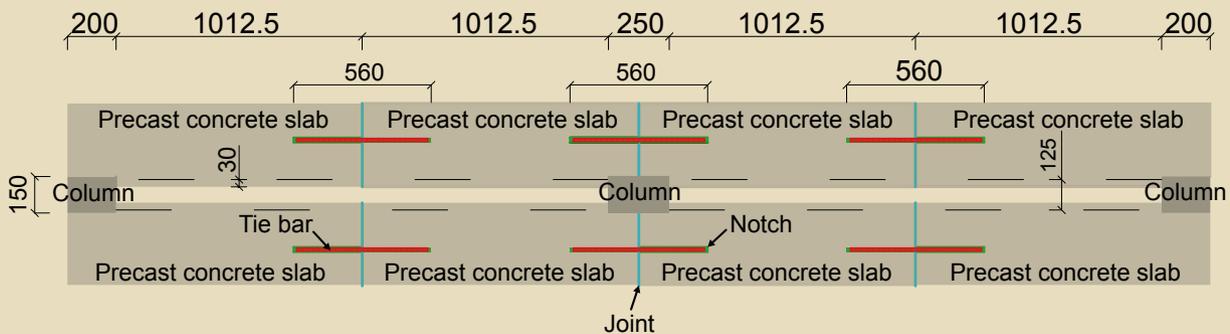
Figure 6. This diagram shows the location of tie bars and joints. Note: All dimensions are in millimeters. 1 mm = 0.0394 in.

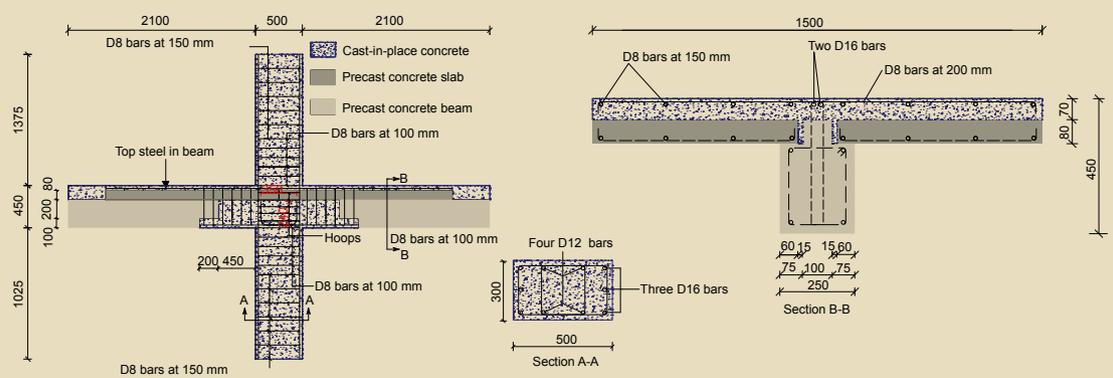
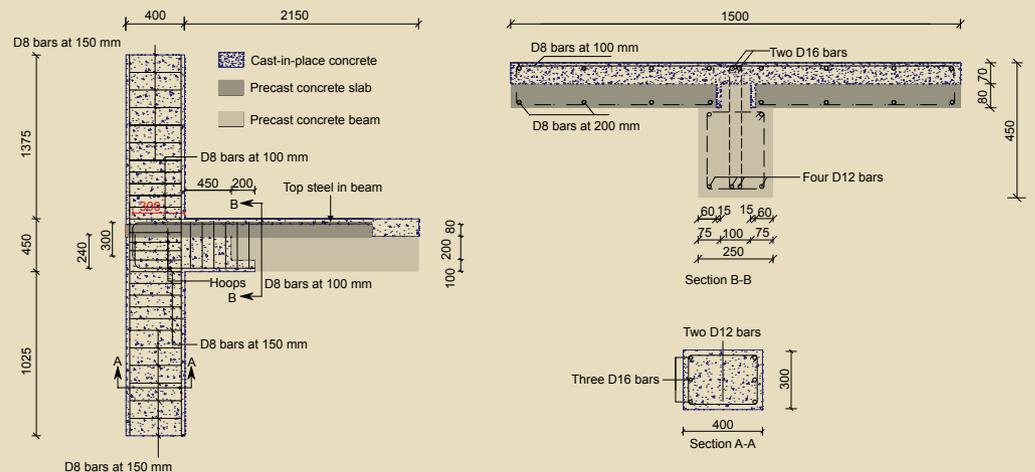
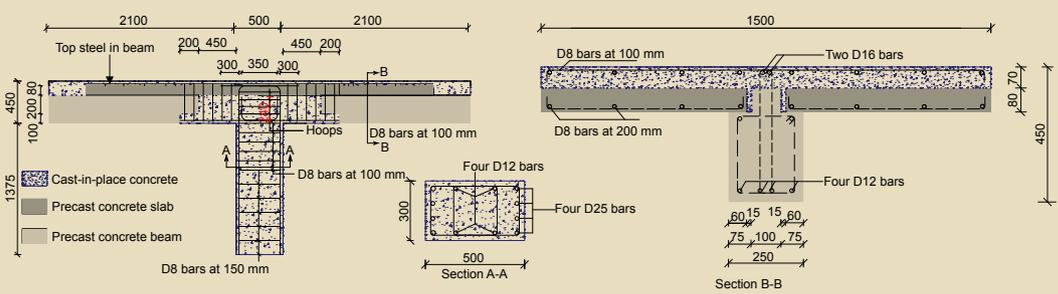
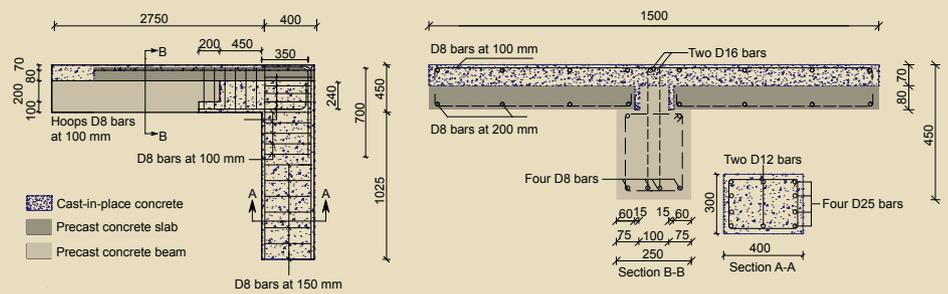
Figure 7. These diagrams show the geometry and steel details of the four connections. Note: All dimensions are in millimeters. 1 mm = 0.0394 in.

Figures 7 and **8** present dimensions and reinforcement details of the four connections and the frame model, respectively.

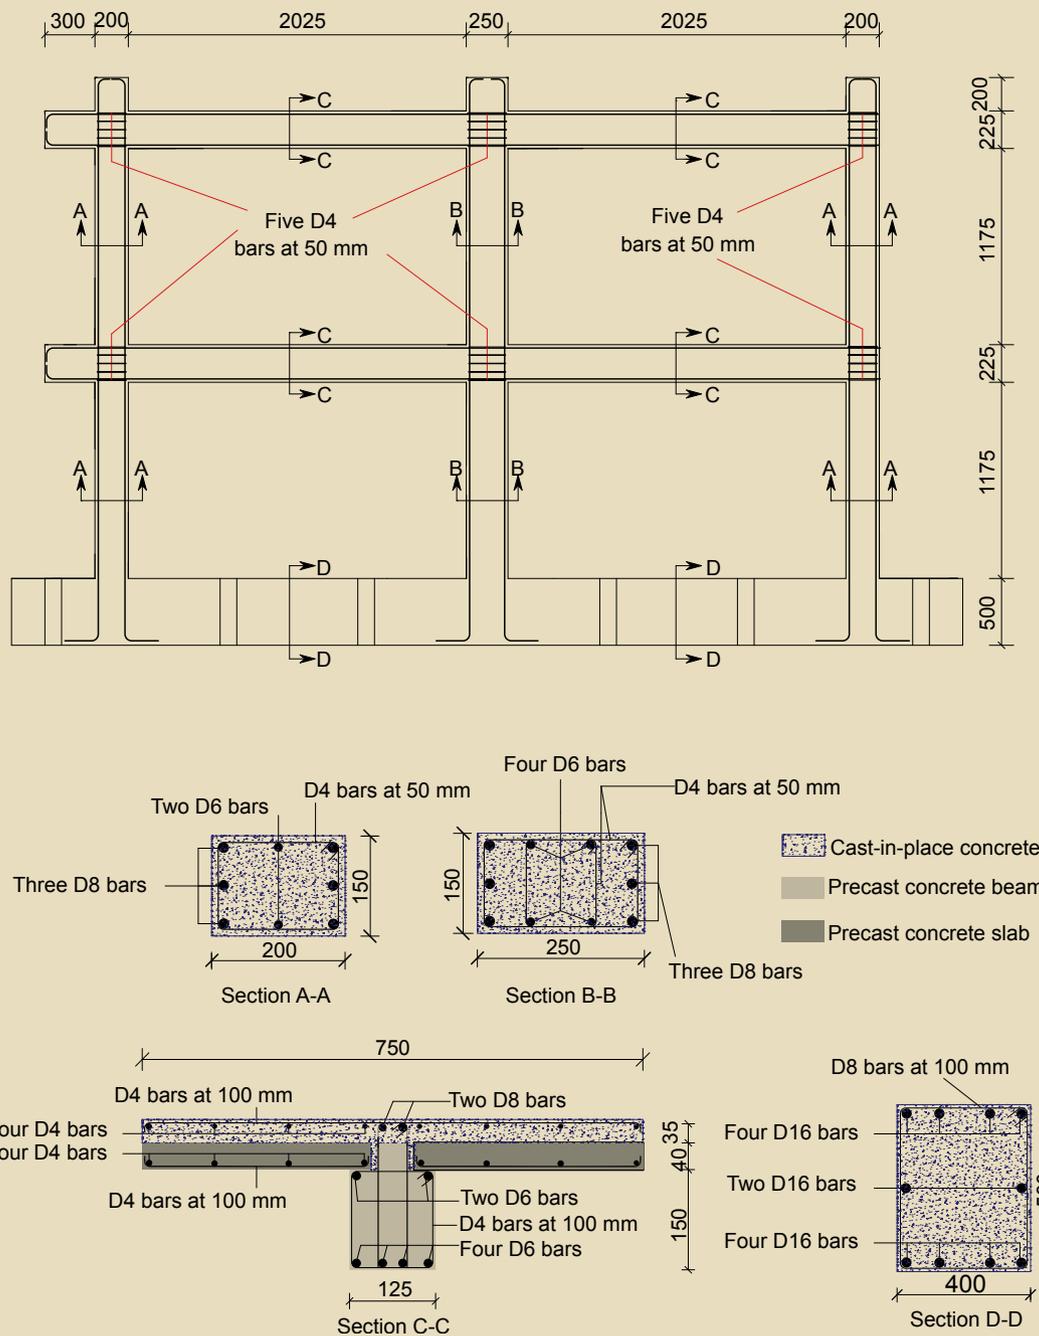
Figure 8. This schematic shows the geometry and steel details of the frame model specimen PCF-1. Note: All dimensions are in millimeters. 1 mm = 0.0394 in.

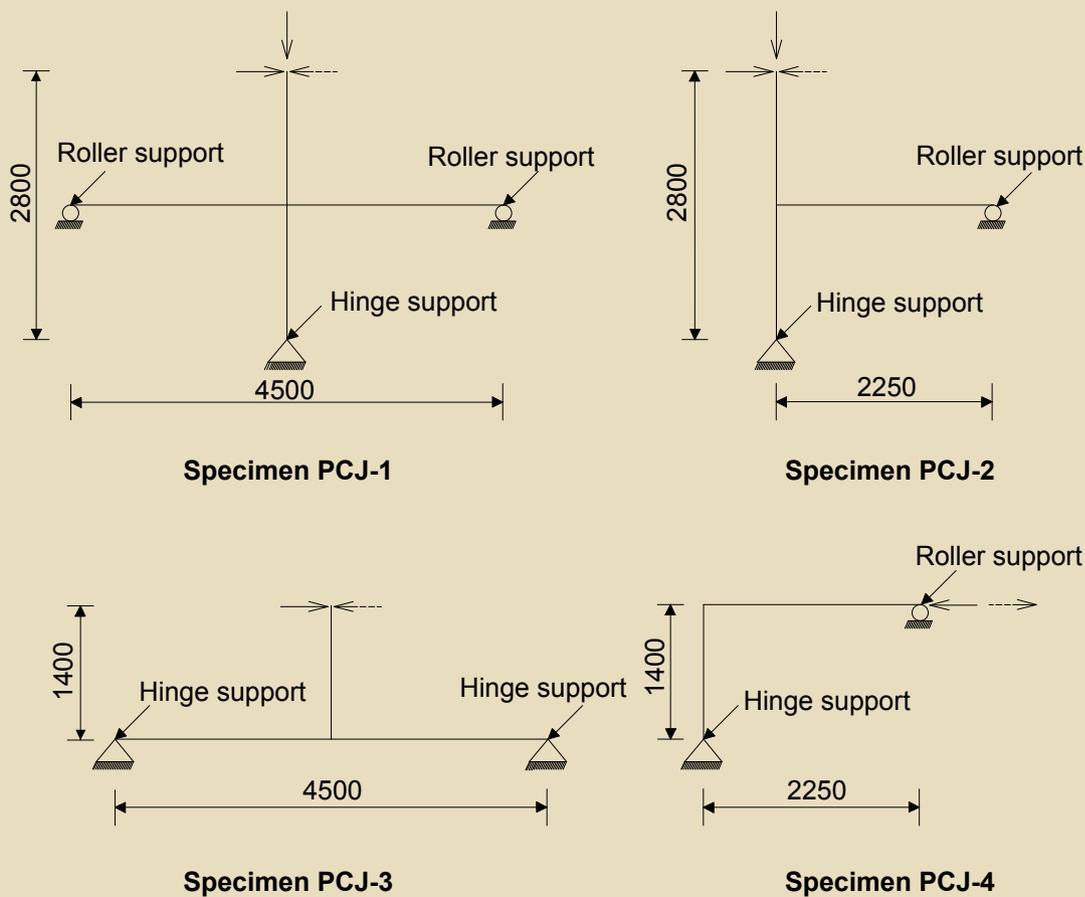
Figure 9. This diagram shows the boundary conditions for connection specimens. Note: All dimensions are in millimeters. 1 mm = 0.0394 in.

All test specimens were constructed and tested at the Tongji University Structural Engineering Laboratory. For the four connections, the adopted geometry of the investigated specimens represented the beam-to-beam inflection points and column-to-column inflection points (points of zero moment) that existed at the midspans of beams and columns when a frame was subjected to earthquake-induced lateral loads. **Figure 9** shows the boundary conditions for the four connections.

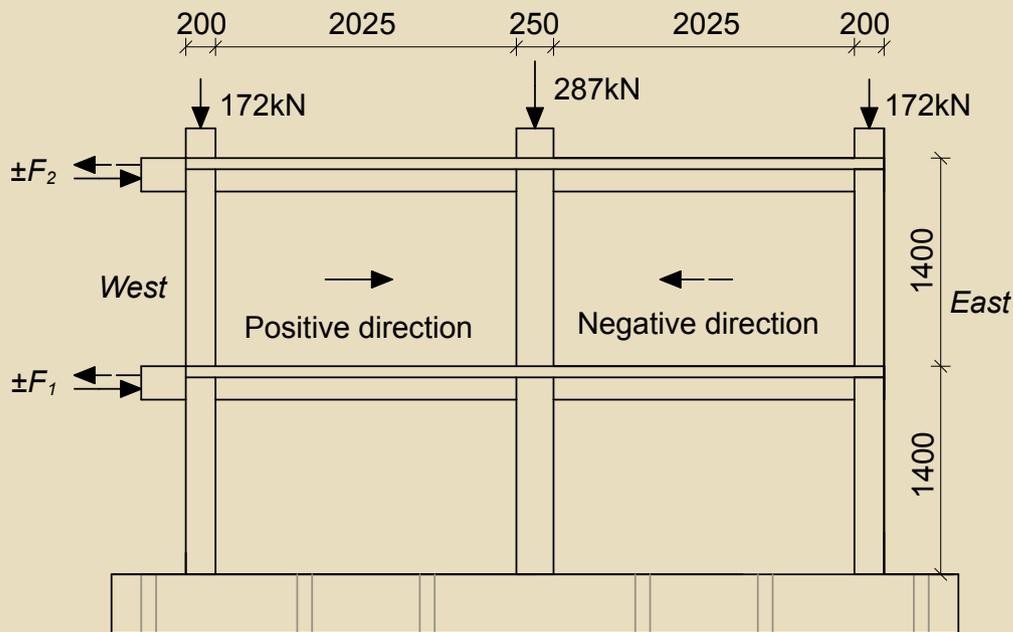
Figure 10. Lateral loads F_1 and F_2 were applied at the first and second levels of the structure, respectively. Note: Dimensions not listed are in millimeters. 1 mm = 0.0394 in.; 1 kN = 0.225 kip.

The frame model, specimen PCF-1, was tested under constant vertical loads (an axial compressive ratio of 0.3 for the two exterior columns and 0.4 for the middle column), which represented the axial load due to live and dead loads of the upper story in the prototype structure. The vertical loads were applied to three column tops by using three identical hydraulic actuators attached to the steel girder through a sliding cart, which could automatically trace the column top when loading to consider the P-delta effect.

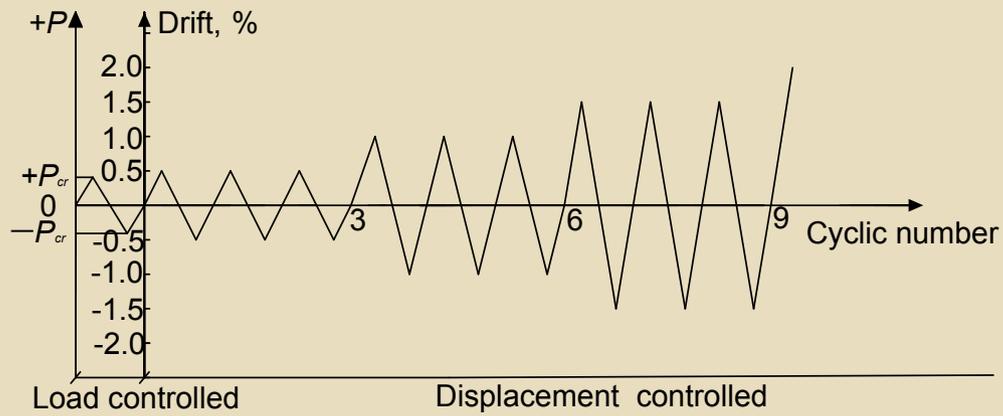
Figure 11. This graph shows the cyclic-loading history used in this study. Note: P = load; P_{cr} = cracking load.

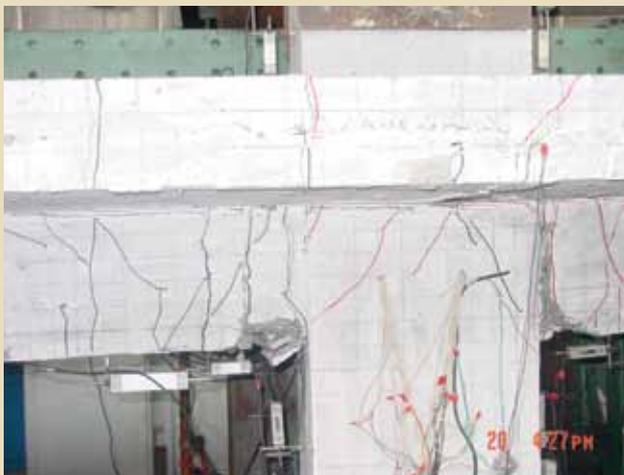
Figure 12. These photos show the crack patterns and failure modes of four connections at the end of the test.

Specimen PCJ-1 The first fine flexural crack occurred in the beam at a distance of 700 mm (27.6 in.) from the face of the column at a load of 46.3 kN (10.4 kip). The initial cracking location was the interface between cast-in-place concrete and precast concrete. At a drift of 0.53%, the specimen reached the yield state that was defined according to the criteria used by Park¹⁷ for equivalent elastoplastic energy absorption and its maximum load-carrying capacity at a drift of 1.0%.

cracks appeared at the bottom of the beam end at a drift of 1.0% as a result of the bars slipping. Diagonal shear cracks appeared in the joint at a drift of 2.0%. Flexural cracks on precast concrete beams were uniformly distributed along the entire length of the beam.

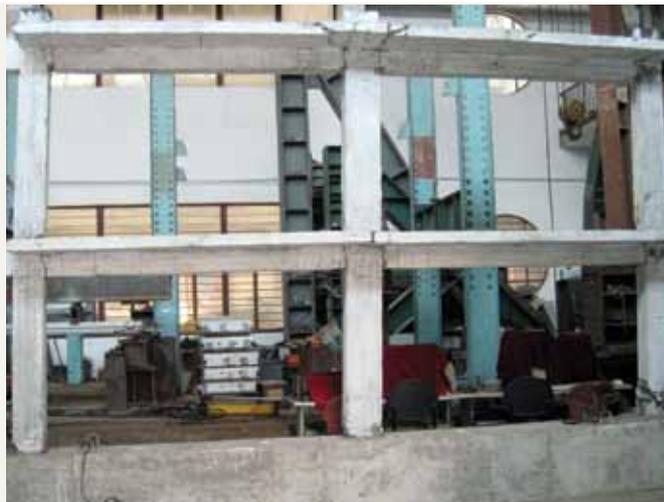
Figure 13. This photo shows the final failure patterns of the frame model specimen PCF-1 at the end of the test.

When the total lateral load reached 77.0 kN (17.3 kip) in the positive direction, the first hairline flexural crack occurred at the west beam end adjacent to the middle column in the first story. When the total lateral load reached 70.0 kN (15.8 kip) in the negative direction, a new fine flexural crack occurred at the east beam end in the first story. Both of the fine flexural cracks were basically symmetrical about the middle column.

The first plastic hinge occurred at the beam end in the first story at a total lateral load of 115.3 kN (25.9 kip), the corresponding roof drift was 0.52%, and many new cracks appeared and progressed when loading. Specimen PCF-1 reached its yield state when the total lateral load reached 195 kN (43.9 kip) at a roof drift of 0.6% in the positive direction, and the total lateral load reached 185 kN (41.6 kip) at a roof drift of 0.8% in the negative direction.

The yield state was defined according to the method used by Park. At a roof drift of 2.0%, its maximum load of 217.3 kN (48.9 kip) was attained and the west column base was damaged. The load-carrying capacity decreased gradually after reaching the peak load with increasing roof drift and dropped 15% at a roof drift of 3.1% in the positive direction and at a roof drift of 3.2% in the negative direction. The test was terminated at a roof drift of 3.5% and a load of 161 kN (36.2 kip) because the load-carrying capacity deteriorated severely and the column bases were severely damaged. In addition, cover concrete was lost, and longitudinal reinforcements and ties were exposed at the column bases in the first story.

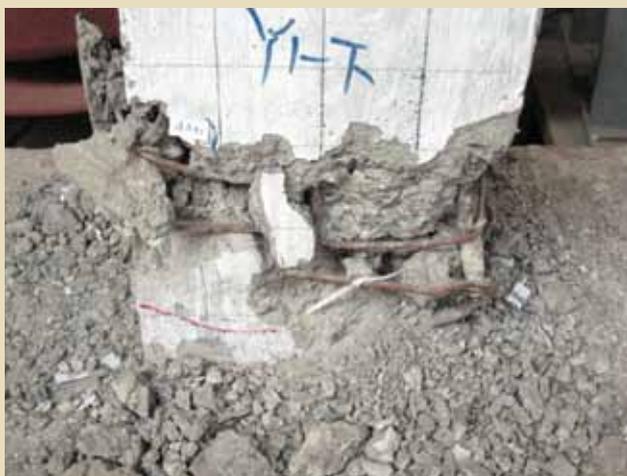
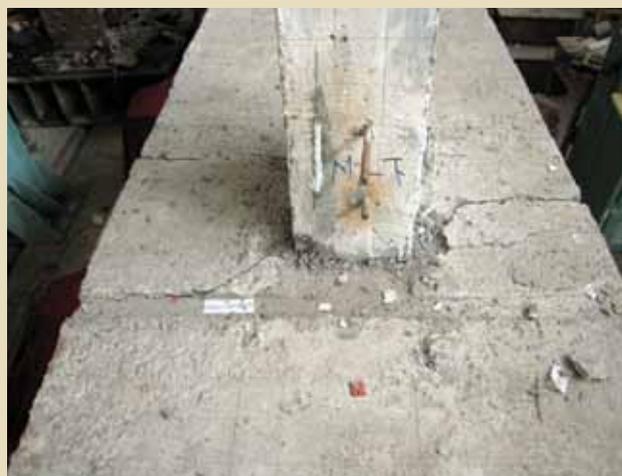
Figure 14. The photos indicate the typical failure patterns at the beam ends and column ends in the frame model specimen PCF-1.

There were a few hairline cracks in the first-story joints, and the strains of all of the joint hoops stayed in the elastic stage, indicating that the shear strength of the joints was sufficient to maintain elastic behavior. **Figure 14** shows the ultimate damage states of the columns and beams. **Figure 15** depicts the measured sequences of hinge formation. The following results were observed:

- The frame, as expected, exhibited a mixed side-sway mechanism and failed due to concrete crushing and buckling of longitudinal bars as a result of plastic hinges at the fixed column bases, and it achieved the design objectives.

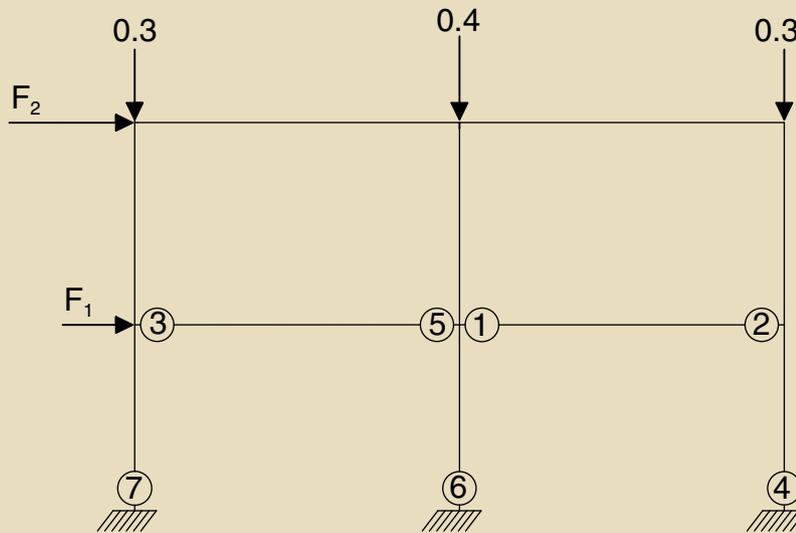
Figure 15. This diagram depicts the measured sequence of hinge formation in the frame model specimen PCF-1. Note: F_1 = lateral load applied to first level of test structure; F_2 = lateral load applied to second level of test structure.

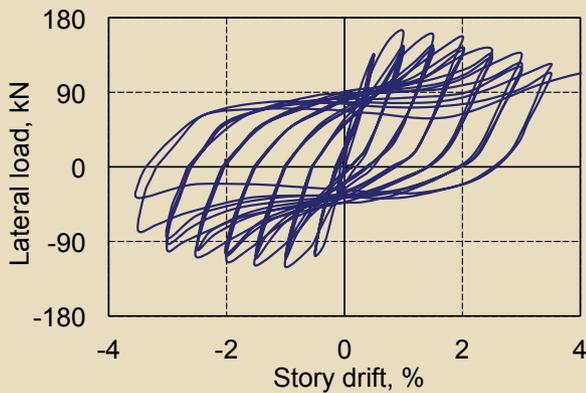
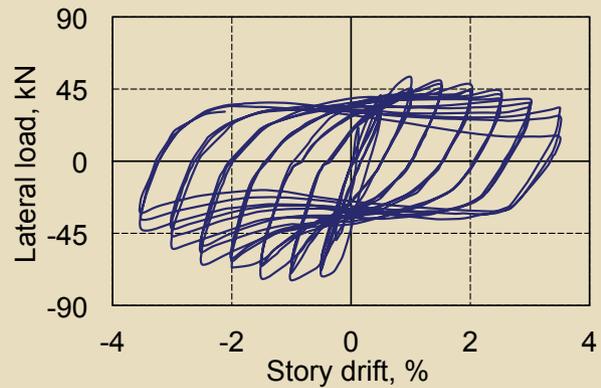
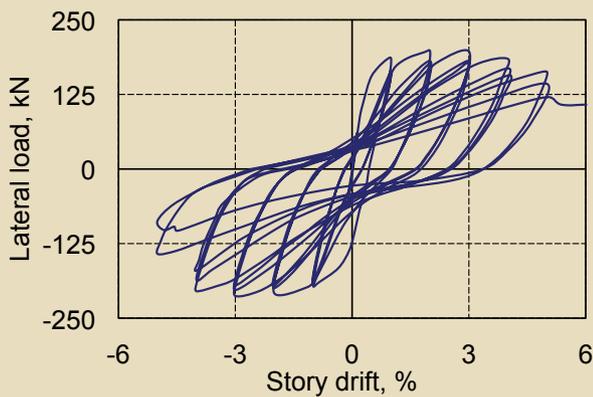
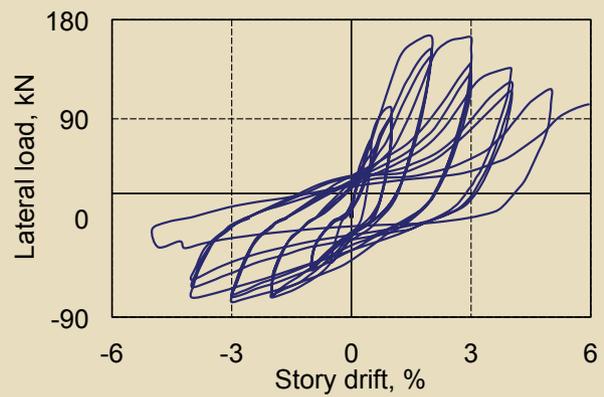
Figure 16. These graphs show the hysteresis curves of connection specimens. Note: 1 kN = 0.225 kip.

Figures 16 and **17** show the lateral load-versus-story drift hysteresis curves of all four connections and the frame model, respectively. At the earlier stage, the four connections exhibited a stable load-versus-story drift hysteretic response, and then slight pinching (the middle part of each hysteretic loop was relatively narrow) could be noticed in the hysteresis loops of the four connections, primarily due to joint diagonal cracking and beam-end cracking. The hysteresis curves of specimens PCJ-3 and PCJ-4 exhibited more pronounced pinching than the other two connections. The areas of hysteresis loops gradually became larger as story drift increased and plastic hinge formed in the beam end, indicating good energy-dissipation capacity.

For specimens PCJ-2 and PCJ-4, the hysteresis curves were not symmetrical due to the presence of the concrete slab, and there were obvious differences in load-carrying capacity in both directions for which the concrete slab was engaged in tension. For specimens PCJ-1 and PCJ-2, the overall response was mainly dominated by beam-end rotations due to the minor nature of the damage in the joint core. However, the characteristics of the hysteretic response of specimens PCJ-3 and PCJ-4 were dominated by beam-end rotations and the degree of damage in the joint regions because the degree of damage in the joint regions of these two connections was more severe than that of the other connections.

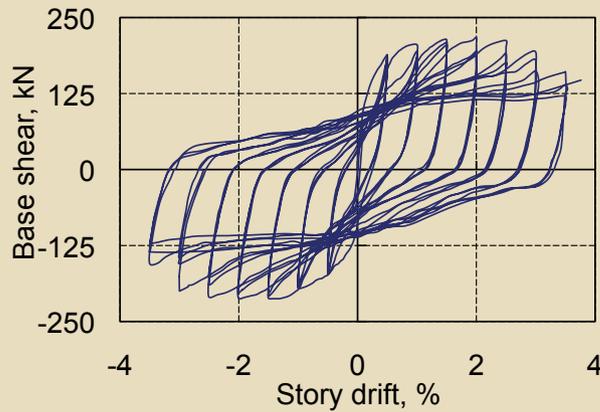
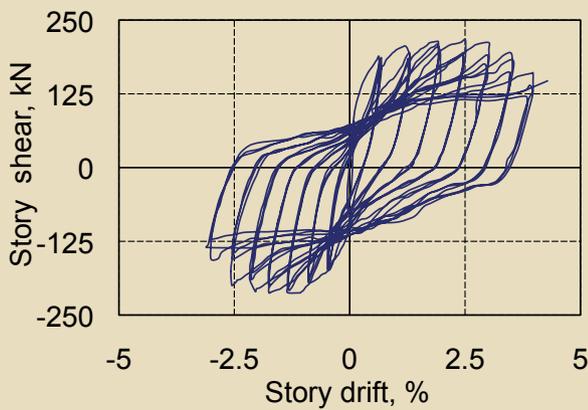
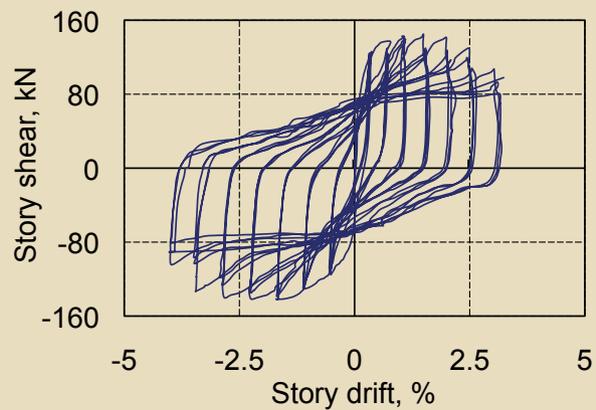
Figure 17. The graphs show the hysteresis curves for the frame model specimen PCF-1. Note: 1 kN = 0.225 kip.

formation in beam ends and column ends, showing good energy-dissipation capacity. The stiffness of the frame degraded after the cracking point and the stiffness degradation was severe after reaching yield point, but the overall behavior of the frame was stable without abrupt strength degradation. Slight pinching was noticed in the hysteretic loops after the roof-drift level of 1.0%, primarily due to column-end and beam-end cracking and concrete softening and bond slip.¹⁸ The maximum load of the first cycle was higher than that of the other two cycles at the same roof-drift level, showing strength degradation. The load-carrying capacity gradually decreased after a roof drift of 2.0%, and specimen PCF-1 exhibited good displacement ductility.

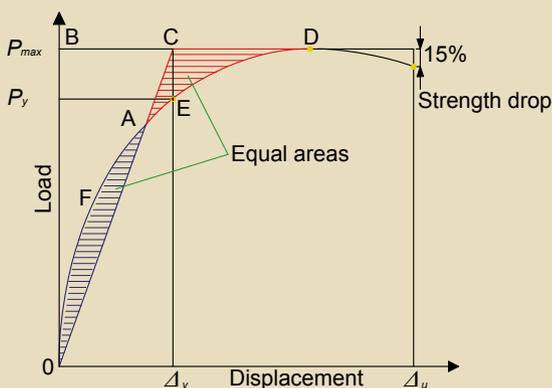
Figure 18. The load-versus-displacement envelope curve was used to define the yield and maximum displacements according to the criteria for equivalent elasto-plastic energy absorption. Note: P_{max} = peak load; P_y = yield load; Δ_u = ultimate displacement; Δ_y = yield displacement.

The displacement ductility is the ratio of the maximum deformation that a structure or element can undergo without a significant loss of initial yielding resistance to the initial yield deformation. However, it was not easy to determine

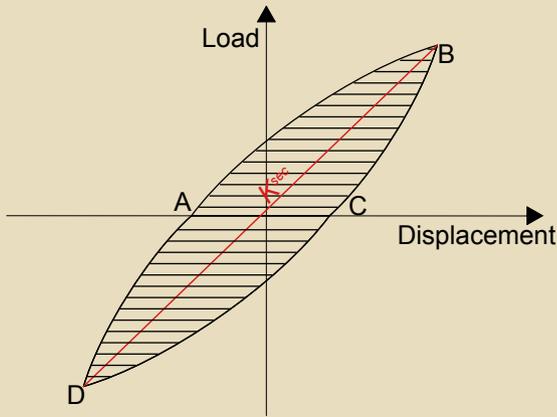
Figure 19. The secant stiffness was calculated using a straight line between the maximum load and corresponding displacement points for the positive and negative directions in a load cycle. Note: K_{sec} = secant stiffness.

The rate of stiffness degradation is a precise parameter that can be used to gauge the specimen's overall response. In order to assess stiffness degradation, the secant stiffness was computed for each loading cycle at a particular drift level. The secant stiffness was calculated using a straight line between the maximum load and corresponding displacement points for the positive and negative directions in a load cycle (Fig. 19). Figures 20 and 21 plot the degradation in stiffness versus story drift. Stiffness continuously decreased with increasing story drift due to the increase in cumulative damage in columns and beams throughout the test, and each specimen experienced severe stiffness degradation at the end of the test.

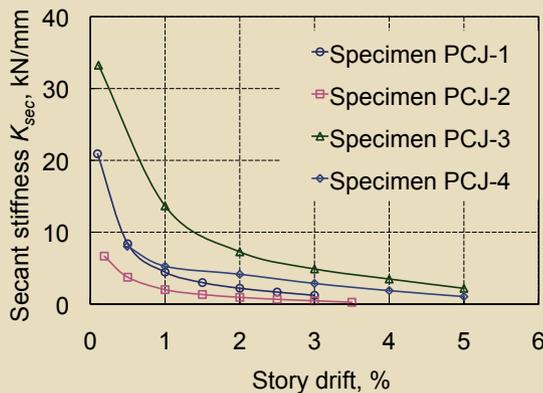
Figure 20. This graph compares the stiffness degradation with story drift for the four connection specimens. Note: 1 kN/mm = 5.71 kip/in.

Stiffness degradation was faster before the drift of 1% for all specimens, which was due to concrete cracking and reinforcement yielding in this stage. At a drift of 2.0%, a reduction of 89.5%, 86.1%, 78.2%, and 48.4% of the initial

stiffness was recorded for specimens PCJ-1, PCJ-2, PCJ-3, and PCJ-4, respectively. This showed that the stiffness degradation of the interior joint was more severe than that of the exterior connection and that the T connection was more severe than that of the knee connection. When the frame model reached its maximum load-carrying capacity at a drift of 2.0%, the stiffness dropped about 87%, 76%, and 85% for the first story, second story, and global frame, respectively, showing that stiffness degradation was severe. The initial stiffness of the second story and the global frame were close and lower than that of the first story.

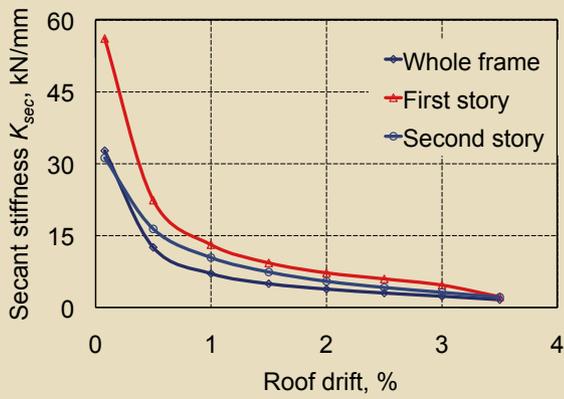
Figure 21. This graph compares the stiffness degradation with roof drift for the frame model specimen PCF-1. Note: 1 kN/mm = 5.71 kip/in.

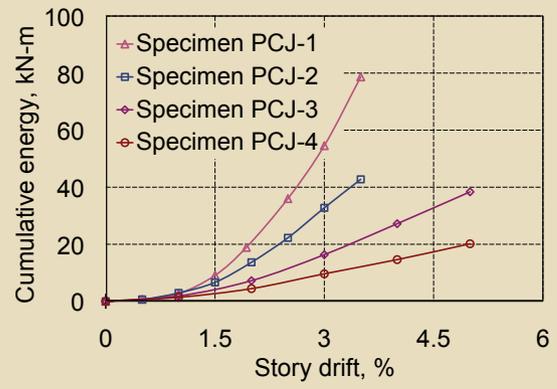
Figure 22. This graph shows the cumulative energy dissipation for the connection specimens. Note: 1 kN-m = 740 lb-ft.

All four connections and the frame model exhibited similar patterns of energy dissipation. The energy-dissipation capacity of the test specimens increased as the drift increased. During the first cycle, the amount of energy that dissipated was small, showing that the test specimen stayed in the elastic stage. When the test specimens entered the elastoplastic stage, the amount of the dissipated energy of the test specimens increased with the increasing damage. After reaching the peak load, the load-carrying capacity of the test specimens began to gradually decrease, but the energy-dissipation capacity still slowly increased.

The energy-dissipation capacity of the interior connection was greater than that of the exterior connection. This could be because only one beam was in the exterior connection. The energy-dissipation of the test specimens is thought to be mainly dependent on the beam end hinging because the column and joint did not have any obvious damage. The energy dissipation capacity of the two top-story connections was lower than that of the two bottom-story connections, and the energy-dissipation capacity of the knee connection was the lowest.

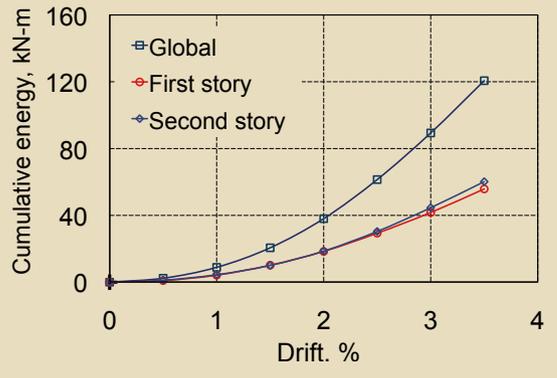
Figure 23. This graph shows the cumulative energy dissipation of the frame model specimen PCF-1. Note: 1 kN-m = 740 lb-ft.
