# Seismic retrofit of reinforced concrete buildings in Japan using external precast, prestressed concrete frames

Kiyoji Takeda, Kyoya Tanaka, Toshiaki Someya, Asao Sakuda, and Yoshiteru Ohno

Seismic design methods in Japan have progressed significantly because of the lessons learned from experience. Existing buildings found not to conform to current codes are required to be retrofitted.

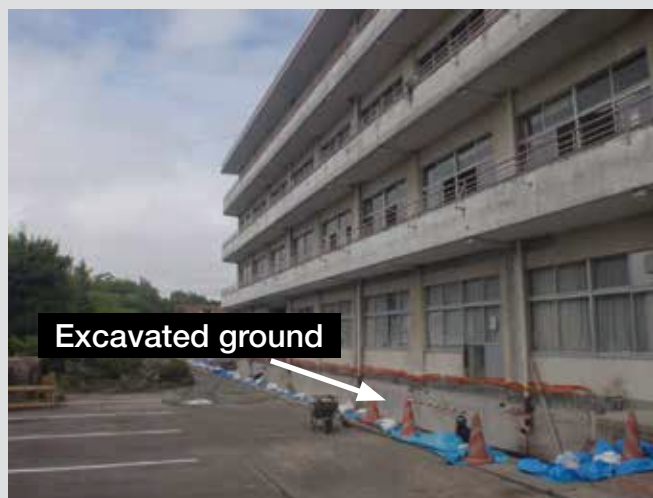
Excavation for newly installed foundation

**Figure 15.** Retrofit work procedure of the parallel unit frame method of the school building.

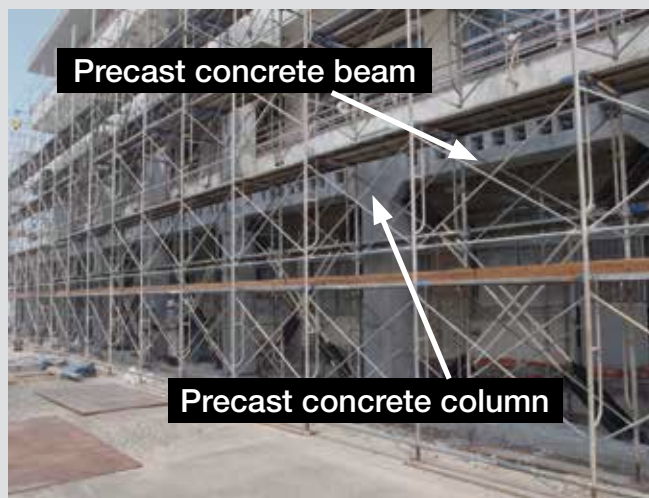
Assembly of precast concrete columns and beams

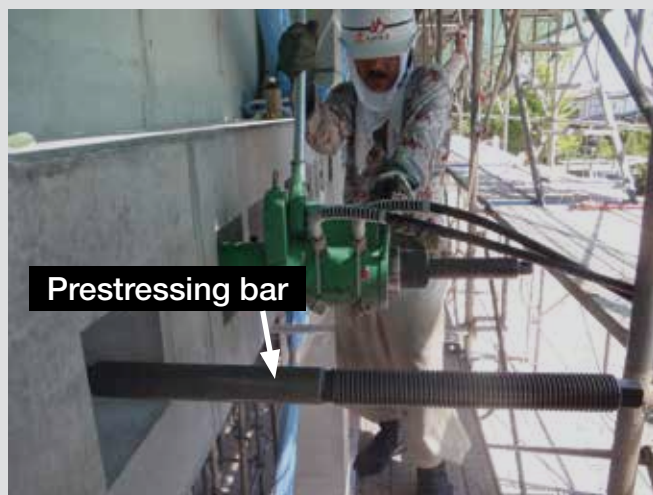
Connecting the parallel unit frame and the building with prestressing steel tendon

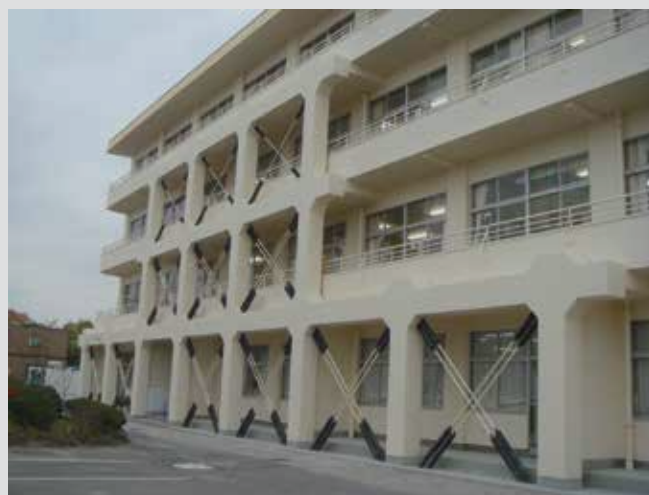
View after retrofit
