Development of a precast concrete barrier wall system for bridge decks

Gaurang Patel, Khaled Sennah, Hossein Azimi, Clifford Lam, and Reza Kianoush

This paper presents a PL-3 precast concrete barrier wall system to accelerate the replacement of deteriorated bridges. The proposed connection detail is intended to expedite construction; minimize traffic disruption; improve work-zone safety, quality, and constructability; and reduce life-cycle cost. The proposed precast concrete barrier is connected to the deck slab using pretensioned threaded steel rods. The proposed male-female vertical joint between adjacent precast concrete barriers would maintain barrier continuity to spread the reaction of vehicle impact. Five full-scale barrier models were fabricated and tested to collapse to examine their ultimate capacities and crack patterns. A control model represented the cast-in-place concrete barrier. Two models represented the proposed precast concrete barrier system. Both models were loaded to induce failure at the barrier-deck slab junction. Two precast concrete barrier models were loaded at midlength and edge, respectively. One of these included the cantilever portion of the deck sl

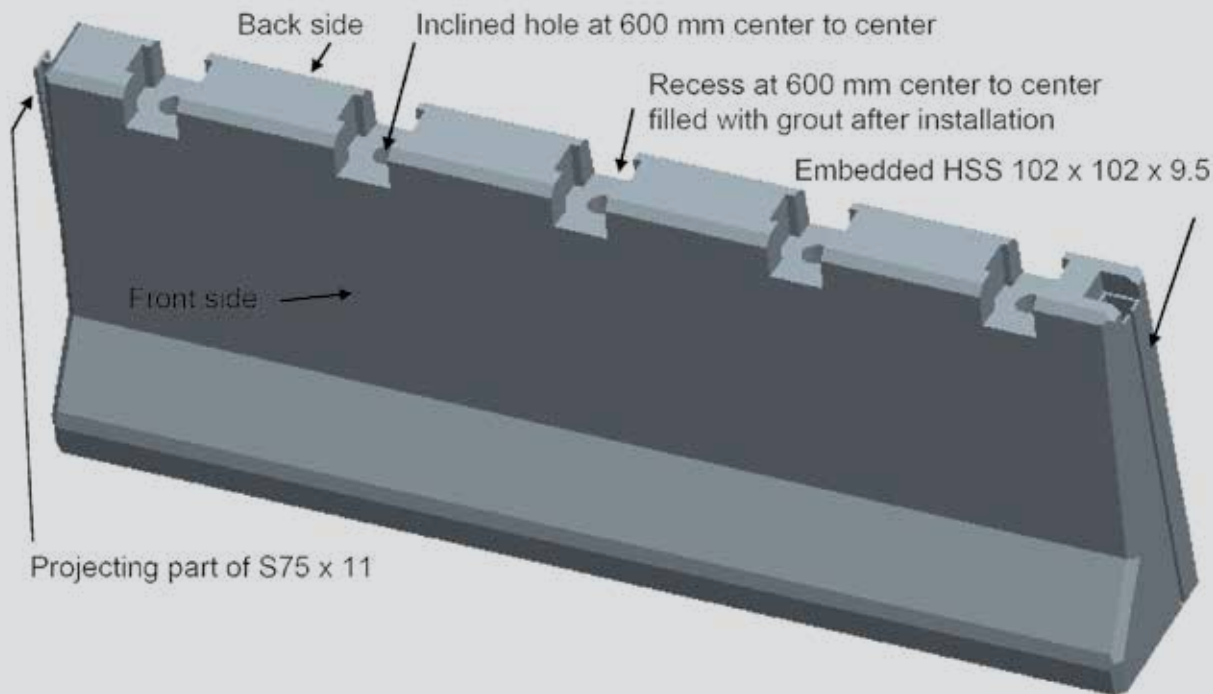
Figure 1. Proposed precast concrete barrier wall. Note: HSS = hollow structural section. 1 mm = 0.0394 in.

This investigation resulted in a barrier wall system (**Fig. 1** and **2**) in which barrier walls of 3 m (10 ft) segments were fabricated in the precast concrete plant and shipped to the bridge site. The proposed barrier wall was intended to meet the criteria for *Canadian Highway Bridge Design Code* (CHBDC)⁴ performance level 3 (PL-3), representing the majority of bridge barriers in Ontario highways. The geometry of the proposed PL-3 precast concrete barrier wall was similar to the cast-in-place concrete barrier specified

to fill the gap between the threaded rod and the sleeve. Finally, the concrete recesses at the top of the precast concrete barrier wall (Fig. 1) were grouted.

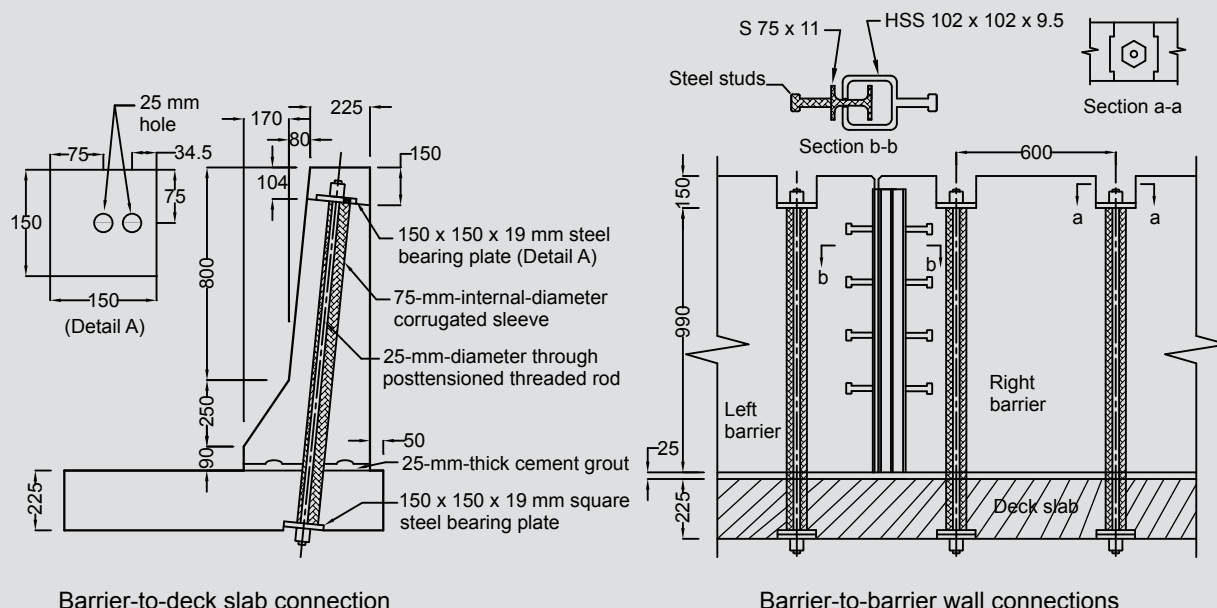
Figure 2. Structural details of proposed precast concrete barrier wall connections. Note: Dimensions are in millimeters unless otherwise noted. HSS = hollow structural section. 1 mm = 0.0394 in.

To increase shear resistance, the top surface of the concrete deck slab was scratched parallel to the direction of traffic. For a similar surface on the bottom of the precast concrete barrier wall, timber strips can be nailed inside the form (Fig. 2). After tensioning the threaded rods to the desired level, concrete grout was inserted from a hole in the top steel plate on the side of the top nut (detail A in Fig. 2)

Figure 2 shows the proposed vertical joint between precast concrete barrier wall segments. In this case, a hollow structural shape (HSS) 102 × 102 × 9.5 mm (4 × 4 × 3/8 in.) tube was embedded at one end of the barrier wall segment, with four shear studs welded to it to provide anchorage resistance with concrete. On the adjacent precast concrete barrier wall segment, an S75 × 11 (S3 × 7.5) steel member was embedded halfway into the concrete with a similar arrangement of shear studs to that of the HSS. To activate the joint resistance, one barrier wall segment was laid over the deck slab. Then the adjacent barrier wall with the S-shaped steel beam was laid over the deck slab vertically so that the projecting portion of the S-shaped member slides through a vertical slot in the HSS skin embedded in the other barrier wall edge (section b-b in Fig. 2). The HSS was then filled with concrete grout to fix it in place, enhancing the rigidity and continuity of the barrier-to-barrier vertical joint to resist vehicle impact.

male-female shear key (Fig. 2) can be established at the vertical joint between the precast concrete barrier walls to enhance the longitudinal continuity of a series of precast concrete barrier segments. As a result, the failure mode would shift toward bi-axial bending about the vertical and horizontal axes of the barrier wall. However, the continuous barrier with shear keys between precast concrete segments needs to be tested under static loading to develop the wall yield line pattern given the flexibility of the proposed joint and then crash tested to comply with CHBDC provisions.

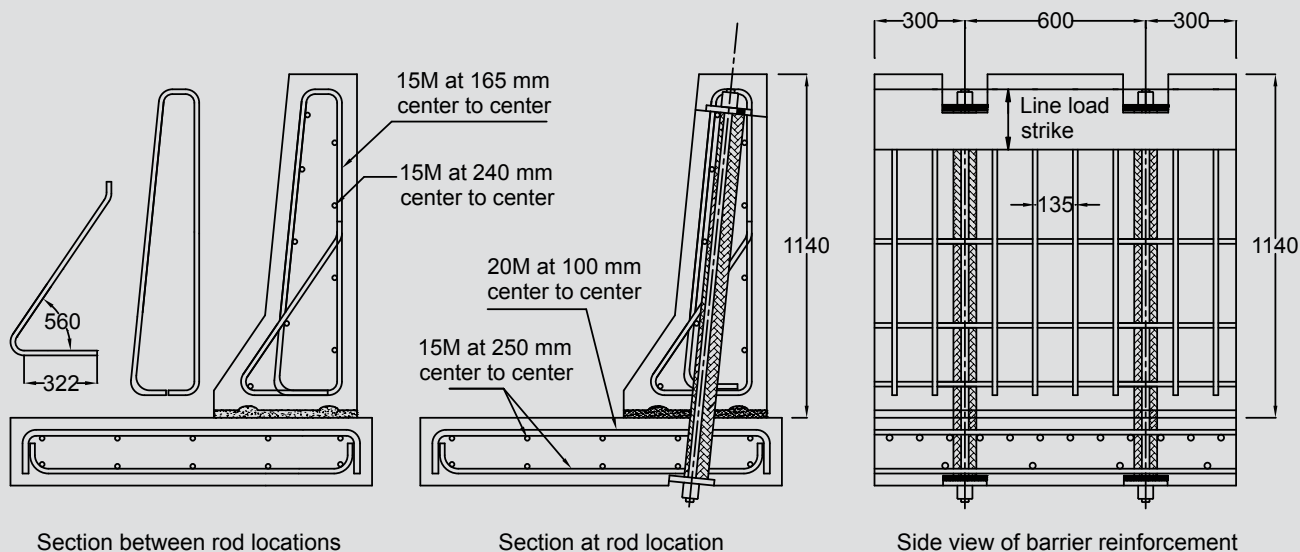
Figure 4. Details of barrier model M1. Note: Dimensions are in millimeters unless otherwise noted. 15M = no. 5; 20M = no. 6; 1 mm = 0.0394 in.

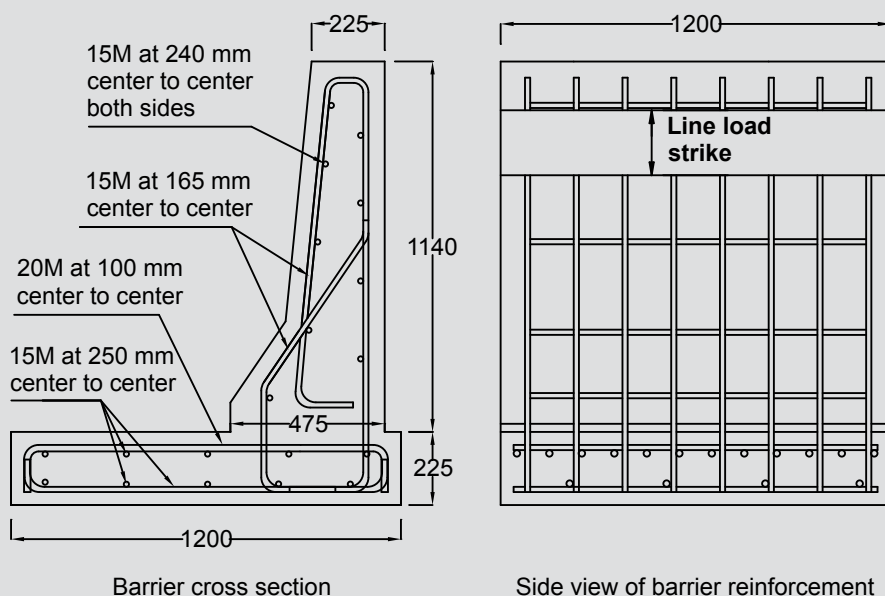
Figure 5. Details of barrier model M2. Note: Dimensions are in millimeters unless otherwise noted. 15M = no. 5; 1 mm = 0.0394 in.

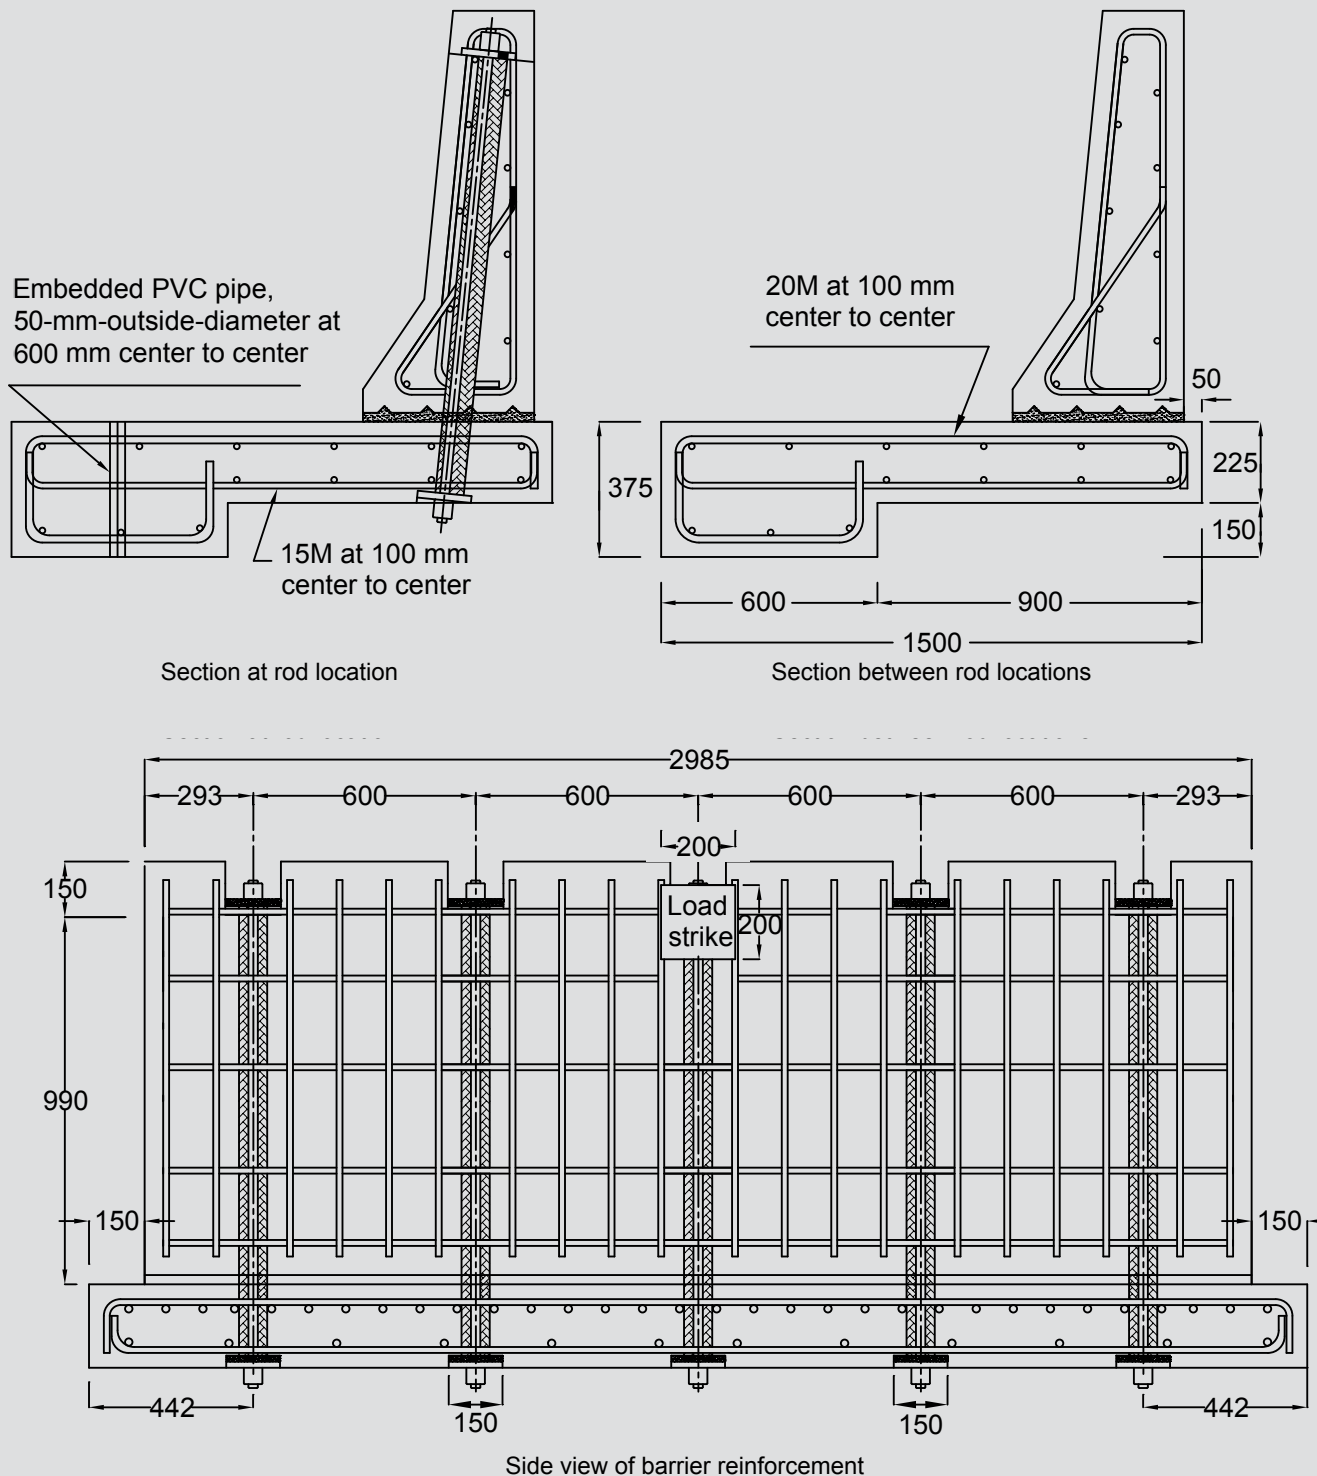
Figure 6. Details of barrier model M3. Note: PVC = polyvinyl chloride. Dimensions are in millimeters unless otherwise noted. 15M = no. 5; 20M = no. 6; 1 mm = 0.0394 in.

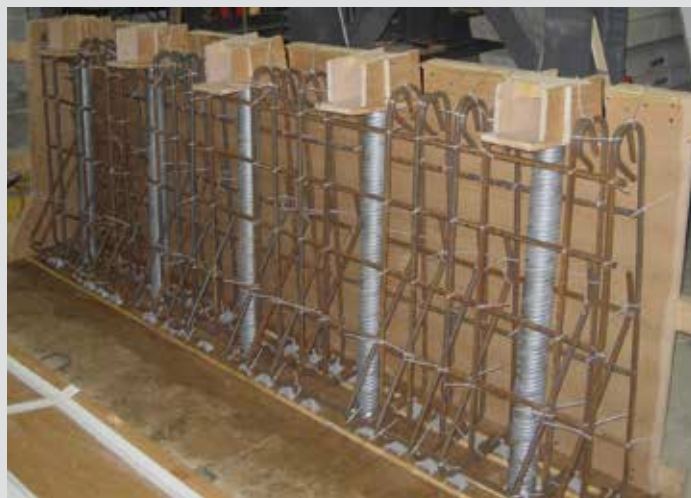
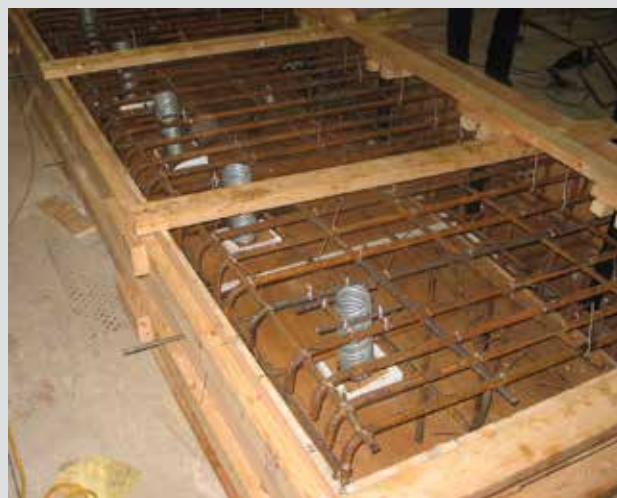
Barrier wall reinforcement

Deck slab reinforcement

Figure 7. Reinforcement and embedded sleeves for barrier model M3.

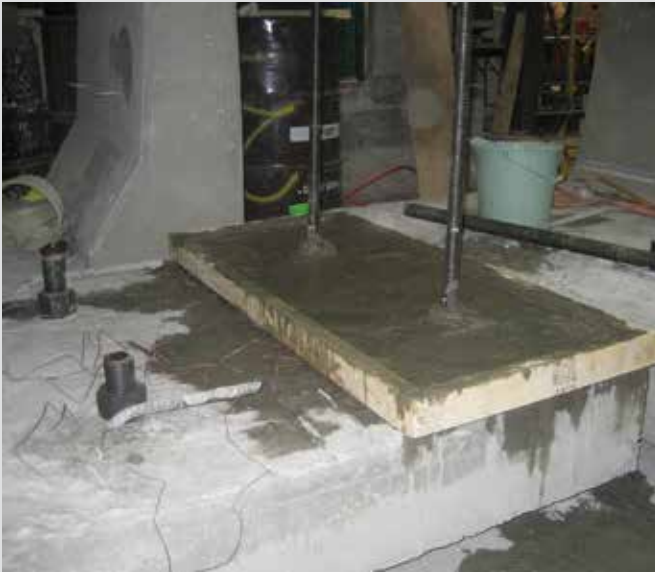
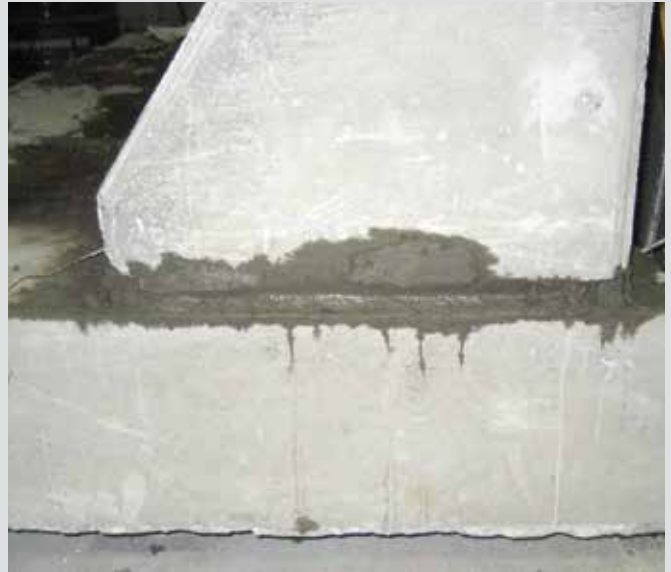
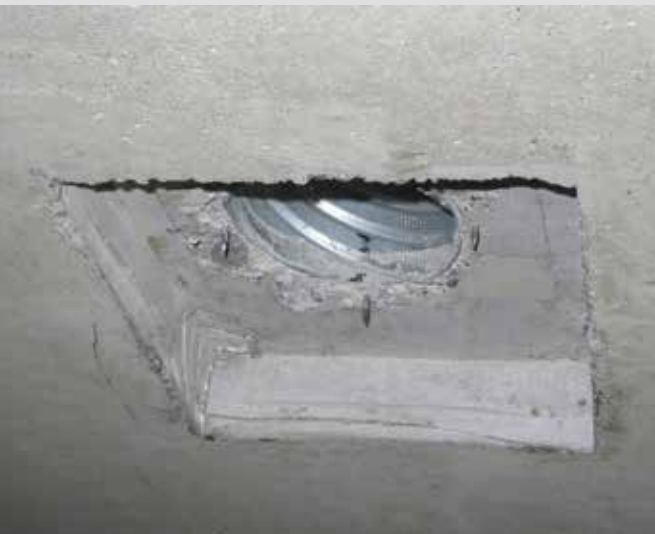
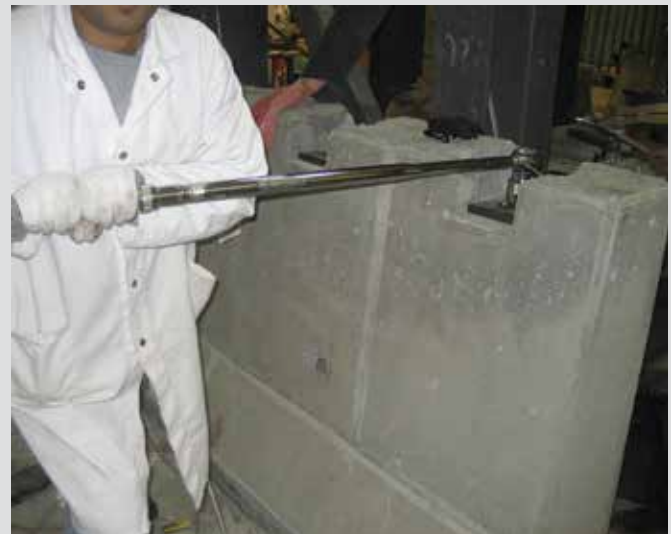
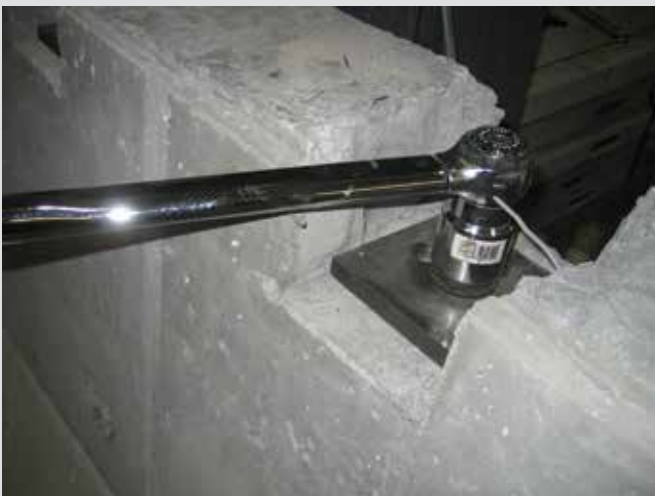
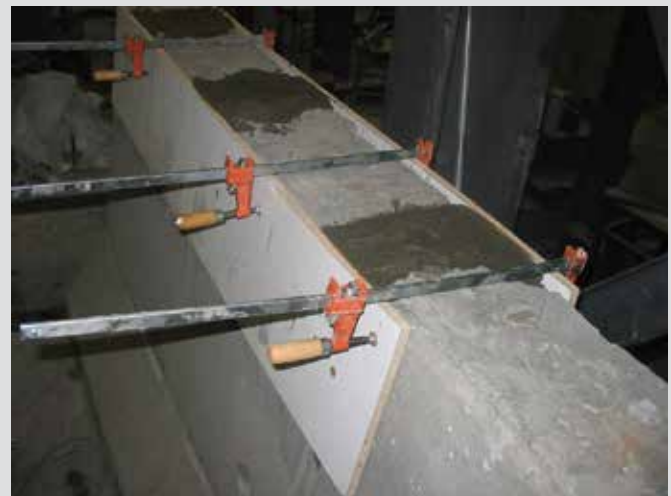
Placement of cement grout over the slab

Barrier wall resting on the cement grout

Recess at the bottom of the slab

Rod pretensioning

Torque device

Top of barrier during recess grouting

Figure 8. Installation of precast concrete barrier wall over deck slab.

the dike. During placement, all the corrugated ducts embedded in the deck slab were plugged. At the specified initial setting time for the cement grout, the barrier segment was placed over the grout. Figure 7 shows the barrier-slab joint after removing the dike. Three days after grouting, threaded rods were placed inside each duct and aligned using the top bearing plates, nuts, and washers in the top recess in Fig. 2, followed by snug-tightening the rods from the bottom of the deck. A design torque of 525 lb-ft (720 N-m) was applied to each rod, equivalent to a 79 kN (18 kip) tensile force. From the torque catalogue, the applied torque was determined based on the desired pretensioning force of 17% of the nominal ultimate tensile strength. After tensioning all rods, grout was injected into the duct through a hole drilled in the top bearing plate (Fig. 2). The duct was left for 24 hours to let the grout settle and then filled again with grout if it was not completely filled. Finally, each recess or trapezoidal pocket was clamped using laminated plywood from the inner and outer side of the barrier wall and then filled with concrete grout. Figure 10 summarizes the sequence of barrier installation.

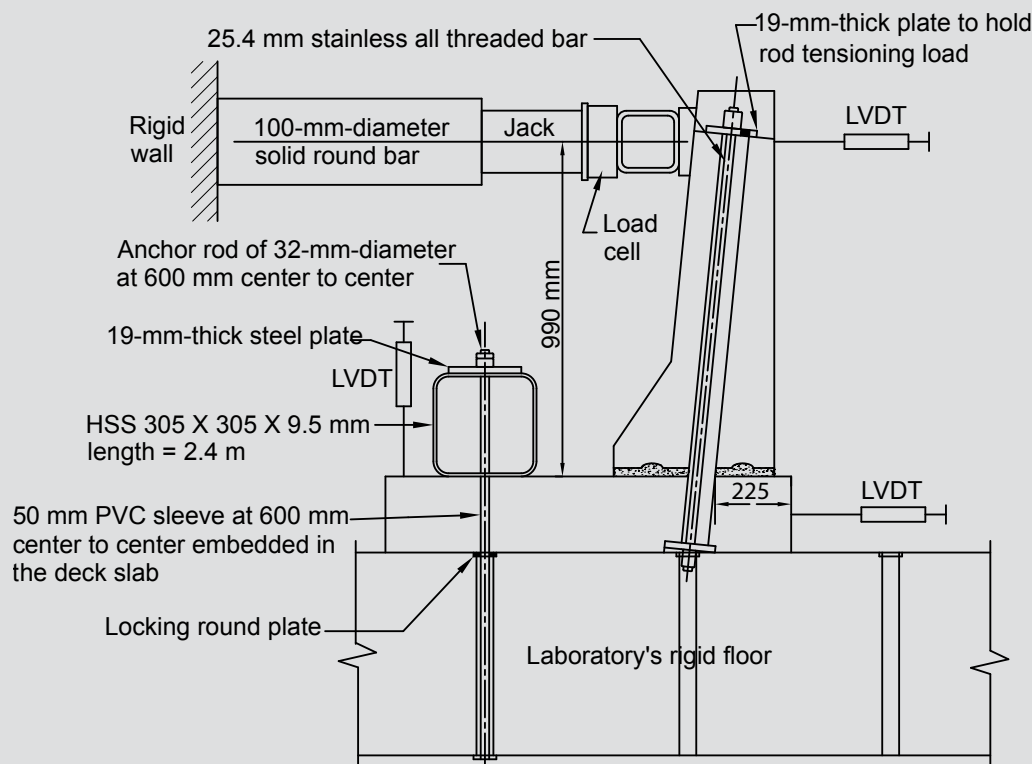
Figure 9. Schematic of test setup. Note: HSS = hollow structural section; LVDT = linear variable displacement transducer; PVC = polyvinyl chloride. 1 mm = 0.0394 in.; 1 m = 3.28 ft.

Figure 8 shows a schematic diagram of the test setup. Each barrier specimen was supported directly on the laboratory floor and tied to the floor using 50 mm (2 in.) diameter threaded rods spaced at 600 mm (24 in.) center to center. The rods were tightened by applying a torque to control slab uplift during testing. A 900 kN (200 kip) hydraulic jack was used to apply a horizontal load to the barrier wall. A universal flat load cell of 900 kN capacity measured the applied loads. The data acquisition unit recorded one reading per second from each sensor. Each specimen was monotonically loaded to collapse. Figure 7 shows the barrier models and loading system before test. During the test, a jacking load was applied in increments of 10 kN (2 kip). The load was maintained for about 5 minutes at each increment to observe crack initiation and propagation as well as changes in barrier geometry as depicted from LVDT readings. Failure was reached when the displacement readings from sensors increased without further load increase.

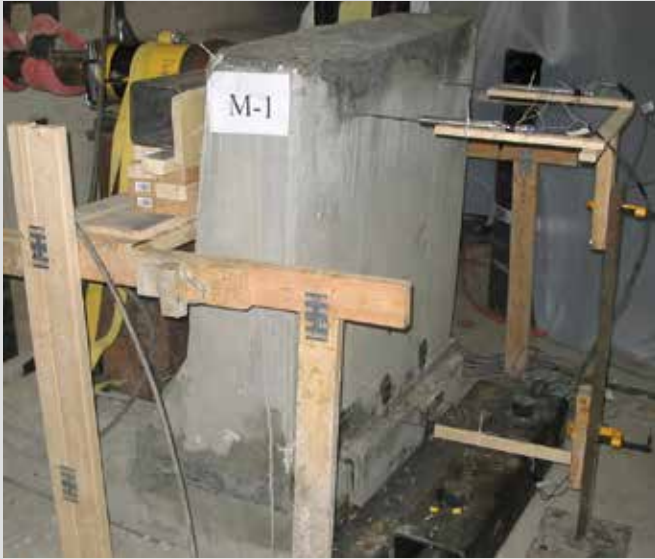
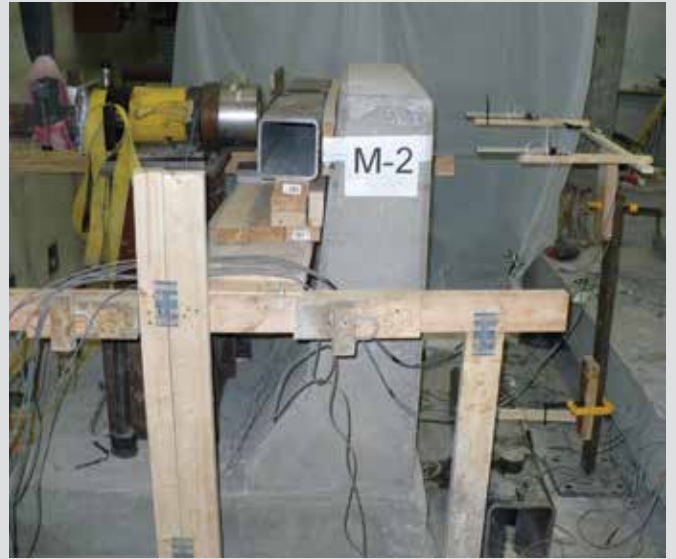
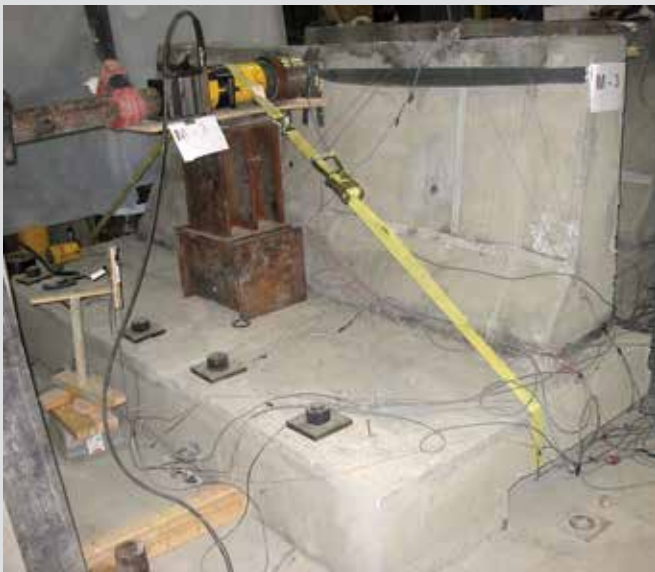
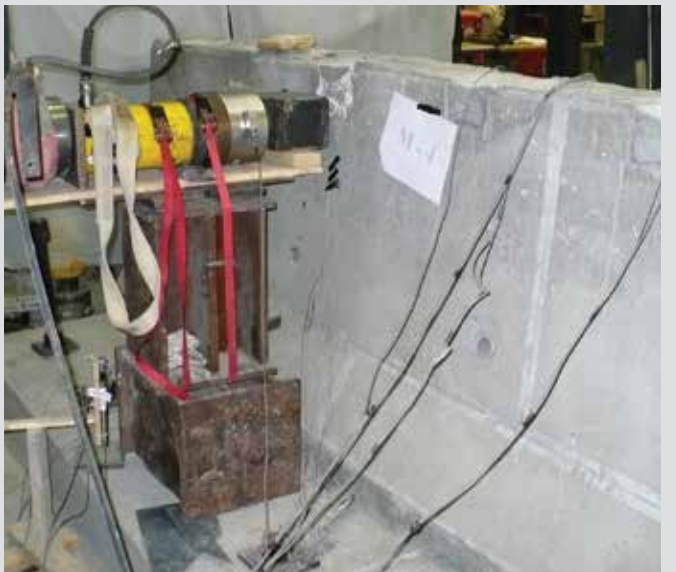
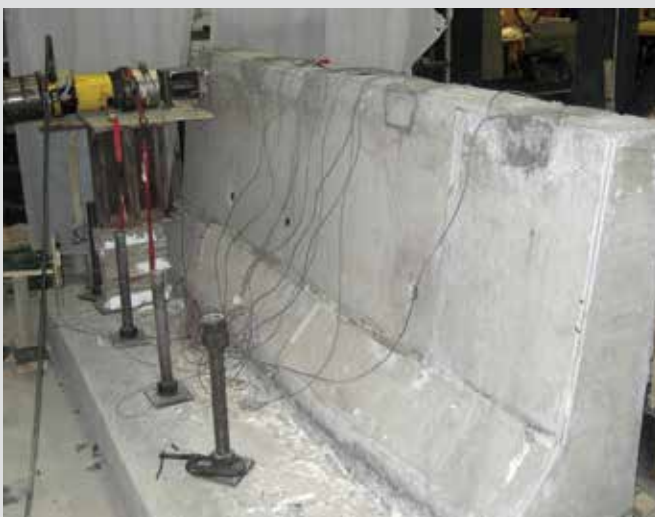
Barrier model M1

Barrier model M2

Barrier model M3

Barrier model M4

Barrier model M5

Figure 10. Tested barrier models.

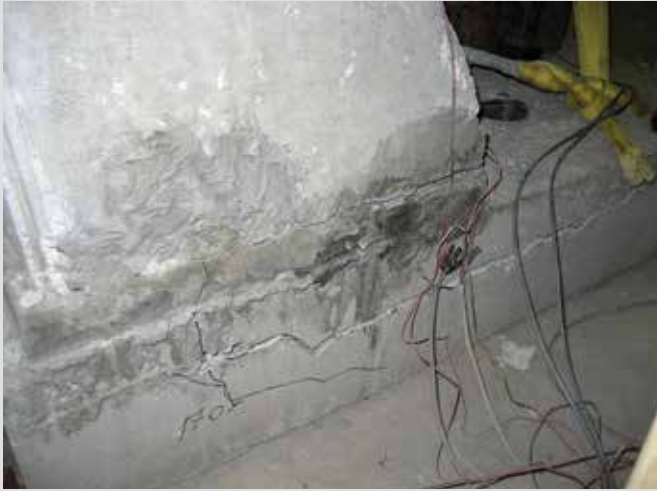
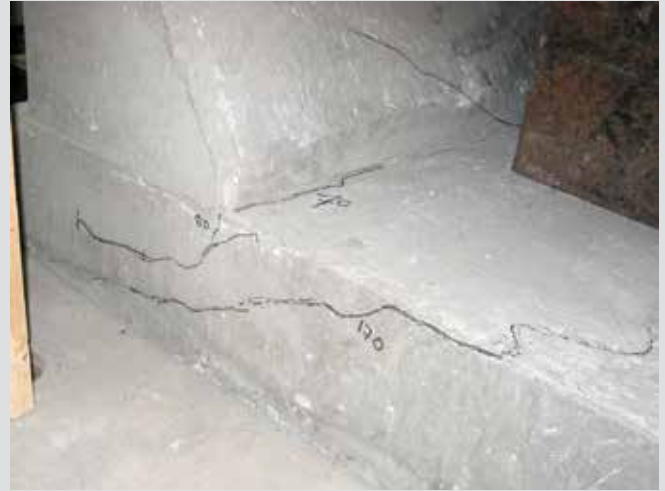
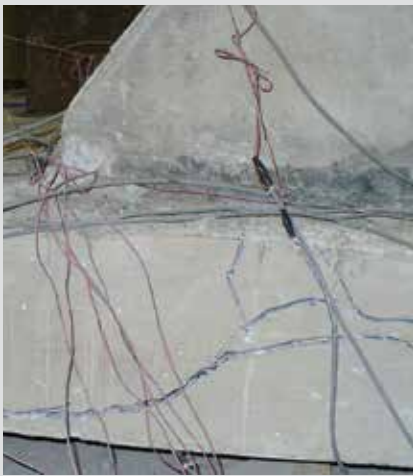
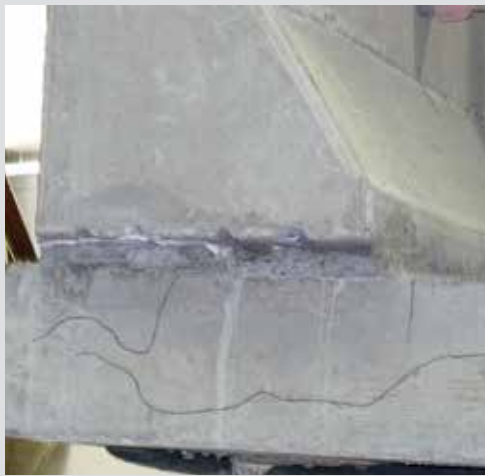
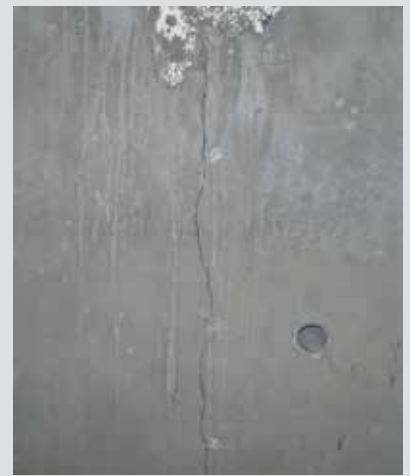
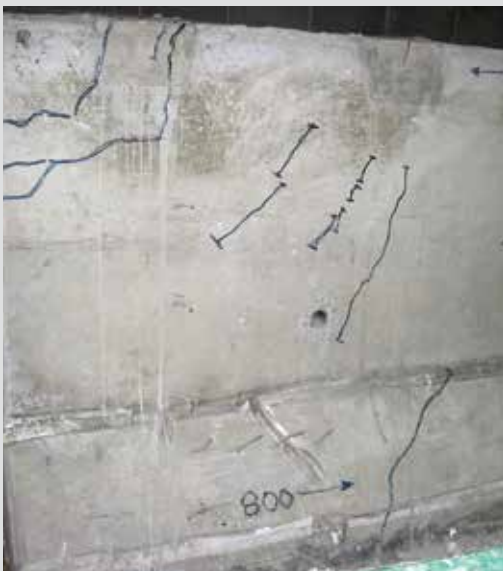
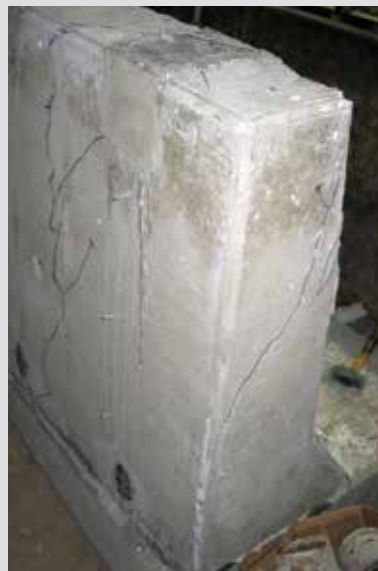
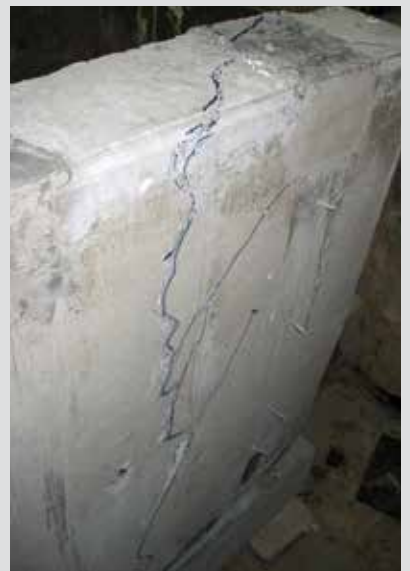
Model M1 slab horizontal tension crack on left side of barrier

Model M2 combined flexural, shear, and bond cracks on left side of barrier

Model M3 anchorage failure in the cantilever slab

Model M4 anchorage failure on left side of barrier

Model M4 vertical flexural crack on rear side at midlength of barrier

Model M5 flexural crack pattern at failure on front side of barrier wall

Model M5 crack pattern on two sides of barrier wall

Figure 11. Failure patterns of the tested barrier models.

observed at the front of the barrier wall between the bottom surface of the barrier and the deck slab (Fig. 11). A combined flexure-shear-bond crack appeared on the sides of the deck slab at 170 kN (38 kip), leading to failure in the same pattern as model M1. Failure of model M2 was due to combined flexural, shear, and bond cracks in the deck slab at the front side of the barrier-deck junction. The specimen failed at a load of 182 kN (40.9 kip) when it could not withstand additional load. No cracks were observed in the barrier walls for models M1 and M2.

Model M3 represented a 3 m (10 ft) long precast concrete barrier wall segment connected to the cantilever portion of the deck slab using pretensioned rods. Testing to collapse was performed in this barrier model by applying a horizontal load over a 200 × 200 mm (8 × 8 in.) patch area at midlength on the barrier wall and at 990 mm (39 in.) above the top of the deck slab. At a load of 50 kN (11 kip), a flexural crack appeared at the top surface of concrete at the fixed end of the cantilever portion of the deck slab (Fig. 11). Also, at a load of 150 kN (33 kip), a horizontal crack was observed between the bottom front of the precast concrete barrier wall and the top surface of the cement grout (Fig. 11). With the increase in applied load, a major anchorage crack appeared on the deck slab under the barrier wall on the right and left sides of the specimen (Fig. 11), leading to failure at a load of 313 kN (70.4 kip).

Model M4 was identical to model M3, but without the cantilever portion of the deck slab. When the load reached 130 kN (19.2 kip), a flexural crack was observed along the cement grout at the barrier-to-slab joint (Fig. 11). With an increase in applied load, a single vertical flexural crack appeared on the rear of the precast concrete barrier wall at the location of the applied load (Fig. 11). With additional load, a major anchorage crack was observed in the deck slab under the barrier wall (Fig. 11), leading to failure at a load of 279 kN (62.7 kip). After failure, the flexural crack in the cement grout between the barrier wall and deck slab was wider at the midlength of the barrier wall and narrower toward the barrier wall ends.

Model M5 was identical to model M4 except that the load was applied at the end, simulating vehicle impact at this location. As the load approached 150 kN (33 kip), a few diagonal cracks were observed on the front face of the barrier wall (Fig. 11). The farthest crack was 1500 and 800 mm (59 and 31 in.) from the barrier end at the top and bottom of the wall, respectively. With an increase in applied load, signs of local punching shear cracks appeared around the loaded area at about 190 kN (42 kip). This punching shear crack pattern was observed on the front face (Fig. 11) and on the rear and top of the barrier wall (Fig. 11). The crack extended vertically on the rear of the barrier wall about 600 mm (24 in.) from the barrier (Fig. 11). The specimen absorbed additional load to 210 kN (47 kip). Although diagonal cracks appearing on the front face of the barrier

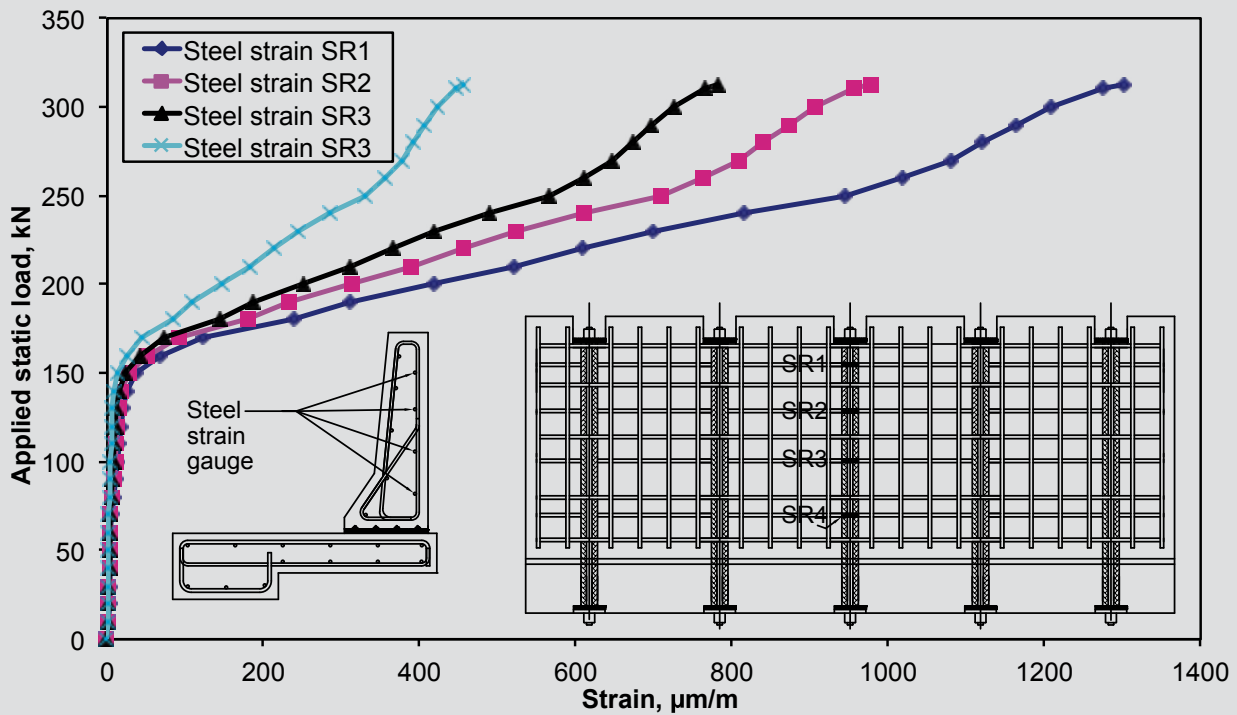
Figure 12. Load-strain relationship in horizontal reinforcing bar at the rear face of barrier wall for model M3. Note: 1 mm = 0.0394 in.; 1 kN = 0.225 kip.

Readings from sensors were recorded at a rate of one per second. A set of strain gauges was installed in the horizontal bars at the applied load location. **Figure 12** depicts the strain history on the horizontal reinforcing bar along the depth of the barrier wall on the rear face of model M3. **Figures 13** and **14** show the strain history for the top horizontal bar at the rear and front faces of the barrier wall, respectively. At a certain load increment, horizontal tensile strains in the reinforcement in model M3 increased toward the top of the barrier wall. However, strains in the horizontal bar on the front face of the barrier wall were all in compression (Fig. 14), as expected. Similar behavior was observed for model M4 (Fig. 13 and 14) for the barrier rear and front faces, respectively. For model M5, horizontal bars at the rear face exhibited increasing tensile strains. However, horizontal bars at the front face started to carry tensile strains at a load of about 140 kN (31 kip) (57% of the peak load) as a result of the premature local punching shear at the load location. **Figure 15** depicts the load-concrete strain relationship at the bottom rear side of the barrier wall.

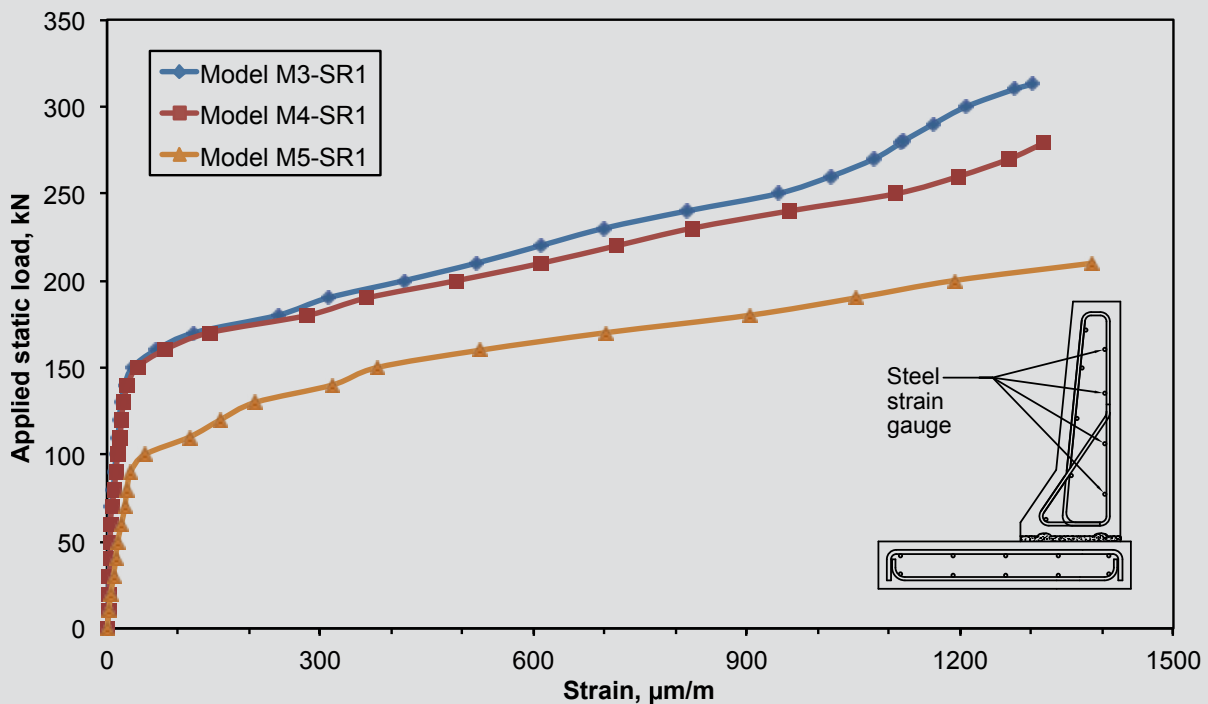
Figure 13. Comparison of applied load-strain relationship in the top horizontal reinforcing bar at the rear face of the tested models. Note: 1 mm = 0.0394 in.; 1 kN = 0.225 kip.

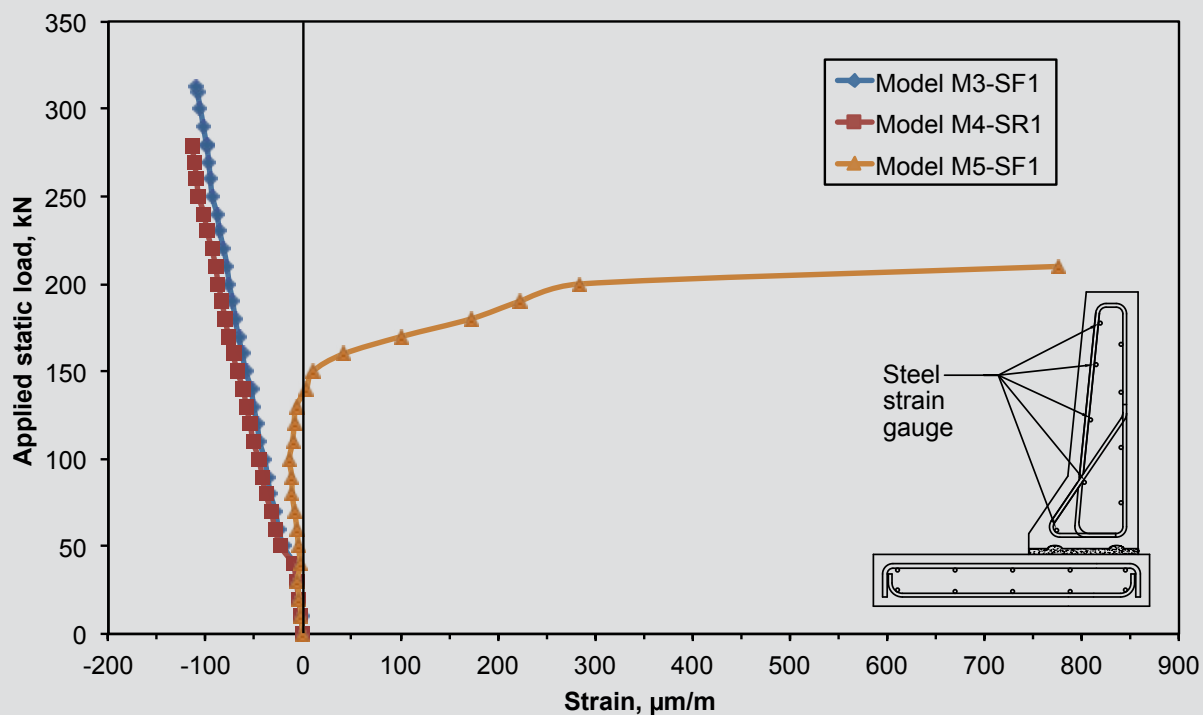
Figure 14. Comparison of applied load–strain relationship in the top horizontal reinforcing bar at the front face of the tested models. Note: 1 mm = 0.0394 in.; 1 kN = 0.225 kip.

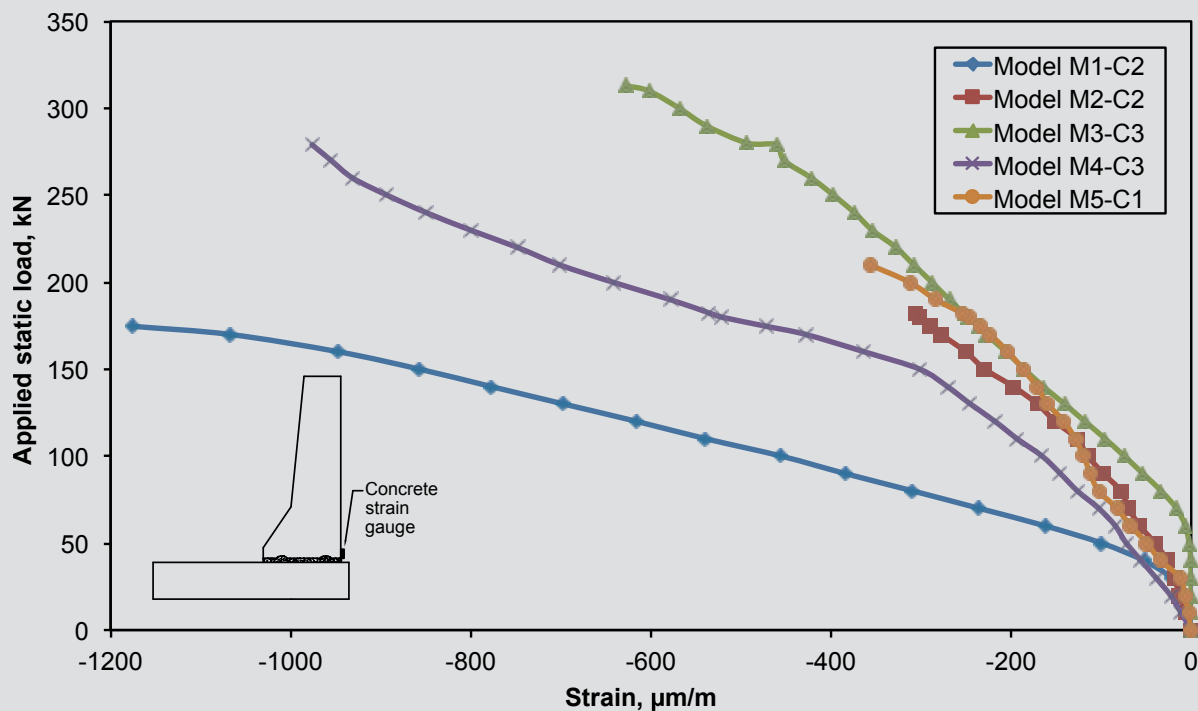
Figure 15. Comparison of applied load–concrete strain relationship in the bottom rear side of the tested models. Note: 1 mm = 0.0394 in.; 1 kN = 0.225 kip.

The strain gauge was located at the barrier midlength for models M1, M2, M3, and M4 and at the barrier end for model M5 as suggested to be the location of the maximum strain along the barrier length. The peak concrete strain was 1175 and 305 $\mu\epsilon$ for models M1 and M2, respectively. The maximum strain at peak load was 628, 976, and 357 $\mu\epsilon$ for models M3, M4, and M5, respectively. No sign of concrete crushing was observed at the concrete strain gauge location in all models. Results presented elsewhere³ showed that concrete cracked at the cantilever end with the deck slab at a load of about 50 kN (11 kip), leading to greater flexibility of the deck slab that assisted in increasing the load capacity of the barrier wall as explained later in this paper. **Figure 16** shows a typical strain history for the threaded rods at the barrier-deck slab junction for model M3. The peak strain in these rods was observed to be 2625 $\mu\epsilon$. This peak strain was 2635 and 2068 $\mu\epsilon$ for models M4 and M5, respectively. All three values are far below the yield strain of 4135 $\mu\epsilon$.

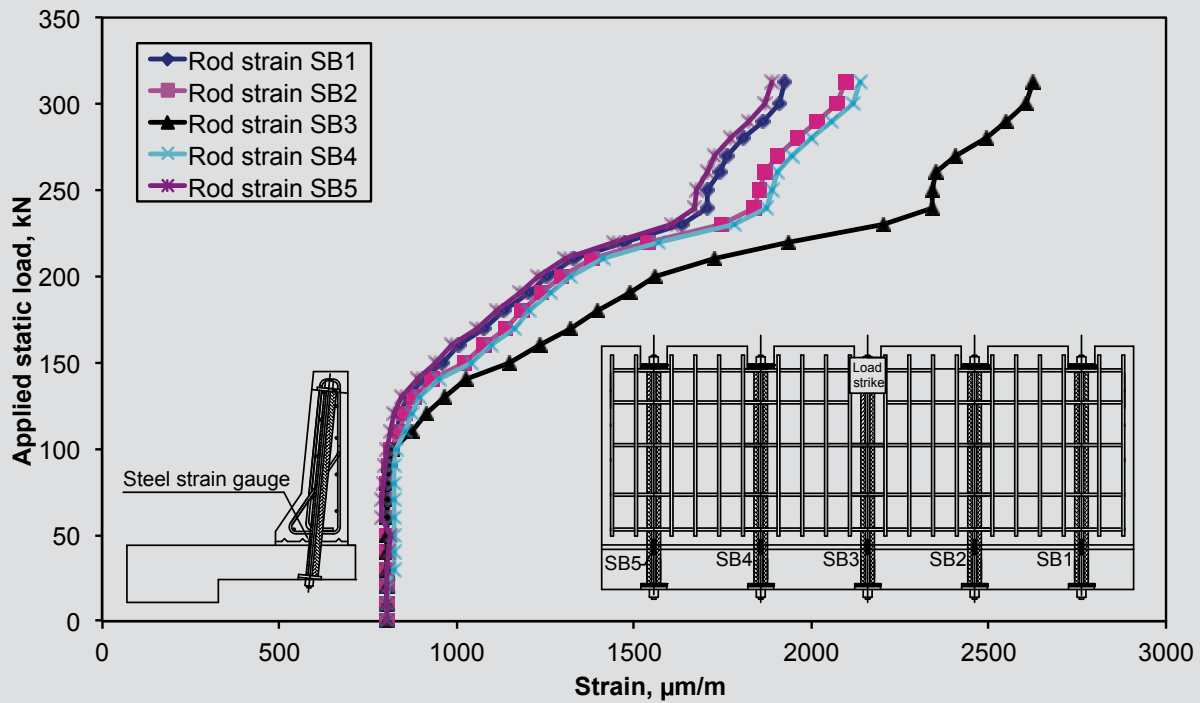
Figure 16. Load-strain relationship in pretensioned threaded rod for model M3. Note: 1 mm = 0.0394 in.; 1 kN = 0.225 kip.

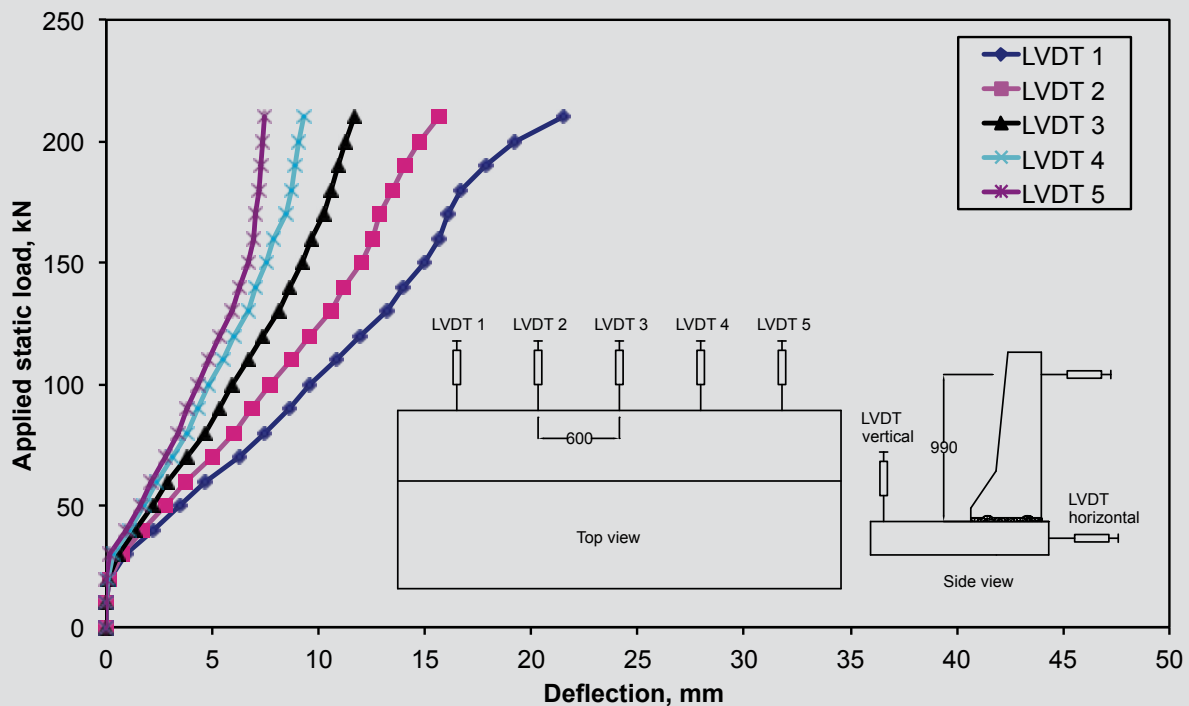
Figure 17. Load-lateral deflection relationship at top of the barrier wall for model M5. Note: LVDT = linear variable displacement transducer. Dimensions are in millimeters. 1 mm = 0.0394 in.; 1 kN = 0.225 kip.

Barrier lateral deflections at each load were recorded along the barrier width. As an example, **Fig. 17** depicts the lateral deflection history of model M5 with end loading. Lateral deflection increases toward the load location, as expected. **Figure 18** shows the lateral deflection history of the barrier wall at the load location for all specimens. The maximum recorded deflection was 43.39 and 14.63 mm (1.708 and 0.576 in.) at peak load for models M1 and M2, respectively. This means that the precast concrete barrier wall system is more flexible than the cast-in-place concrete barrier wall

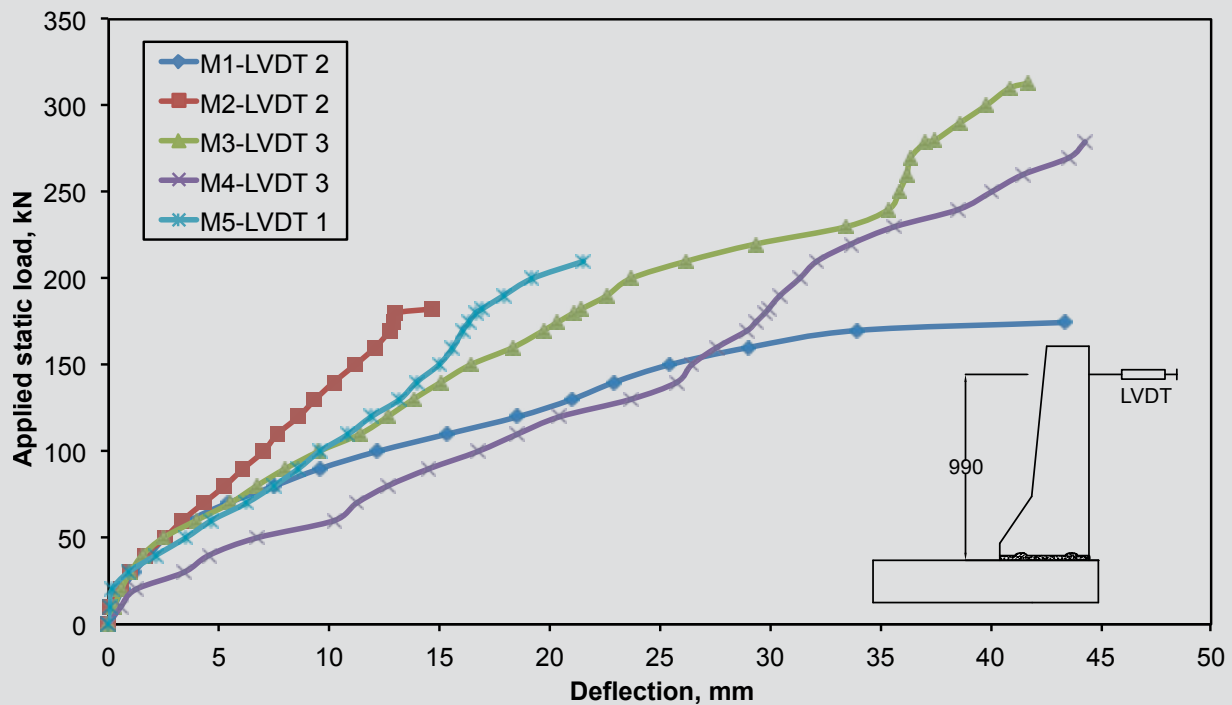
Figure 18. Comparison of load–lateral deflection relationship at location of load for all tested models. Note: LVDT = linear variable displacement transducer. Dimensions are in millimeters. 1 mm = 0.0394 in.; 1 kN = 0.225 kip.

system represented by model M2. Figure 18 also shows that model M5 with end loading exhibited 21.53 mm (0.848 in.) peak deflection, which is 51% less than that for model M4 with central loading. For models M3 and M4, the maximum recorded deflection was 41.67 and 44.28 mm (1.641 and 1.743 in.) at peak load, respectively. Model M3 exhibited less lateral deflection at the top of the barrier wall than model M4 exhibited at all loads. However, the change of deflection values of about 6% at peak load does not indicate the significance of the presence of the cantilever slab to support the barrier wall.
