# Behavior of free and connected double-tee flanges reinforced with carbon-fiber-reinforced polymer

A. W. Botros, G. Lucier, S. H. Rizkalla, and H. Gleich

- This paper presents an experimental program conducted to evaluate the performance of precast concrete double-tee flanges reinforced with carbon-fiber-reinforced polymer grids under various types of loading.
- Test results indicated that the flanges were capable of resisting a maximum applied load significantly higher than their factored design loads and that the concentrated load-carrying capacity of the flange depends on the location of the applied load.
- Based on this investigation, idealized failure surfaces and the corresponding modes of failure were identified for the free and connected flanges of prestressed concrete double tees subjected to concentrated loads.

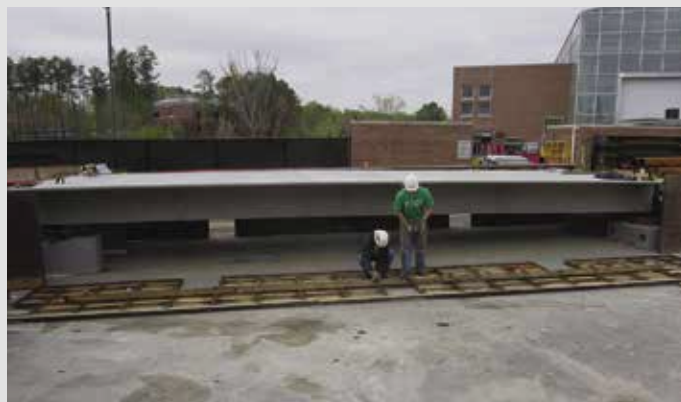
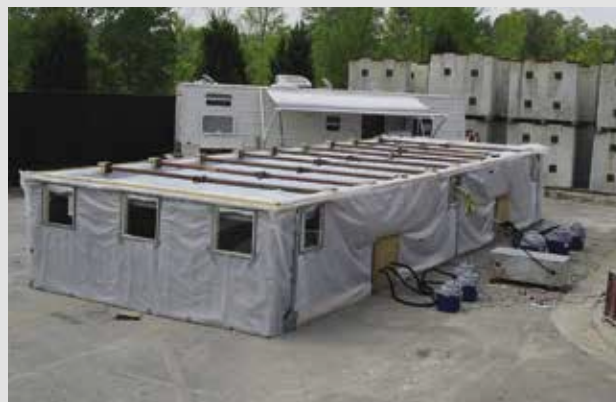
Under construction

Before testing

**Figure 2.** Sketch and photos of test chamber. Note: 1 ft = 0.305 m.

**Figure 2** shows a cross section of the test setup and the concept used to apply a uniform pressure loading condition to the top surface of the flange. At the start of the test, pressures P1 and P2 were both equal to the atmospheric pressure. Consequently, no load was applied to the top surface of the double-tee deck. With the chamber sealed, pressure P2 was reduced with vacuum equipment while atmospheric pressure P1 remained constant. With pressure P1 greater than P2, the atmospheric pressure acted evenly

inward on the top surface of the double tee, creating a uniform downward pressure on the entire top surface of the flange.

Modular formwork panels were used to construct the four vertical walls of the chamber around each double tee. The panels were sealed to the pavement surface and wrapped in plastic to minimize air leakage. The chamber walls were also anchored to the pavement for stability and were braced against one another with shoring to resist the horizontal

pressures acting on the chamber. Bracing was provided along the length of the chamber at the top and bottom of the sidewalls. The end walls were braced at the bottom against the supporting concrete blocks and were stiffened at their top edges with steel angles. The chamber was constructed with windows on all sides to allow access for instrumentation and for observation of the behavior under the applied load. Figure 2 shows the chamber under construction and the completed chamber before testing.

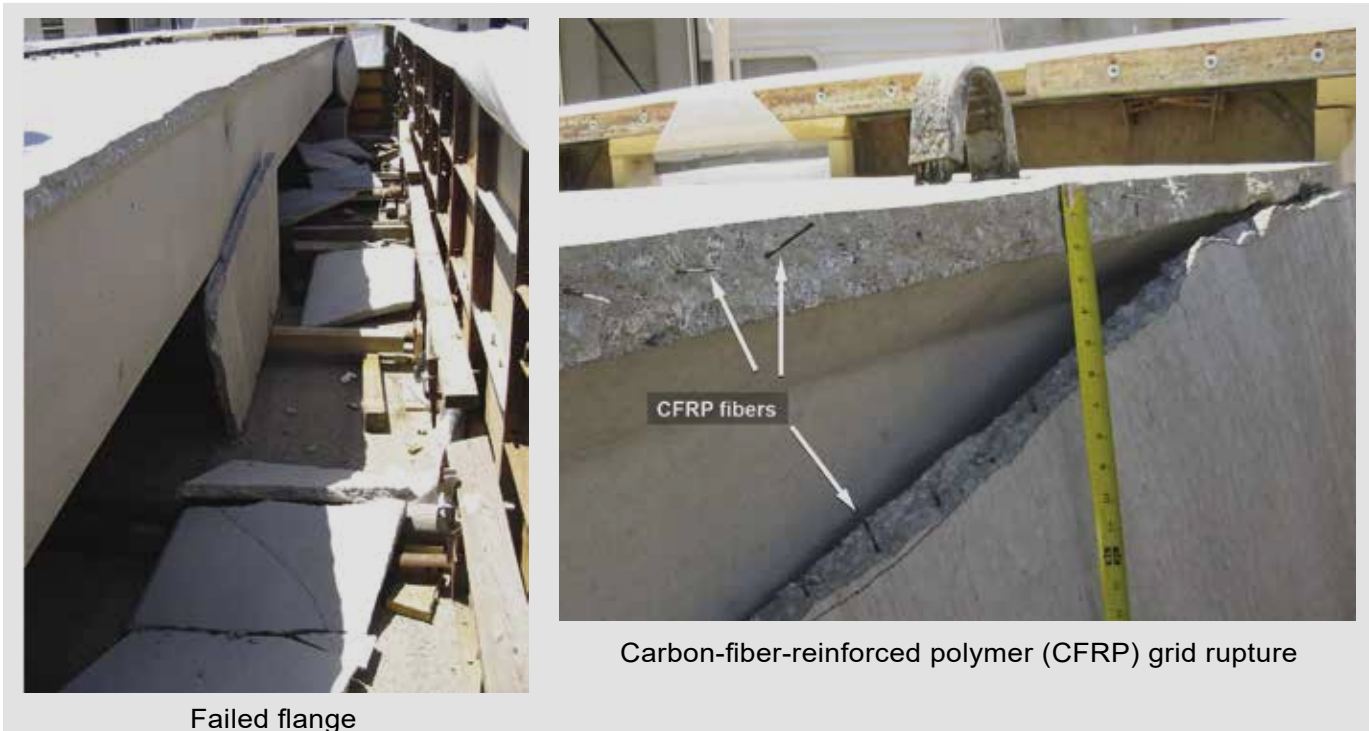
**Figure 3.** Specimen DT1 failure.

mode was a flexural failure in one of the cantilever flanges of the beam accompanied by rupture of the CFRP grid reinforcement. The failure resulted in complete detachment of the cantilever flange along the entire length of the beam (**Fig. 3**). Failure occurred suddenly after the formation of a longitudinal flexural crack on the top surface of the flange. This crack was located 6.5 in. (165 mm) outward from the center of one stem where the flange tapered into the stem (**Fig. 3**). Two initial cracks on the top surface of the inner flange were observed in specimen DT1 before testing. The initial longitudinal cracks were located at the web-flange juncture and extended along the entire length of the beam.

They were also visible on the bottom face of the flange but were not involved in the final failure mode.

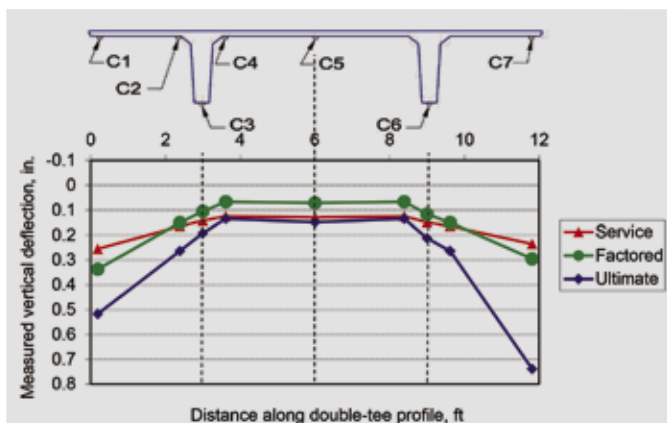
**Figure 4.** Deflection profile at midspan for specimen DT1. Note: C1 to C7 are the vertical deflection measurement locations across the cross section from the tip of one flange to the tip of the other. 1 in. = 25.4 mm; 1 ft = 0.305 m.

**Figures 4 and 5** show the measured net deflection profile at midspan and selected strain measurements for specimen DT1. Deflection profiles are shown at the service load, factored load, and ultimate load levels. The measured deflections at the tips of the cantilevers at service and factored loads were each less than 0.3 in. (8 mm). The measured transverse strains, gauges 2 and 4, located on the top surface of the cantilever at the flange stem juncture, indicated a linear load-strain behavior beyond the factored load and up to failure. This behavior indicates that no cracks occurred at this location up to failure. The behavior also justifies the small measured deflections at failure and highlights the brittle nature of failure. This result indicates that flange failure occurred immediately after cracking of the cross section at the maximum moment location. The load-strain behavior recorded by strain gauges 1 and 3 across the precracked inner flange-stem connection was nonlinear (**Fig. 5**). This result reflects widening of the preexisting cracks and straining of the CFRP grid at these locations as the applied uniform pressure increased.

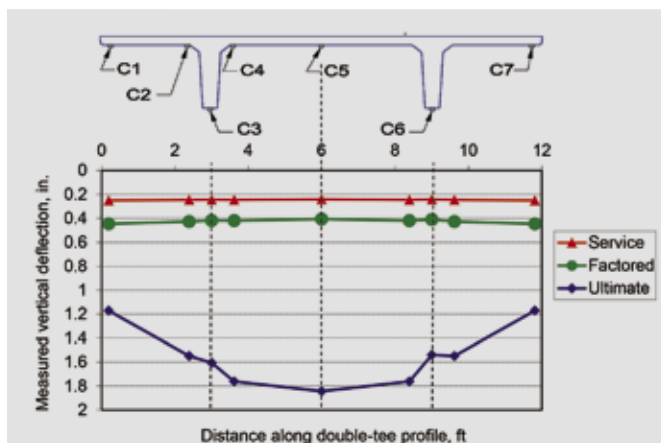
**Figure 6.** Deflection profile at midspan for specimen DT2. Note: 1 in. = 25.4 mm; 1 ft = 0.305 m.

**Figures 6 and 7** show the measured net deflection profile at midspan and measured concrete strains for specimen DT2, respectively. The measured load-deflection behavior indicates small deflections at the service and factored load levels and confirms that the flange remained nearly flat, even at the factored load. As the load increased beyond

the factored level, the deflection at the midspan increased compared with the end of the cantilever. The deflection profile for specimen DT2 indicates global deformation of the flange beyond the factored load. The measured concrete strains (Fig. 7) remained below 500 microstrain, and the load-strain behavior was relatively linear up to the maximum applied pressure with no evidence of cracks.

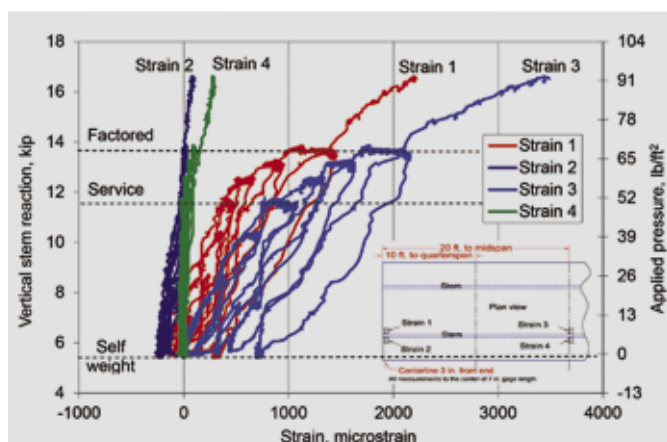
**Figure 5.** Measured strains for specimen DT1. Note: 1 kip = 4.448 kN; 1 lb/ft<sup>2</sup> = 0.0479 kPa.

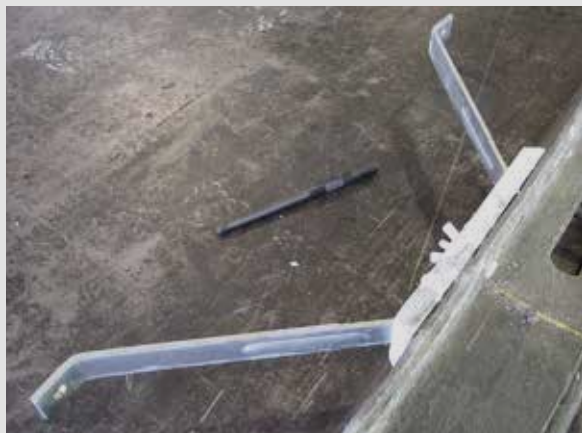
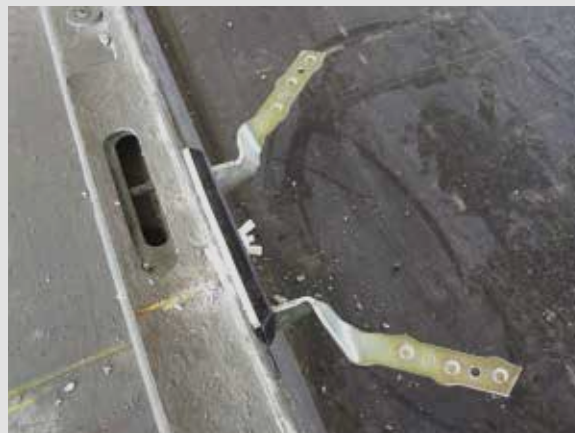
Straight connector

Twisted connector

**Figure 9.** The two types of flange connectors used in the program.

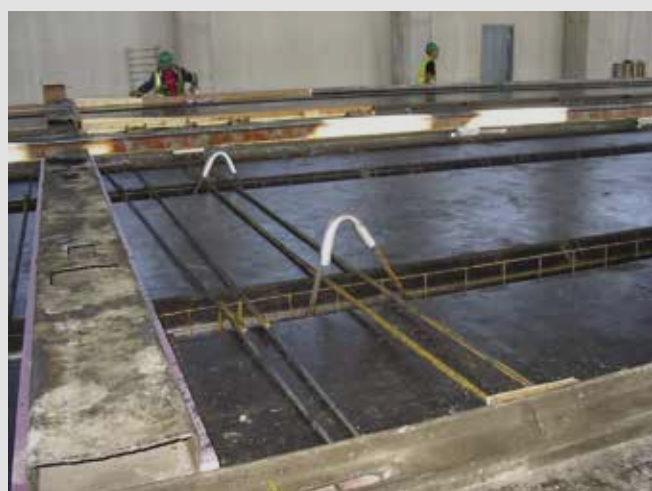
**Figure 10.** Typical steel bars (both ends of the double tee) and chord detail (one end of the double tee).

The CFRP grid was the only transverse flange reinforcement, with the exception of two no. 3 (10M) steel reinforcing bars placed at each end of the beam and a welded chord detail consisting of two no. 5 (16M) bars placed at one end only. The steel bars and chord detail are typical of all specimens (**Fig. 10**). A total of six double tees were tested in connected pairs, while only two double tees were tested individually. A total of 48 tests were performed.

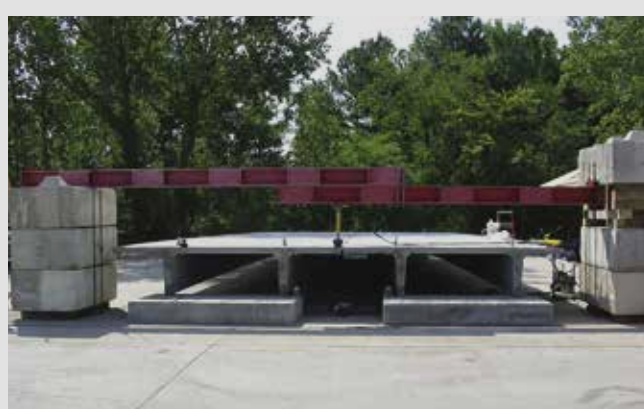
**Figure 11.** Concentrated load test setup (two double tees welded together).

Tests were conducted by applying concentrated loads at selected locations on the top surface of the flange using a hydraulic jack and self-reacting frame (**Fig. 11**). The jack was secured to the reaction beam, and the entire frame could be moved along the length of the specimens. The double tees were supported on randomly oriented fiber

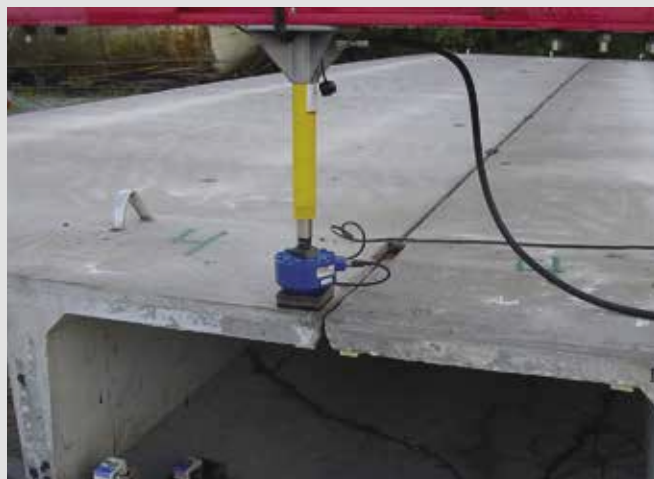
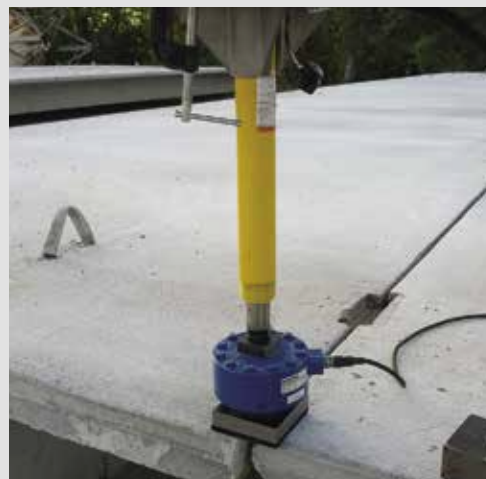
One side of the gap

Spanning the gap

**Figure 12.** Loading plate for connected double tees.

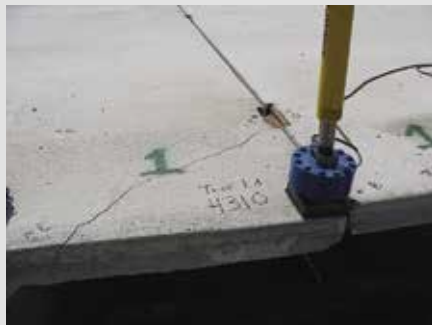
Test 1A: Connected double tees, internal corner, side of gap

Connected flanges loaded at internal corner locations with the load beside the gap (Fig. 13, test 1A) failed due to formation of an inclined flexure crack on the top surface of the loaded flange. This inclined crack extended from the web-flange juncture to the connector plate joining the two flanges. A portion of the concentrated load was also carried by the adjacent flange because it is connected to the loaded flange; however, failure took place in the loaded flange only, and the adjacent flange remained intact after the test.

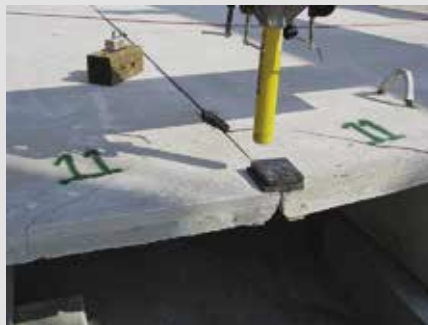
Test 11: Connected double tees, internal corner, spans gap

Loading the two flanges simultaneously at an internal corner in the configuration, referred to as *spans gap*, resulted in a flexure failure in the two flanges. Failure occurred after the formation of inclined flexure cracks on the top surfaces of the two connected flanges. These cracks extended from the web-flange juncture to the connector plate for each flange (Fig. 13, test 11).

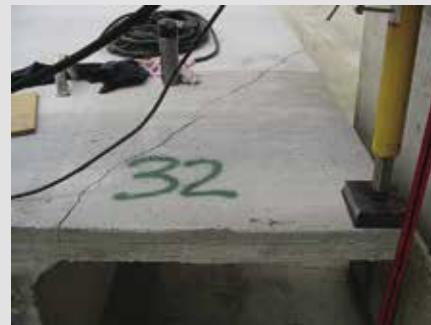
Test 32: Free double tee, corner

Test results for a free double tee loaded at the corner indicated failure due to formation of an inclined flexure crack on the top surface of the flange. This crack extended from the web-flange juncture to the edge of the flange with an inclination of about 60 degrees. The top right of Fig. 13, test 32, shows the failure mode for a corner test of a free double tee.

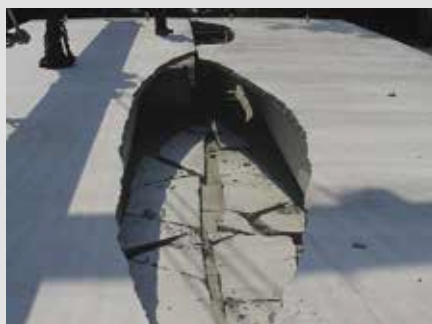
Test 19: Connected double tees, midspan, spans gap

Test results for connected flanges loaded at the midspan with the load spanning the gap (Fig. 13, test 19) indicated flexure failure in the two flanges. The flexural cracks that constituted failure occurred immediately after reaching the cracking capacity of the flanges at the critical section. The cracks took place on the top surface of the flanges close to the web-flange juncture. Under the applied load, the cracks widened and propagated longitudinally and transversely toward the gap between the two flanges. For each of the connected flanges, the flexure crack intersected the edge of the flange beside the gap at two points almost 25 ft (7.6 m) apart. This behavior resulted in the complete detachment of segments of the two connected flanges upon rupture of the CFRP grid. In general, the failure was brittle and occurred immediately after the formation of the flexure cracks.

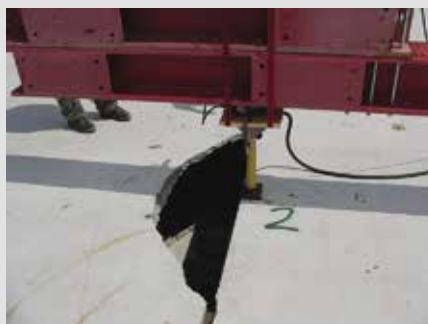
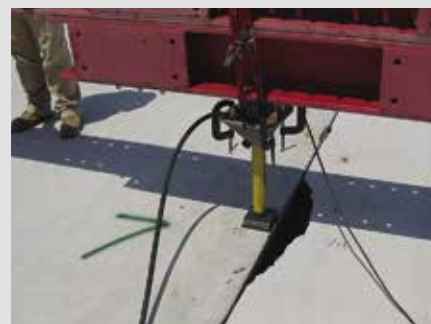
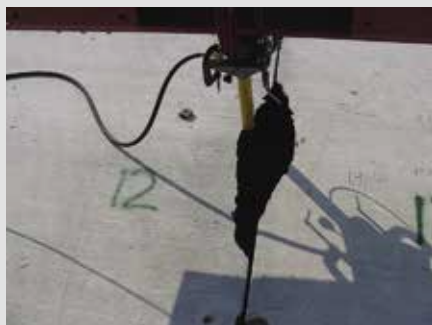
Test 2B: Connected double tees, midspan, side of gap

Test 7A: Connected double tees, midspan, side of gap

Tests 12A and 12B: Connected double tees, midspan, side of gap

Test results for connected flanges loaded at the midspan with the load placed at one side of the gap exhibited a different failure mode. Figure 13, test 2B, 7A, and 12A and 12B show the failure mode for the midspan side-of-gap tests, where the observed failure was a local punching shear failure in the flange at the location of the applied load. The failure took place suddenly. In some tests, a flexure crack occurred on the top surface of the flange close to the web-flange juncture before the punching failure of the flange.

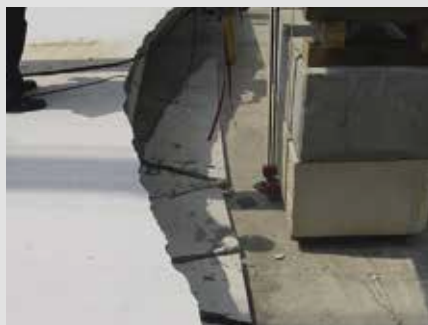
Test 28: Free double tee, midspan, edge

Test results for a free double tee with loading at the midspan edge (Fig. 13, test 28) indicated a flexural failure in the flange. Failure occurred after the formation of a longitudinal flexural crack on the top surface of the flange. This crack initiated close to the web-flange junction and progressed longitudinally and transversely toward the edge of the flange. The failure resulted in complete detachment of a segment of the flange upon rupture of the CFRP grid.

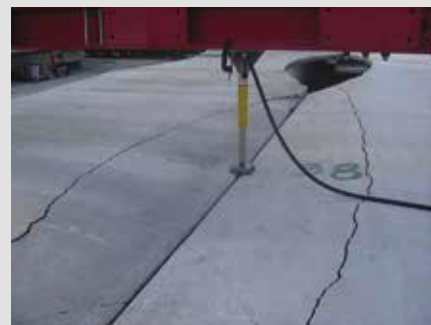
Test 38: Test at connector

Results of tests conducted directly over connectors indicated a flexural failure in the two connected flanges. Failure

occurred immediately after the formation of flexural cracks on the top surface of the two flanges. The cracks initiated close to the web-flange junction and propagated in the longitudinal and transverse directions toward the gap between the two flanges (Fig. 13, test 38).
