Dapped ends of prestressed concrete thin-stemmed members: Part 1, experimental testing and behavior

Amir W. Botros, Gary J. Klein, Gregory W. Lucier, Sami H. Rizkalla, and Paul Zia

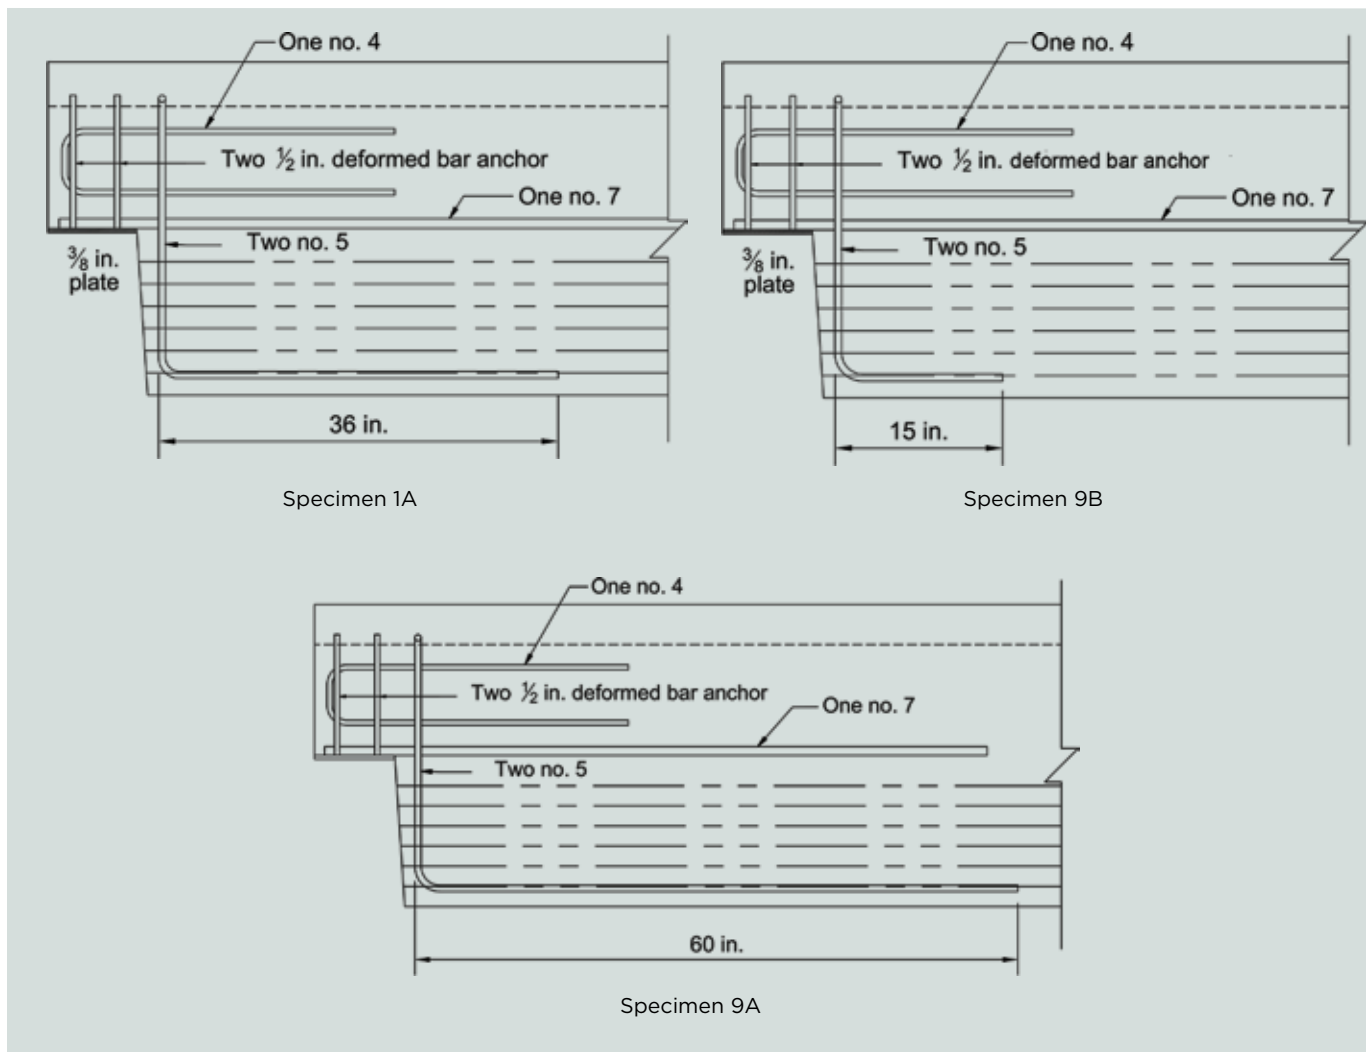
Figure 6. Specimens 1A, 9B, and 9A with different splice lengths. Note: no. 4 = 13M; no. 5 = 16M; no. 7 = 22M; 1 in. = 25.4 mm.

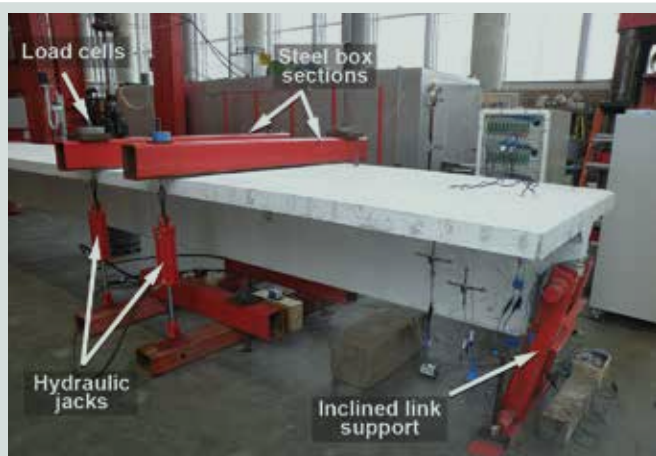
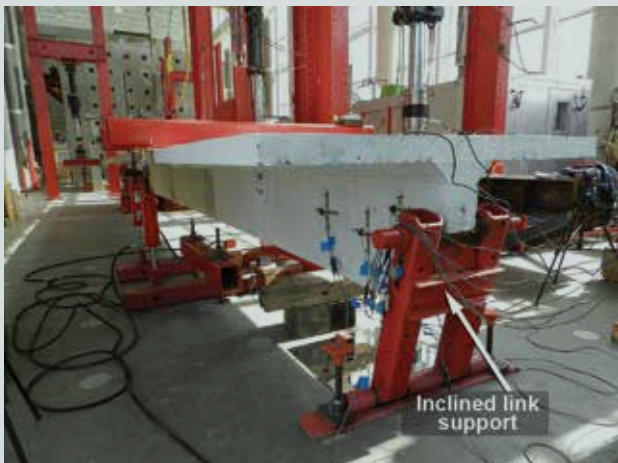
General view

Inclined link support

Figure 8. Test setup.

Load was applied to the specimen by four hydraulic jacks (Fig. 8). All four hydraulic jacks shared the same pressure source, ensuring equally applied loads. The jacks were operated manually with an electric pump to apply load incrementally to failure. The four hydraulic jacks were connected to two loading beams located across the top of the specimen, placed 7 and 10 ft (2 and 3 m) from the end of the beam.

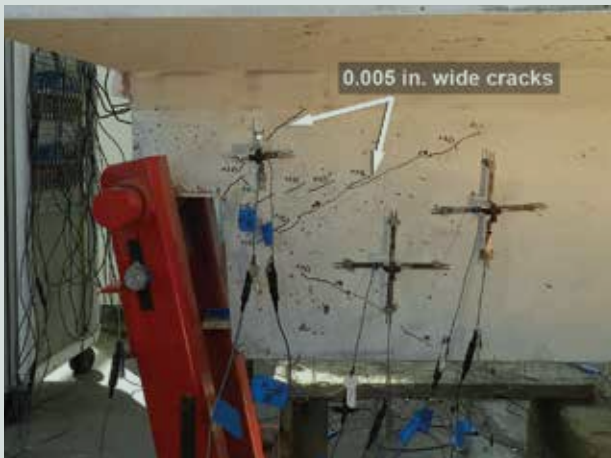
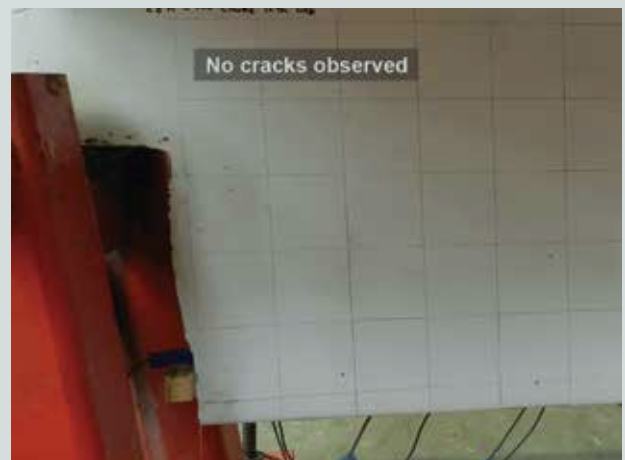
Specimen 1A (vertical L scheme)

Specimen 3A (inclined L scheme)

Specimen 2A (vertical Z scheme with corner angle)

Specimen 5A (two strands in the nib)

Figure 10. Crack patterns at service load for selected specimens. Note: 1 in. = 25.4 mm.

measured crack width at service load varied from 0.005 to 0.02 in. (0.13 to 0.5 mm) for all tested specimens. **Figure 10** shows typical cracking observed at the service load level for selected specimens. The cracking

patterns observed at service load indicated that the vertical Z with corner angle and the inclined L reinforcement schemes exhibited the best performance in terms of crack control compared with all other schemes. For the inclined L scheme, the orientation of the hanger steel normal to the diagonal tension cracks effectively arrested the cracks at service loads. For the vertical Z scheme, use of the corner angle effectively reduced cracking at service load. No cracks were observed at service load for the specimens with strands in the nib because prestressing the nib applies direct precompression force to the concrete section in the nib region and the full-depth section, which prevented formation of cracks up to the service load level.

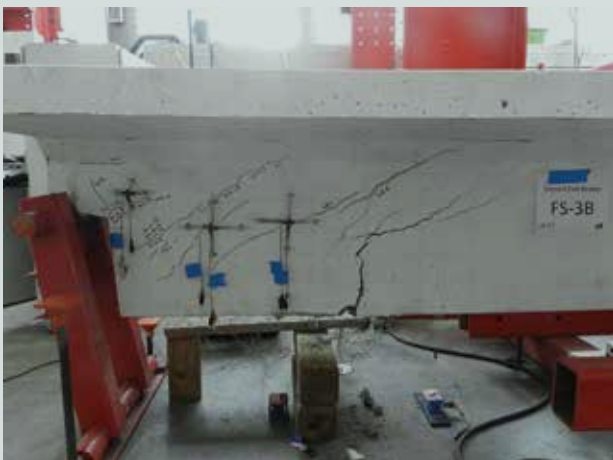
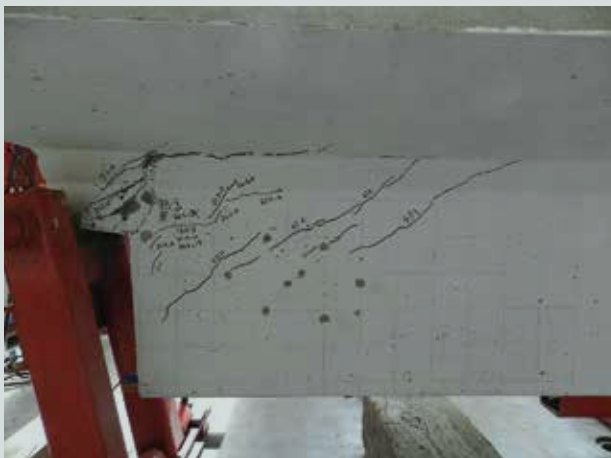
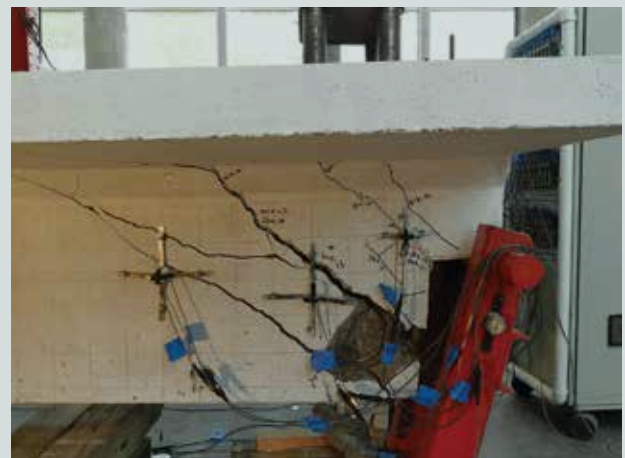
Diagonal tension cracking in the web

Flexure-shear failure

Associated splitting in the web

Diagonal tension cracking within the nib

Concrete crushing at the bottom corner

Figure 11. Failure modes for the dapped ends.

Nine of the 20 dapped ends failed due to the formation and widening of a critical diagonal tension crack within the web. This diagonal tension crack extended from or close to the bottom corner of the web up to the web flange junction with an angle of inclination of 30 to 45 degrees from the horizontal. In some cases, the diagonal tension crack occurred so abruptly that it was not possible to specify its origin and the load dropped significantly upon the formation of this crack. In other cases, usually for specimens with webs that had higher amounts of stem reinforcement, a series of diagonal tension cracks occurred in the web before the formation of the critical crack that caused ultimate failure. Although the final failure was brittle, this type of failure was preceded by extensive cracking near the reentrant corner and dap end face before the critical diagonal crack took place. Strand slip measurements indicated significant slip that occurred immediately after the initiation of the critical diagonal tension crack. This observation indicates strand bond failure, which implies that the tension chord of the beam was effectively disabled after the formation of the critical diagonal crack. **Figure 11** shows the typical diagonal tension failure in the web.

diagonal crack started from the inside edge of the bearing pin and extended upward to the web-flange junction. Specimens 8A and 10B, with reduced nib heights, failed in this mode. Specimens 4B and 7B, both with the typical nib height of 15 in. (380 mm) and vertical C scheme, also failed in this mode. Diagonal tension cracks in the nib region extending up from the bearing are not captured by the C-hanger reinforcing bar detail because the upper end of the bar is anchored by turning it toward the full-depth section rather than out toward the nib. The diagonal tension crack in the nib extended upward and ran around the upper bend region of the C-shaped bar. Figure 11 shows the diagonal tension cracking within the nib.

The last failure mode observed in the dapped ends was a sudden diagonal compression crushing of the concrete at the bottom corner of the web (Fig. 11). This failure mode was brittle and sudden in nature. Specimens 1A, 6B, and 9A failed in this mode.

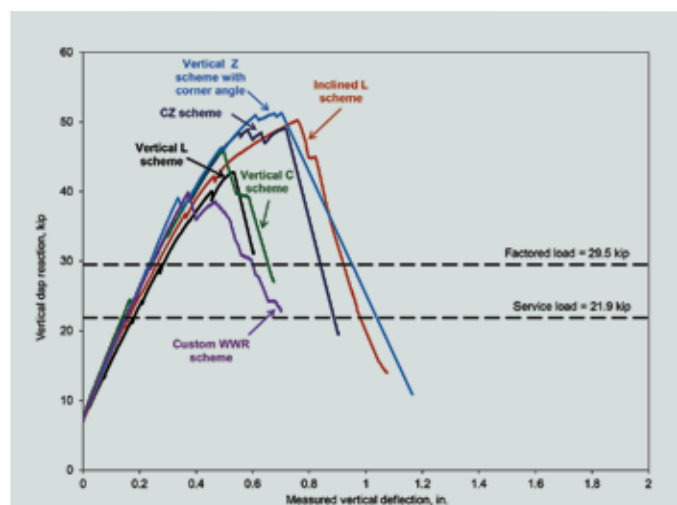
Figure 13. Measured vertical deflections for the six reinforcement schemes. Note: WWR = welded-wire reinforcement. 1 in. = 25.4 mm; 1 kip = 4.448 kN.

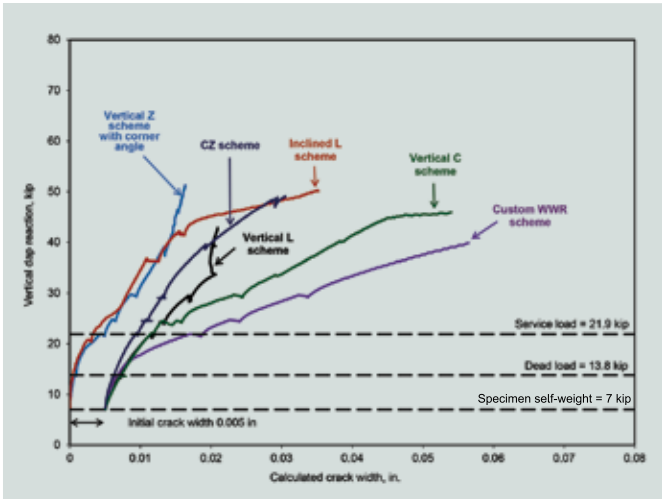
Figure 14. Reentrant corner crack width for six reinforcement schemes (calculated from strain data). Note: WWR = welded-wire reinforcement. 1 in. = 25.4 mm; 1 kip = 4.448 kN.

Figure 14 plots the crack width versus the dap reaction for the six reinforcement schemes. **Figure 15** shows a summary of the maximum crack widths at a service load level of 21.9 kip (97.4 kN) for each reinforcement scheme. Comparison of crack widths with the dap vertical reactions for the six reinforcing schemes indicated that the vertical Z with corner angle and the inclined L schemes exhibited the best performances in terms of crack control. The reentrant corner crack width for these two schemes was less than 0.005 in. (0.13 mm) at service load. The custom WWR scheme had the widest crack, with a width of 0.02 in. (0.50 mm) at service load. The vertical L, vertical C, and CZ schemes showed good performance, with crack widths ranging from 0.010 to 0.015 in. (0.25 to 0.38 mm) at service load.

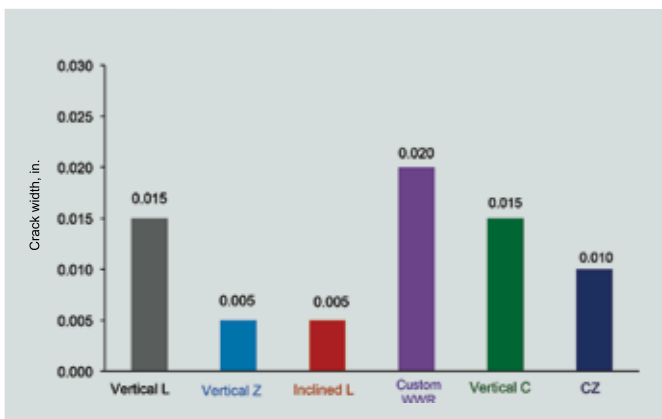
Figure 15. Crack widths at service load level (21.9 kip [97.4 kN]) for six reinforcement schemes. Note: WWR = welded-wire reinforcement. 1 in. = 25.4 mm.

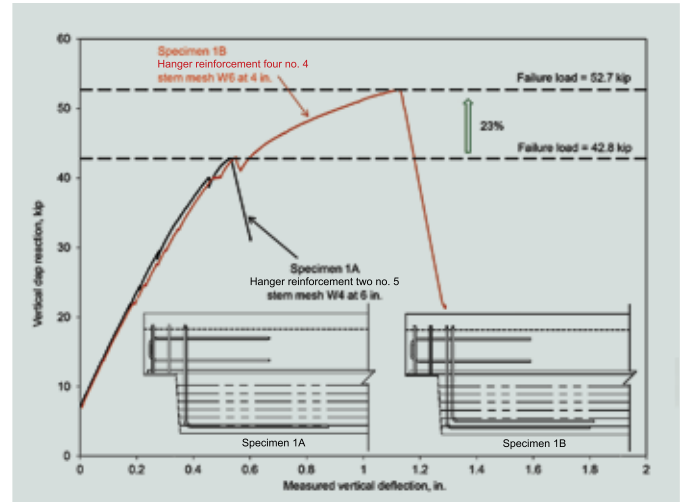
Figure 17. Measured vertical deflections for specimens 1A and 1B. Note: no. 4 = 13M; no. 5 = 16M; W4 = 5.7 mm; W6 = 7.01 mm; 1 in. = 25.4 mm; 1 kip = 4.448 kN.

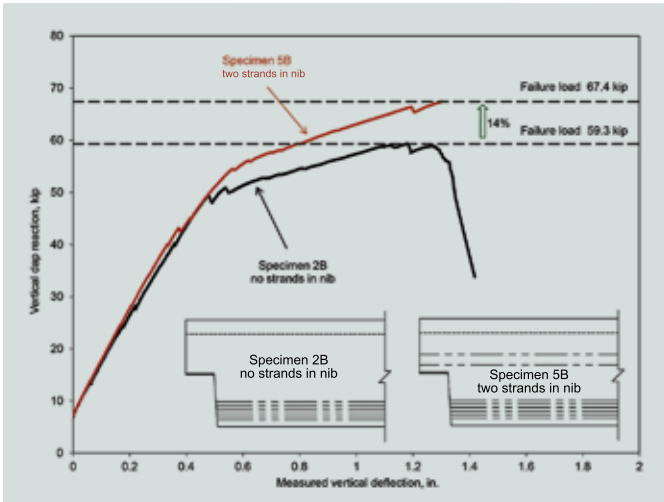
Figure 18. Measured vertical deflections for specimens 2B and 5B. Note: 1 in. = 25.4 mm; 1 kip = 4.448 kN.

nib. **Figure 18** compares the measured load with vertical deflections for specimens 2B and 5B. The results indicated a 14% increase in the ultimate strength for the case where two prestressing strands were located in the nib. This is attributed to the fact that having prestressing strands in the nib applies direct compression force to the concrete section in the nib region and the full-depth section of the beam. Prestressing of the nib also helps delay the formation of the reentrant corner crack and increases the shear strength of the full-depth section. It prevented cracking before loading and limited the width of the reentrant corner cracks at service loads. Specimen 5B with strands in the nib exhibited narrow reentrant corner cracks at service loads, whereas the identical specimen 2B without nib prestressing exhibited approximately 0.015 in. (0.38 mm) wide cracks at the service load level.

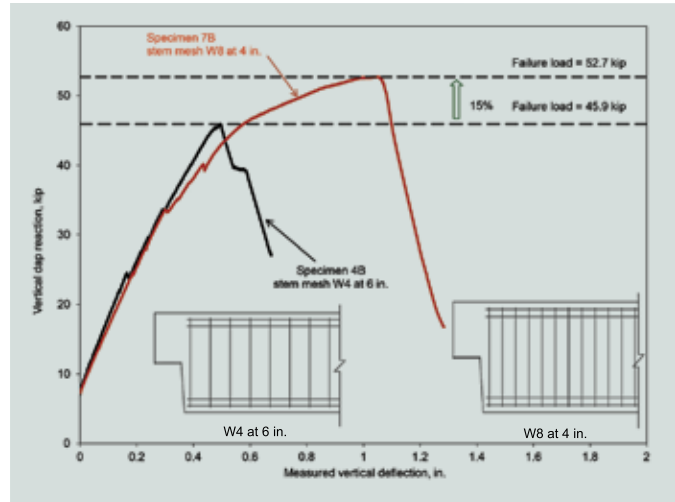
Figure 20. Measured vertical deflections for specimens 4B and 7B. Note: W4 = 5.7 mm; W8 = 8.10 mm; 1 in. = 25.4 mm; 1 kip = 4.448 kN.

6 in. (150 mm) spacing. **Figure 20** compares the measured load with vertical deflections for specimens 4B and 7B. Specimen 7B exhibited a 15% increase in ultimate strength compared with specimen 4B. Although specimens 4B and 7B both failed due to diagonal tension cracking in the nib, a significant difference in the behavior was observed between the two specimens. Specimen 7B, with the heavier stem WWR, exhibited excessive diagonal cracking in the web before failure. A series of diagonal tension cracks evenly distributed took place in the web as the load was increased up to failure. However, specimen 4B showed a rather brittle and sudden failure without warning. The increase in stem WWR allowed significant cracking in the full-depth section, postcracking strength gain, and considerably more deflection before failure.

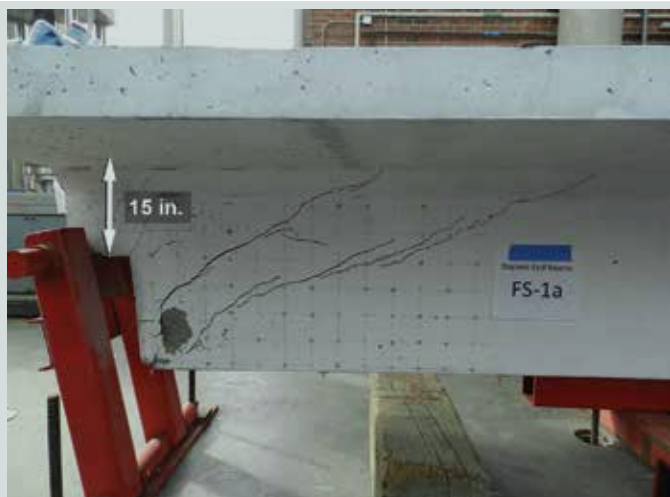
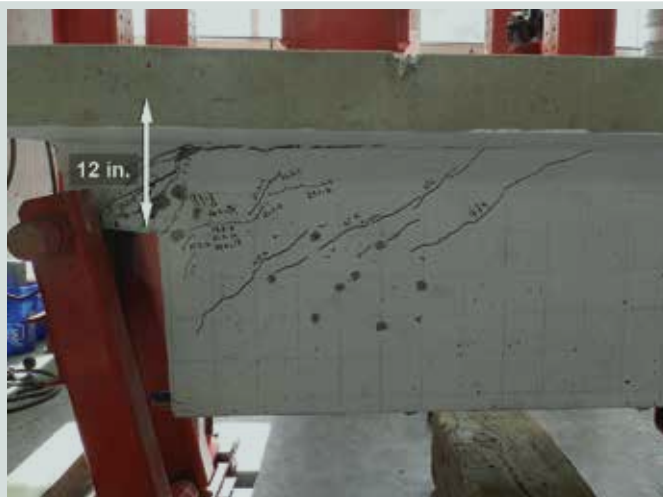
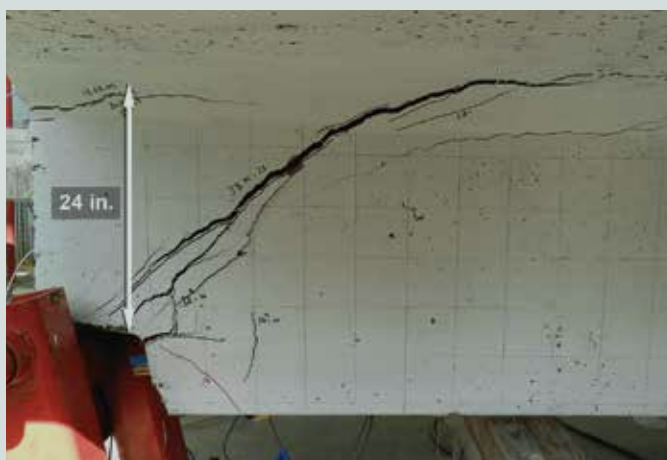
Specimen 1A (15 in. nib height)

Specimen 8A (12 in. nib height)

Specimen 8B (24 in. nib height)

Figure 21. Specimens after failure. Note: 1 in. = 25.4 mm.

The effect of this parameter was investigated by comparing specimen 8A, with a nib height of 12 in. (300 mm) (40% of the full height); specimen 1A, with a nib height of 15 in. (380 mm) (50% of the full height); and specimen 8B, with a nib height of 24 in. (610 mm) (80% of the full height). Specimens 1A and 8A had the same dapped-end reinforcement, while specimen 8B was constructed without hanger and shear friction reinforcement. **Figure 21** shows the failure modes for specimens 1A, 8A, and 8B. Test results indicated that the failure mode was affected by the nib height. Specimen 1A, with a nib height of 15 in., failed due to concrete crushing at the bottom corner of the web. Specimen 8A, with a reduced nib height of 12 in., experienced a diagonal cracking failure in the nib

section. Clearly, reducing the nib section height increased the shear stresses within the nib section, which resulted in a nib failure.
