Performance of precast concrete moment frames subjected to column removal: Part 1, experimental study

H. S. Lew, Joseph A. Main, Yihai Bao, Fahim Sadek, Vincent P. Chiarito, Stephen D. Robert, and Jorge O. Torres

- This paper presents a full-scale experimental study of two precast concrete moment-frame assemblies (one ordinary and the other special) representing portions of seismically designed perimeter moment frames from two 10-story prototype buildings.
- The assemblies were subjected to monotonically increasing vertical displacement of the unsupported center column to observe their behavior and failure modes under simulated column removal.
- The failures of both the ordinary moment frame and special moment frame specimens were characterized by fractures of the bottom anchorage bars at the welded connection to the center column and diagonal cracking and shear deformation of the end columns under outward forces generated by arching action in the beams.

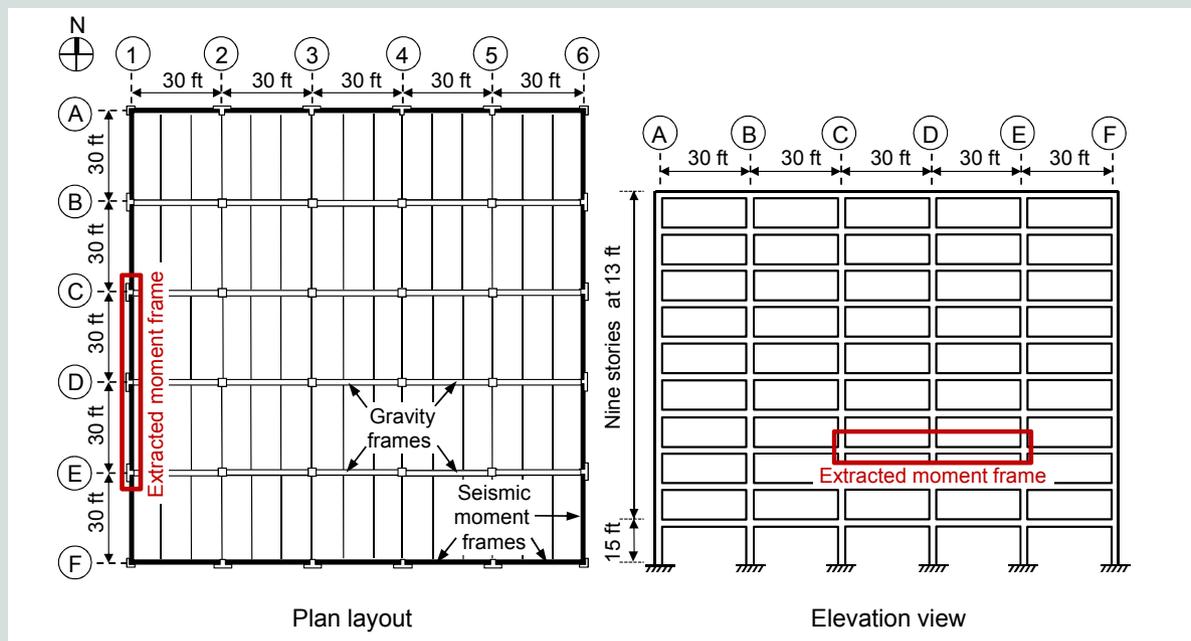
Figure 1. Prototype buildings. Note: 1 ft = 0.305 m.

The test specimens were two-span moment-frame assemblies extracted from the third-floor framing system in the north-south direction (C1~E1) of the 10-story buildings (Fig. 1). The specimen from the seismic design category B building was part of an ordinary moment frame, while the specimen from the seismic design category D building was part of a special moment frame.

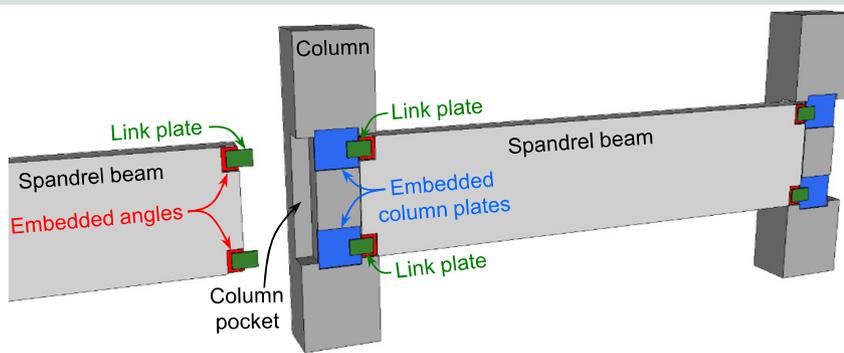
Figure 2. Perspective illustration of a perimeter moment frame showing link-plate connections and placement of spandrel beams within pockets in the columns.

The spandrel beams in the perimeter moment frames were placed inside pockets in the exterior columns (Fig. 2), and moment connections were established by welding steel link plates to steel angles embedded in the beams and to steel plates embedded in the columns. Figure 3 shows the special moment frame connection details. The ordinary moment frame connections were similar but with two no. 10 (32M) anchorage bars per link plate and different dimensions of the components. Details are provided in NIST Technical Note 1886.¹³ The steel column plates were embedded in the column concrete using AWS D1.1 Type B headed studs.¹⁴ Anchorage reinforcing bars in the spandrel beams were welded to the steel angles embedded at the top and bottom of the beams. The beam moment was transferred to the column by the coupling forces generated in the top and the bottom link plates. Torsional restraint for the spandrel beams was provided by torsion rods installed through sleeves in the beams and columns. For both the ordinary moment

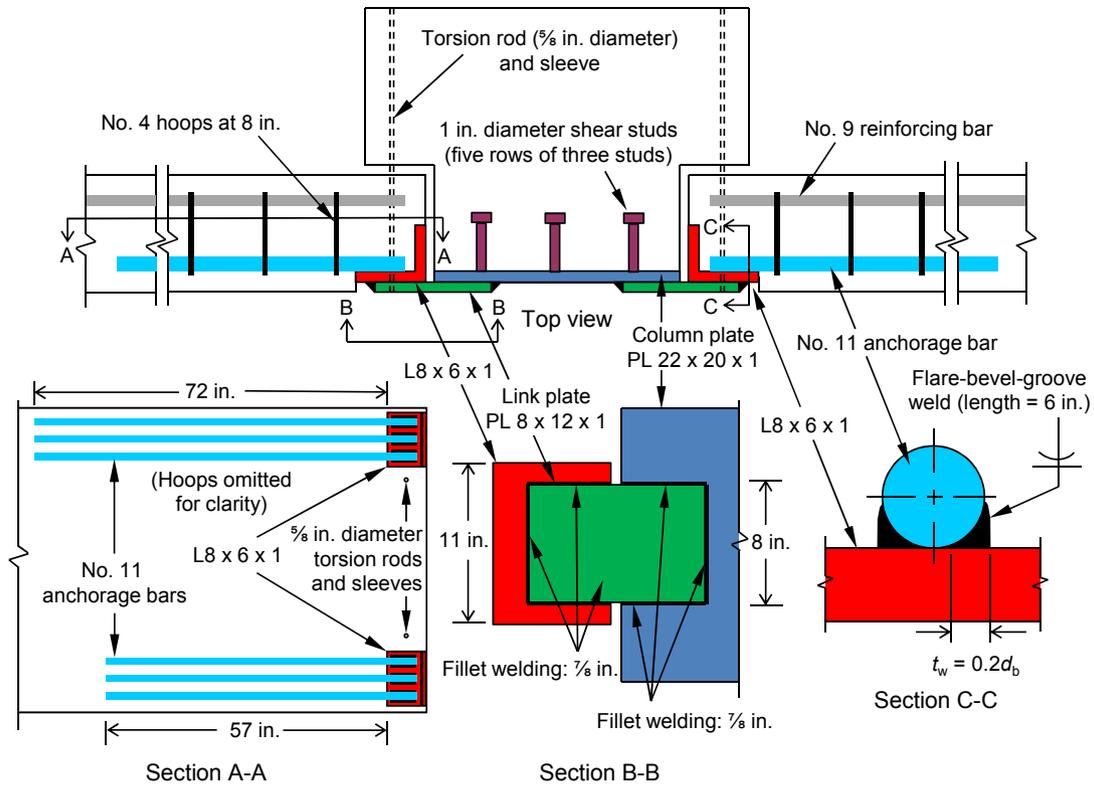
Figure 3. Special moment frame connection details. Note: d_b = reinforcing bar diameter = 1.41 in.; t_w = throat dimension of flare-bevel-groove weld = 0.28 in. No. 4 = 13M; no. 9 = 29M; no. 11 = 36M; L8 x 6 x 1 = L200 x 150 x 25; PL8 x 12 x 1 = PL200 x 300 x 25; PL22 x 20 x 1 = PL560 x 510 x 25; 1 in. = 25.4 mm.

The beams of the special moment frame specimen were inadvertently installed in an inverted orientation so that the longer anchorage bars were at the bottom of the beams rather than at the top as designed (Fig. 3). A slight misalignment of the torsion rod sleeves in the beams and columns also prevented installation of the torsion rods for the special moment frame specimen. As discussed in NIST Technical Note 1886,¹³ the implications of these errors were investigated using computational modeling and were found to have only a slight influence on the response of the special moment frame specimen. The experimental results obtained for the special moment frame specimen are therefore believed to represent quite closely the behavior of the specimen as designed.

to decrease. A drop in the load at point D was associated with detachment of the upper column plate from the left end column. The column plate was attached to the column with shear studs (Fig. 3), and detachment of the column plate was associated with concrete cracking on the left end column (Fig. 7). **Figure 8** shows another view of the cracking and spalling of concrete associated with detachment of the upper column plate from the left end column.

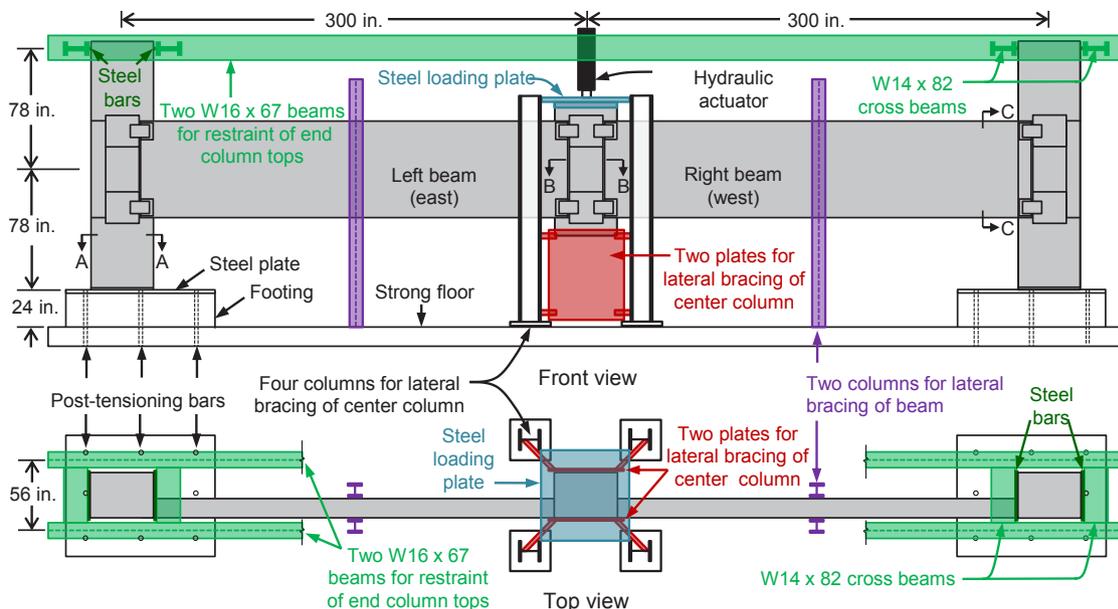
Figure 4. Front and top views of experimental configuration. Note: W14 x 82 = W360 x 120; W16 x 67 = W410 x 100; 1 in. = 25.4 mm.

Figure 4 illustrates the experimental configuration, which was essentially the same for both specimens and is further described in NIST Technical Note 1886.¹³ The span length of the test specimens was reduced from 30 ft (9.1 m) to 25 ft (7.6 m) to fit within the testing facility. The effect of the shortened span length was evaluated using computational modeling and is discussed in the companion paper.⁶

The tops of the end columns were restrained by a steel frame to simulate the bracing effect provided by the upper stories in a multistory building. Vertical load was applied to the unsupported center column using a hydraulic actuator with a capacity of 400 kip (1800 kN) and a stroke of 20 in. (510 mm). The load was applied under displacement control at a rate of 1 in./min (25 mm/min). Horizontal movements of the steel loading plate were restrained by four columns positioned at the corners of the plate (Fig. 5). A special roller bearing support arrangement at the four corners of the plate allowed free vertical displacement of the plate along the four columns. Lateral bracing was provided at the lower end of the center column and at the midspan of each beam (Fig. 4).

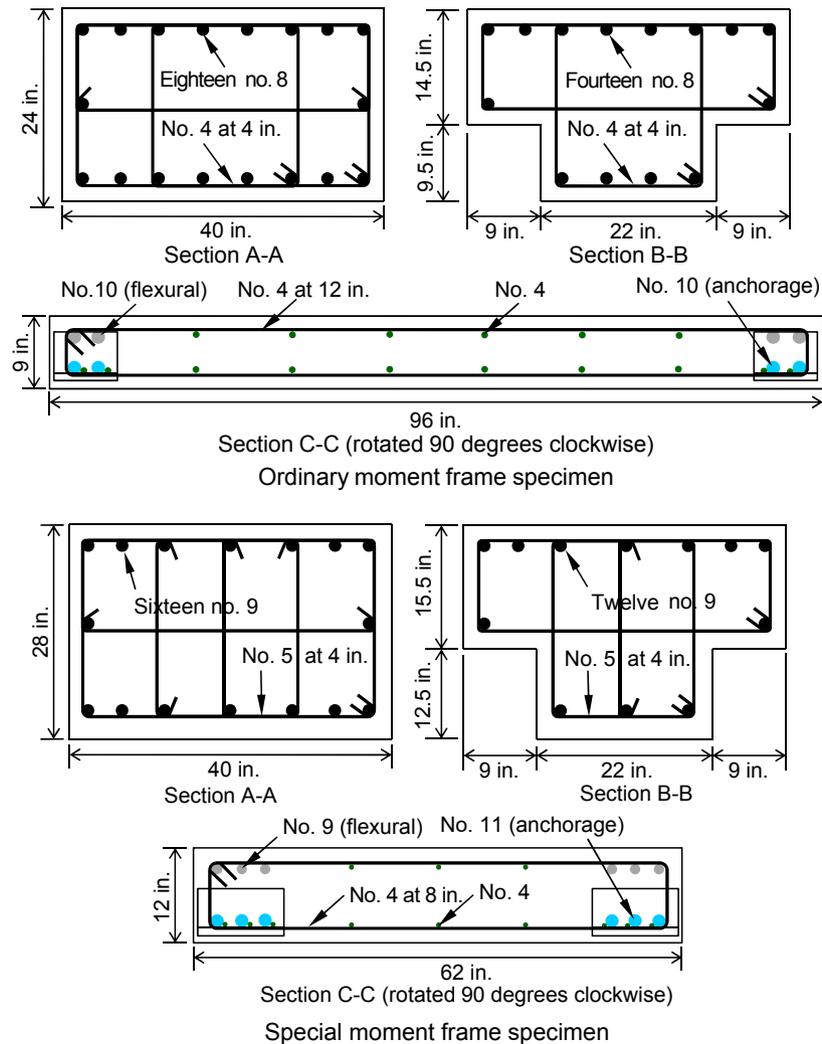
Figure 5. Member cross section and reinforcement details. Note: No. 4 = 13M; no. 5 = 16M; no. 8 = 25M; no. 9 = 29M; no. 10 = 32M; no. 11 = 36M; 1 in. = 25.4 mm.

Figure 5 shows member sizes and reinforcement details for the ordinary moment frame and special moment frame specimens. The columns had a rectangular cross section (section AA in Fig. 4), which was reduced to a T shape in the connection regions to form pockets for the spandrel beams (section BB in Fig. 4). Column longitudinal reinforcing bars were welded to 1 in. (25 mm) thick steel plates

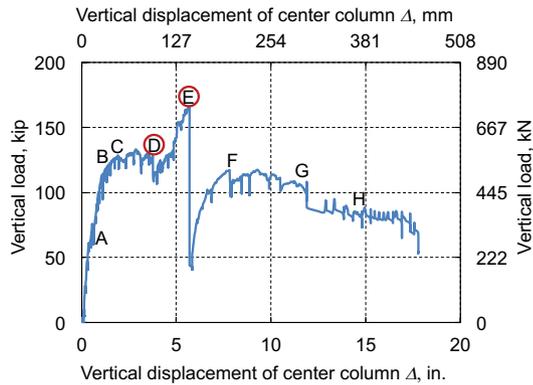
Figure 6. Applied vertical load versus vertical displacement of center column for ordinary moment frame specimen. Note: Labeled points D and E correspond to images in Fig. 7.

Figure 6 shows a plot of the applied vertical load versus the vertical displacement Δ of the center column for the ordinary moment frame specimen. **Figure 7** illustrates the progression of damage corresponding to the circled labels in Fig. 6. The load versus displacement was es-

entially linear up to point A, when concrete cracking occurred in the beams around the upper link plates at the center column and the stiffness of the specimen decreased. Further reductions in stiffness occurred at points B and C as concrete cracks formed in the end columns at the lower column plates. The load reached an initial peak of 133 kip (592 kN) at Δ equal to 2.87 in. (72.9 mm) and then began

After the drop in load at point D in Fig. 6, the load began to increase steeply again up to point E, reaching an ultimate peak of 166 kip (738 kN) at Δ equal to 5.66 in. (144 mm). Between points D and E, the specimen developed additional capacity through arching action, with the top corner of each beam bearing against the center column and the bottom corner of each beam bearing against the end columns. Such bearing was evidenced by a narrowing of the gaps between the beams and columns with associated cracking and spalling of concrete in regions where bearing forces developed (Fig. 7).

After reaching the ultimate load at point E, the load dropped sharply to only 25% of its peak value. This drop in load was associated with fracture of the no. 10 (32M) anchorage bars welded to the bottom connecting angle on the left side of the center column. The anchorage bars fractured at the end of the flare-bevel-groove weld on the

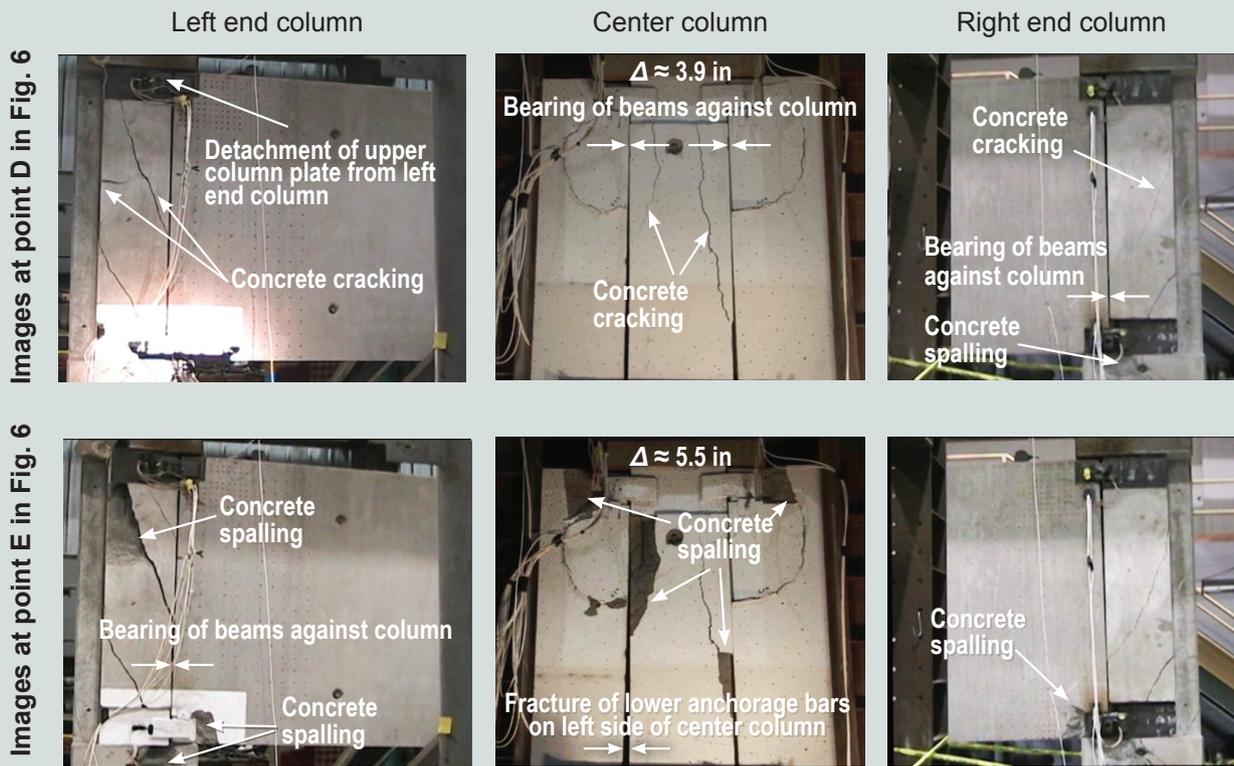
Figure 7. Progression of damage for ordinary moment frame specimen. Note: Images correspond to labeled points in Fig. 6.

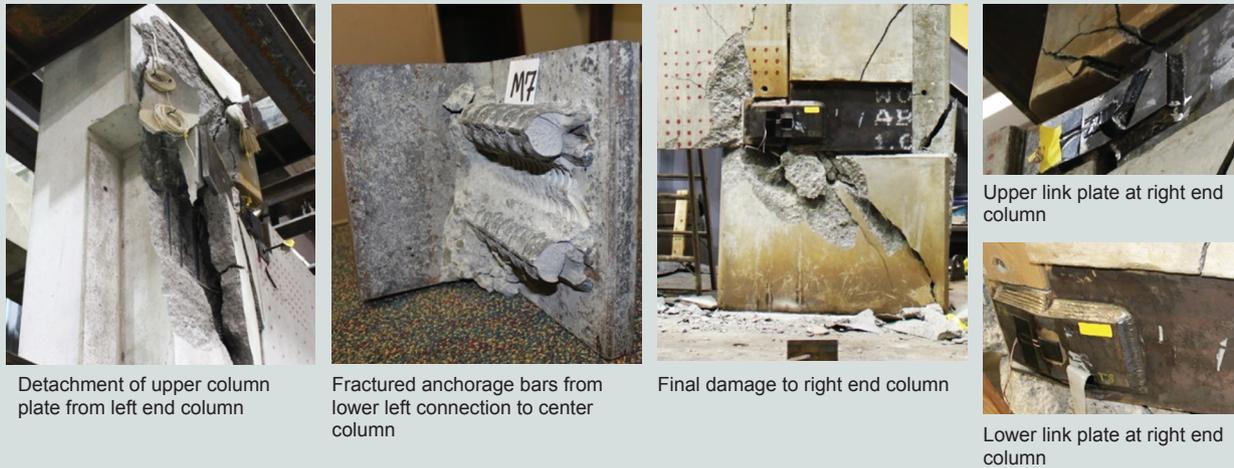
Figure 8. Observed failure modes for ordinary moment frame specimen.

connecting angle (Fig. 3), as is evident in **Fig. 8**, which shows the connecting angle and welded anchorage bars recovered from the specimen after the test.

Shear deformation of the right end column continued throughout the remainder of the test, and Fig. 8 shows the final state of damage. Another drop in load at point G was associated with fracture of the lower torsion bar at the left end column accompanied by shear deformation of the left end column below beam level, which continued throughout the remainder of the test. Shear deformation of the left end column occurred with extensive concrete spalling. At point H in Fig. 6, the upper column plate detached from the right end column, similar to the failure observed previously on the left end column at point D. This failure was accom-

panied by cracking and spalling of concrete on the right end column. Large deformations of the link plates were observed (Fig. 8), which indicated extensive yielding. Out-of-plane bending of the link plates resulted from eccentricity in the transfer of forces through the link plate connections (**Fig. 9**). This eccentricity also resulted in bending of the anchorage bars, which contributed to their fracture, as discussed subsequently.

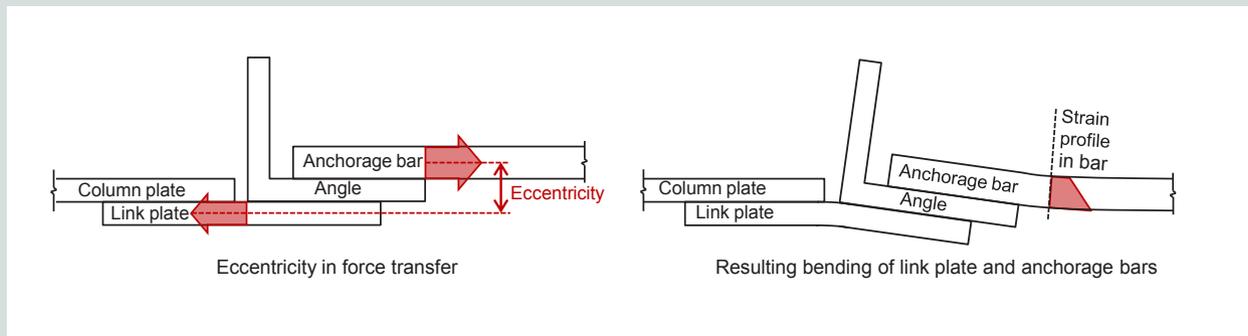
Figure 9. Top view of link plate connection illustrating eccentricity in force transfer and resulting bending of link plate and anchorage bars.

Figure 9 illustrates the bending that resulted from link plates in tension. For link plates in compression, the bending was reversed. (Compare the bending of the upper and lower link plates at the right end column in Fig. 8.) Finally, as the load continued to decrease and large chunks of concrete spalled from the specimen, the test was terminated at Δ equal to 17.8 in. (452 mm).

from the measured strains by assuming a linear strain profile across the bar (Fig. 9) using the measured stress-strain curve for a no. 10 (32M) bar (from tensile testing reported in NIST Technical Note 1886¹³) to calculate the corresponding stress profile and numerically integrating the stress profile over the cross section of the bar. Open circles on the curves of calculated bending moment and axial force indicate the point at which yielding first occurred on the front side of the bar. Based on tensile testing,¹³ the yield capacity of a no. 10 (32M) bar was 81.3 kip (362 kN). Figure 12 thus shows that bending moments due to connection eccentricities caused yielding to initiate when the axial force was at about half of the yield capacity of the bar.

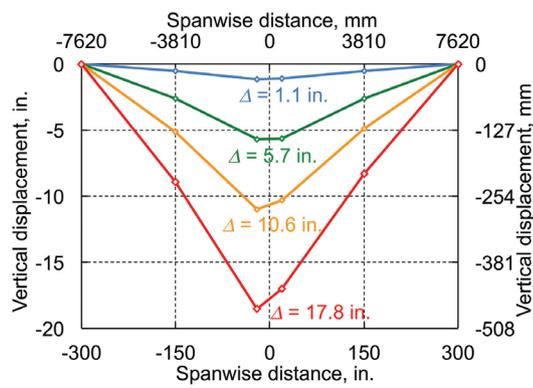
Figure 10. Vertical displacement profile of beams corresponding to indicated center-column displacements (ordinary moment frame specimen; displacements magnified). Note: Δ = vertical displacement. 1 in. = 25.4 mm.

Figure 10 shows the displacement profile of the beams at selected values of the center column vertical displacement Δ . The displacement profile is largely symmetrical up to the ultimate load at Δ equal to 5.66 in. (144 mm), but

some asymmetry is evident after the ultimate load, with larger displacements on the left side of the center column than on the right side. This asymmetry resulted from the anchorage bar fractures on the lower left side of the center column. Measured rotations at the beam ends differed from the calculated beam chord rotation by about 0.20 degrees at most. This implies that the beams essentially rotated as rigid bodies, with most of the deformations localized at the beam-to-column connections.

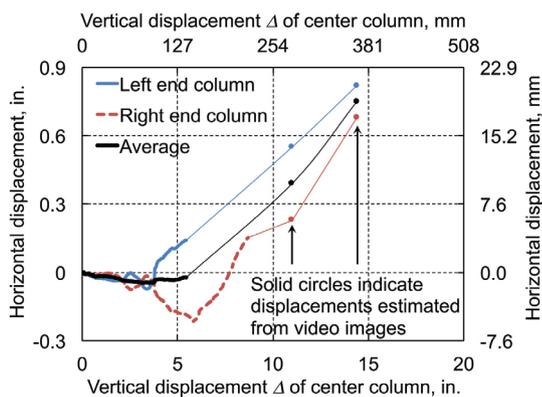
Figure 11. Horizontal displacement of end columns at beam midheight (ordinary moment frame specimen).

Figure 11 shows the horizontal displacement of the end columns at beam midheight, with positive values signifying outward displacement, plotted against the vertical displacement of the center column. The average of the two measurements, which cancels out rigid-body motions, is also plotted for comparison. Initially, both end columns displaced slightly inward, reaching an average inward displacement of 0.044 in. (1.1 mm) prior to the onset of arching action. After the onset of arching action at Δ equal to 4.0 in. (100 mm) (point D in Fig. 6), both end columns displaced to the left by about 0.17 in. (4.4 mm), indicating a slight rigid-body rotation of the end columns, which were linked at their tops by brace beams (Fig. 4). During this rigid-body rotation, the average inward displacement decreased slightly as a result of arching action.

After fracture of the anchorage bars at Δ equal to 5.66 in. (144 mm) (point E in Fig. 6), the motion of the right column changed directions and both end columns moved outward. The measured displacement from both gauges froze at an outward displacement of about 0.15 in. (3.8 mm) and did not provide meaningful data after this point. Horizontal displacements after this point were estimated from video images, with an estimated uncertainty of ± 0.1 in. (± 2.5 mm) determined by comparing displacements obtained from the video images with those measured by the displacement gauges. The displacements estimated from the video images are shown as solid circles in Fig. 16 and indicate that both end columns continued to displace outward as a result of arching action. An average outward displacement of 0.75 in. (19 mm) was estimated at Δ equal to 14.4 in. (366 mm), which corresponds to point H in Fig. 6.

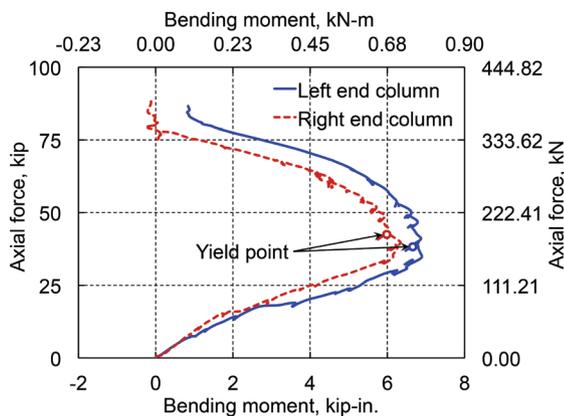
Figure 12. Axial force versus bending moment for upper anchorage bars at end columns (ordinary moment frame specimen). Note: 1 in. = 25.4 mm; 1 kip = 4.448 kN.

Strain gauges were installed in pairs on the front and back sides of anchorage bars near the link plate connections, and these gauges enabled measurements of the bending that resulted from connection eccentricities (Fig. 9). At link plates subjected to tension, this bending was evidenced through tensile strains that were larger on the front of the bar than on the back (strain profile in Fig. 9). **Figure 12** presents an interaction diagram of axial force versus bending moment in the upper anchorage bars at the end columns. These axial force and bending moment values were calculated

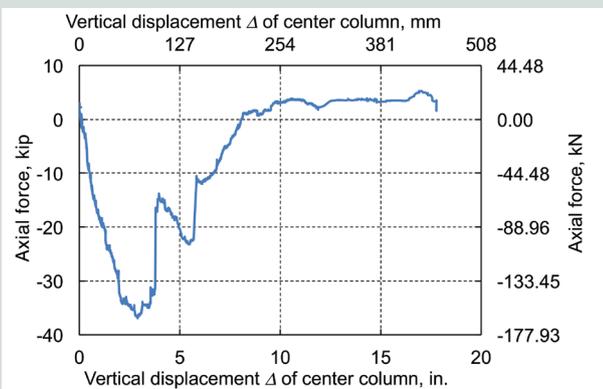
Figure 13. Axial force in front brace beam (ordinary moment frame specimen). Note: 1 kip = 4.448 kN.

Figure 13 shows the axial force in the front brace beam spanning between the tops of the end columns, which was obtained from the average measured axial strain at mid-span of the brace beam. Compressive forces developed

in the brace beam initially when the end columns moved inward at beam midheight (Fig. 11) and as negative moments in the beams tended to rotate the tops of the end columns inward. A drop in the compressive force at Δ equal to 3.7 in. (94 mm) corresponded to detachment of the upper column plate from the left end column, and a second drop at Δ equal to 5.7 in. (145 mm) corresponded to anchorage bar fracture. Tensile forces subsequently developed in the brace as the tops of the end columns were pushed outward by arching action.

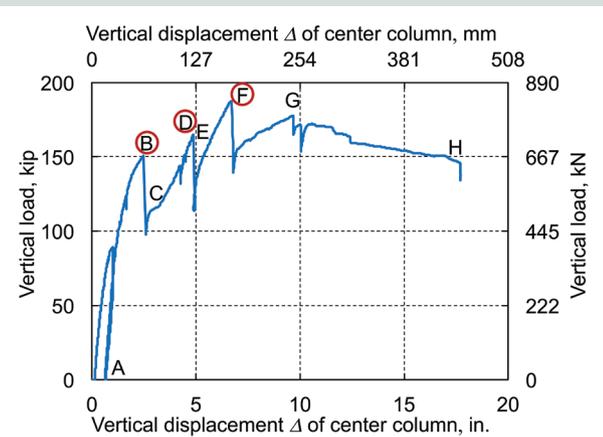
Figure 14. Applied vertical load versus vertical displacement of center column for special moment frame specimen. Note: Labeled points B, D, and F correspond to images in Fig. 15.

Figure 14 shows a plot of the applied vertical load versus the vertical displacement of the center column for the special moment frame specimen. **Figure 15** illustrates the progression of damage corresponding to circled labels in Fig. 14. The specimen was initially loaded to 89 kip (390 kN) and then unloaded to confirm that the instrumentation, data acquisition, and loading systems were working properly. During the initial phase of loading, some limited damage occurred, including concrete cracking on the right beam near the link plates. After unloading, the center column had a residual vertical displacement Δ of 0.65 in. (17 mm), corresponding to point A in Fig. 14. From this point, the specimen was loaded under monotonically increasing displacement for the remainder of the test.

After reaching an initial peak load of 151 kip (672 kN) at Δ equal to 2.49 in. (63.3 mm) (point B in Fig. 14), the vertical load dropped to 98 kip (435 kN). This drop in load was associated with fracture of a no. 11 (36M) anchorage bar welded to the bottom connecting angle on the left side of the center column (connection detail in Fig. 3). Strain data from the link plates indicated that the bottom anchorage bar fractured first and that the upper two anchorage bars fractured subsequently. The anchorage bars fractured at the end of the flare-bevel-groove weld on the connecting angle (**Fig. 16**).

After the drop in load at point B in Fig. 14, the load increased beyond the initial peak load, reaching a peak of 165 kip (735 kN) at point D before dropping sharply again at Δ equal to 4.88 in. (124 mm). Between points C and D, the specimen developed additional capacity through arching action, with the bottom corner of each beam bearing against the end columns and the top corner of each beam bearing against the center column. The drop in load at point D was associated with the fracture of the two remaining no. 11 (36M) anchorage bars welded to the bottom connecting angle on the left side of the center column. Fracture of these anchorage bars was evidenced by further

After the drop in load at point D in Fig. 14, the load increased again up to point F, reaching an ultimate peak load of 188 kip (836 kN) at Δ equal to 6.69 in. (170 mm). Between points E and F, the specimen continued to develop additional capacity through arching action. The sharp drop in load at point F was associated with bond failure of the upper anchorage bars at the right end column, resulting from the formation of splitting cracks and spalling of the concrete covering the upper anchorage bars near the right end column. Initial surface cracking was previously evident at this location (point E in Fig. 15). Finally, at point F, extensive spalling had occurred and a substantial gap had opened between the right beam and the right end column, providing evidence of bond failure (Fig. 15). A close-

After the drop in load at point F (Fig. 14), the load continued to increase, but with a reduced stiffness, reaching 95% of the ultimate load at point G. A drop in load at point G was associated with diagonal cracking of the left end column below the beam level (Fig. 16). Shear deformation of the left end column commenced at point G and continued throughout the remainder of the test. By the end of the test, both end columns had displaced noticeably outward below the beam level, as a result of arching action, while the tops

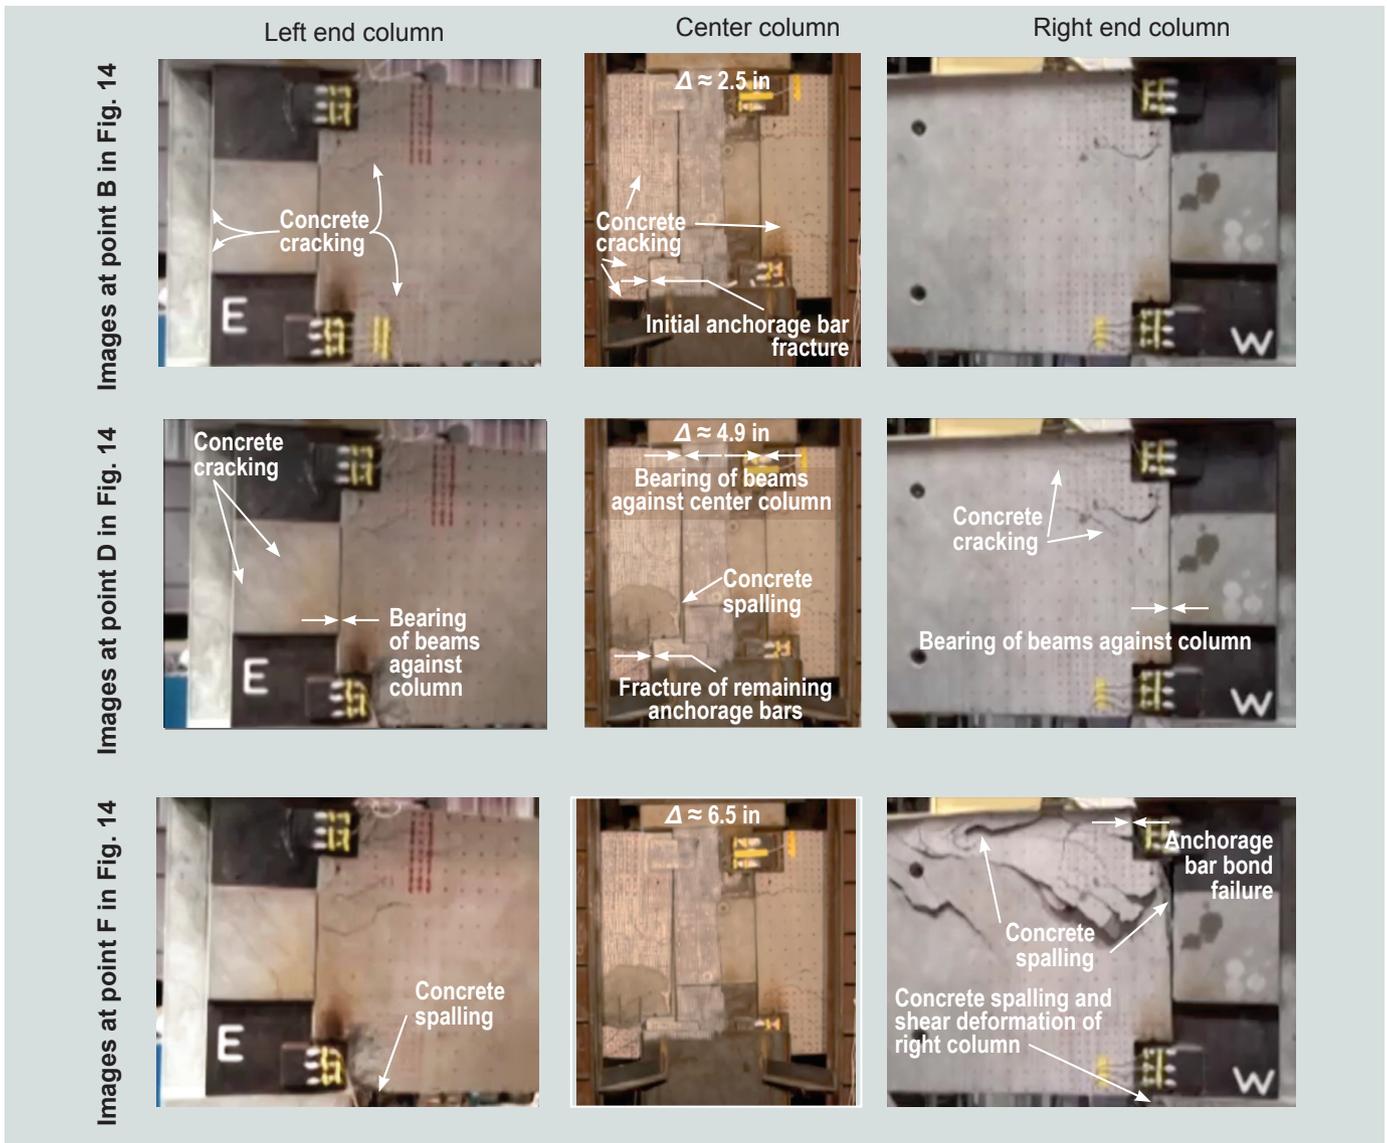
Figure 15. Progression of damage for special moment frame specimen. Note: Images correspond to labeled points in Fig. 14.

increases in the gap between the left beam and the center column, as well as extensive spalling of concrete near the anchorage bars (Fig. 15).

up photograph in Fig. 16 illustrates the splitting failure and concrete spalling that resulted in bond failure at this location. As indicated in Fig. 15, shear deformation of the right end column also commenced with the drop in load at point F accompanied by diagonal cracking and spalling of concrete below the beam level (Fig. 16). Shear deformation of the right end column continued throughout the remainder of the test.

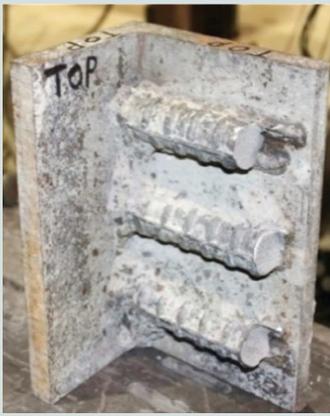
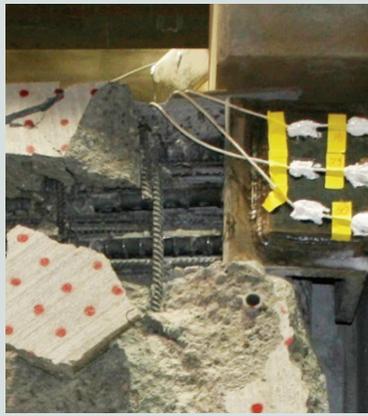
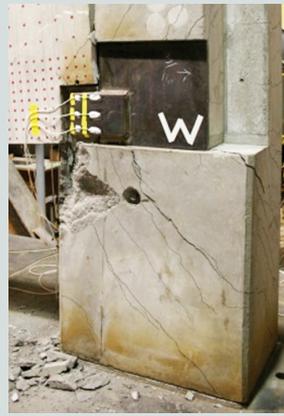
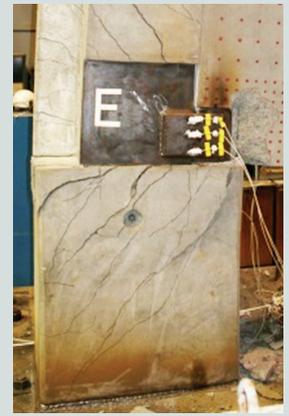
Figure 16. Observed failure modes for special moment frame specimen.

Fractured anchorage bars from lower left connection to center column

Splitting failure and spalling at upper anchorage bars at right end column

Diagonal cracking of right end column

Diagonal cracking of left end column

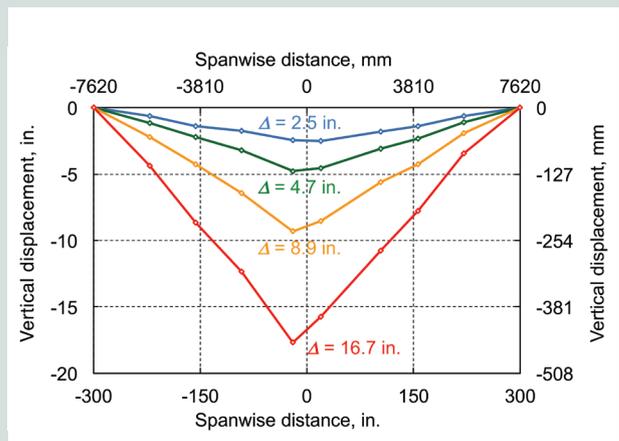
Figure 17. Vertical displacement profile of beams corresponding to indicated center-column displacements (special moment frame specimen; displacements magnified). Note: 1 in. = 25.4 mm.

Figure 17 shows the displacement profile of the beams at selected values of the center-column vertical displacement Δ . The displacement profile is largely symmetrical up to the initial peak load at Δ equal to 2.49 in. (63.3 mm). Some asymmetry is evident after that point, with larger displacements on the left side of the center column than on the right side, as a result of the anchorage bar fractures on the lower left side of the center column. Figure 17 shows that the deflected profile of each beam was approximately linear at each level of loading, indicating that most of the deformations were localized at the beam-to-column connections, with the beams primarily rotating as rigid bodies.

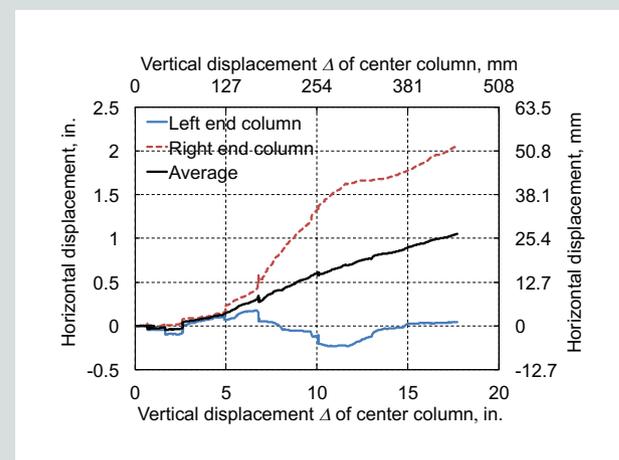
Figure 18. Horizontal displacement of end columns at beam midheight (special moment frame specimen).

Figure 18 shows the horizontal displacement of the end columns at beam midheight, with positive values signifying outward displacement, plotted against the vertical displacement of the center column. Figure 18 also shows the average of the two measurements, which cancels out rigid body motions. Initially, both end columns displaced slightly inward at beam midheight, reaching an average inward displacement of 0.042 in. (1.1 mm) prior to the onset of arching action. After fracture of the anchorage bars at Δ equal to 2.6 in. (66 mm) (point B in Fig. 14), both end columns began to move outward as a result of arching

action in the beams. At Δ equal to 6.7 in. (170 mm), after bond failure of the upper anchorage bars at the right end column, and after shear deformation of the right end column commenced (point F in Figure 14), the motion of the left column changed direction, and both columns moved to the right at beam midheight. The left column reached a peak inward (rightward) displacement of 0.23 in. (5.8 mm) at Δ equal to 11.7 in. (297 mm) before changing direction again and beginning to move outward as a result of cracking and shear deformation of the left column. Although the displacement of the left column changed directions due to rigid-body motions, the average displacement at beam midheight shows a monotonically increasing outward displacement after the onset of arching action, with an average outward displacement of 1.05 in. (26.7 mm) at the end of the test.

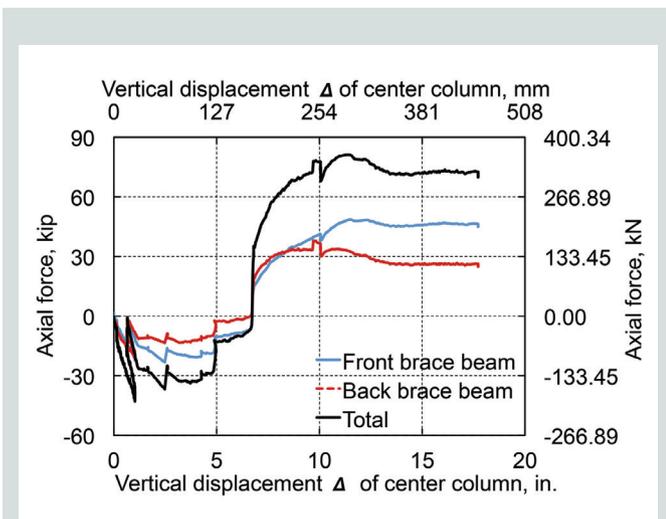
Figure 19. Horizontal displacement of end columns at beam midheight (special moment frame specimen).

Figure 19 shows the axial forces in the brace beams spanning between the tops of the end columns, which were obtained from the average measured axial strains at midspan of the brace beams. Figure 19 also shows the total brace force obtained by summing the axial forces in the two brace beams. Compressive forces developed in the brace beams initially when the end columns moved slightly inward at beam midheight (Fig. 18) and as negative moments in the beams tended to rotate the tops of the end columns inward. Sudden reductions in the compressive force in the brace beams at Δ equal to 2.5 in. (64 mm) and at Δ equal to 4.9 in. (120 mm) corresponded to fracture of the lower anchorage bars on the left side of the center column (Fig. 15). A steep reversal in the sign of the brace beam forces, from compressive to tensile, occurred at Δ equal to 6.7 in. (170 mm), which corresponded to bond failure of the upper anchor-

age bars at the right end column and the onset of shear deformations of the right end column (Fig. 15). The top of the right end column was subsequently forced outward (rightward) by arching action, pulling the top of the left end column rightward as well, and thus developing tensile forces in the brace beams.

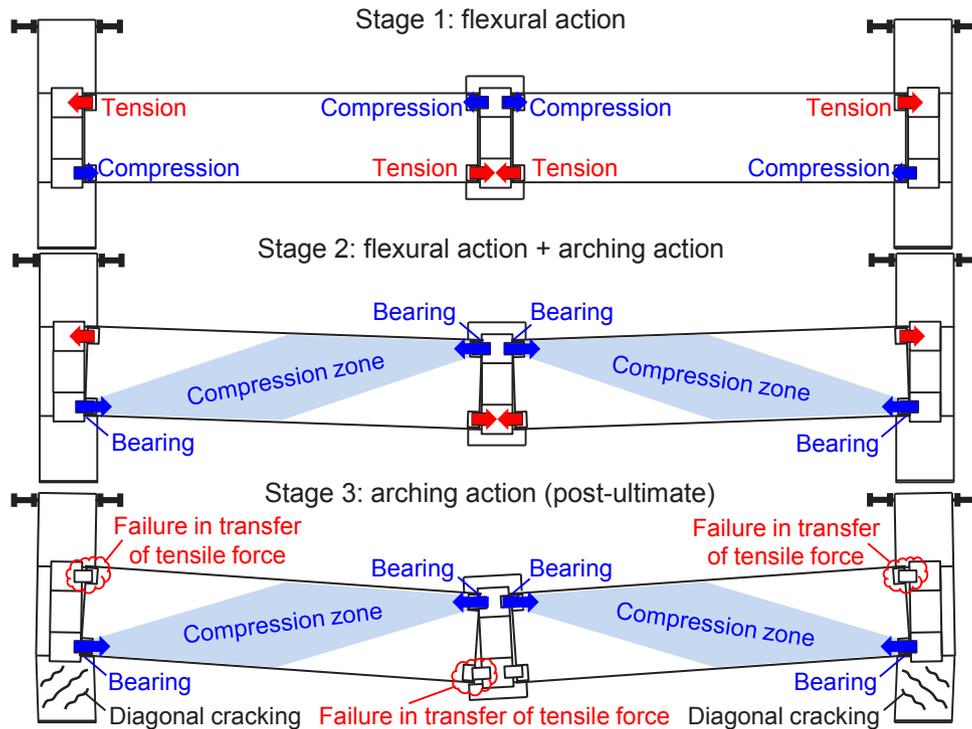
Figure 20. Three stages in the response of the precast concrete specimens.

In the second stage, loads were resisted through a combination of flexural action and arching action. This stage began when deflections and rotations of the beams caused the initial gaps between the beams and columns to close, with the top corners of the beams bearing against the center column and the bottom corners of the beams bearing against the end columns, pushing them outward.

In the third stage, the specimens continued to carry loads through arching action but at a reduced capacity because of multiple failures that reduced the flexural resistance of the beam-to-column connections. Specifically, these failures degraded the capacity for transfer of tensile forces through the link plate connections, both at the upper link plates on the end columns and at the lower link plates on the center column. After the flexural resistance was compromised by these failures in the transfer of tensile forces, diagonal cracks and shear deformations developed in the lower portions of the end columns as continued arching action forced the end columns outward. Catenary action did not
