Flexible filler mock-up injections of bridge post-tensioning tendons

Natassia R. Brenkus, Rahul Bhatia, Will A. Potter, and H. R. Hamilton III

- This paper presents the results of five mock-up injections of post-tensioning tendons with flexible filler material to assess standard grouting procedures for the use of flexible filler materials instead of cementitious products.
- Variables included the injection procedures (pumping equipment, flow rate, injection pressure, inlet/outlet location, and venting), the post-tensioning anchorage system, and the filler material.
- This work influenced the subsequent development of specifications for flexible filler injection procedures.

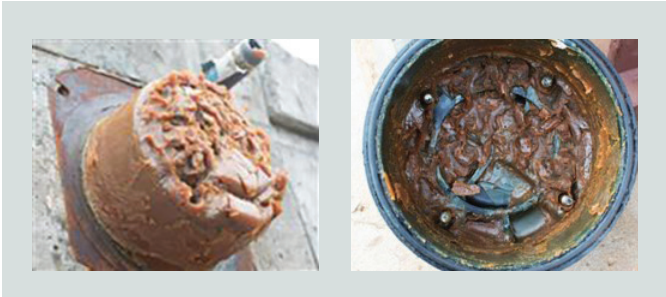
Figure 3. Anchor cap inspection (injection 4).

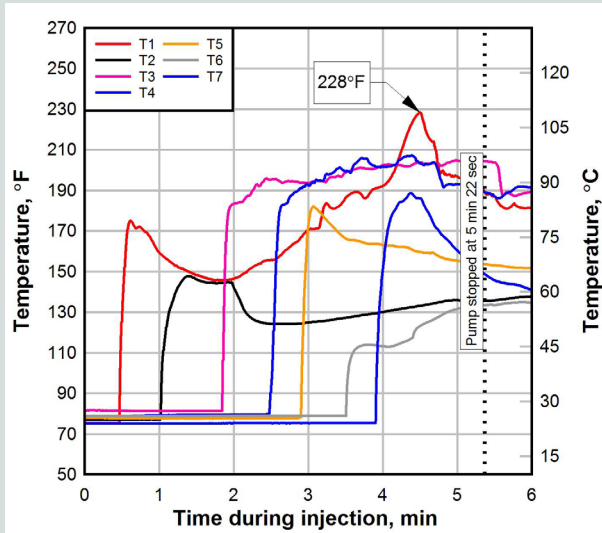
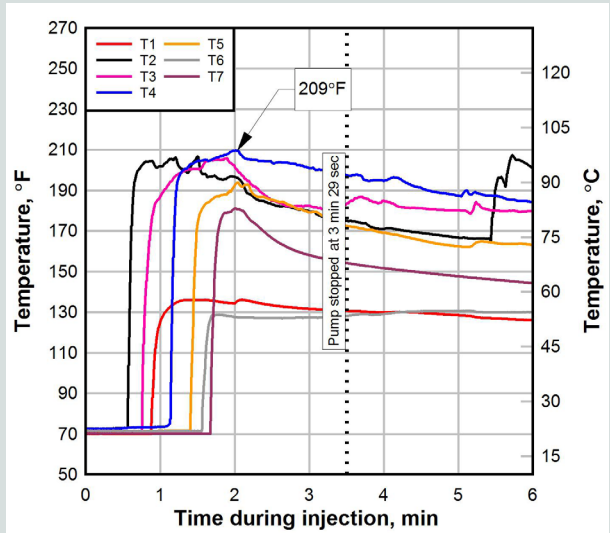
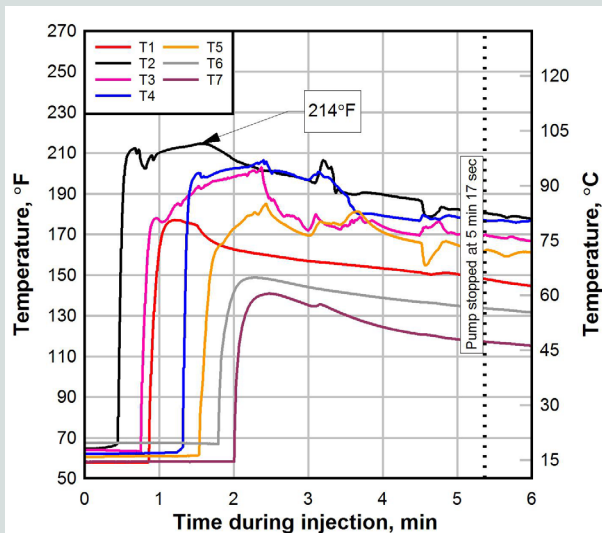
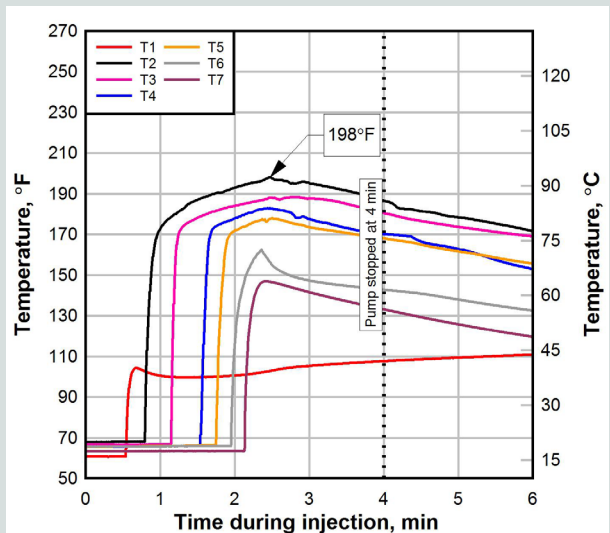
Internal temperature **Figure 6** shows the temperature of the wax inside the duct over time for each of the five specimens. **Figure 2** shows the temperature probe positions. In general, the sudden increases in temperature indicate the times at which the front of the filler reached the instrumentation. For instance, in the injection 1 specimen, which was injected end to end, the filler arrived at the temperature probes in sequential order: T1, T2, T3, T4, T5, T6, and T7. In specimens injected from the low point, the filler flowed in opposing directions, away from the injection point, and the arrival times (as interpreted from the sudden rise in measured temperature) are therefore less intuitive, though similarly revealed.

The peak temperature measured by a particular gauge does not necessarily correspond with the arrival time, suggesting that the flow was turbulent and that the filler material filled the duct unevenly. Gauge T1 from injection 1, for example, was the first location to register increased temperature but did not measure the maximum temperature until after the filler had reached all gauge locations, approximately 4.5 minutes after the injection started. This suggests that although probe T1 (nearest the inlet) experienced a temperature increase at the initial arrival of the hot filler, a backflow of the filler material occurred after the material reached the far probe (T7).

After initial contact with each thermocouple probe, temperatures generally decreased rapidly as the heat was transferred to the prestressing strands. The rate of temperature decrease slowed once equilibrium was attained between the flexible filler and the strands. The measured temperature decrease of subsequent temperature probes illustrates the cooling of the filler along the tendon length. Thermocouples in the parabolic profile (T3 and T4) had a slower rate of temperature decrease and typically settled at a higher temperature than the in other thermocouples. This is attributed to their orientation in the top of the duct at the high point of the profile, clear of the strand bundle. Thermocouples in the straight profile were oriented at 90 degrees from vertical, located near the strand bundle. The proximity of the probe to the strand bundle in these locations accelerated the rate of temperature decrease.

Figure 6. Filler temperature during injection. Note: °C = (°F - 32)/1.8.

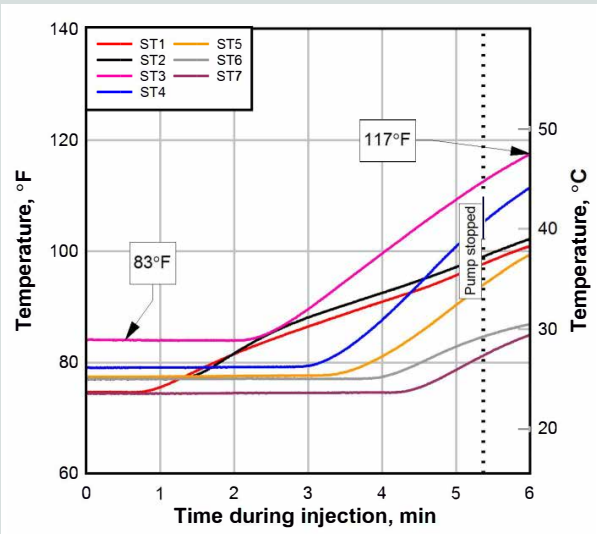
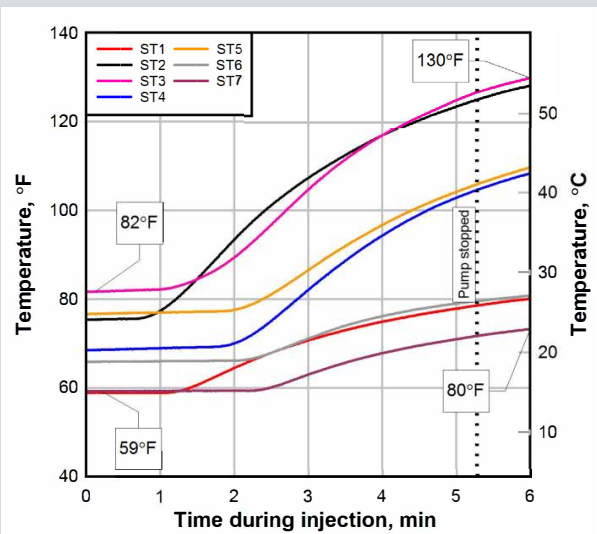
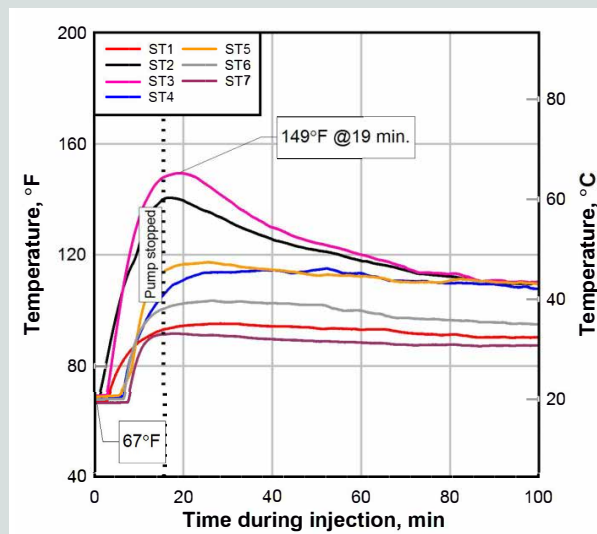
Surface temperature The surface temperature of the HDPE duct was measured at seven locations (**Fig. 7**) and exhibited a similar trend at all measurement locations and for all injections. At the start of the injection, measured

Figure 7. High-density polyethylene surface temperature during injection. Note: °C = (°F - 32)/1.8.

surface temperatures were near the ambient air temperature and immediately started rising as the filler passed the probe. Temperatures plateaued at varying temperatures, depending on the orientation and location of the surface-mounted thermocouples. In general, surface temperatures measured on the bottom of the duct (ST1, ST6, and ST7) were lower than the surface temperatures at other locations. ST3 and ST4 showed the highest temperatures because they were installed at the top of the duct and had the highest elevation among the surface-mounted thermocouples.

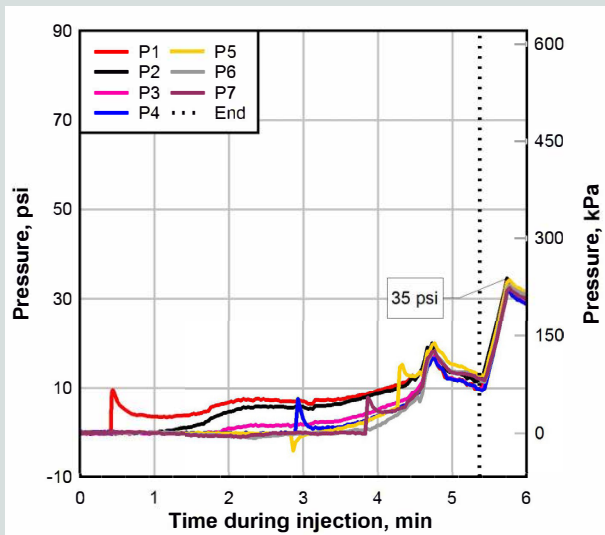
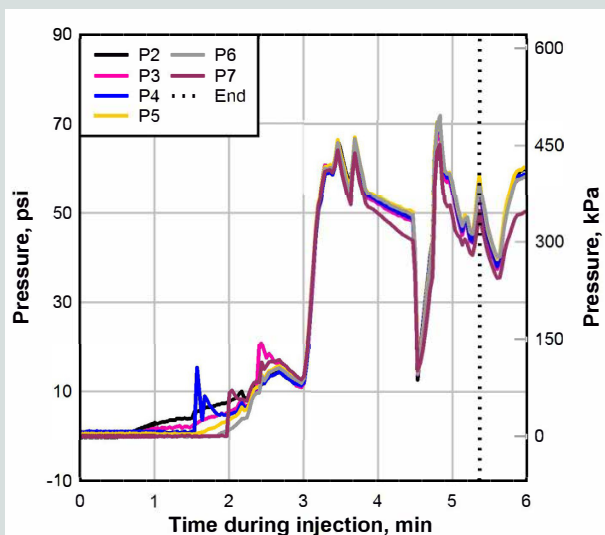
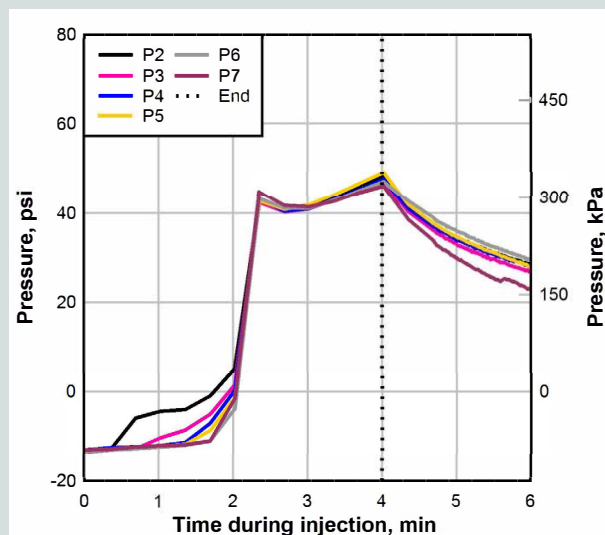
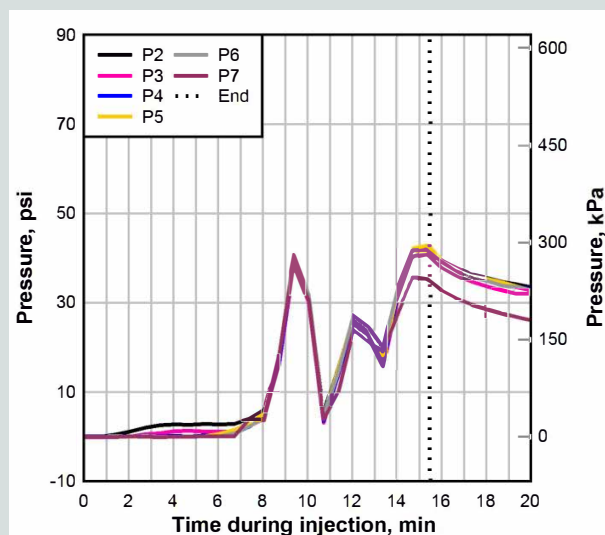
Figure 8. Internal duct pressure during injection. Note: 1 psi = 6.895 kPa.

Pressure The internal pressure of the duct was measured at seven locations (**Fig. 8**). Maximum internal pressure for the duct was limited to 75 psi (520 kPa). The plots indicate that there was little variation in the pressure readings among the individual pressure gauges (P1 through P7 measured approximately the same internal pressure) along the length of the duct during the post-injection hold period.

During injection, the internal duct pressure was 10 to 20 psi (70 to 140 kPa) for injection 1 (using the hopper-fed grout pump) and 40 to 70 psi (280 to 480 kPa) for injections 2 through 5 (using the centrifugal pump). These differences were attributed to the pumping equipment, selected injection point, and pumping and venting technique, not to the filler material or post-tensioning hardware.

Similarly, the duct hold pressure varied. The hold pressure was 34 psi (230 kPa) for injection 1 and 40 to 50 psi (280 to 340 kPa) for injections 2 through 5, again due to variation in technique and equipment. Gauge P1 malfunctioned during injections 2 through 5.

Figure 8 illustrates the internal duct pressure during injection 4, which was accomplished with vacuum assist. The plot also indicates pressure buildup in the tendon once the filler crossed the P7 location. During injection, the vacuum in the tendon was -13.5 psi (93.1 kPa) and the hold pressure was approximately 45 psi (310 kPa).
