Experimental testing of older AASHTO Type II bridge girders with corrosion damage at the ends

Cameron D. Murray, Brittany N. Cranor, Royce W. Floyd, and Jin-Song Pei

PCI Journal (ISSN 0887-9672) V. 64, No. 1, January–February 2019.

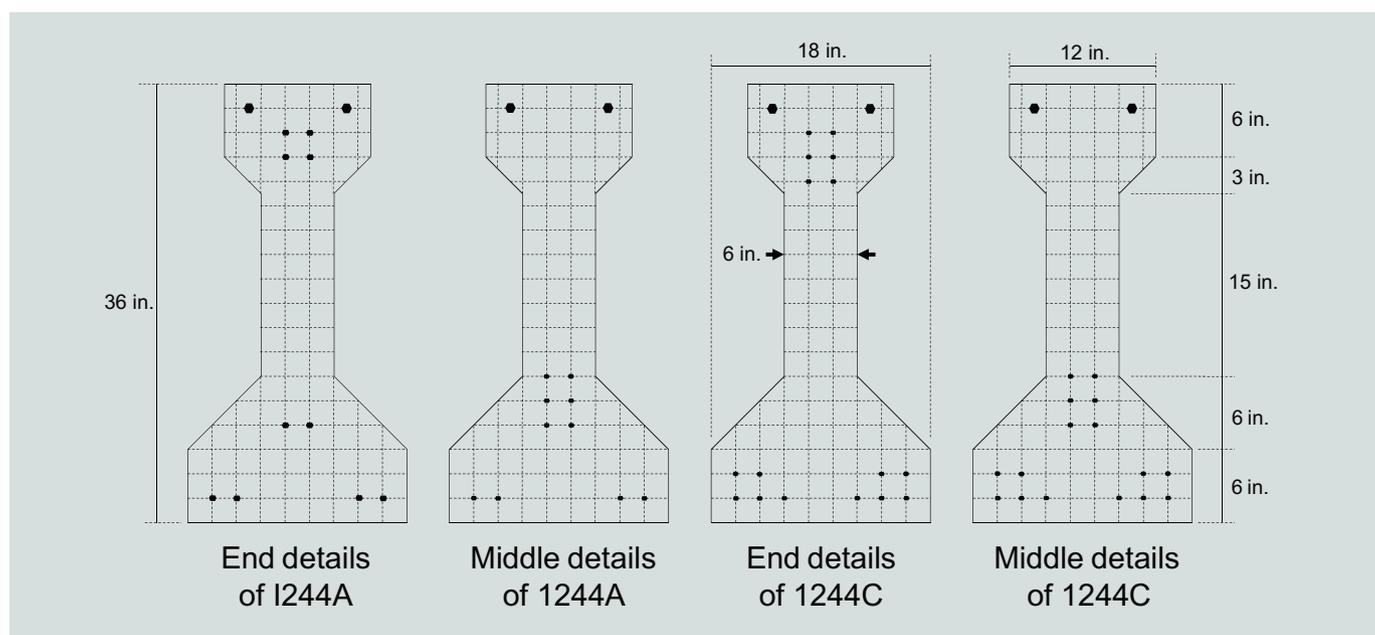
Figure 1. Details of I244A and I244C with an overlaid 2 in. (50 mm) grid to show the dimensions more clearly. Note: 1 in. = 25.4 mm.

Figures 1 and 2 show the cross sections of the girders as designed and the delivered sections including the deck, respectively. Both girders had a 6.5 in. (160 mm) thick original deck with a 2 in. (50 mm) concrete deck overlay.

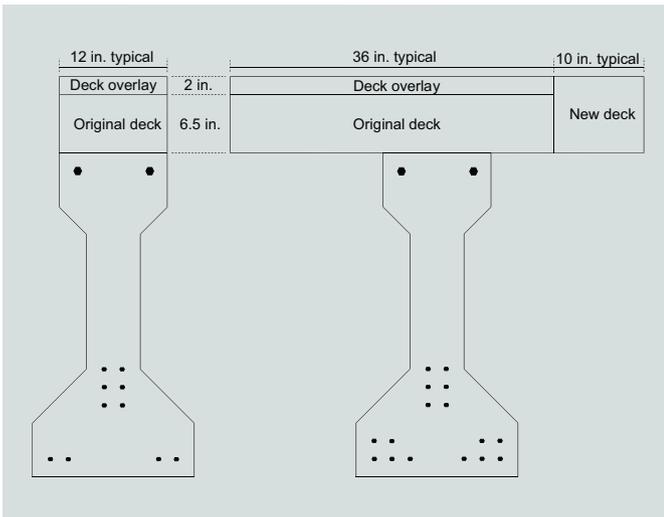
Figure 2. Deck details as tested for I244A (left) and I244C (right). Note: 1 in. = 25.4 mm.

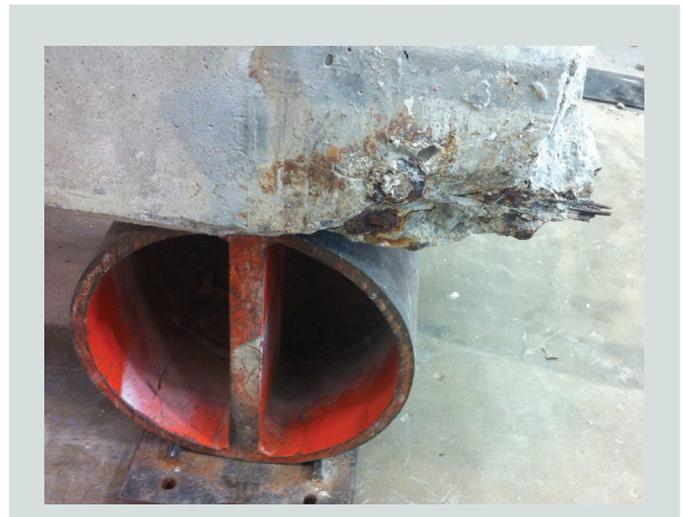
Figure 3. Corrosion at tested end for test A1.

The two girders each had mild to moderate corrosion damage at one end. **Figure 3** shows the worst example of the damage (on I244A), with exposed strands and visible section loss. I244C did not have such significant corrosion in terms of visible deterioration of the strands, but some initial cracking around the strands was present due to corrosion. The opposite end of each girder had relatively little corrosion. Samples of the most corroded strands were removed from the I244A girder after testing was completed. Evidence of corrosion (for example, rust and pitting) was visible on these strand samples for up to 8 in. (200 mm) from the strand end. Strand samples were not removed from I244C because this girder was slated for repair and rehabilitation as part of an associated project, but strands exposed by spalling during testing exhibited visible corrosion extending a similar distance into the beam.

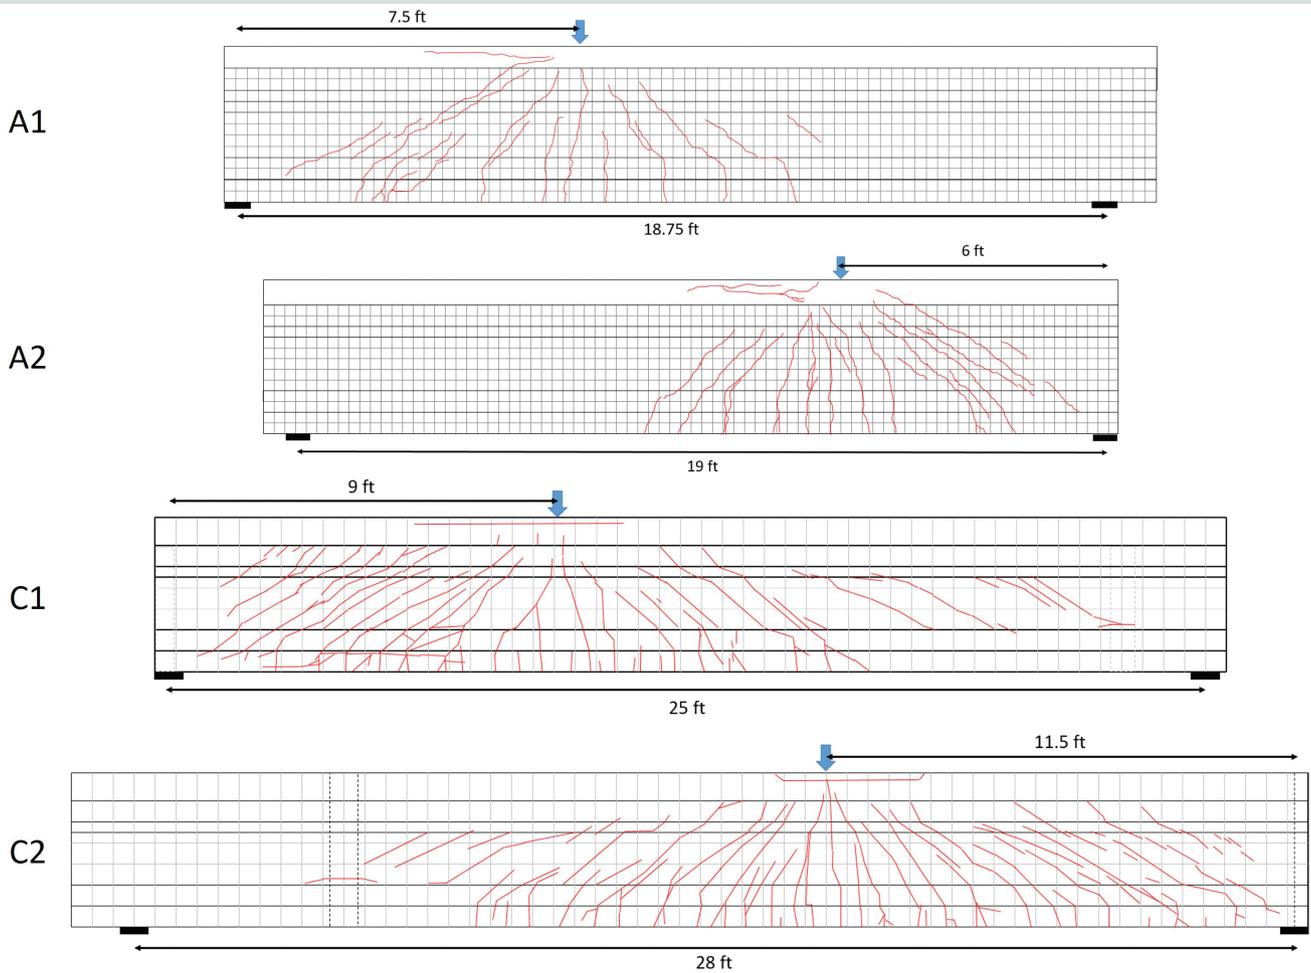
Figure 4. Cracking patterns for all tests: 3 in. (75 mm) grid shown for A1 and A2, and 6 in. (150 mm) grid shown for C1 and C2. Note: 1 ft = 0.305 m.

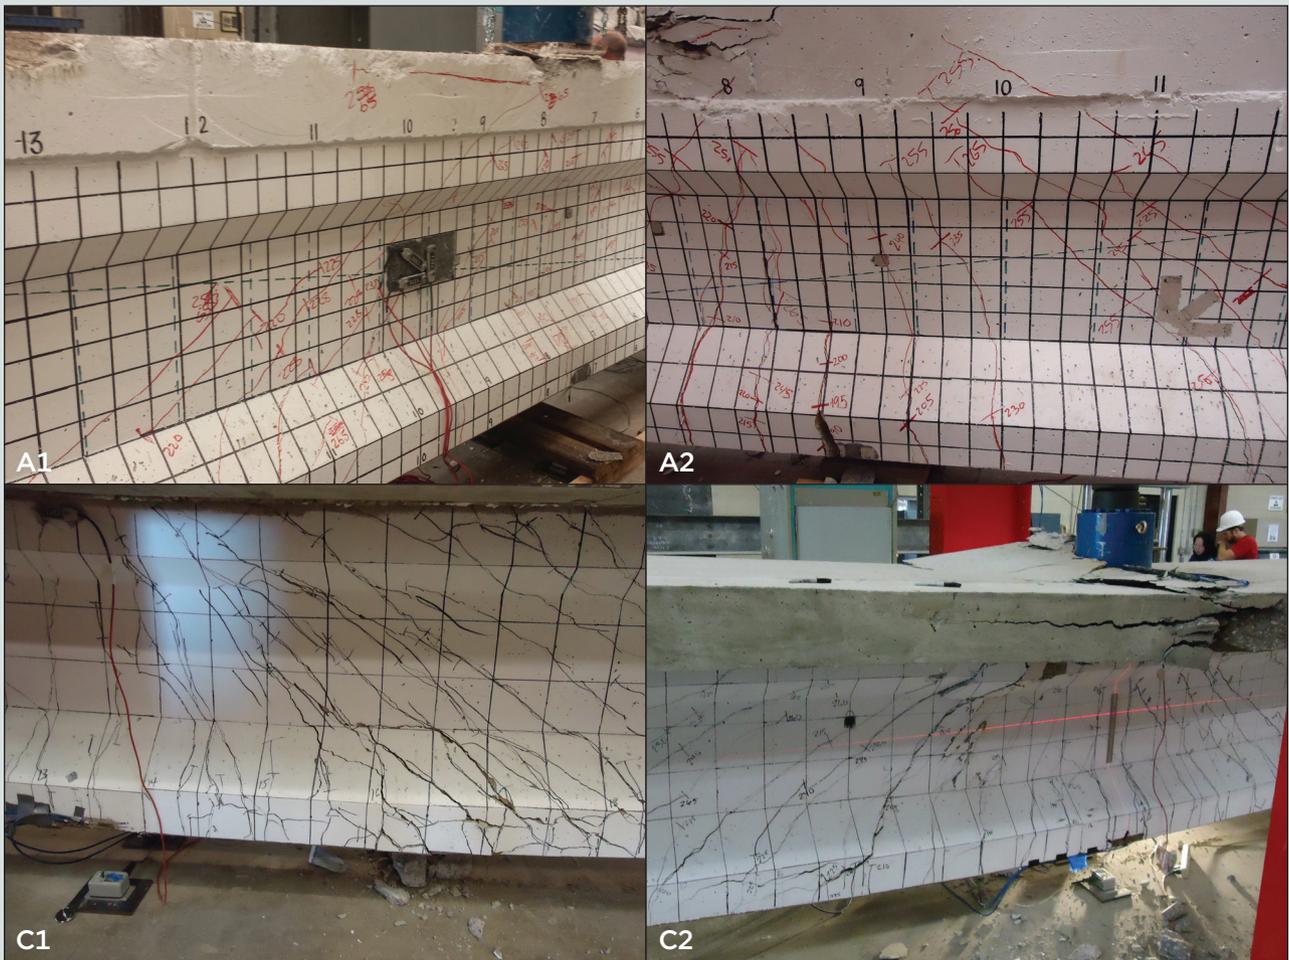
Figure 5. Failure photos from each test.

The first test of I244A (A1) was performed at an *a/d* of 2.5 with a span length of 18.75 ft (5.72 m). Initial cracking, which was due to flexure, occurred at an applied shear of 104 kip (463 kN) directly under the load point (applied moment = 753 kip-ft [1021 kN-m]). The first shear crack was a web-shear crack 4.5 ft (1.44 m) away from the load point toward the near support and occurred at an applied shear of 138 kip (614 kN). As the load was increased, several shear cracks began at the bottom flange. At an applied shear of 157 kip (698 kN), the bottom four strands slipped, leading to a loss of load-carrying capacity. Slip was measured for six of the strands before failure, which was possibly influenced by the corrosion (Fig. 3) present at the girder end. Shear was increased to a maximum of 160 kip (712 kN), at which point the deck overlay delaminated. The cracking pattern for this test is shown in Fig. 4. Initial flexure cracking occurred near the load point. Flexure-shear and web-shear cracks occurred between the load point and near support (Fig. 4). The failure mode for test A1 can be characterized as bond shear/flexure because strand slip reduced the capacity of the section and ultimately led to a shear failure that included flange crushing.¹⁶ Because *a/d* was less than 3.0, a bond-shear failure was expected based on work by Ross, Ansley, and Hamilton.⁹ The strand slip reduced the available tie force and contributed to the shear-cracking and shear-failure mechanism. The deflection measurements for test A1 were lost due to a malfunction of the wire potentiometers, so load-versus-deflection data were not available for this test. Figure 5 shows a photo of the failure.

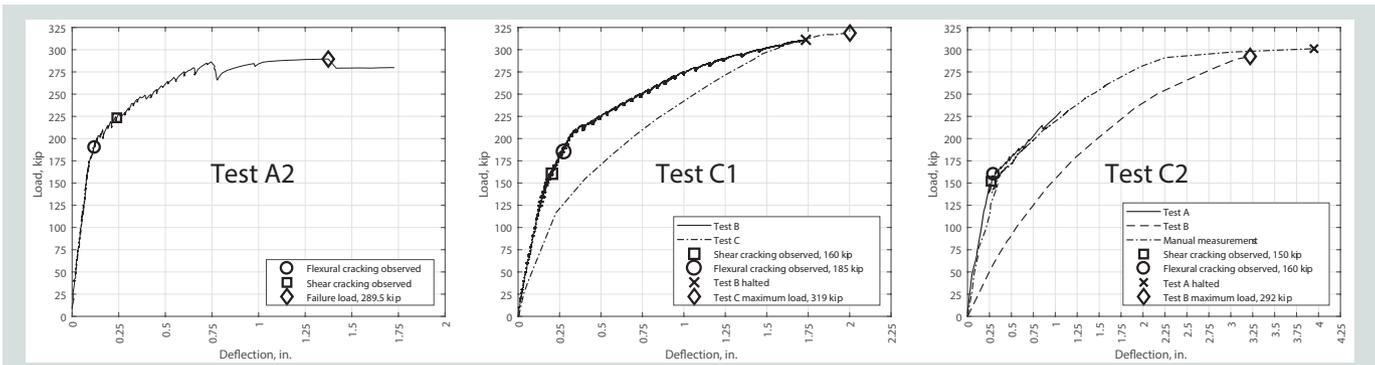
Figure 6. Deflection versus load for tests A2, C1, and C2. Note: 1 in. = 25.4 mm; 1 kip = 4.448 kN.

the compression flange followed by a compression failure. This failure type is common for this *a/d*.⁹ Figure 6 shows the load-deflection curves for both iterations of test C2 (tests A and B). The wire potentiometers began to yield unreliable data at a load of approximately 230 kip (1023 kN) during test A, so manual measurements are shown instead of the potentiometer data past this point. After initial cracking, there was an increase in deflection of 3.75 in. (95.3 mm) and many additional cracks appeared, indicating some ductility. Some strand slip was measured in four of the bottom strands in the girder during this test. Despite this slip, the compression steel in both the deck and top flange buckled at failure.

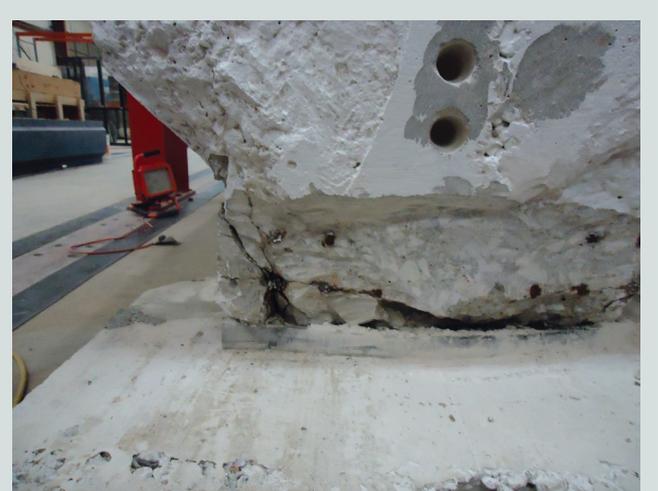
Figure 7. Spalling under load during test C1 initiated by cracking caused by corrosion.

sion-induced cracks at this end to open and for concrete to spall off of the bottom flange (**Fig. 7**). At this point, the test had to be stopped so the LVDTs on the strands at that end of the girder could be repositioned. When the test was resumed, spalling mostly ceased and web-shear cracks were observed at an applied shear of 101 kip (449 kN) at the web-top flange interface. Flexural cracking under the load was observed at a shear of 117 kip (520 kN).

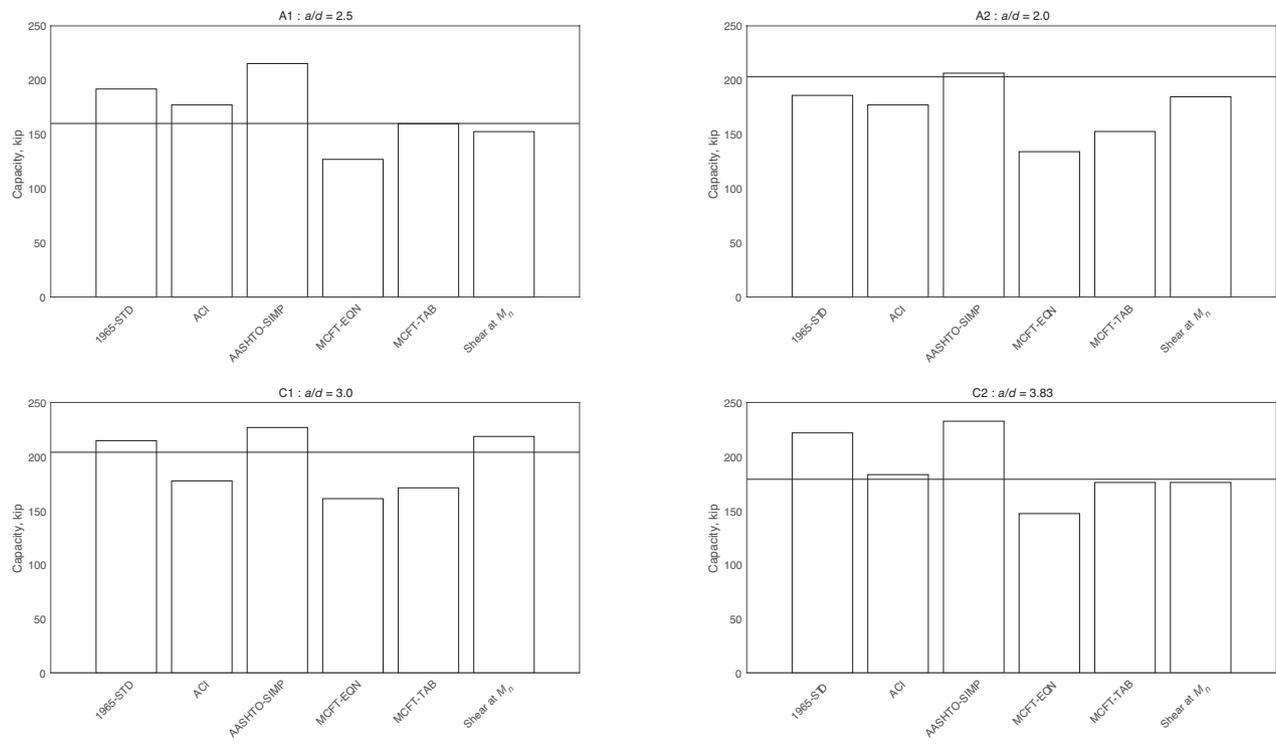
Figure 8. Calculated design capacity compared with experimental shear capacity. Note: a/d = shear span-to-depth ratio; M_n = nominal moment capacity. 1 kip = 4.448 kN.

Figure 8 shows that the experimental shear capacity was generally greater than the capacity calculated by the MCFT-EQN and MCFT-TAB methods at each location tested. In the case of the MCFT-EQN method, the experimental capacity was greater than the predicted capacity by a factor

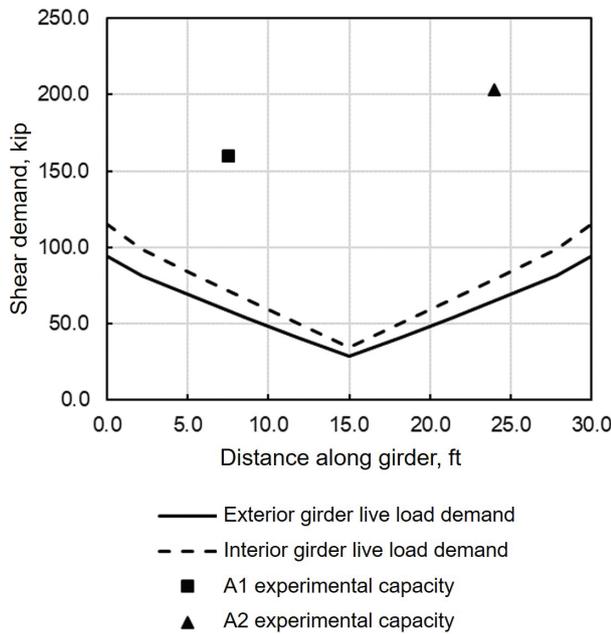
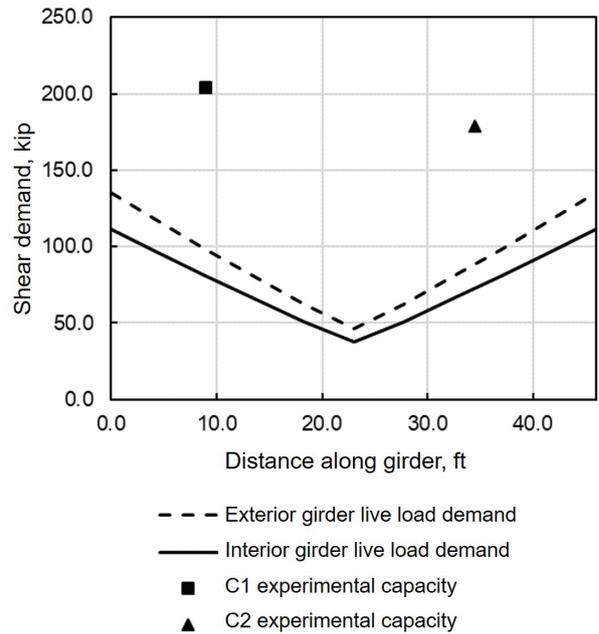
Figure 9. Experimental capacities compared with factored live load shear demand for I244A (left) and I244C (right). Note: 1 ft = 0.305 m; 1 kip = 4.448 kN.
