## Environmentally friendly bridge design stands up to location challenges

The new \$252 million, 2.8 mi (4.5 km) long Marc Basnight Bridge along the North Carolina coast, winner of a Sustainable Design Award as part of PCI's 2020 Design Awards, spans a channel with treacherous currents, constantly shifting depths, and high winds, making it one of the most dangerous channels along the Atlantic Coast.

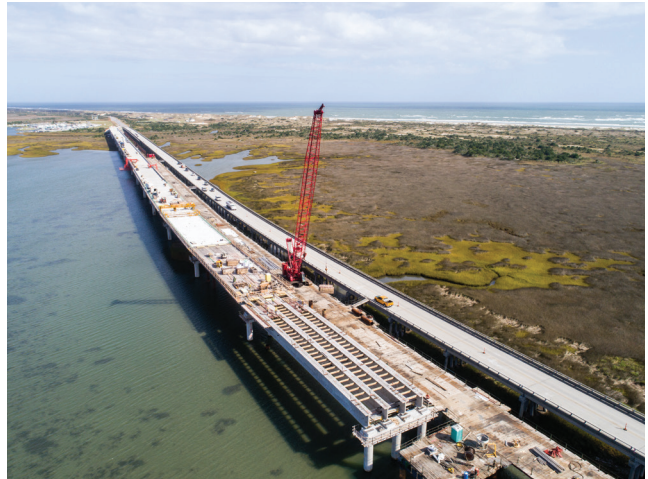
To withstand the saltwater environment, stand up to hurricane winds, protect vulnerable species, and achieve a 100-year service life, the Marc Basnight Bridge in North Carolina was constructed with precast concrete. Photo courtesy of HDR Inc.: © 2019.

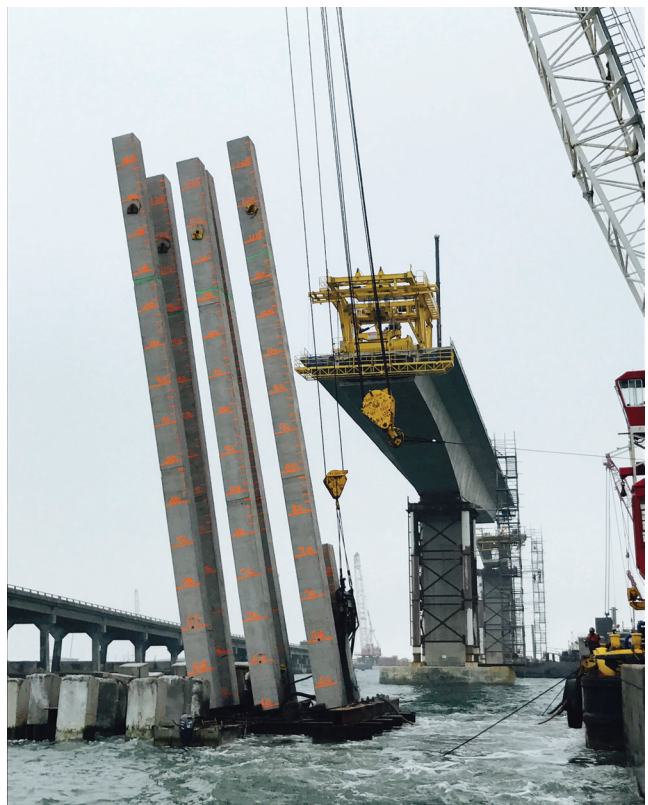
Construction of the Marc Basnight Bridge in North Carolina was a dangerous feat with treacherous currents, constantly shifting depths, and high winds. Photo courtesy of HDR Inc.: © 2019.

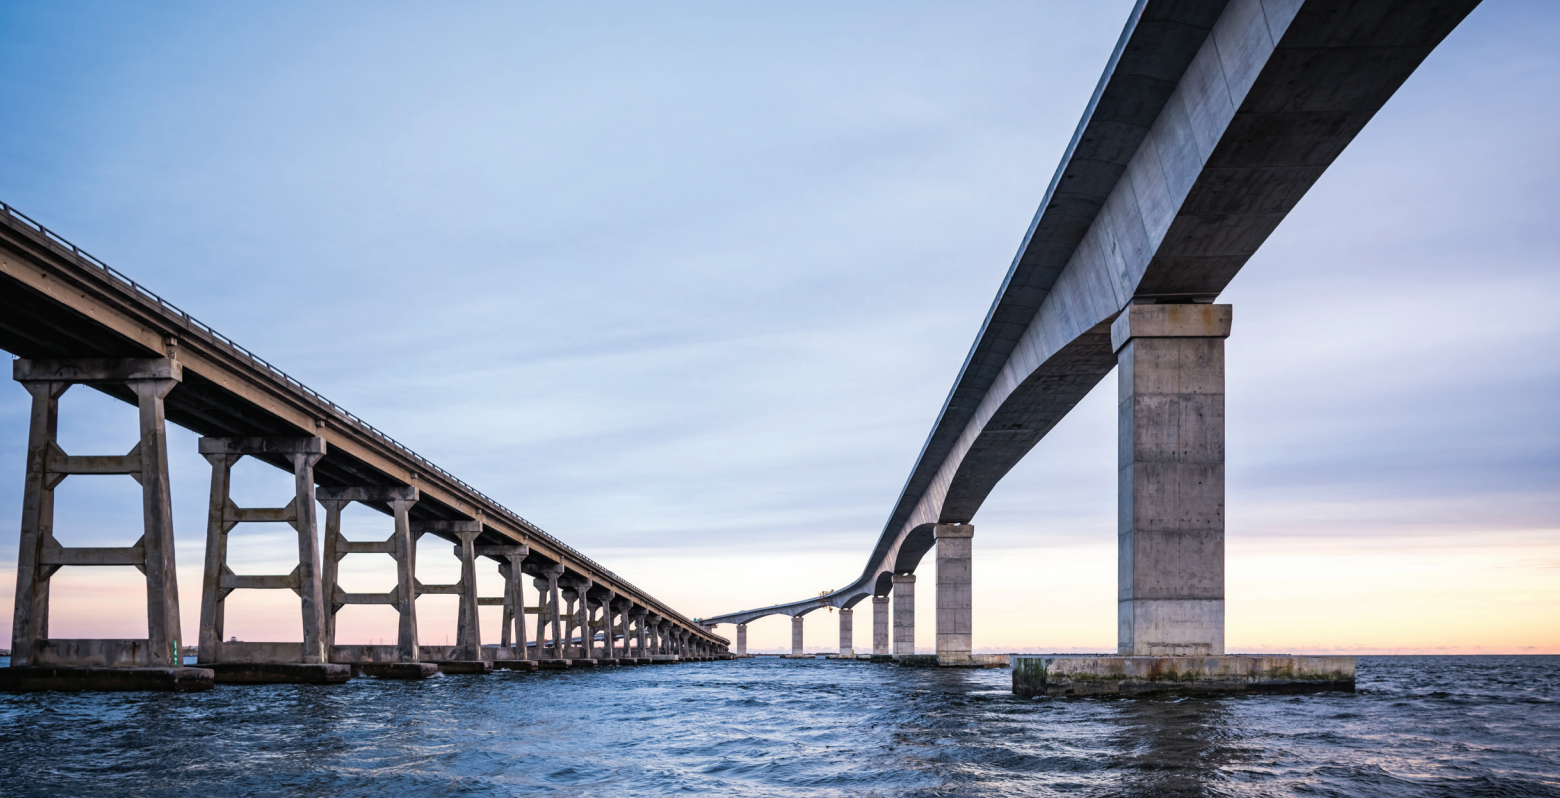
The Marc Basnight Bridge, right, along the North Carolina coast won a 2020 PCI Sustainable Design Award. It replaces the Bonner Bridge, left, which opened in 1963, and most of which will be demolished. Photo courtesy of HDR Inc.: © 2019.
