Live-load distribution of an adjacent box-beam bridge: Influence of bridge deck

Ryan T. Whelchel, Christopher S. Williams, and Robert J. Frosch

PCI Journal (ISSN 0887-9672) V. 66, No. 6, November–December 2021.

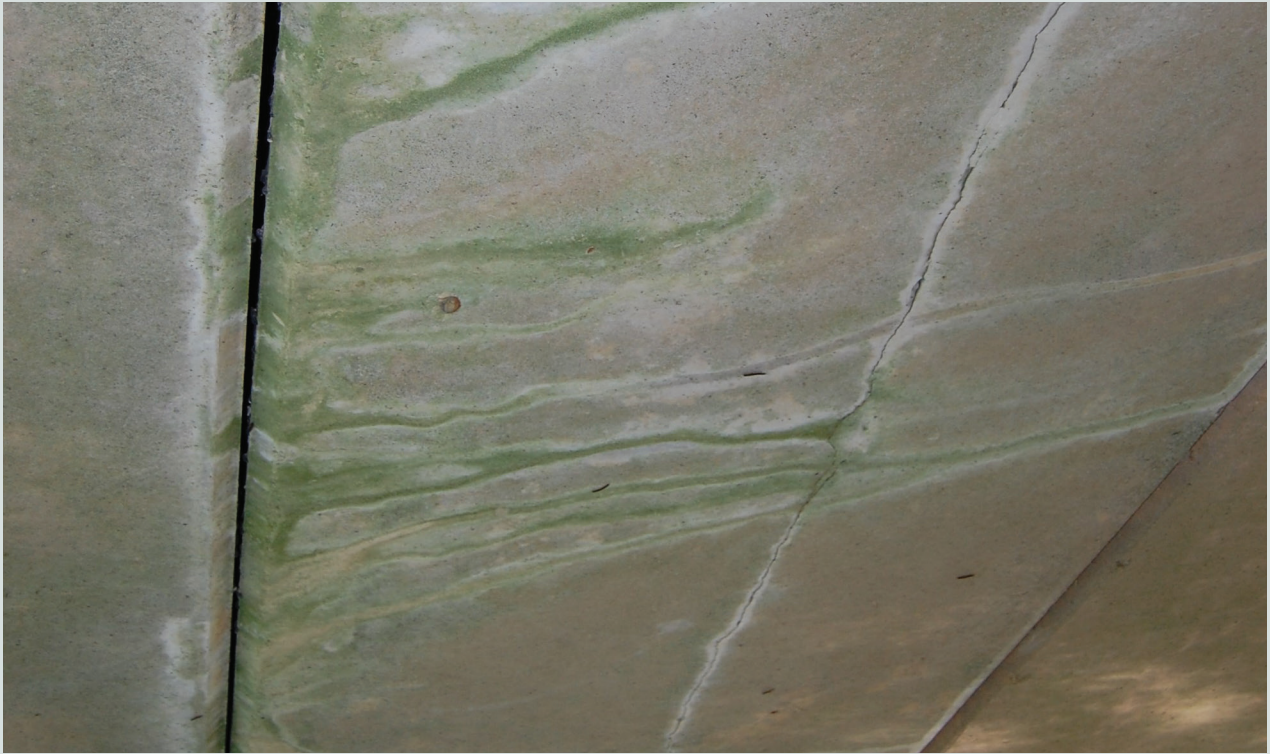
Figure 1. Leaking joint of an adjacent box-beam bridge.

Leaking longitudinal joints are commonly observed in adjacent box-beam bridges and are often associated with an assumed loss of load distribution at the leaking joint. Evidence of a leaking joint (Fig. 1) or the presence of a reflective crack in the deck calls into question the condition of the shear key and the capacity of the shear key to transfer load between beams. The position of shear keys within an adjacent box-beam bridge makes visual inspection impossible, and there is no standard nondestructive inspection method to evaluate the condition of the shear key. In the absence of a dependable inspection, load-rating engineers may assume that there is no load distribution where signs of shear key deterioration are observed.

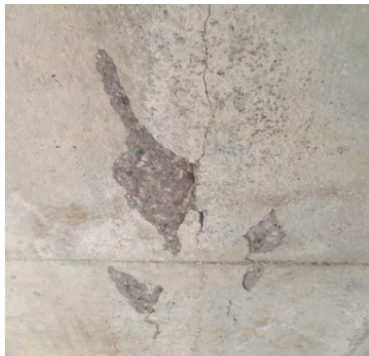
Longitudinal cracking and minor concrete spalling in west end of beam 7

The condition of the existing bridge was investigated prior to testing and is documented in Fig. 3. Investigators found evidence of water leaking through the shear keys between every beam, with the exception of the joint between beams 4 and 5 (Fig. 3). The investigation also revealed deterioration on beams 1 and 7. Minor longitudinal cracking and concrete spalling were observed on the west end of beam 7 (Fig. 4), and the investigators assumed that these conditions had a negligible effect on the flexural strength of the beam. Beam 1 had two rust-stained longitudinal cracks approximately 5 ft (1.5 m) long, located at midspan (Fig. 4) and three exposed strands at the east support (Fig. 4).

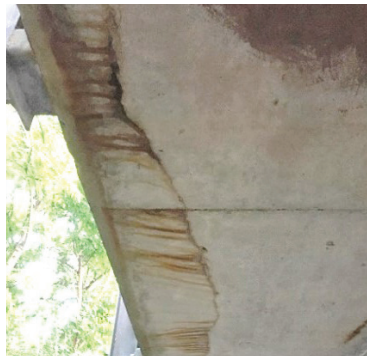
Rust-stained longitudinal crack on south side of beam 1

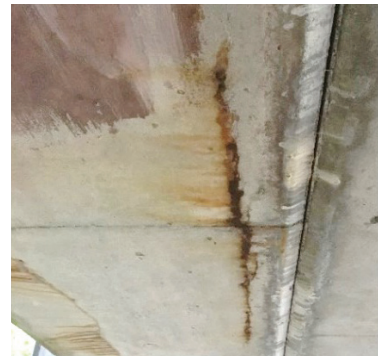
Rust-stained longitudinal crack on north side of beam 1

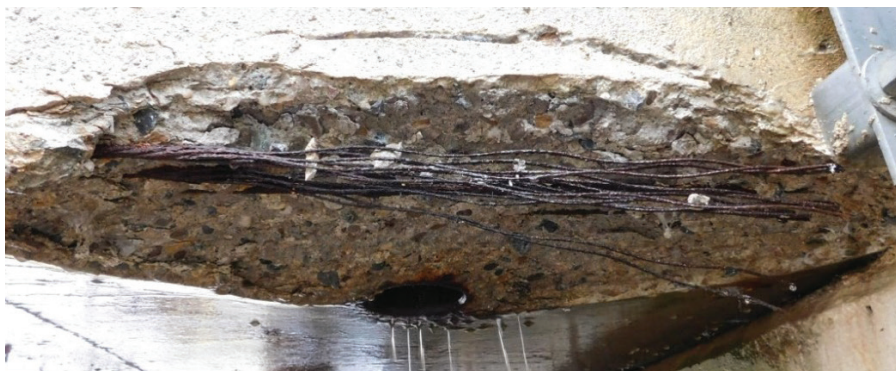
Three exposed strands at east support of beam 1

Figure 4. Bridge deterioration.

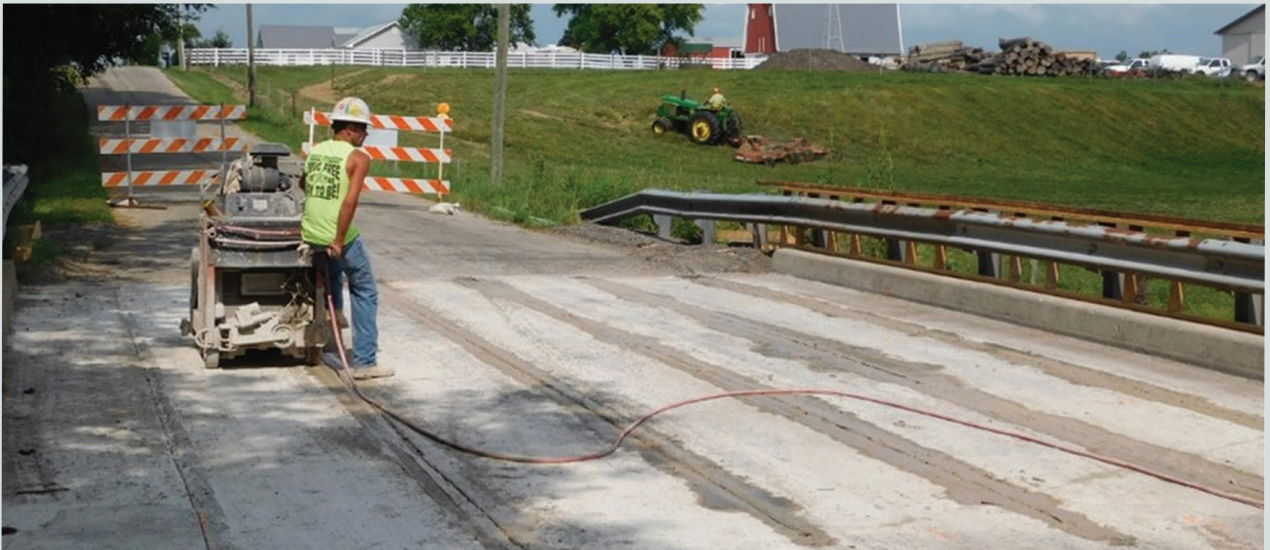
Figure 7. Shear key-cutting operation.

A pavement saw, cutting to a depth of 12 in. (305 mm), was used to cut through the entire depth of the shear keys (**Fig. 7**). The third load test (LT3) was performed to verify that the

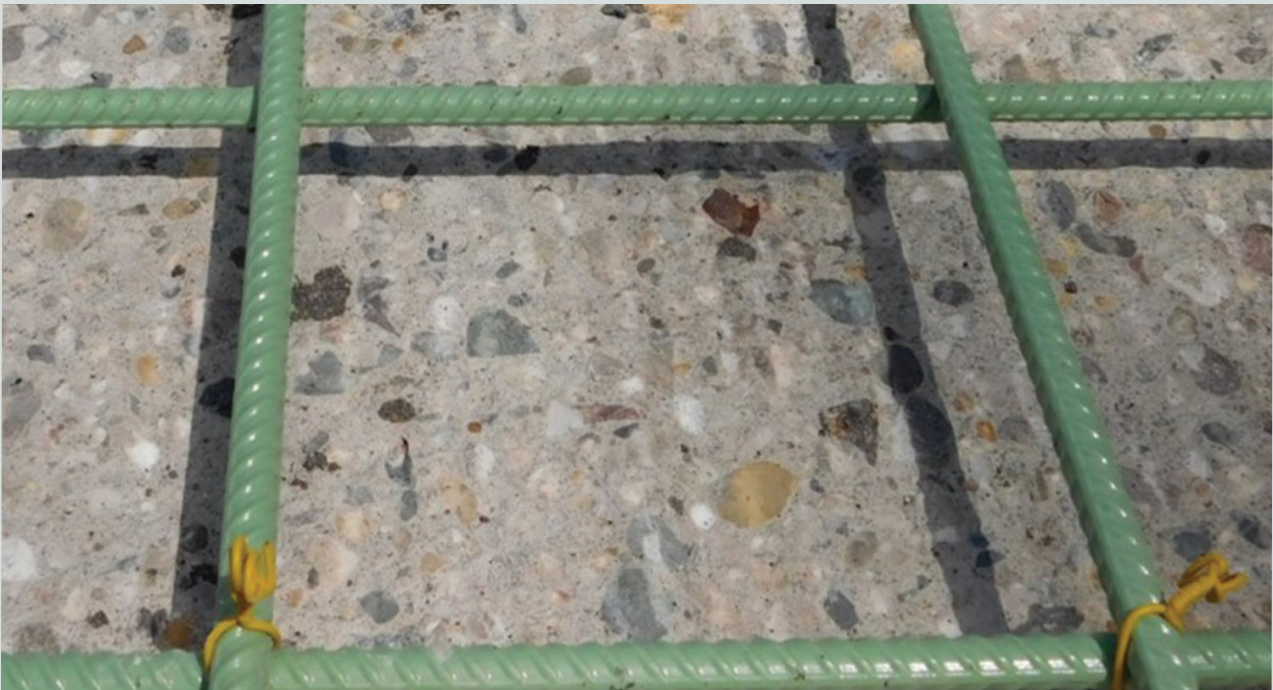
Figure 8. Sandblasted box-beam surface.

The surface of each box beam was prepared by sandblasting (Fig. 8) to ensure that an adequate bond between the beams and the deck was achieved. The deck was placed in four sections from south to north (Fig. 6), each requiring one concrete truck. The deck thickness was tapered from the bridge centerline to the curb for water drainage. The thickness of the deck was 7 in. (178 mm) at the bridge centerline and 5 in. (127 mm) at each curb line of the transverse section (1.3% cross slope) (Fig. 5). The cross slope was achieved by using tapered formwork at the bridge ends and

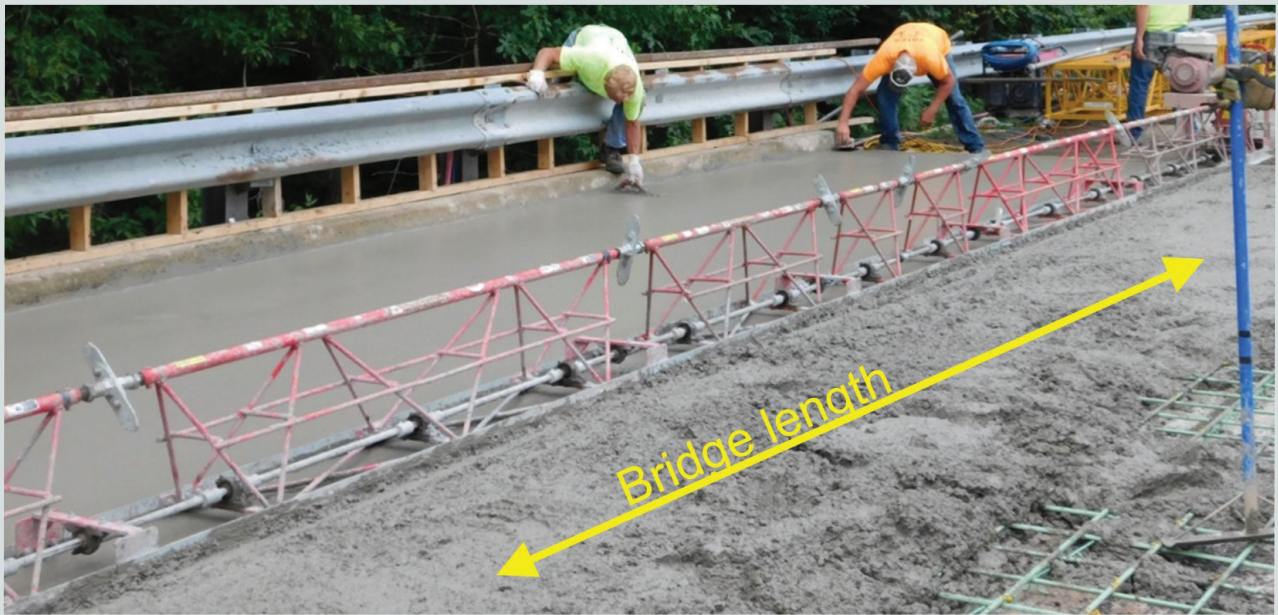
Figure 9. Use of mechanical screed and tapered formwork to construct bridge cross slope.

using a mechanical screed to finish the bridge along the span and across the width (**Fig. 9**). For the final surface finish, the deck was tined after the concrete set. After the surface finish was applied, the deck was covered with wet burlap and plastic for a three-day wet cure.

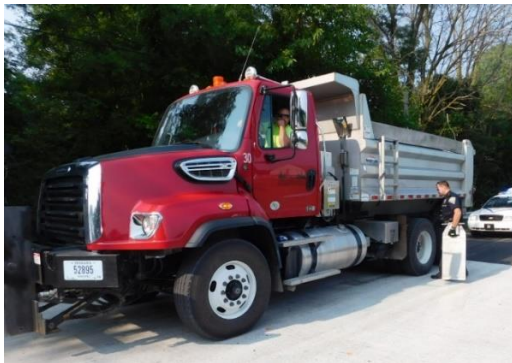
Figure 11. Truck used for load tests and diagram of truck wheel locations. Note: 1 in. = 25.4 mm; 1 ft = 0.305 m.

Each of the four load tests was conducted with the same tri-axle truck loaded with gravel. The weight of the vehicle was measured using portable truck-weigh scales from the Indiana State Police Division of Commercial Vehicles. **Figure 11** includes the wheelbase dimensions and axle labels for the truck, and **Table 2** provides the axle weights for each load

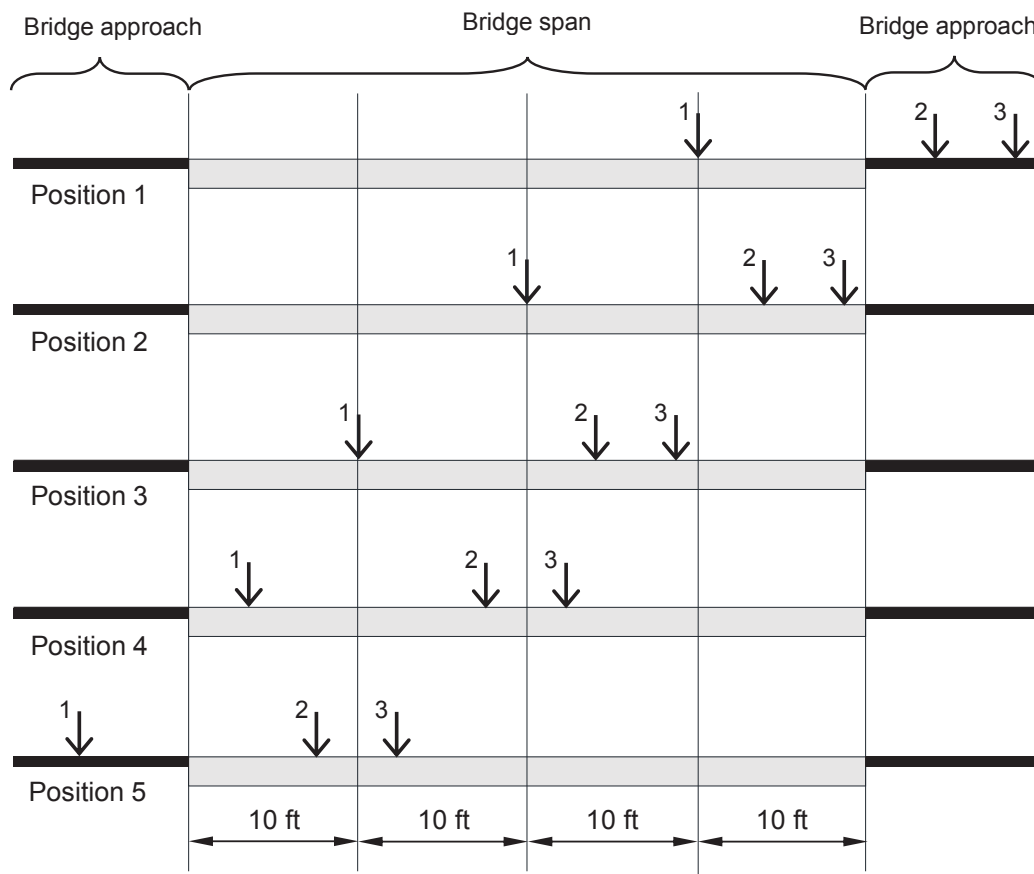
Figure 12. Longitudinal truck positions. Note: Numerical values next to arrows refer to axle labels in Fig. 11. 1 ft = 0.305 m.

A total of 50 load positions—five longitudinal locations along 10 transverse paths—were defined for the bridge. The five positions along the span were selected to approximate the progression of a vehicle crossing the bridge (Fig. 12). The 10 transverse paths traveled by the truck were split into five eastbound paths (paths 1 through 5) and five westbound paths (paths 6 through 10). Figure 13 illustrates the transverse positions of the truck for the 10 paths. The deterioration observed in the site survey and after removal of the bituminous wearing surface prevented some paths from being used for LT1, LT2, and LT3.
