# Investigating UHPC in deck bulb-tee girder connections, part 2: Full-scale experimental testing

Abdullah Haroon, Eric Steinberg, Richard Miller, Bahram Shahrooz, and Waleed Hamid

- This paper, part 2, presents full-scale experimental testing performed as a follow-up to the analytical investigation that appeared in part 1. Longitudinal joints of a deck bulb-tee girder system grouted with ultra-high-performance concrete were tested under thermal and fatigue loading. The longitudinal joint system was also subjected to camber differential between adjacent girders. In addition, a continuity joint composed of conventional concrete and ultra-high-performance concrete was tested for positive and negative moments at the pier.

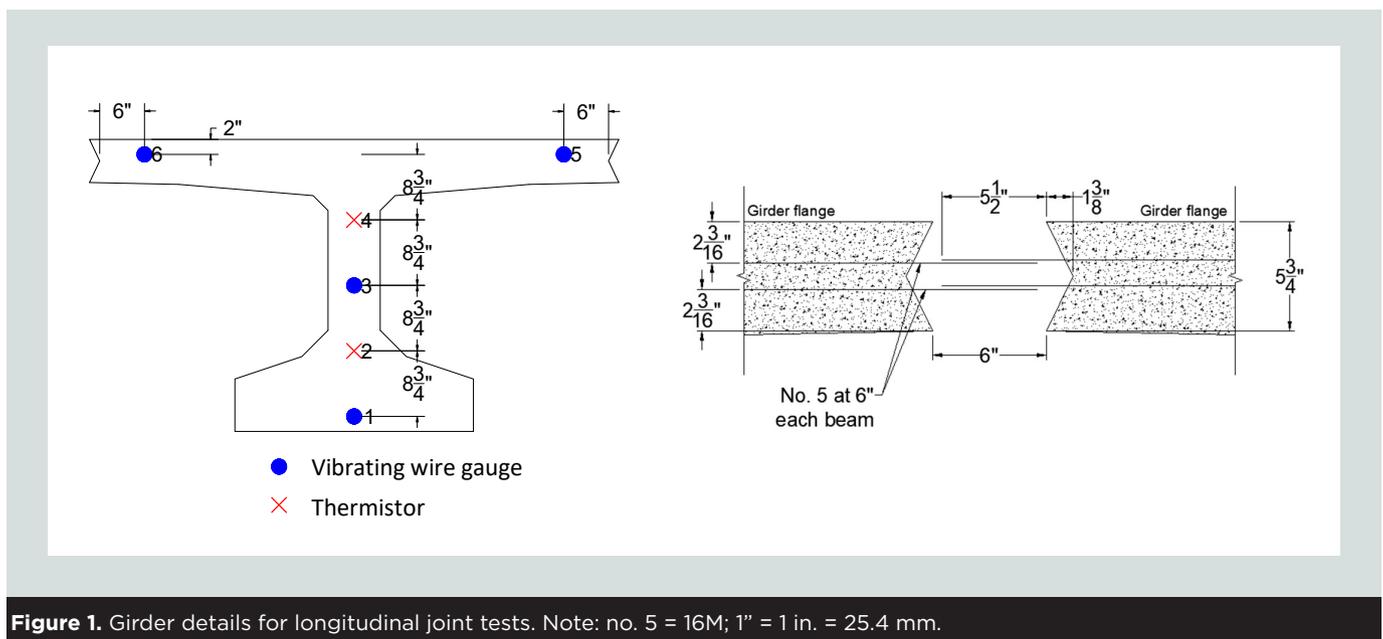
Figure 1. Girder details for longitudinal joint tests. Note: no. 5 = 16M; 1" = 1 in. = 25.4 mm.

The test girders were designed based on the ninth edition of the American Association of State Highway and Transportation Officials' *AASHTO LRFD Bridge Design Specifications*.<sup>15</sup> Figure 1 illustrates the joint reinforcement detail and the locations of the instrumentation embedded in the girder during construction; complete details of the design can be found in the first part of this article series.<sup>14</sup> The precast concrete economical fabrication deck bulb-tee section was used for the girders. Although a typical deck bulb-tee girder span ranges between 90 and 180 ft (27 and 54.9 m), the test girder span was limited to 55 ft (16.8 m) due to limitations on the laboratory testing floor. Most of the bridges in the experiment have skews under 30 degrees. In the analytical modeling, it was found that the bridges with skew have higher forces; therefore, the test girders were designed to have a 30-degree skew angle. The two layers of transverse no. 5 (16M) reinforcing bar

provided in the top flange were doweled 5.5 in. (140 mm) into the joint to constitute the joint reinforcement. The transverse reinforcement spaced at 6 in. (150 mm) in the beam was offset longitudinally to create a 3 in. (76 mm) reinforcement spacing in the joint. The reinforcement doweled into the joint from the flanges was fanned at the skewed ends to allow for placement without interference.

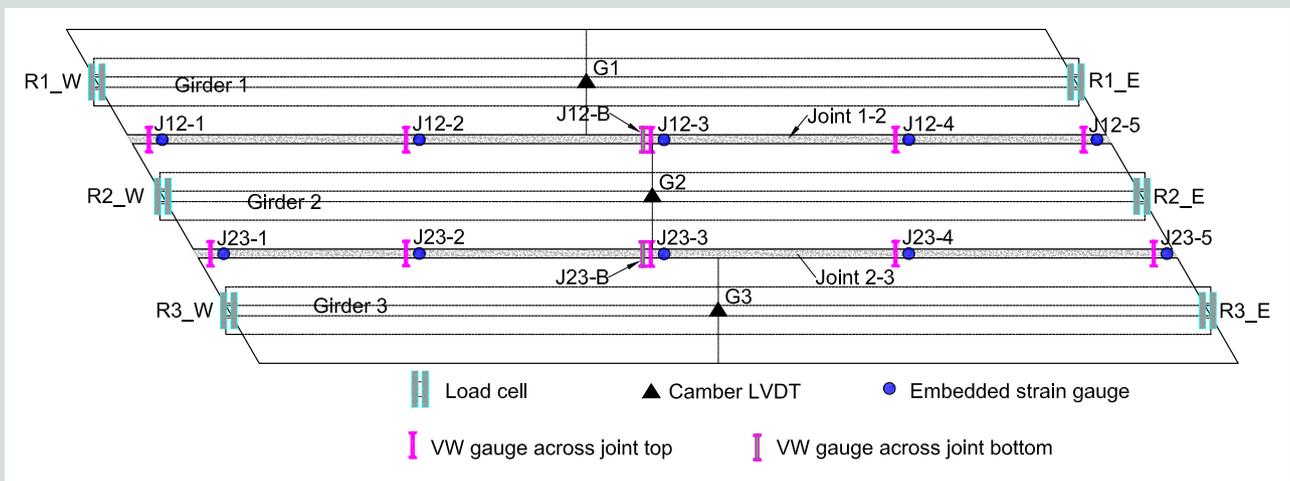
Figure 2. Instrument location and labels for thermal and fatigue testing of longitudinal joints. Note: LVDT = linear variable displacement transducer; VW = vibrating wire.

be used to monitor temperature profiles and measure strains inside the girder. To measure the girder camber during heating and cooling cycles and during live load tests, linear variable displacement transducers were installed at the midspan of each girder. To measure the lateral movement of the joints due to applied temperature load, 12 in. long (300 mm) vibrating-wire strain gauges were attached on the top surface of the girders such that they spanned across the joints. A total of five vibrating-wire strain gauges were installed on each joint. Since the gauges also have an inbuilt thermistor, they were also used to measure the surface temperature of the girders. A 12 in. long vibrating-wire strain gauge that spanned across the bottom of the joint was also installed at midspan of each joint. To measure the strains in the joints after UHPC was placed, strain gauges were attached to the joint reinforcement bars. Upon placement of the UHPC into the joints, these strain gauges were embedded into the joints and then used to measure the strain in the joints as well as any slip of the reinforcement. The layout of these gauges is shown in Fig. 2.

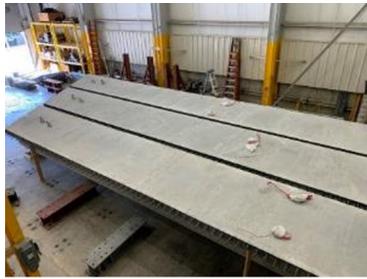
Test girders on laboratory floor

**Figure 3.** Test setup for thermal and fatigue load test for longitudinal joints. Note: AASHTO = American Association of State Highway and Transportation Officials,  $T_1$  = thermal gradient between girder surface and 16 in. depth;  $T_2$  = thermal gradient between 4 and 16 in. depths. 1 in. = 25.4 mm;  $^{\circ}F = 1.8(^{\circ}C)$ .

Figure 3 shows the girder assembly on the laboratory floor. To apply the temperature load, a temperature gradient along the girder depth was to be developed. For this purpose, a closed environmental chamber or “insulated box” was built on top of the girder deck. This methodology was adapted from a paper by Shi et al.<sup>16</sup> A wooden frame was constructed on top of the girders and then covered with 2 in. thick (51 mm) expanded polystyrene foam sheets. The top view of the completed insulated box is shown in Fig. 3. Eighteen 250-watt heat lamps, eight high-capacity heaters, and six circulation fans were installed inside the insulated box. The heat lamps, heaters, and fans were uniformly distributed inside the insulated box and were regulated to generate thermal gradient in the girders.

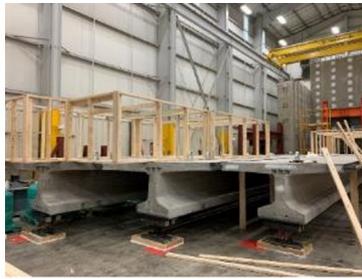
Construction of wooden framing for insulation box

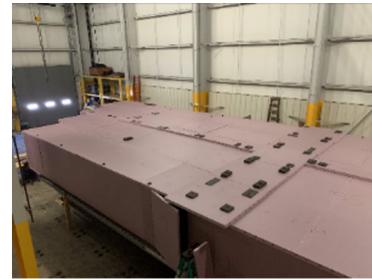
Top view of the completed insulation box

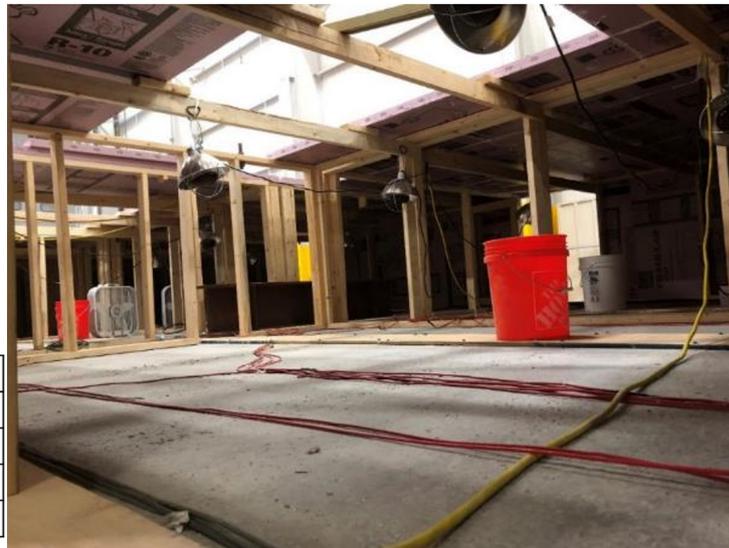
Inside view of the insulation box

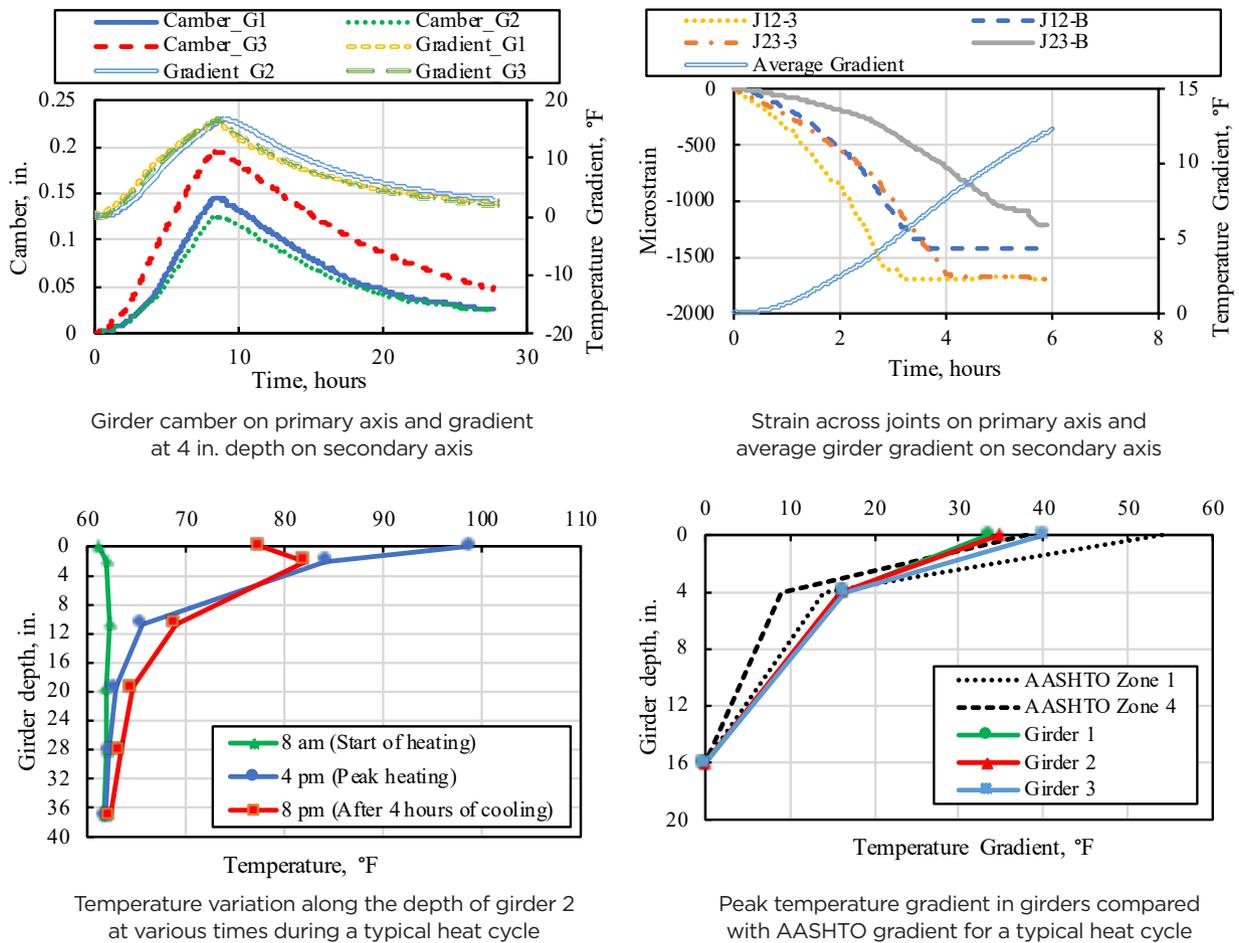
**Figure 4.** Thermal testing of the girder system with open joints before grouting the joints with ultra-high-performance concrete. Note: AASHTO = American Association of State Highway and Transportation Officials. 1 in. = 25.4 mm; °F = 1.8(°C).

**Figure 4** shows the camber of the girders alongside the gradient at a depth of 4 in. (100 mm) during a typical heating cycle. As expected, all the girders cambered up with an increase in the girder temperature gradient and cambered down as the girders cooled. Girders 1 and 2 had almost the same maximum camber of approximately 0.13 in. (3.3 mm), whereas the maximum camber for girder 3 was about 0.2 in. (5 mm). This variation in the cambers of the girders was expected given the concrete variability. Figure 4 shows the strain across the tops and bottoms of the joints alongside the average girder temperature gradient before grouting. Both the tops and bottoms of the joints showed a compressive strain as the girder temperature gradient, indicating that the girder flanges were expanding and the joint was closing. The tops of the joint (gauges J12-3 and J23-3) developed higher compressive strain than the bottoms of the joint (gauges J12-B and J23-B).

Figure 4 shows the temperature profiles through the depth of girder 2 at various times during a typical heat cycle. At the start of heating, the temperature was almost uniform

throughout the girder depth. It took around 8 hours to reach the heating peak (defined by a 14°F [8°C] gradient at a 4 in. [100 mm] depth); at that point, the surface temperature was around 100°F (37.8°C) and the temperature at a depth of 20 in. (510 mm) was almost same as at the beginning of the heating cycle. After 4 hours of cooling, the surface temperature dropped faster than the temperature inside the girder flange. Also, the girder web became slightly warmer than it was at the peak heating.

Figure 4 compares the girder temperature gradient with the gradient band recommended in the AASHTO LRFD specifications. The gradient at 4 in. (100 mm) depth  $T_2$  was in the range of 15°F (8°C) to 16.5°F (9°C) for the three girders. This temperature gradient is above the recommended value of 14°F (8°C) for  $T_2$  in the most extreme AASHTO zone 1 condition. The temperature gradient at the surface of the girders  $T_1$  was between 33°F (18°C) and 40°F (22°C), which was slightly below the range of 38°F (21°C) to 54°F (30°C) recommended in the AASHTO LRFD specifications. However, as discussed,

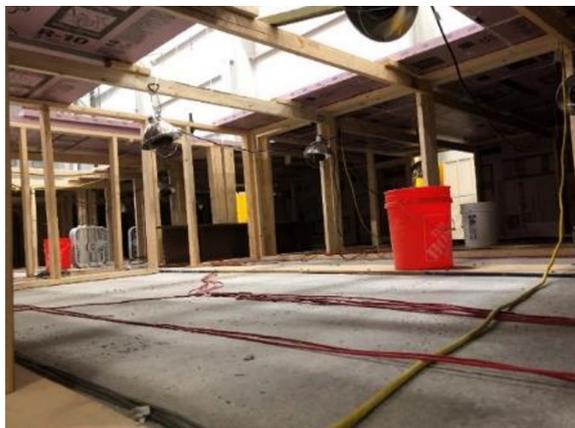
“Chimneys” at third points used to pour UHPC into the joints

To make the UHPC flow along the joints, the joints were covered with formwork both at the bottom and the top. Two openings were made on each joint, and “chimneys” were installed. The UHPC was placed into the joint through these chimneys. To simulate field conditions, the girders were heated the day before UHPC placement and again in the morning of placement to keep the girders as warm as possible during the placement process. When the crew was ready to grout the joints, the ceiling of the insulation box was removed to allow easy access of the joints to place the UHPC. Just before the UHPC was placed into the joints, the top forms were removed and a fine water mist was applied to wet each joint; then the top forms were screwed back into place. The UHPC was transferred from the mixer in buckets into the chimneys, which were placed approximately at third points on the joints (**Fig. 5**). This arrangement allowed the UHPC to flow in each direction. A hydraulic head was maintained in the chimneys to ensure that the entire joint was filled.

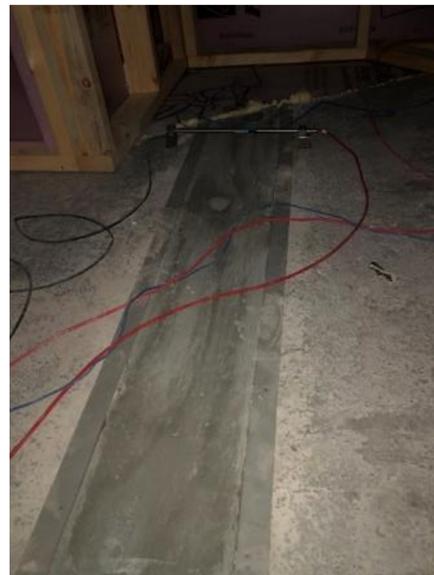
Top view of the UHPC joint between girders 2 and 3 after removing the formwork

After sufficient UHPC was placed into the joints, the insulated box was closed, and girders were heated again to regain the lost temperature gradient. Three days later, the forms were removed from the joint. Both joints turned out well. Figure 5 shows the top of the joint between girders 2 and 3 at the west end. The sealer material on each side of the joint was used to ensure that the UHPC did not leak out of the joint and gave an approximately 0.125 in. (3.2 mm) height above the joint. UHPC is often placed approximately 0.125 to 0.375 in. (3.2 to 9.5 mm) higher than the adjoining members in the field and ground flush.

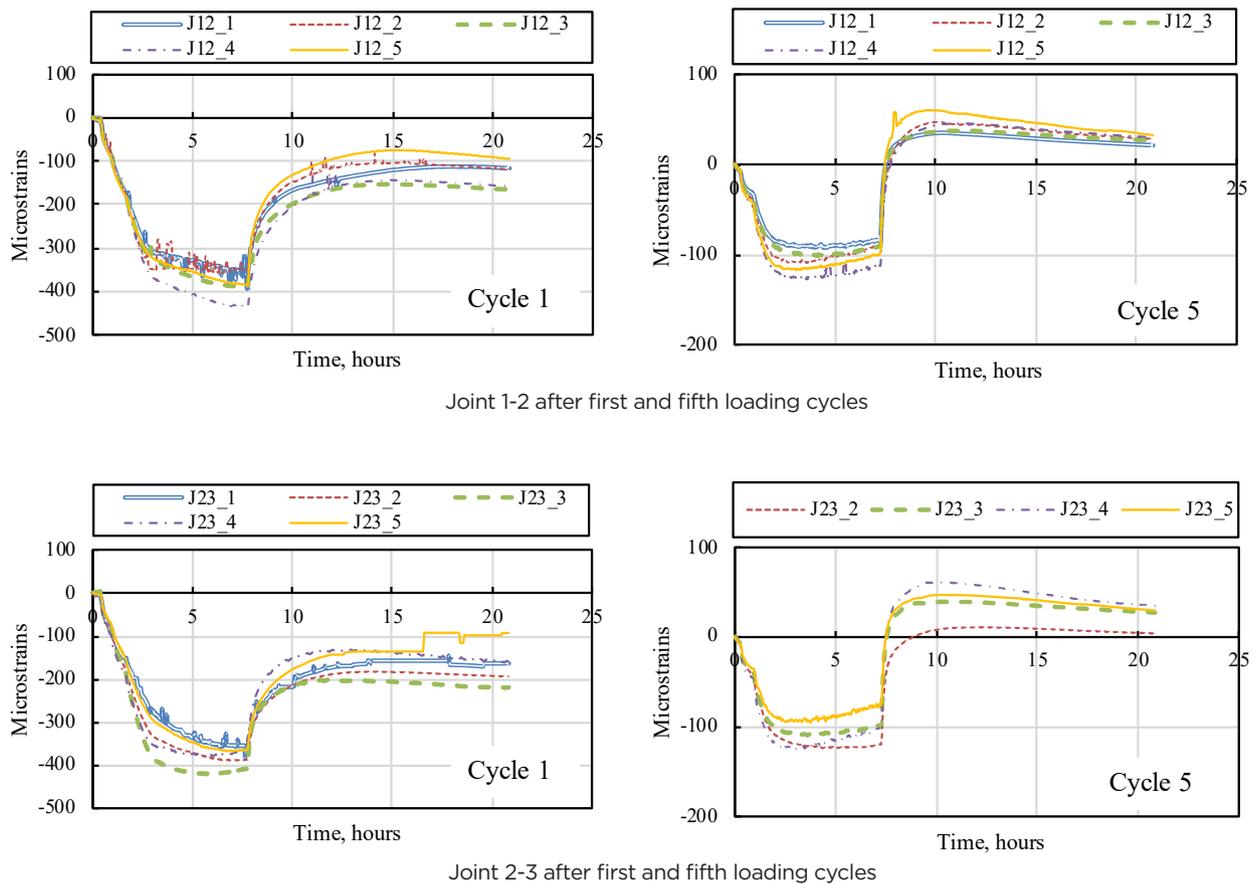
**Figure 6.** Strain across the joints during thermal loading of the girder system after placement of ultra-high-performance concrete in the longitudinal joints.

Figure 6 compares the strain across joints 1–2 and 2–3 during the first and fifth thermal cycles. During the first cycle, both joints developed a compressive strain in the range of 300 to 400 microstrains upon heating. Upon cooling, the strains reduced in magnitude but remained compressive. However, during the fifth cycle, the joints developed a compressive strain in the range of 80 to 120 microstrains upon heating and then, upon cooling, the strain became tensile in the range of 0 to 50 microstrains. These findings indicate that during the first cycle, when the UHPC joints were still gaining strength, they allowed the girder flanges to expand and therefore the

joints developed higher compressive stresses (300 to 400 microstrains). However, during the fifth cycle, when the joints had gained strength, they resisted the movement of girder flanges and therefore the compressive stresses were reduced (80 to 120 microstrains).

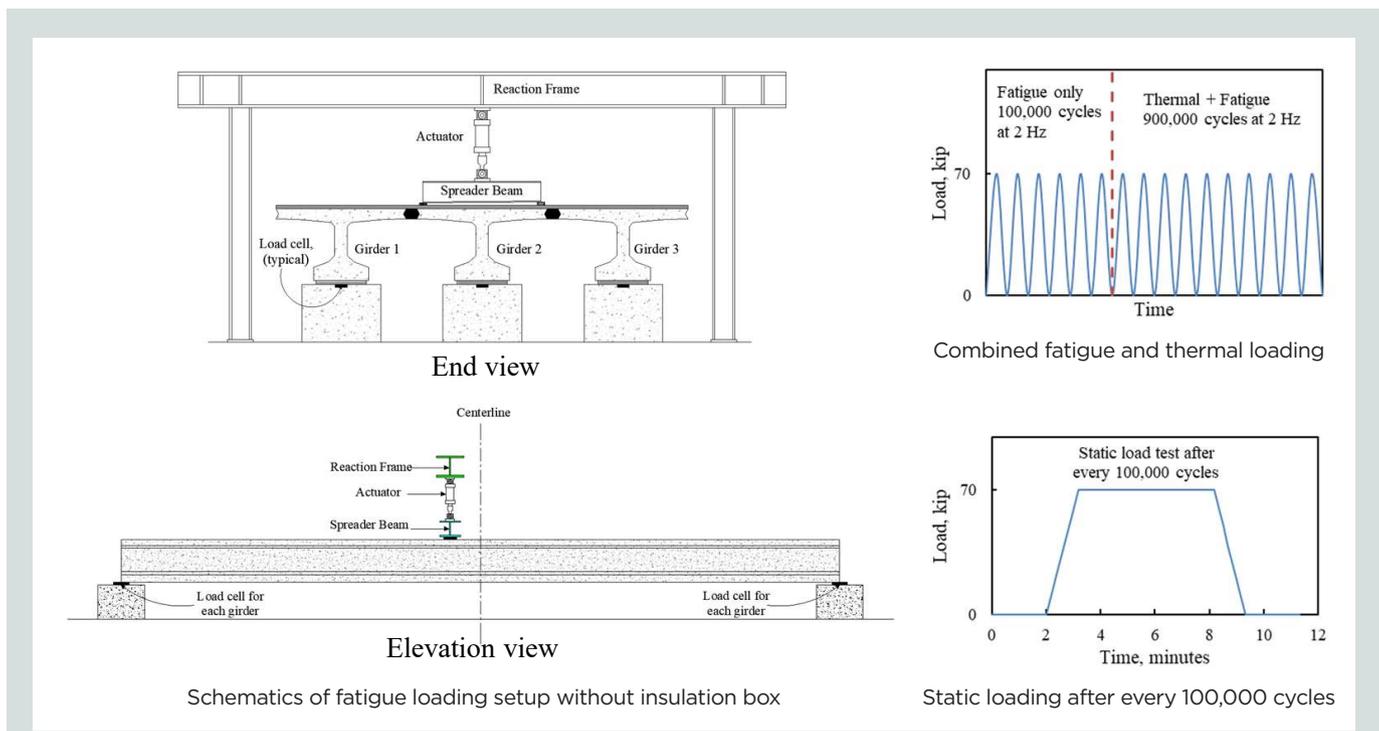
**Figure 7.** Combined thermal and fatigue load setup and loading protocol. Note: 1 kip = 4.448 kN.

**Combined thermal and fatigue loading** After the thermal cycles were completed, cyclic live loading was applied to the girder system. **Figure 7** illustrates the load setup without the insulating box in place. A cyclic load between 0 and 70 kip (0 and 310 kN) was applied at a frequency of 2 Hz. A total of 1 million live-load cycles were applied.

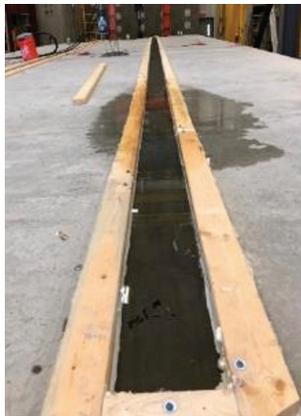
Dams filled with water

**Figure 8.** Joint flooding details.

**Joint flooding and inspection** After the combined thermal and fatigue loading was completed, the joints were visually analyzed. No cracking was visible. However, micro-cracking can be difficult to visually identify; therefore, joints were flooded with water to inspect for any leaks (Fig. 8). Dams were constructed and sealed around the top surface of the joints. These dams were then flooded with water. Flooding revealed severe cracking in joint 1–2 between girders 1 and 2.

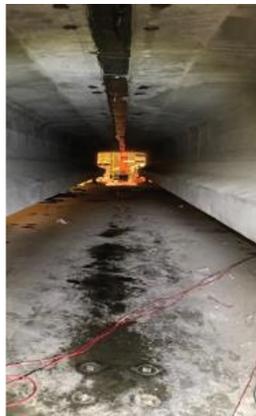
Puddles of water leaked from joint between girders 1 and 2

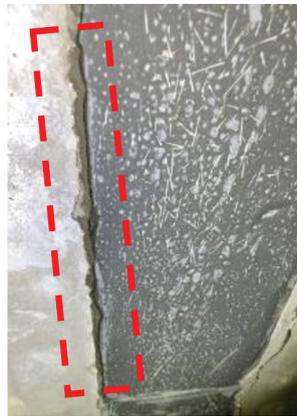
UHPC girder interface leakage

Joint 2–3 between girders 2 and 3 had a few small leaks. The leakage occurred both at the interface between the girder and the UHPC and within the UHPC.

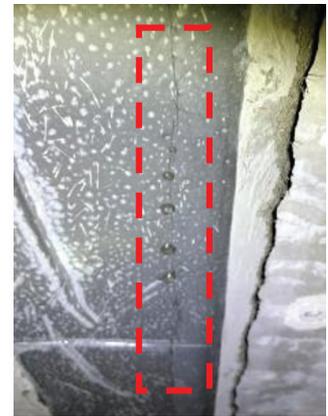
Leakage within the UHPC

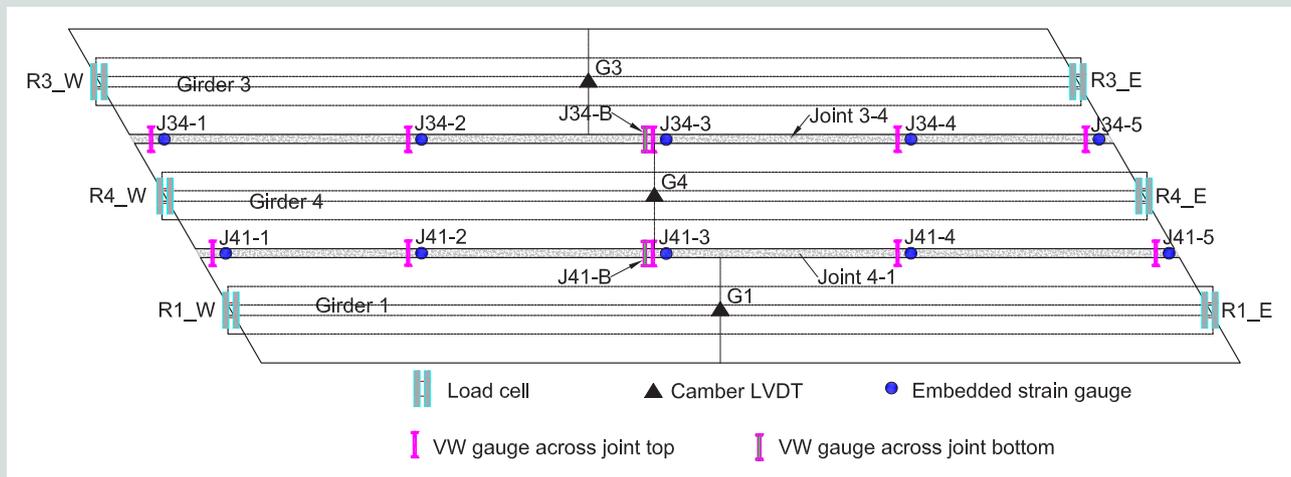
**Figure 9.** Instrument location and labels for differential camber testing of longitudinal joints. Note: LVDT = linear variable displacement transducer; VW = vibrating wire.

The instrumentation used to monitor the behavior of the joints was same as the instrumentation used in the thermal and fatigue tests, except that the vibrating-wire gauges were now used to record strain only. Because the girder assembly was changed for the differential camber testing, a new scheme of instrumentation labels (**Fig. 9**) was used to be consistent with the changed girder labels and to avoid confusion with the previous scheme of instrumentation.

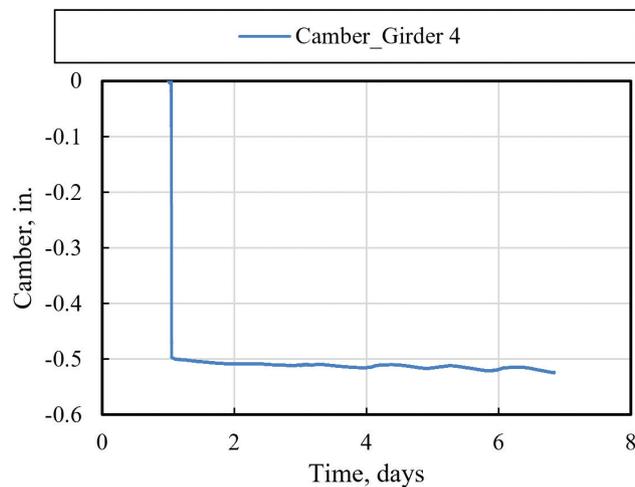
Deflection of girder 4 during jacking operation

**Figure 10.** Differential camber testing of longitudinal joints. Note: 1 in. = 25.4 mm.

**Leveling of camber and UHPC placement** The differential camber between girders was removed by loading the middle girder (girder 4) to approximately 90 kip (400 kN). This loading resulted in a downward deflection of 0.5 in. (12.7 mm) for girder 4. The hydraulic cylinder was locked off to hold the girder in position. The loading slightly decreased from seepage of the hydraulic pressure, creep of the girder, and settlement of the system. However, the downward deflection remained at approximately 0.5 in. to match flange heights (**Fig. 10**). Formwork was then attached to the girders and the UHPC was placed. **Table 4** presents the UHPC mixture proportions and fresh properties, and **Table 5** provides the compressive strength of the UHPC.

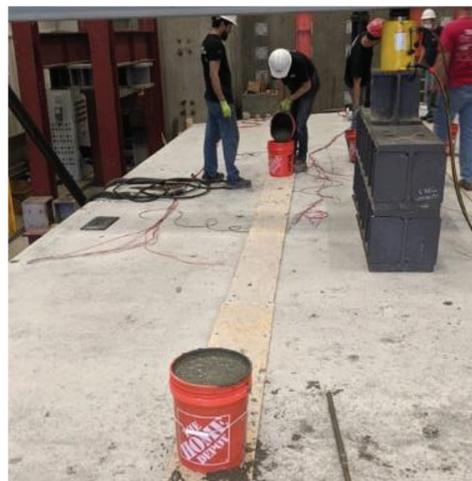
Grouting the joints with ultra-high-performance concrete with jacking in place

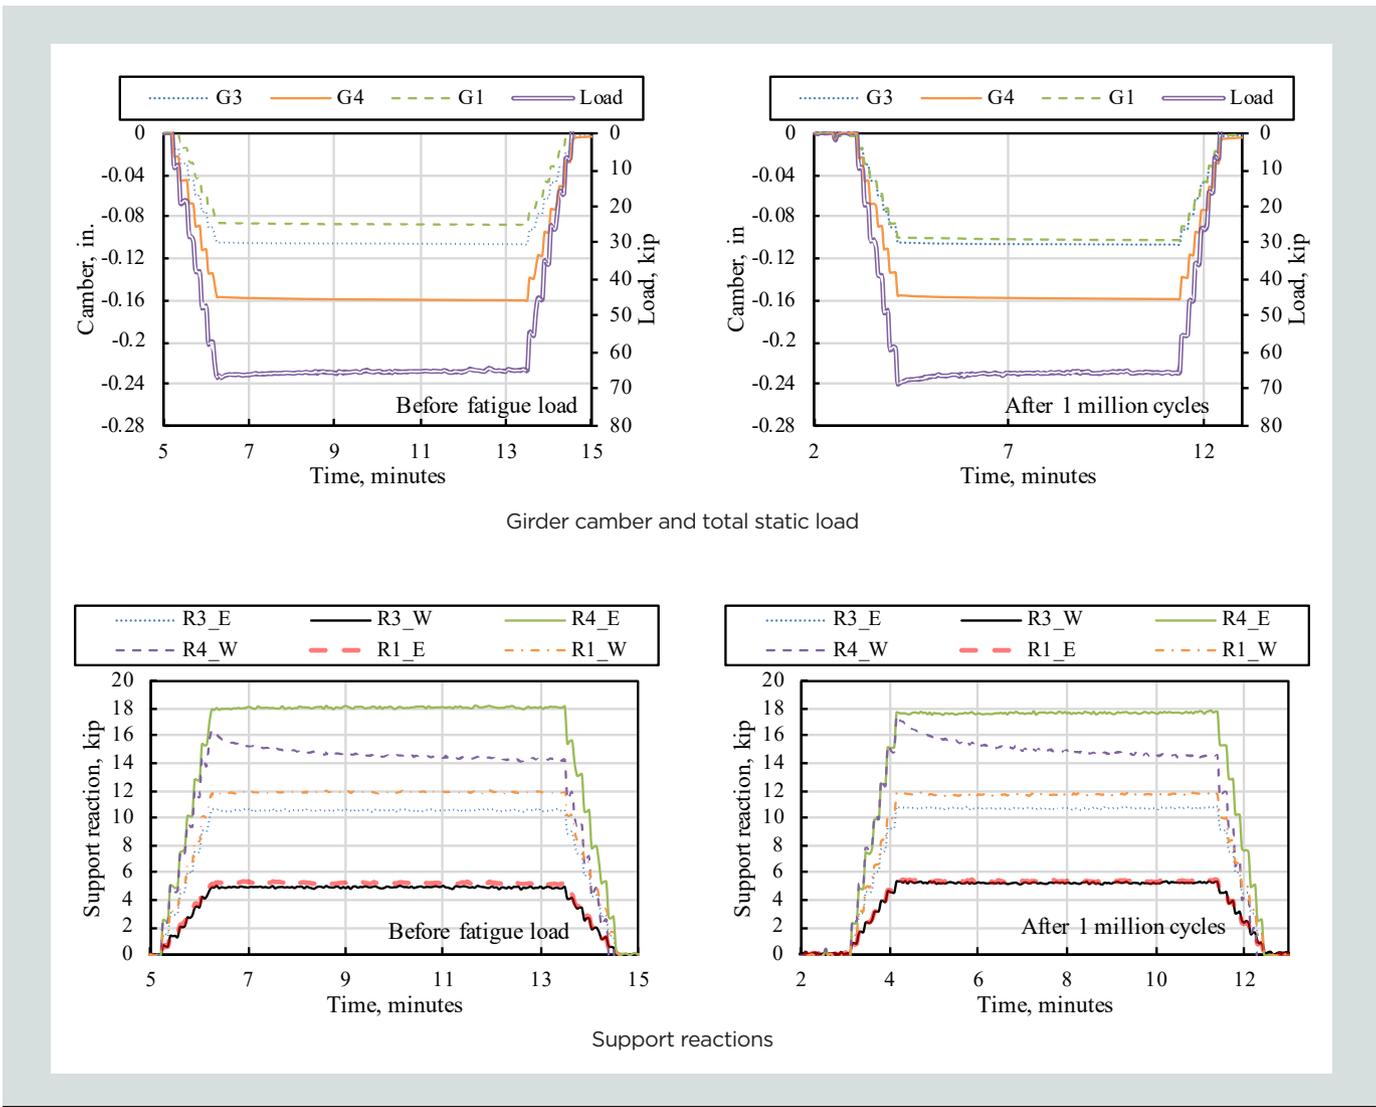
**Figure 11.** Results of static load tests at the beginning and end of the live load cycles for differential camber test. Note: 1 in. = 25.4 mm; 1 kip = 4.448 kN.

**Figure 11** plots the camber data from static load tests before the start of the load cycles and after completion of 1 million cycles of loading. The cambers at the start and end are nearly identical, indicating that the system did not degrade over the loading cycles. Figure 11 plots the support reaction data from the beginning of the experiment and after 1 million cycles of loading. The reactions are also nearly identical, indicating that the system did not degrade.

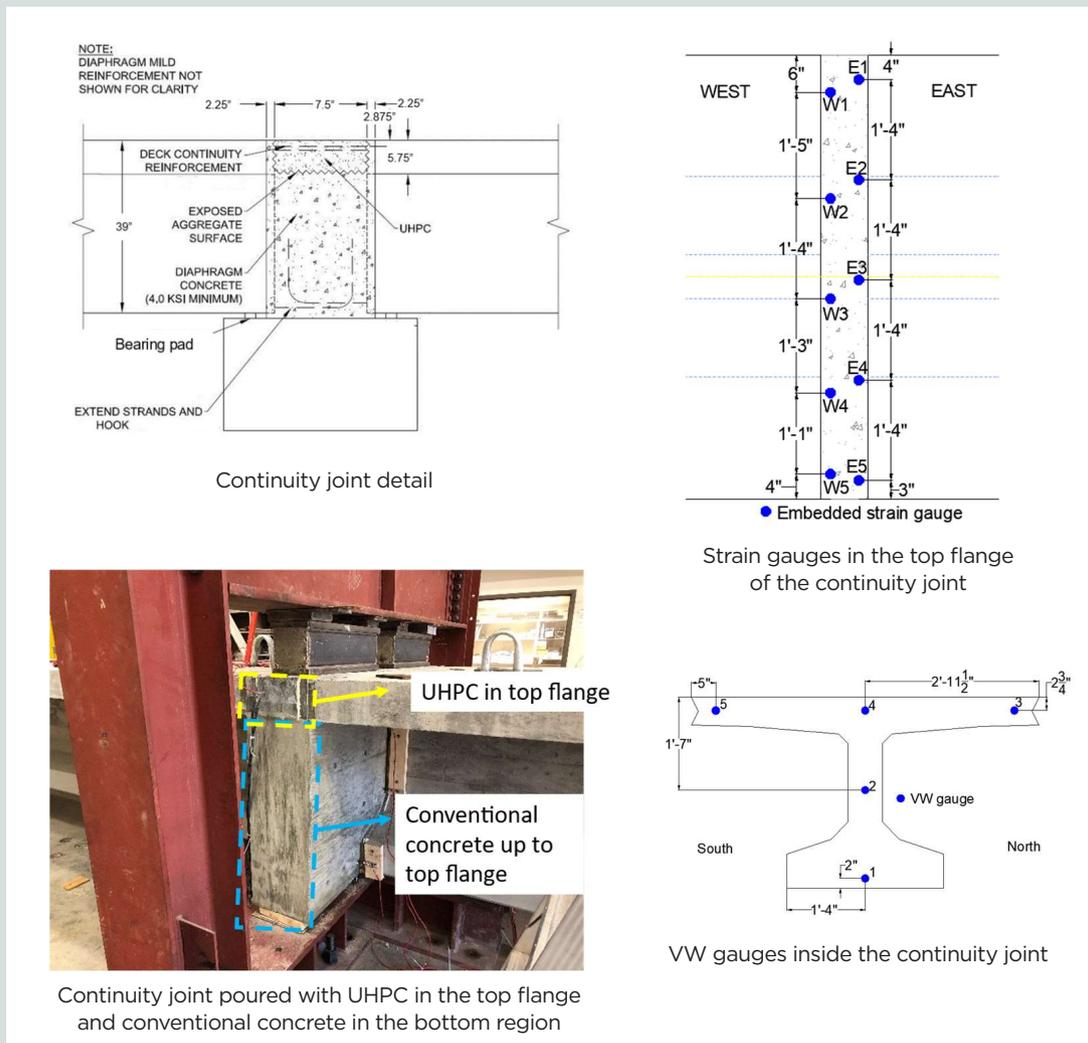
**Figure 12.** Continuity joint test setup details. Note: UHPC = ultra-high-performance concrete; VW = vibrating-wire. 1" = 1 in. = 25.4 mm; 1' = 1 ft = 0.305 m.

reinforcement in the diaphragm was provided according to the requirement of continuity joint design. In addition, welded wire mesh (12 × 12 in. [305 × 305 mm]) was placed to prevent shrinkage cracking. The bottom 33 in. (840 mm) of the diaphragm was constructed using conventional concrete. Eleven days after the placement of the concrete, the UHPC was placed only in the top 6 in. (150 mm) of the diaphragm, equal to the depth of the top flange. Figure 12 shows the continuity diaphragm after removal of the formwork. Instrumentation was installed within the joint and on the top reinforcement.

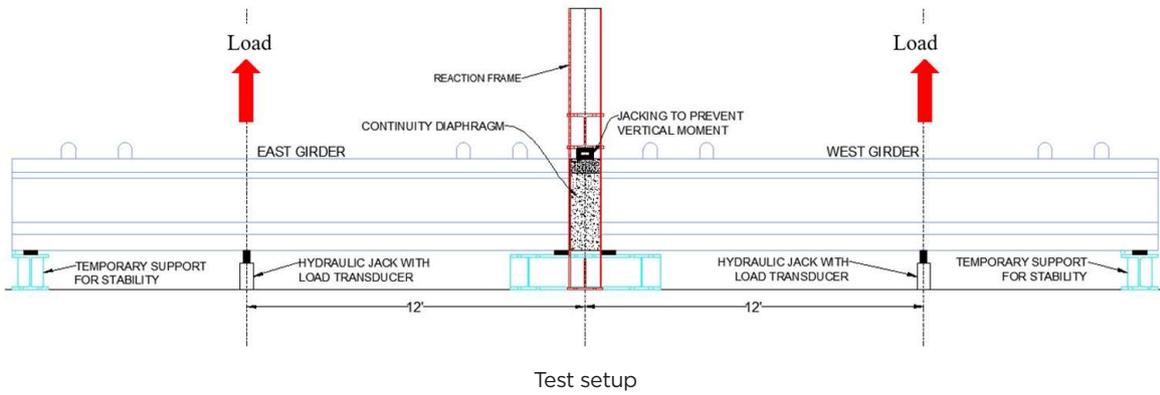
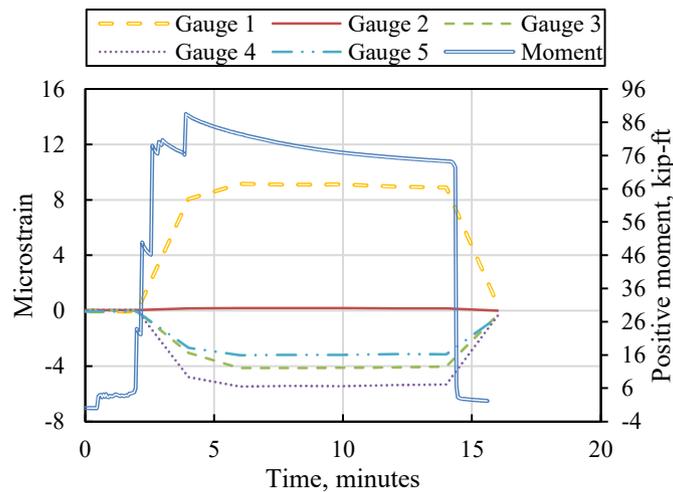
Vibrating-wire gauge reading and positive moments at the joint

**Figure 13.** Positive moment testing of the continuity diaphragm. Note: 1' = 1 ft = 0.305 m; 1 kip-ft = 1.356 kN-m.

the joint and the positive moment developed at the joint. The strains were very small. As expected, gauge 1 near the bottom of the connection experienced tension whereas the gauges in the flanges (gauges 4, 5, and 6) experienced compression. No cracking was observed.

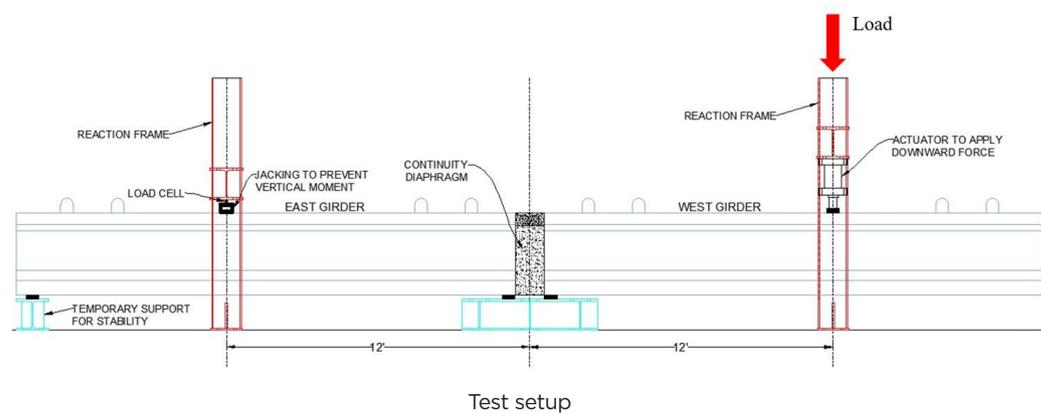
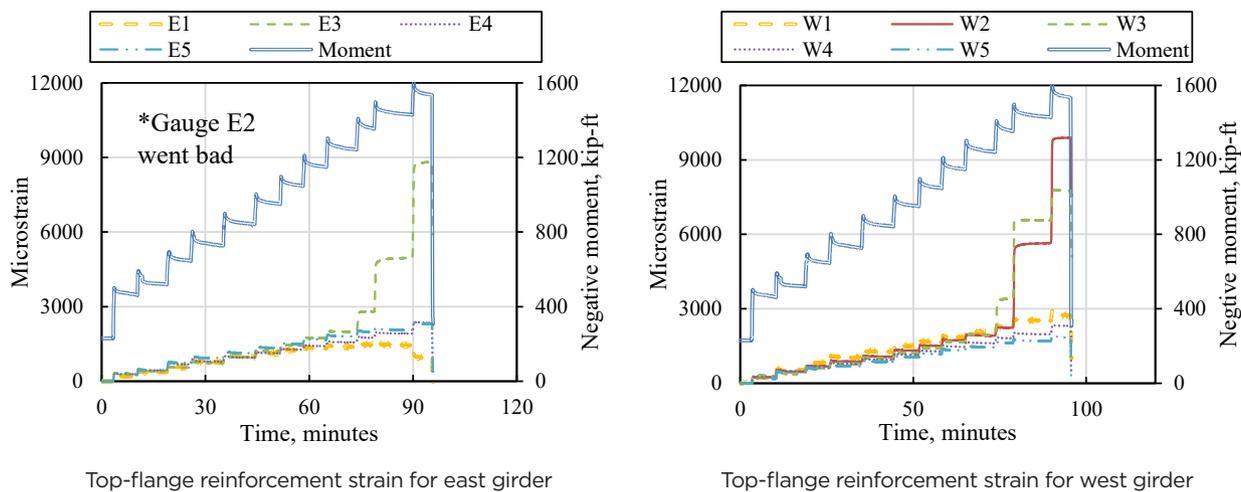
**Figure 14.** Negative moment testing of the continuity diaphragm. Note: 1' = 1 ft = 0.305 m; 1 kip-ft = 1.356 kN-m.

**Negative moment testing** To test the joint for negative moment, two frames were erected at 12 ft (3.7 m) on either side of the diaphragm. The east frame was hinged to the top flange of the girder to prevent vertical movement. On the west frame, a hydraulic cylinder was attached to load the diaphragm. **Figure 14** shows the schematics of the test. The temporary support on the west end of the girder was then removed to create a cantilever. The self-weight of the west girder resulted in a negative moment of approximately 230 kip-ft (310 kN-m) at the joint. An additional 114 kip (507 kN) load was applied through the hydraulic cylinder to create another 1311 kip-ft (1777 kN-m) negative moment at the joint. Tensile cracks formed at the top of the continuity joint due to negative moment. Most of the cracking occurred either in the girder flanges or at the interface of the connection. The UHPC did not crack.
