Rehabilitation for shear strength of prestressed concrete girders and continuity reinforcement of bridge deck slabs along with full load test verification

Durgesh Rai, Shambhavi Dube, and Vaibhav Singhal

Brief description of overpass bridge

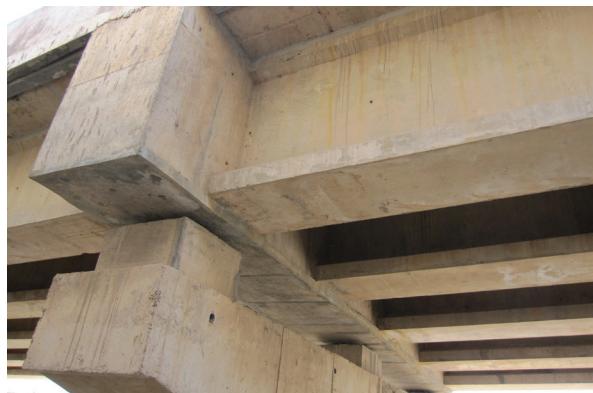
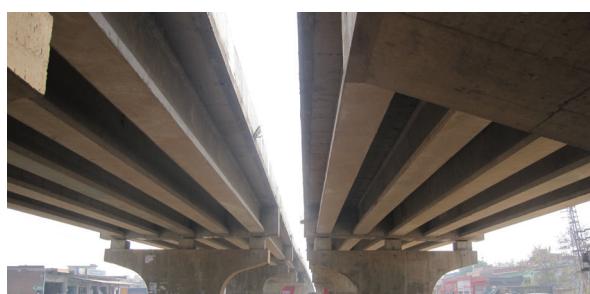
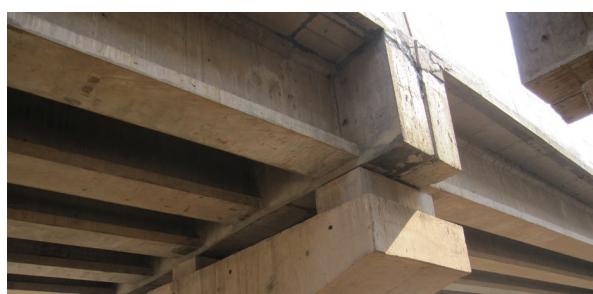
Figure 1. Details of bridge overpass. Note: All dimensions are in millimeters. A.C. = asphalt concrete; LHS = left hand side; POT = pot type bearing; PTFE = polytetrafluoroethylene bearing; RCC = reinforced cement concrete; RHS = right hand side; Typ. = typical. 1 mm = 0.0394 in.

View of the right hand side and left hand side carriageway of the overpass structure composed of three-span modules of simple-span precast, prestressed concrete girders made continuous and an expansion joint between three-span modules over the pier

continuity between the adjacent precast concrete girder spans was achieved through a cast-in-place reinforced concrete diaphragm of 1200 mm (47.2 in.) width with the girder ends embedded 150 mm (5.9 in.) into the diaphragm (Fig. 1).

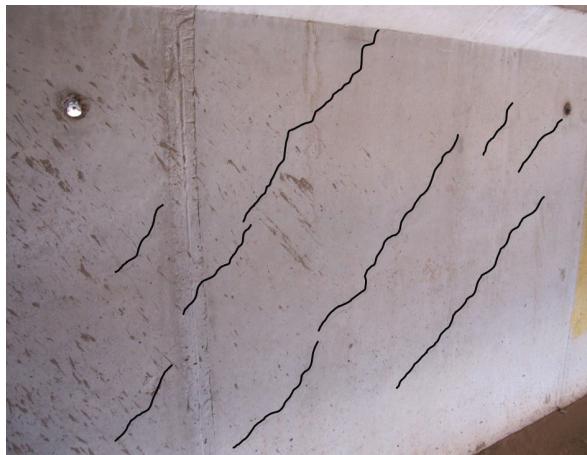
Figure 4. Cracks that formed within three months of conditioning. Note: Cracks in images have been enhanced for visibility.

Within three months of being commissioned, the structure experienced visible distress in the form of inclined web cracks near the ends of nearly all girders and transverse cracks in the deck slab running perpendicular to the carriageway (Fig. 4). A close inspection of girder cracks was performed, and the maximum crack width of about 0.45 mm (0.018 in.) was measured using a crack detection microscope. Figure 4 shows a cluster of downward-inclined cracks in one of the observed spans. Following the observation of distress, the bridge was immediately closed to traffic for safety. The rehabilitation project commenced shortly thereafter. Based on the nondestructive and concrete tests, the compressive strengths of M45 grade concrete were a characteristic compressive strength of cube at 28 days of 45 MPa (6.5 ksi) and cylinder strength of 36 MPa (5.2 ksi) for the prestressed concrete girders and the M35 grade concrete for the deck slab had a compressive strength of 35 MPa (5.1 ksi). These concrete compressive strengths were considered adequate for the assumed structural design requirements, which ruled out any material deficiencies as the cause of failure. Furthermore, no visible

Inclined cracks in the web of a prestressed concrete girder near its ends

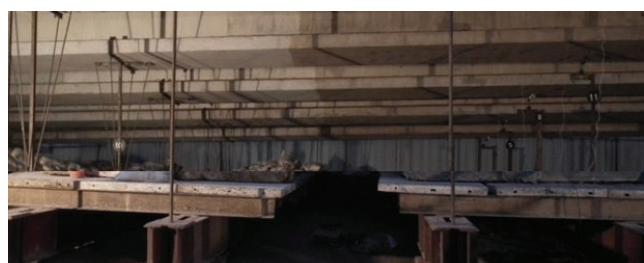
Figure 13. Typical loading arrangement and strain gauges to measure shear strains in steel plates for load cases 5 and 6. Note: 1 kN = 0.225 kip.

Platform with dead weights below the deck and arrangement for measuring girder deflection using dial gauges

Dial gauges of sufficient accuracy (0.01 mm [0.0004 in.]) were used to measure girder deflections at the quarter-span locations ($L/4$, $L/2$, and $3L/4$) of each loaded girder (Fig. 13). These deflection measurements were made only for the loaded spans in each load case. For temperature corrections to these deflections, the girder deflections, along with the temperature measurements in the unloaded condition, were recorded from dawn to dusk in the days preceding the load test. The observed girder deflections with a change in the ambient temperature were used to correct the deflections observed during the load test by compensating for the thermal deflections. Calibrated thermocouples were used to monitor the temperature of the deck slab and prestressed concrete girders during the load testing.

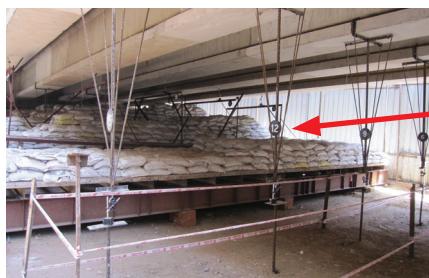
Dial gauge

Arrangement for measuring girder deflection using dial gauges

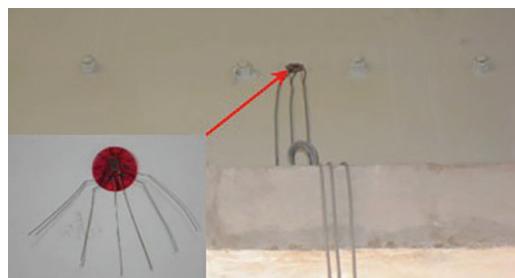
Electric resistance strain gauge rectangular rosette installed on steel plate
